SUMMARY OF UNDERWATER ROBOT SURVEY OF PASSENGER FERRY ESTONIA 14-15.07.2021

20.07.2021

According to the order of the Estonian Safety Investigation Bureau (hereinafter ESIB), Tuukritööde OÜ carried out underwater robot survey at the wreck of the passenger ferry Estonia between 14 and 15 July 2021 to check the images and objects on the sonar images.

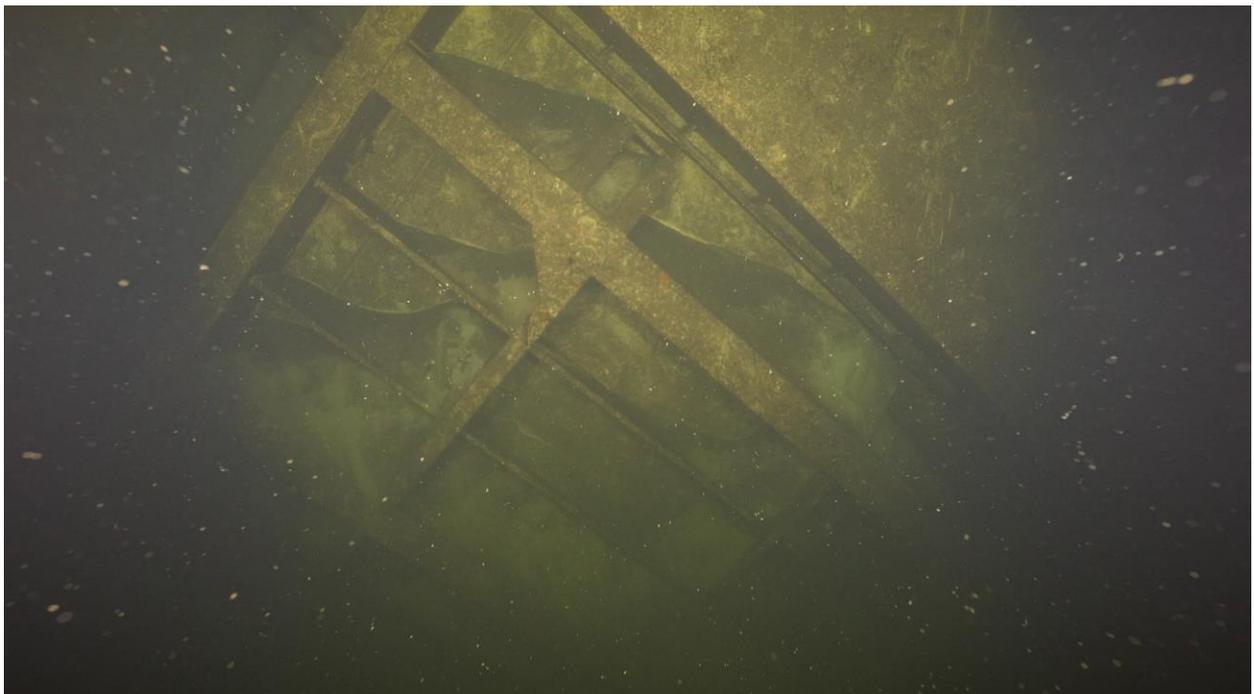
Work was performed in the stern part of the wreck to determine the position and condition of the stern ramps, the condition of the rudder blades and propellers, and the mudline in the stern part. During the works it became clear that the stern ramps are in the closed position: 15.55

No damages were discovered on the outer sides of the stern ramps. The lower right stern corner of the hull is partly inside the ground.

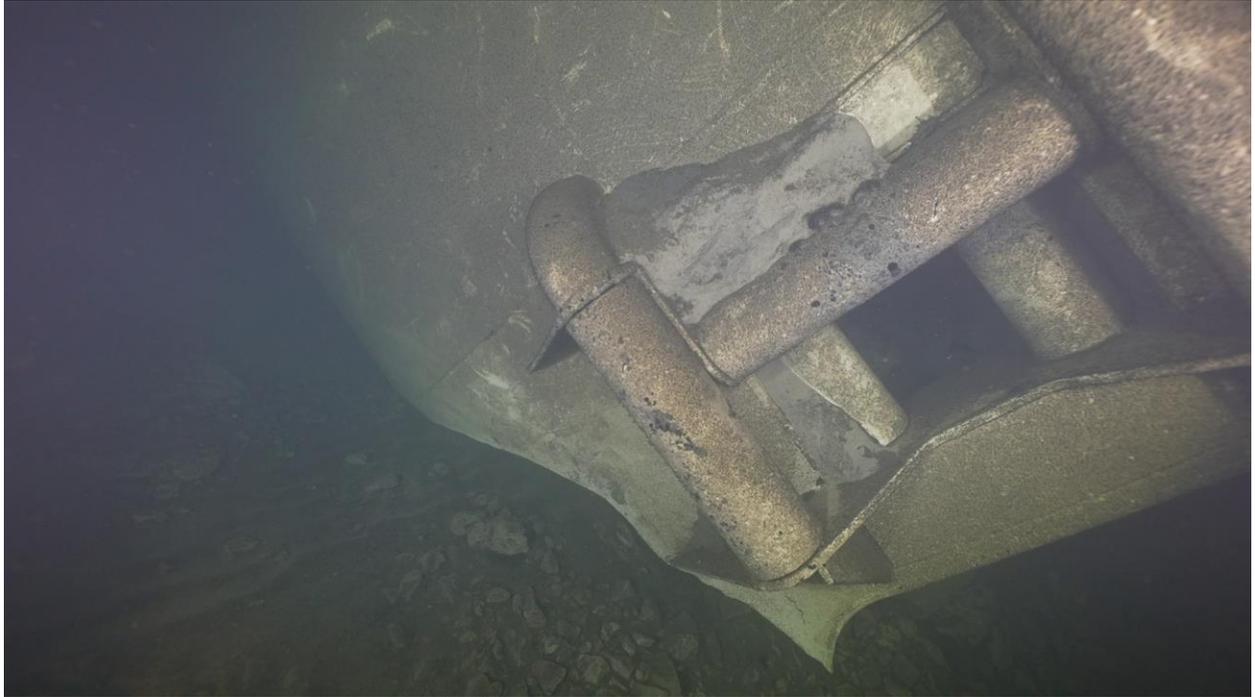
One can see a fairlead with rollers and gravel used for wreck covering works:
21.13

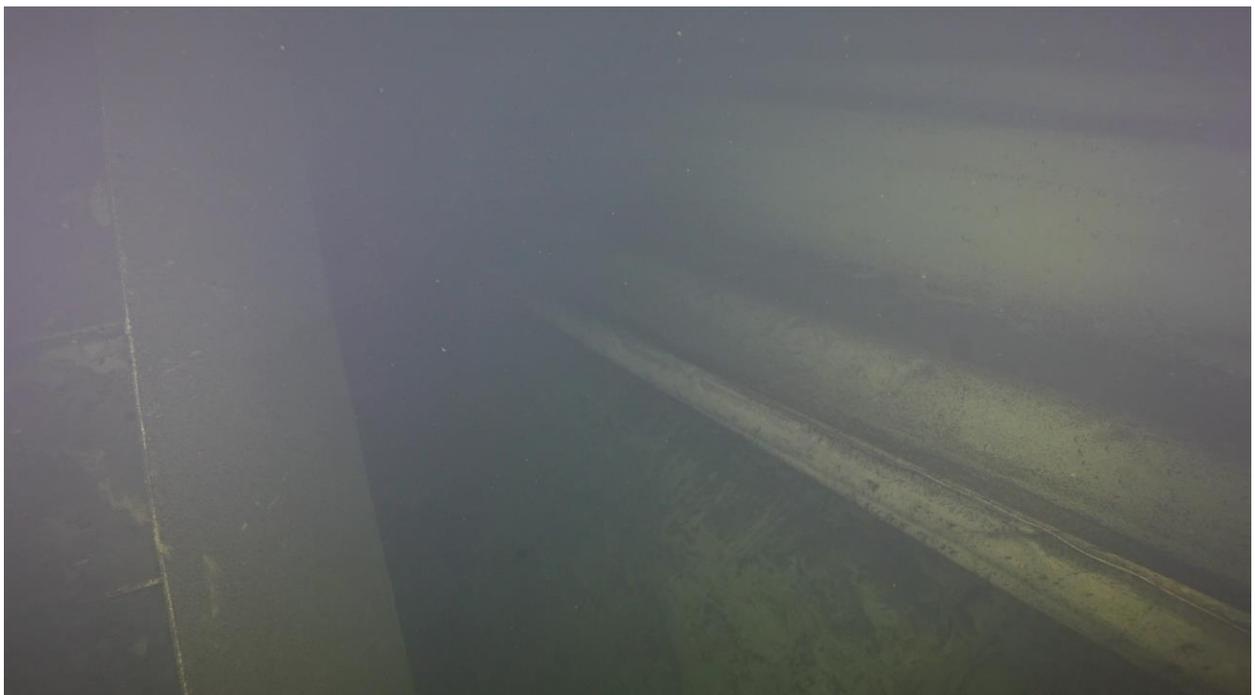
One can see a geotextile or a detail of the superstructure lying on the seabed behind the stern (pictured on the right): 22.23

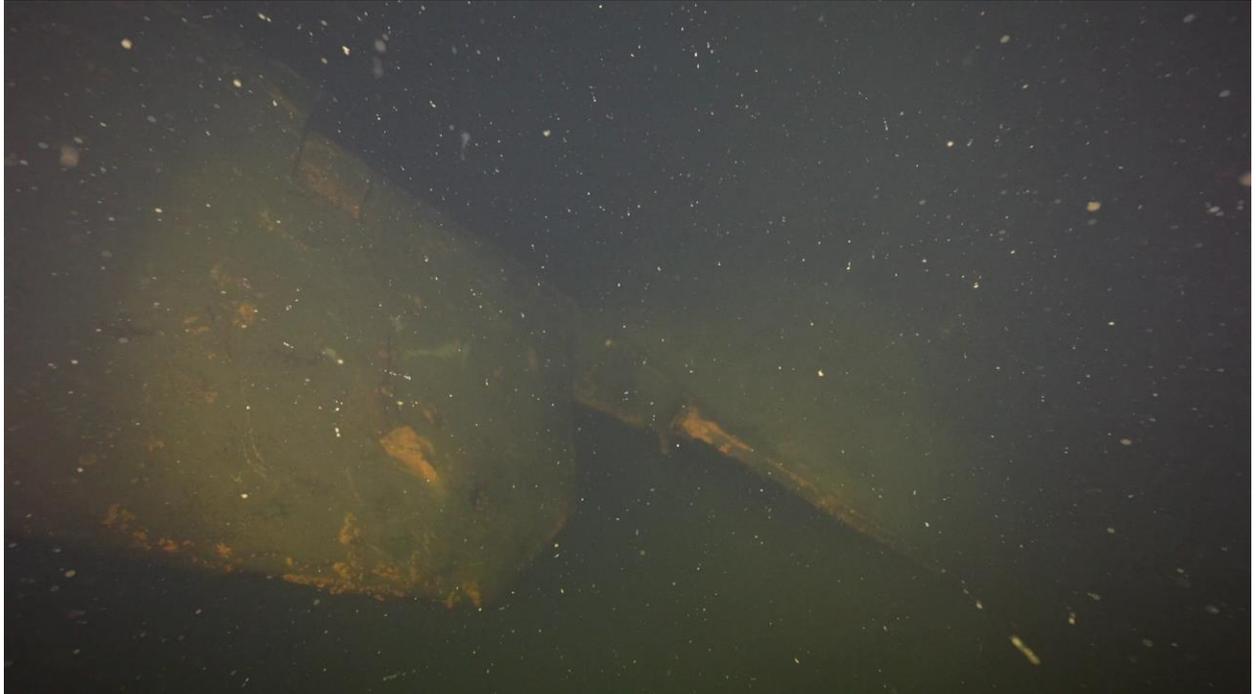
Both rudder blades were on the starboard: 30.14 and 38.14 No damages were identified.

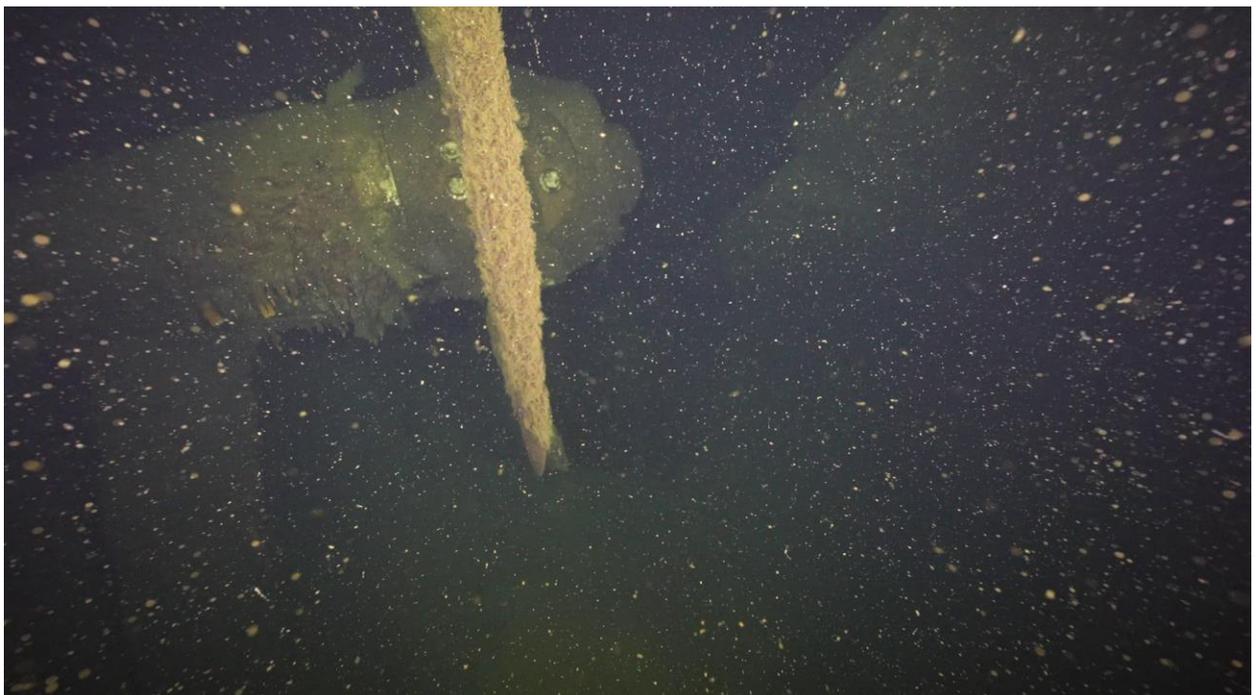
Both propellers are without any visible damages.
The propeller blades are in neutral position: 31.40

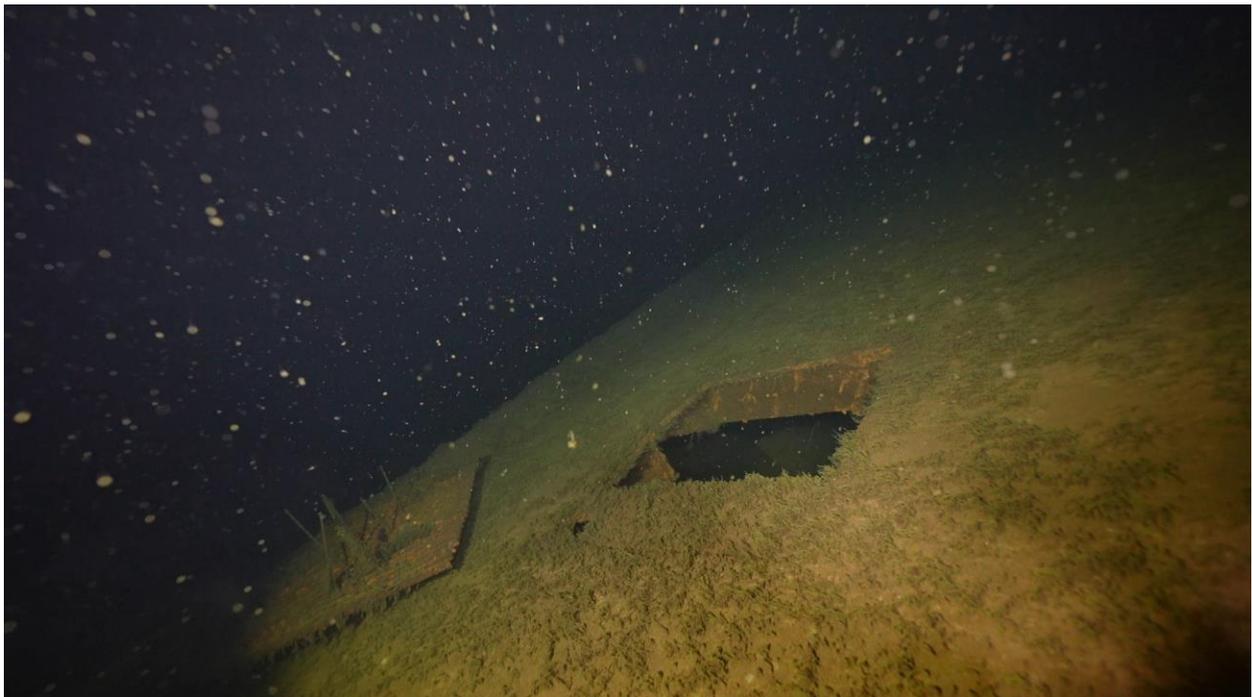
Next it was headed upwards to the port side (1.25.00), where the condition of the centre part of the flat bottom of the vessel and an inlet on the port side cut into the hull (1.35.34) during the diving survey in 1994 was observed, and the metal truss that was used to close it with a cut-out piece of the hull.

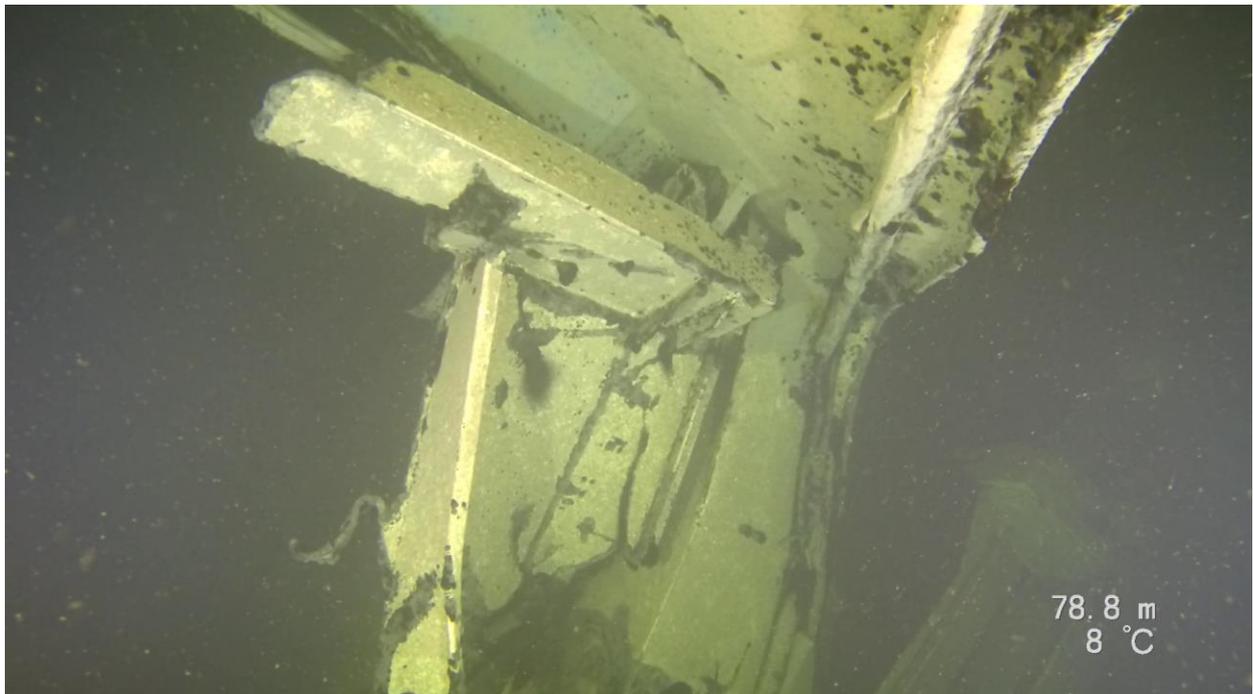
55.06 A closer look shows how the stiffeners, plating and welds are torn on the fragment. Next to the longitudinally hanging longitudinal stiffener, one can see a strip of torn and rolled steel plate.

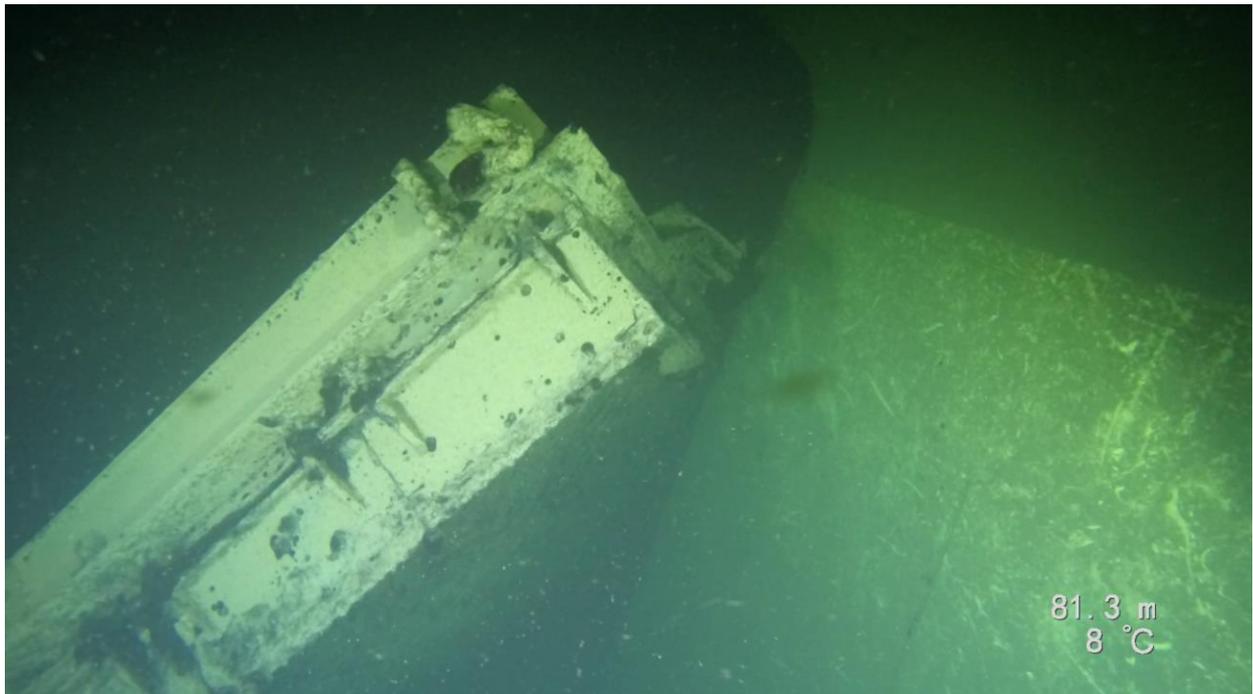
1.03.30 Back again next to the draught marks on the starboard side of the bow and descending to the bow ramp: 1.06.32

1.08.05 The hinge lugs of the bow ramp are being observed, moving from top to bottom, i.e. from the left side of the normal position of the ramp towards the right side. It can be seen that both of the lugs of the hinges on portside are strongly deformed, the lugs of the second hinge from the left are broken/torn.

1.08.47 Two hinges on the starboard side are missing (torn off with the corner of the ramp).

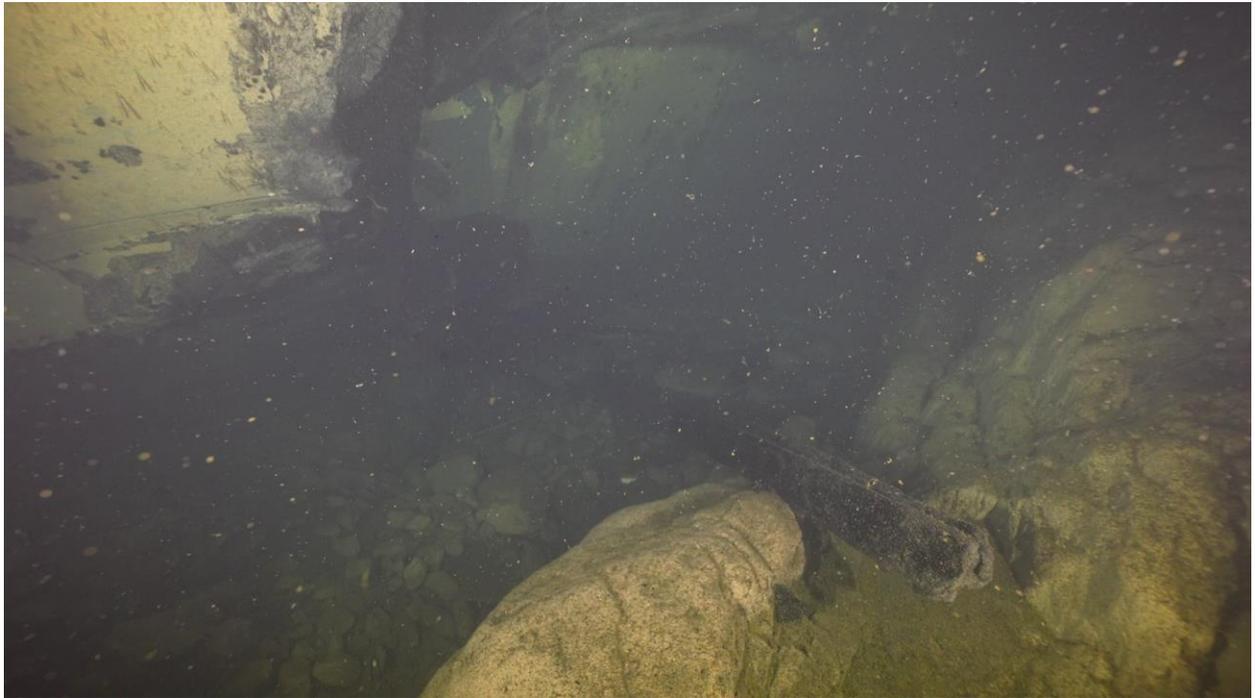
25.03 Even steeper ascent and rupture in bow side. One can see a stronger base and the slope of the moraine layer on it.

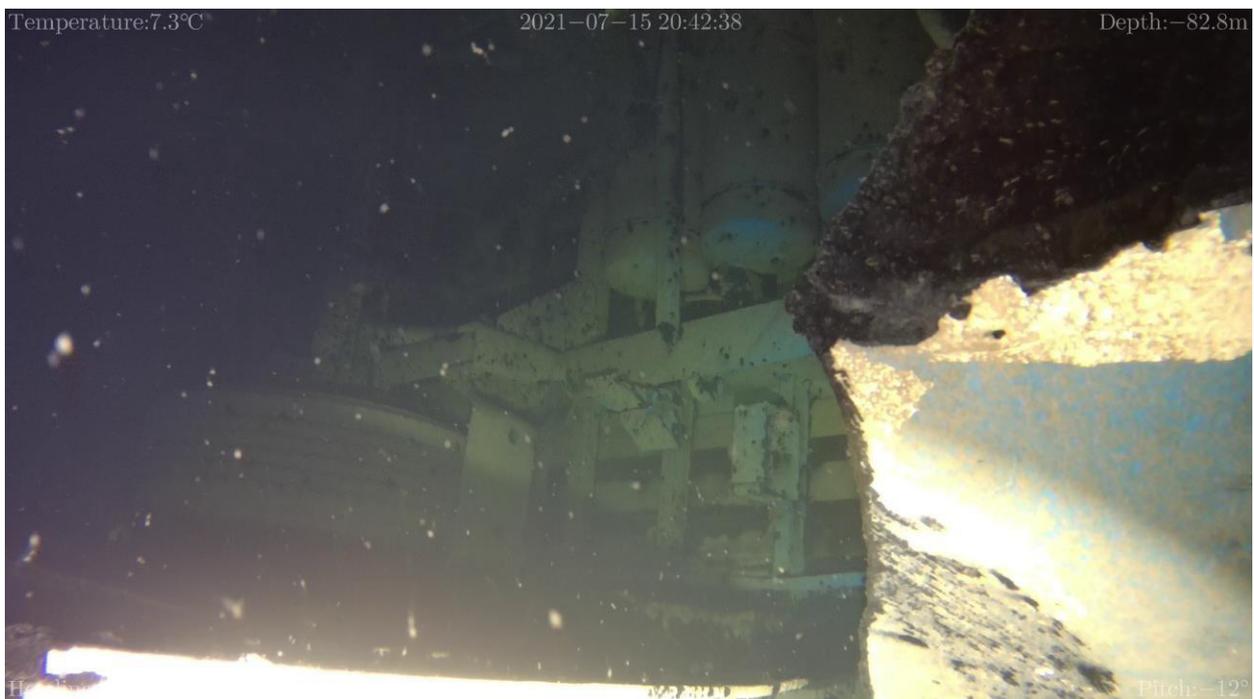
The rupture runs through the hull at a depth of 82.2 m from the 50 mm outlet.
The central part of the rupture and the torn beam at a depth of 83.1 m.
We push the drone into the opening and see the frame and axle of a truck turned upside down on the car deck 27.43

The rupture opening has been formed exactly at the level of the car deck.

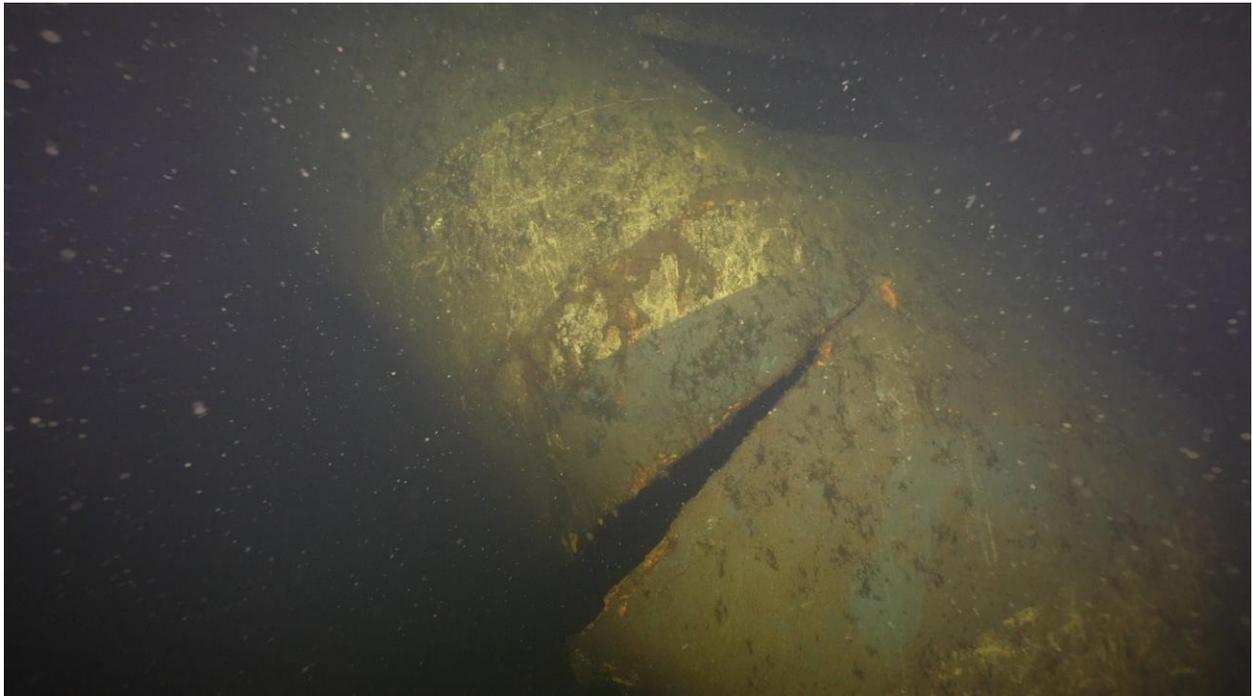
- 08.29 Bridge windows
- 13.09 We continue moving towards the stern along the edge of deck 6.
- 21.03 H-beam section lying on the edge of the deck
- 22.43 Larger windows without glazing
- 24.49 Left side passenger corridor door opening closed by divers.
- 28.35 A window with bars
- 29.17 Deformation and cracks near the edge of the deck
- 29.50 A window with bars
- 30.09 Deformation and cracks near the edge of deck 6
- 30.50 Deformation and cracks continue
- 31.20 Deformation and cracks
- 32.47 Deformation and cracks
- 34.40 Same
- 39.45 Visibility significantly better as we ascended: 68 m
- 40.50 The pillar of the stern mooring deck on the port side is open and its deck beams are clearly deformed.
- 48.10 A rupture in the stern corner of deck 6.
