**PART-REPORT**

**MV ESTONIA**

Our date  
April 1995

**Part-Report on the ESTONIA Disaster of 28 September 1994**

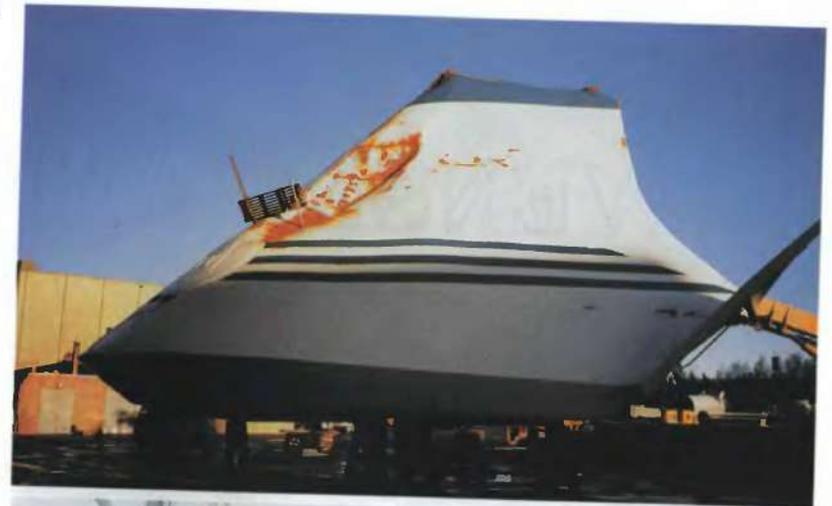
FIG 10.1  
The bow visor  
as recovered and  
brought ashore

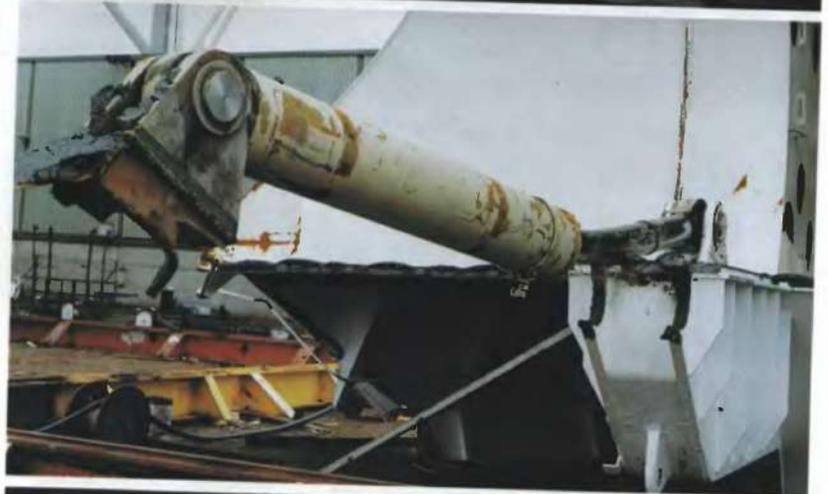
FIG 10.2  
The visor  
starboard side  
actuator

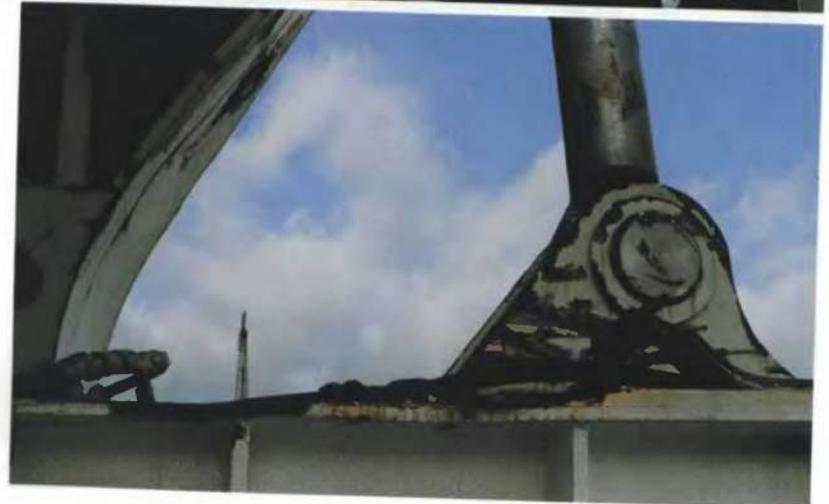
The hinge bushings at the end of the hinge beams had separated from the beam side plates due to failure of the side plates and the welds around the bushings.

It is regarded as likely that the forces to cause the hinges to fail were created when the hinge arms started to contact the upper deck as a consequence of compression of the visor bottom structure. The leverage thereby created in combination with the mass forces generated when the visor was pounding on the forepeak deck were more than adequate to pull the hinges apart.

FIG 10.3  
Damage in the area  
of the hinge beam  
and the actuator  
attachment lug,  
starboard side

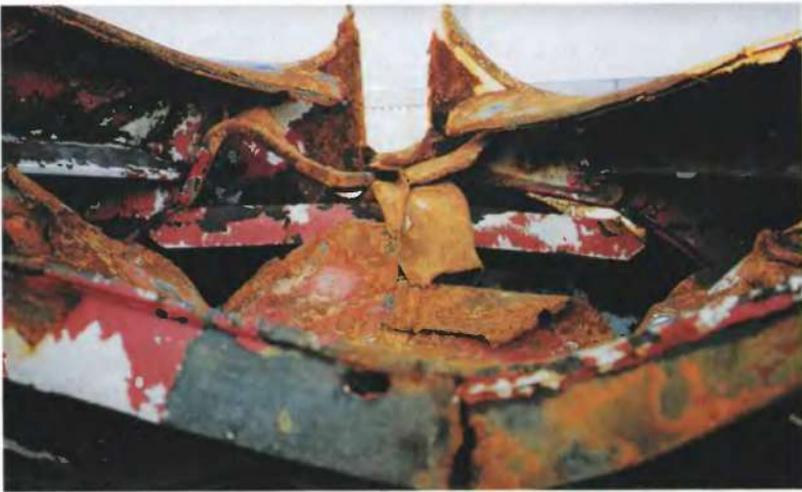
**FIG 10.4**  
Damage to the  
bottom structure  
of the visor

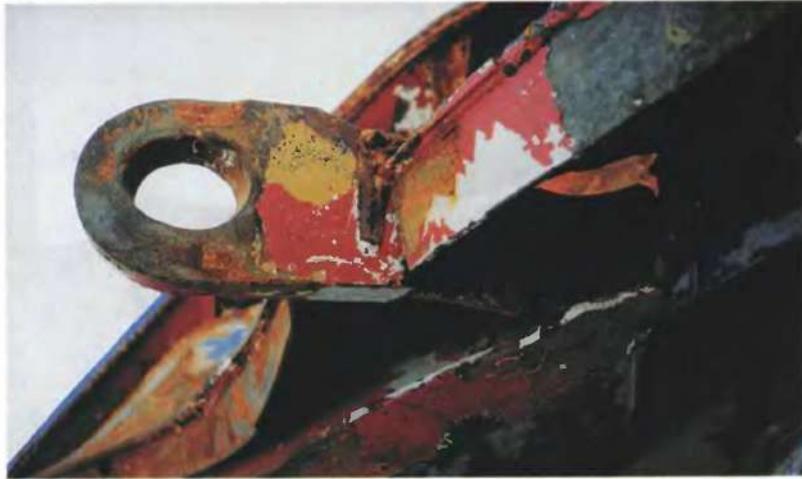
The mating lug in the bottom structure of the visor consisted of a single steel lug, welded to a transverse beam of the visor bottom structure and supported by a bracket as shown in Figure 5. The lug had a hole for the locking bolt with an original diameter of 85 millimetres. The diameter of the hole had increased in service and after the accident the hole was oval with dimensions about 90 x 105 millimetres. The elongation may have been caused by wear or by yielding during the failure of the locking device.

**FIG 10.5**  
The visor lug for  
the bottom lock

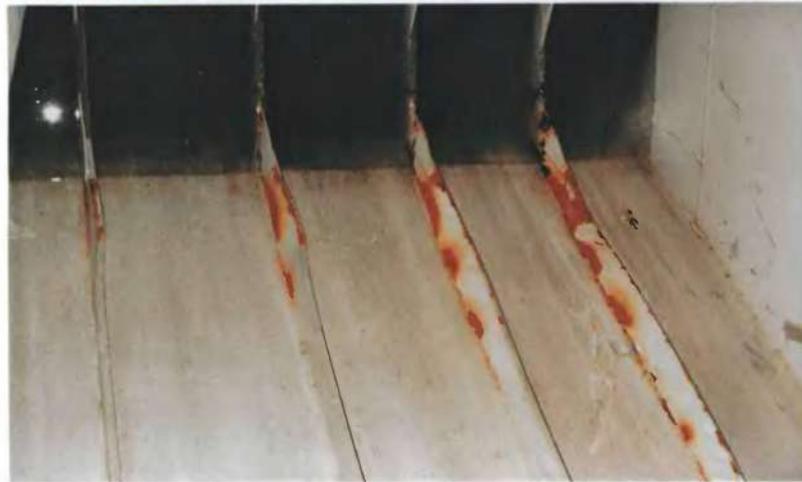
The box on the visor deck had impact damage to the port part of its aft inner wall, including bent and dented bulb bars.

**FIG 10.6**  
Damage to  
the aft wall of the  
visor deck box

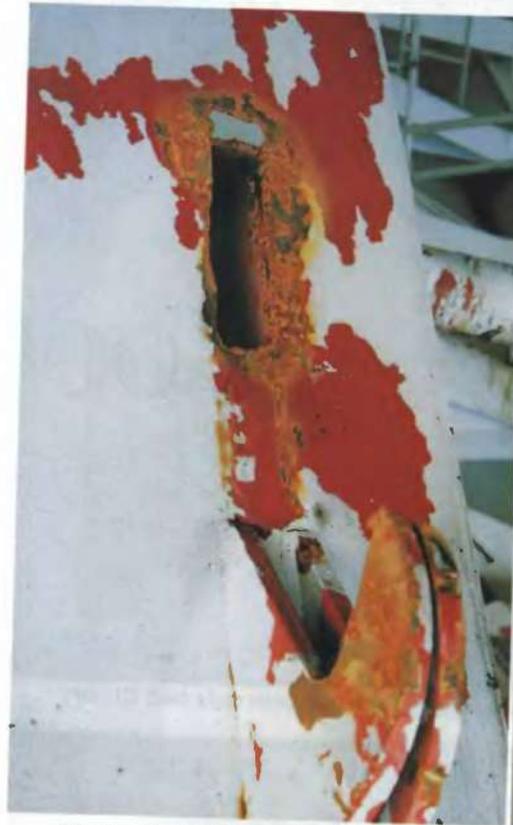
The lugs were ripped out of the visor plating together with part of the plating itself, leaving rectangular holes with fracture surfaces in shear. The lugs remain in the wreck. The bottom surface of one of the lugs is shown in Figure 14.

**FIG 10.7** Damage from separation of a side locking lug

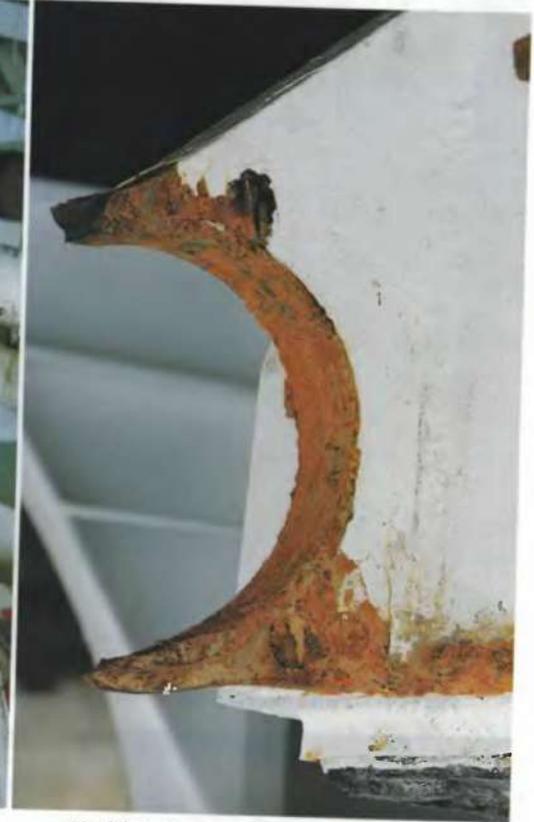
The failure of the lugs at the hinges took place in tension. The fracture surfaces indicate that the failure took place in a monocyclic overload condition. The lugs and the welds of the hinge bushings have undergone metallurgical and strength investigation which will be reported in an appendix to the final report.

**FIG 10.8** A failed visor hinge

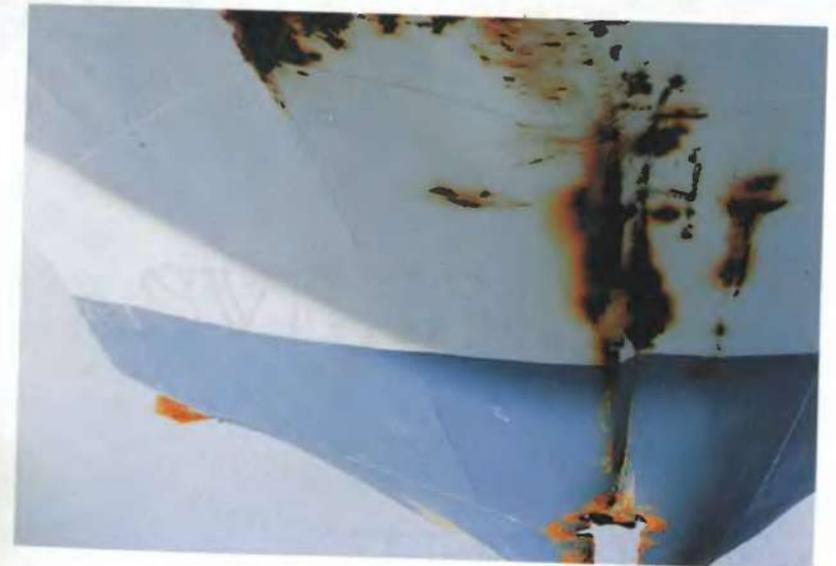
sequence the visor was beating on its three bottom resting pads, the main one being the visor stem post, which was in contact with the ice-breaking stem. The stem post separated from the visor due to failure of the attachment welds in consequence of this hammering. The violence of the pounding action caused the stem post to leave the visor with a considerable upward velocity, creating a sharp indentation in the front of the visor for a length of about 2 metres as shown in Figure 10.

**FIG 10.9**  
Damage to the visor  
front, including  
indications of  
separated stem post

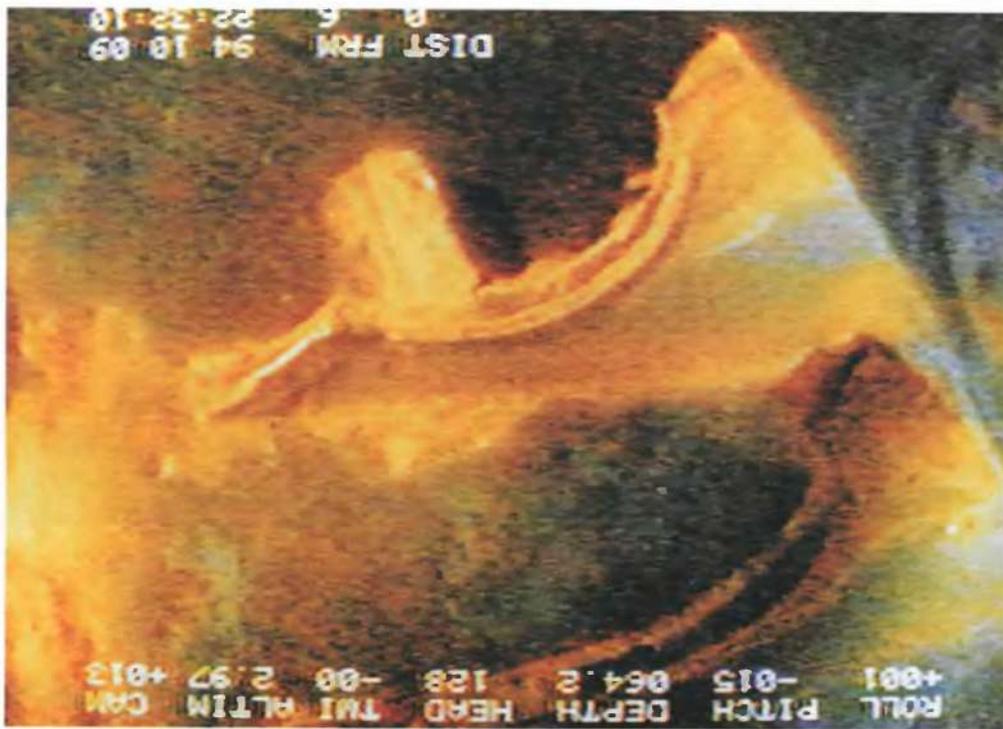
The bottom locking bolt housing was torn away as well as the support bushing. All three attachment lugs were fractured in their thinnest cross sections. The welds between the lugs and the housing and bushing respectively had failed. The locking bolt remained attached to the piston rod of the actuating cylinder.

The bottom locking device failed in its attachments to the fore peak deck. The failure took place in the plate lugs carrying the bolt housing and the mating support bushing and in the weld around the housing and the bushing.

The failed lugs were recovered from the wreck and have undergone metallurgical and strength examination of the fractured surfaces and of the base material as will be reported in detail in an appendix to the final report. All indications are that the lugs failed in an overload condition with a low number of cycles. The general appearance of the failed lugs is shown in Figure 13. The failure in the weld was partly in the beads and partly through separation between the weld and the housing material. The thickness of the weld beads was about 3 millimetres.

FIG 11.1 Failed mounting lugs for the bottom lock

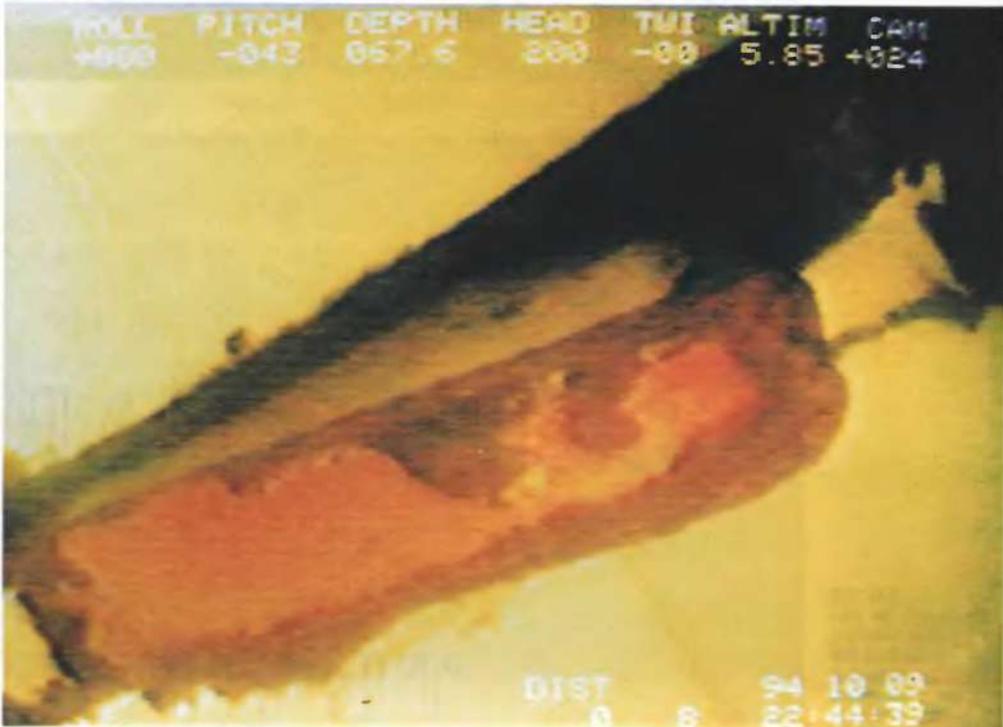
The side locks failed at the attachment of the lugs to the visor aft plating. No detailed drawings have been found, that show the exact dimensions of the lugs, nor details of the welding of these to the visor plating. The lugs had a bottom length of about 380 millimetres as measured at the attachment remains on the visor, compared to about 480 indicated on general arrangement drawings.

FIG 11.2 Bottom face of a side locking lug

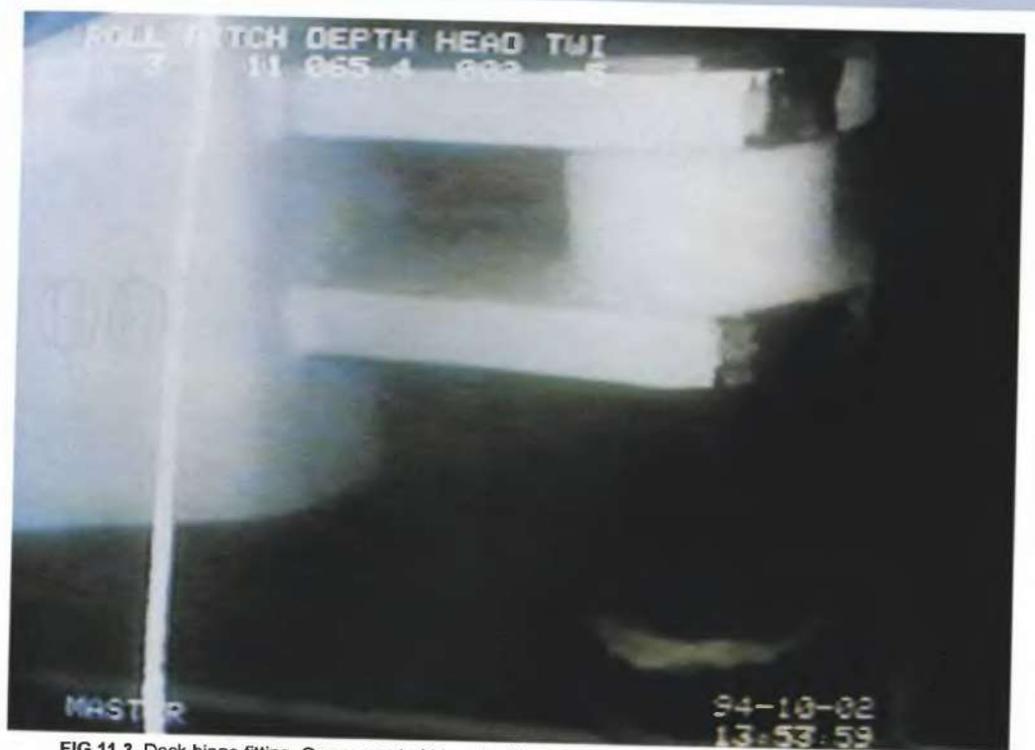
FIG 11.3 Deck hinge fitting. One separated hinge bushing visible at bottom picture.

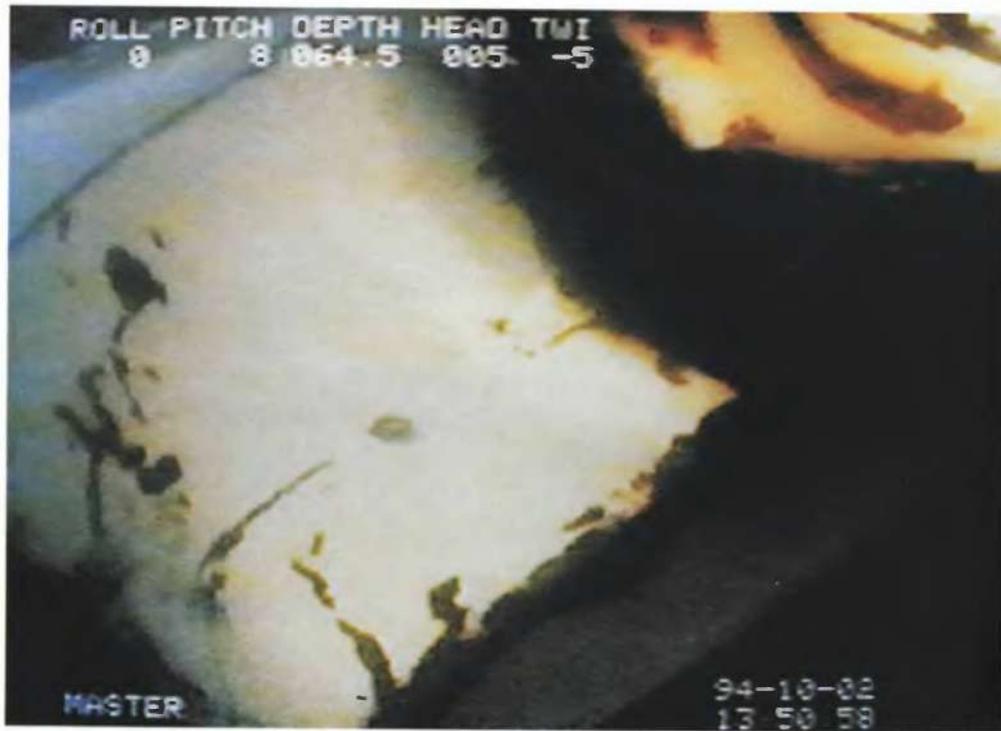
FIG 11.5 Damage on front bulkhead caused by actuator during movement of visor

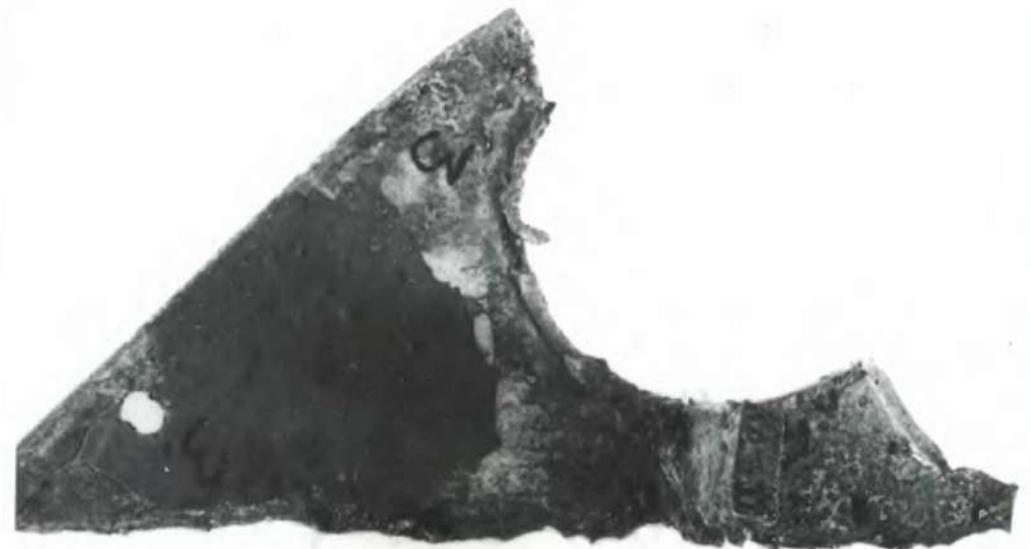
The load-carrying capability of the bottom lock assembly has been estimated according to different calculations to be in the range from 90 to maximum 150 tons. The calculations take into account the cross section of the fractured surfaces of the lugs and a contribution from the weld joints.

The actual failure load was most likely less as the lugs may have failed in sequence. The gap between the housing and the bushing was 100 millimetres compared to the 60 millimetre thickness of the mating lug on the visor. The actual transverse position of the lug on the locking bolt would influence which lug would carry the major part of the load and thereby fail ahead of the other one. The deformation of the visor lug indicates that the single lug for the support bushing failed first.

FIG 13 Details of failed mounting lug for bottom locking device

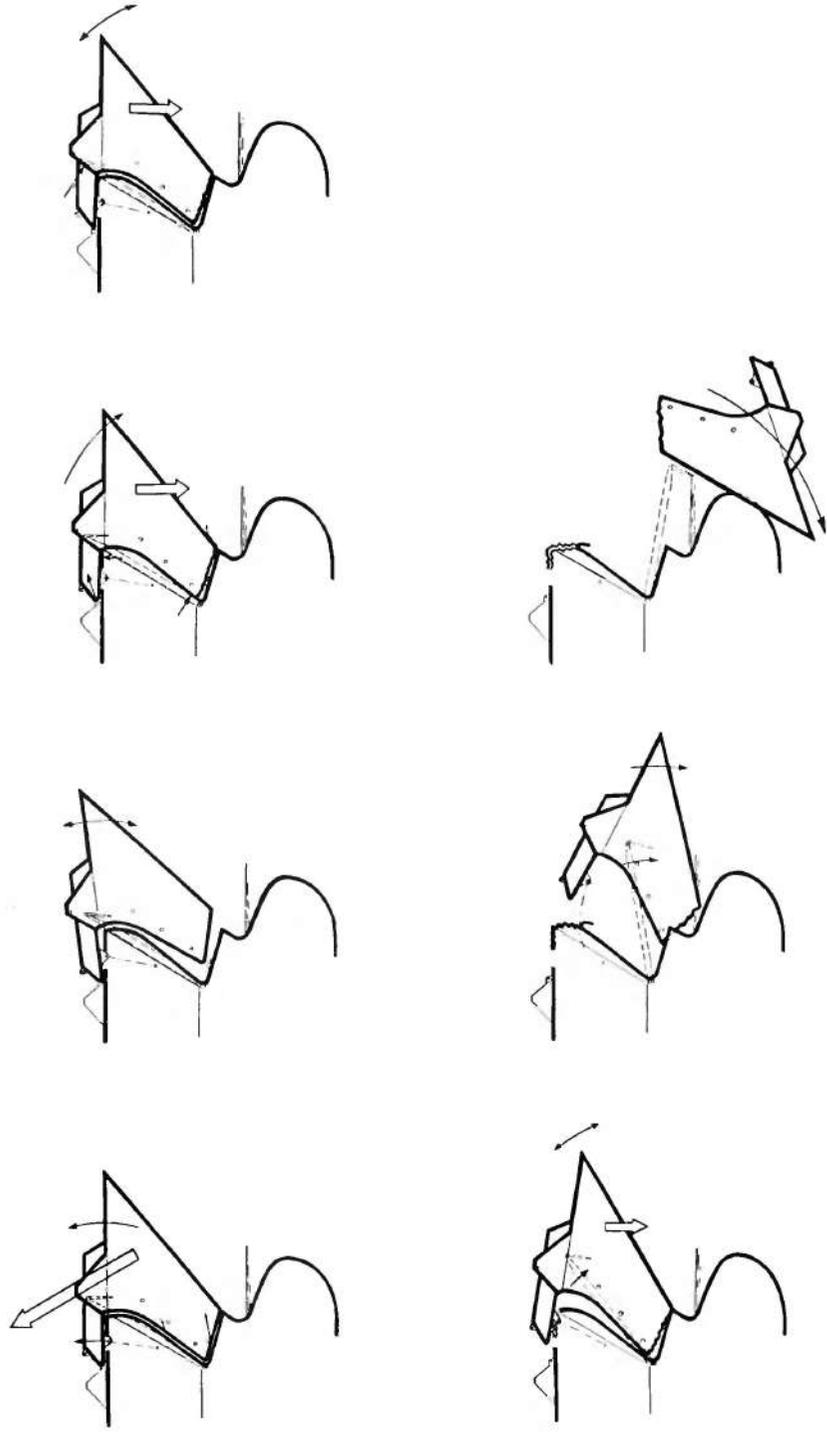
The most probable sequence of events during the failure has been reconstructed based on damage observations and calculations. Figure 15 illustrates this sequence as described below.

The three locking devices may have failed in any one sequence. The chance that they failed simultaneously has been considered to be small, taking into account the uncontrolled play at each locking bolt and the elasticity of the structure.

After failure of the bottom and side locks, the visor operating actuators resisted further opening movement. The leverage of the sea loads created sufficiently high loads on the actuators to cause these to be pulled out of the hull or to fail internally.

FIG 14 Probable failure sequence of the bow visor
