# The Vessel M/S Estonia

## Review of geotechnical investigations

Commissioned by: Swedish Accident Investigation Authority

14/09/2021

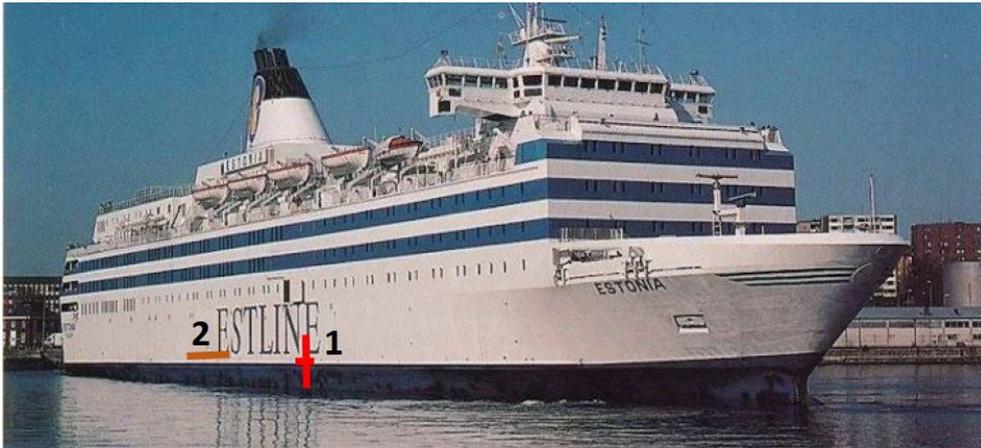
In 2020, a group of Estonian experts was given access to video material from an ROV that filmed the vessel's hull. Parts of this video material were published on 28 September in a documentary by Discovery+. A written opinion by the group of experts (Tabri et al., 2020) states that a hole (Hole 1), with a width of c. 1 m and a height of c. 4 m has been observed by the fender close to the waterline. A clear inward dent in the sheet metal with a depth of c. 1.2 m has been observed around the hole. A second hole (Hole 2) was also observed along the fender on the starboard side, further aft. The sheet metal around Hole 2 has been torn up, most probably along a longitudinal weld. No local buckling was observed in the area surrounding the hole.

Figure 12. Approximate positions of observed Hole 1 (red cross) and Hole 2 (orange line) (Tabri et al., 2020)

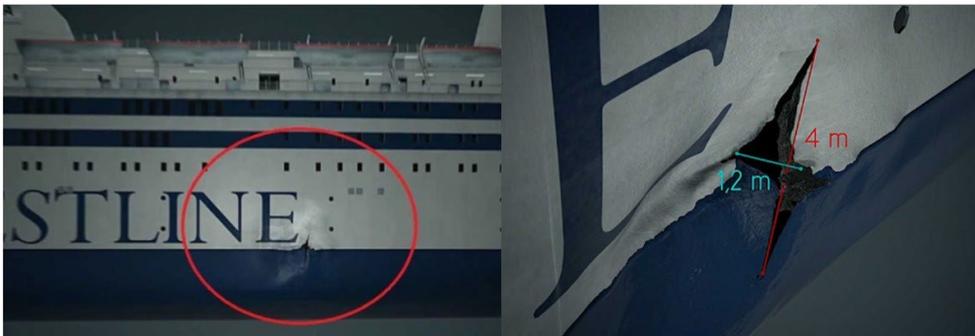
Figure 13. Animation with geometries and position of Hole 1 (Discovery+)

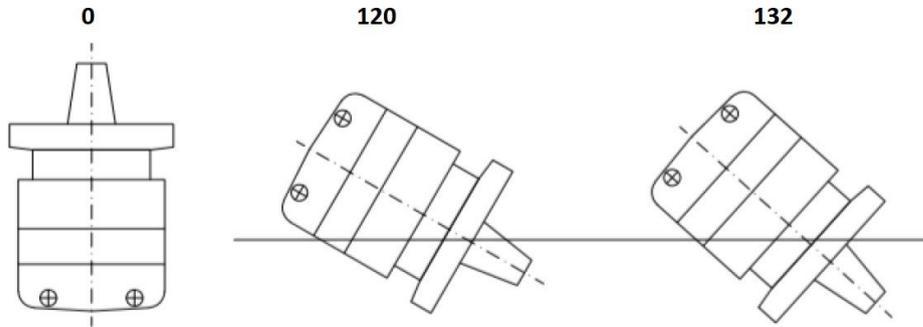
Figure 14 is taken from the opinion by the group of Estonian experts. On the left is shown the vertical position of the vessel before she sank, in the middle is the position given for the vessel on the seabed between 1994 and 1997, and on the right is the position given for the vessel in 2020.

Figure 14 Illustration of the change in the position of the vessel through clockwise rotation, described as a heaving of the starboard side (Tabri et al., 2020).

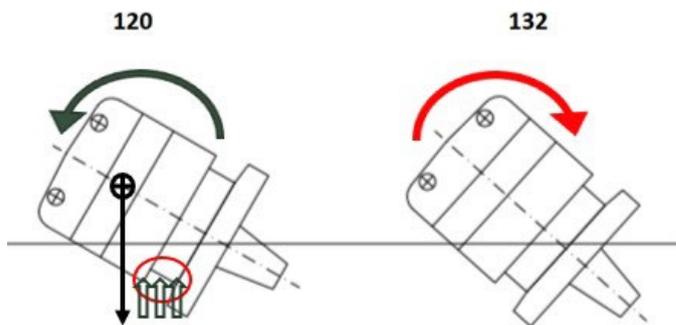
If the position of the vessel's centre of gravity is assumed to be the same after its sinking as before, and that the vessel is a rigid construction, it is possible to formulate a hypothesis for the expected rotation. Taking into account the interpreted contact point between the glacial till and the vessel, and the position of the vessel's centre of gravity, the vessel can be expected to rotate towards the north, which equates to anticlockwise rotation in Figure 18 on the left. However, the vessel is reported to have rotated towards the south, which is clockwise rotation as shown in Figure 18 on the right.

Figure 18. Left: expected direction of rotation taking into account the position of the vessel's centre of gravity and the interpreted contact area with glacial till. Right: the vessel's reported direction of rotation (figure based on Tabri et al., 2020).

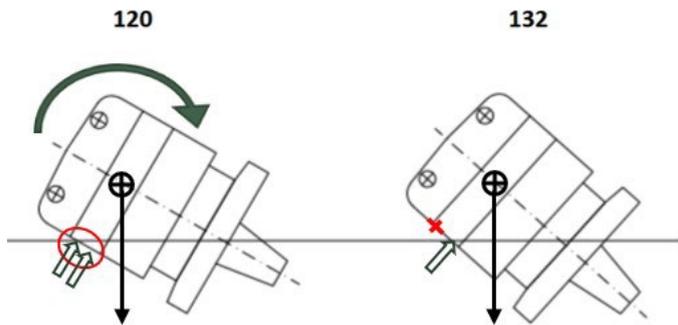
An alternative scenario may be that the vessel is in contact with the glacial till at a lower deck on the starboard side (farther north) as shown on the left side of Figure 19. If the glacial till layer is close to the surface of the seabed or exposed along the northern side of the vessel, there may be a contact area north of the centre of gravity. If the vessel is not in simultaneous contact with the glacial till south of the centre of gravity, a rotation can arise as a result of settlements on the south side. In which case, settlements occur over a longer period of time and is caused by the effect of the load of the vessel on the clay layer. The vessel can then be expected to rotate around the southern end of the area of glacial till and, over time, make any damage north of the rotation point visible as shown on the right side of Figure 19.

Figure 19. Alternative scenario in which the area of contact between the glacial till and the vessel is north of the centre of gravity. The red cross represents the approximate location of Hole 1 (figure based on Tabri et al., 2020).

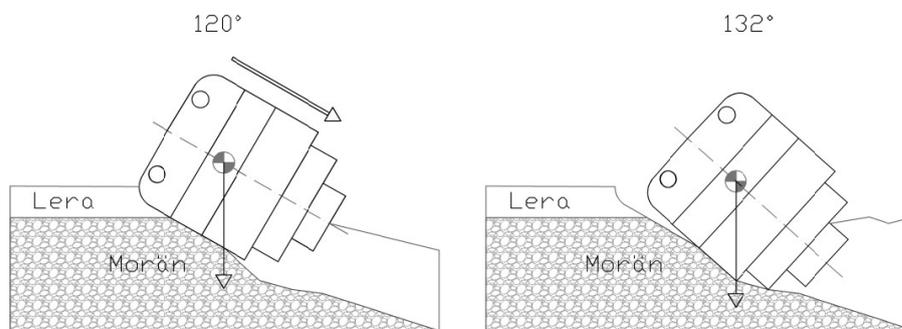
One further alternative scenario is that, at some point during the period 1996 to 2020, the vessel has moved from its position and slid down the sloping layer of glacial till. If the glacial till layer under the vessel has a varying inclination, the vessel may have rotated in conjunction with the slide, see example in Figure 20.

Figure 20 Schematic drawing of the hypothesis that the rotation was caused by sliding. Geometries of the glacial till and clay layers are shown schematically and are not consistent with actual conditions.

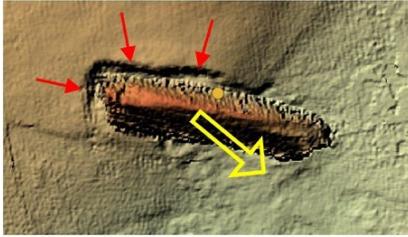
From the bathymetric measurements by Traficom (2006), it is possible to discern a depression or 'trench' to the north and west of the vessel, see Figure 21. Currents normally arise along the edges of sunken vessels. If the soil consists of material that is sensitive to erosion, an eroded depression arises in the surface of the seabed. However, the deep trench around Estonia may also have been caused by the vessel having moved in a south-westerly direction, which is the expected direction if movement were to occur.

Figure 21 Depression around the vessel (red arrows) and expected direction of movement of the vessel (yellow arrow), based on Traficom (2006).

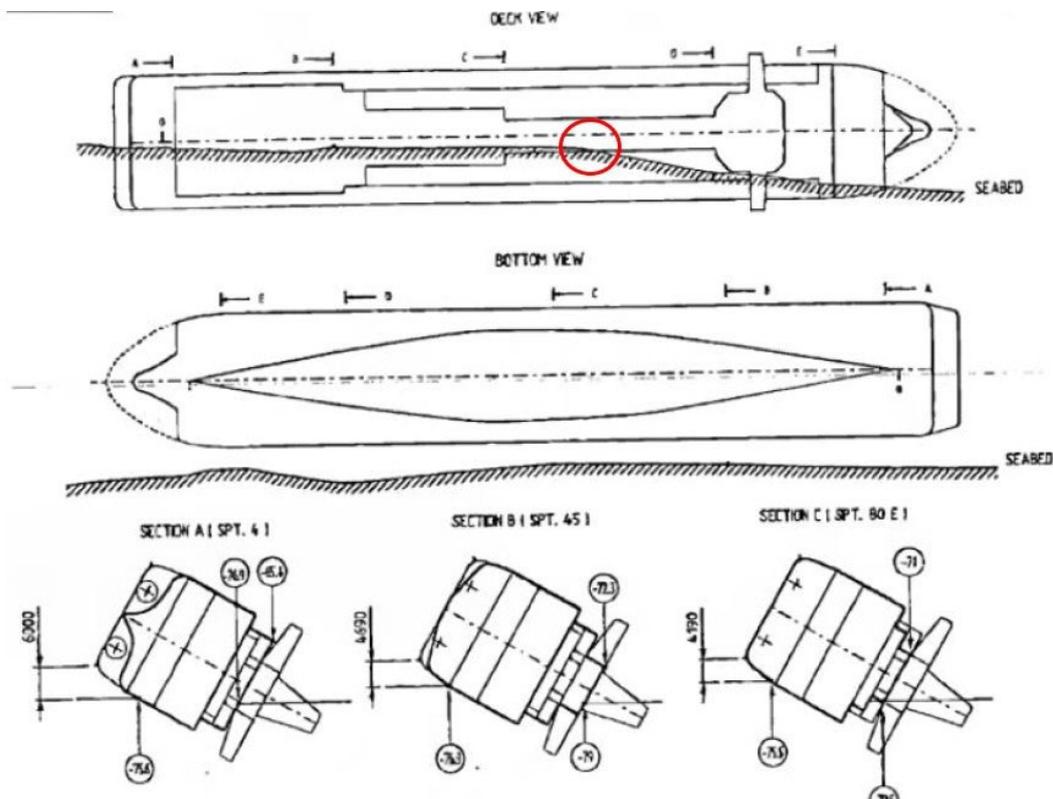
Furthermore, the opinion states: ‘*Ship mass (12 000 ton) significantly exceeds the force required for the opening (500–1000 ton). Thus, an uneven surface under the ship side could introduce concentrated forces that could lead to penetration damage*’ (Tabri et al., 2020). In the opinion, the position of the vessel is compared with the original seabed topography and the position of Hole 1, see Figure 22.

Figure 22. Schematic showing the position of the vessel on the seabed in relation to the original seabed surface according to documentation from 1994. The red circle marks the approximate position of Hole 1, which is said to coincide with the crest of a slope on the surface of the seabed (Tabri et al., 2020).

The comparison refers to the total mass of the vessel and the size of the force required to act on the point at which the hole has arisen. According to the estimate above, this is equivalent to 4.5–9 % of the weight of the vessel above the water (total steel weight: 10,920 tonnes [Smit Tak, 1995]). Another starting point is evaluation of the contact pressure that can arise between the vessel and the earth. For Hole 1 and the dent to arise on the vessel, increased local contact pressure needs to be applied to the soil layer without the soil breaking up. A force of 500–1000 tonnes distributed evenly over an area of 4.1 m<sup>2</sup> results in a contact pressure of c. 1–3 GPa.

However, contact pressure of such a size cannot arise in the clay since the clay would be expected to reach failure from a contact pressure equivalent to a few per cent of

what is required in order to cause the hole. The presence of rocks on the surface of the seabed alone does not therefore provide a complete explanation of the occurrence of Hole 1 as there must also be contact between rocks and more solid soil layers at a greater soil depth, e.g. glacial till. The preceding chapter contains proposed site investigations for the purpose of assessing whether the holes observed in the vessel may have geological causes.
