REPUBLIC OF ESTONIA  
SAFETY INVESTIGATION BUREAU

Statens haverikommission  
Swedish Accident Investigation Authority

# Intermediate Report of the Preliminary Assessment of MV ESTONIA

2023

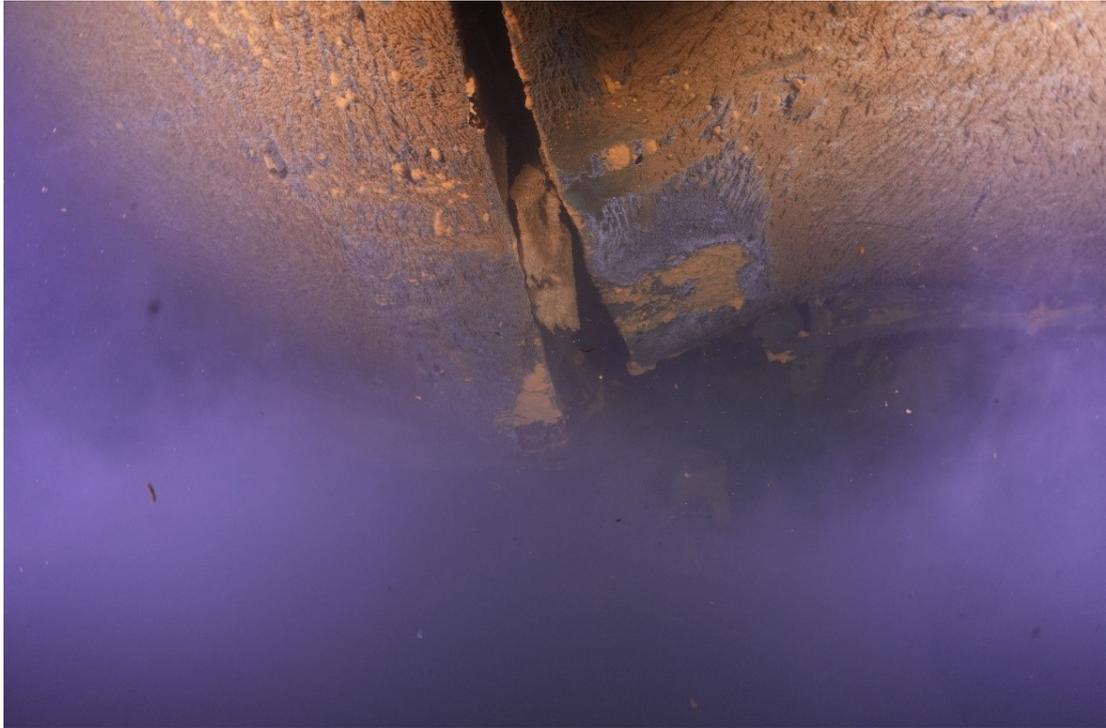
FIG. 1.1: The hole that was displayed in the TV documentary in 2020 as seen in the photogrammetry during 2022. Image from photogrammetry.

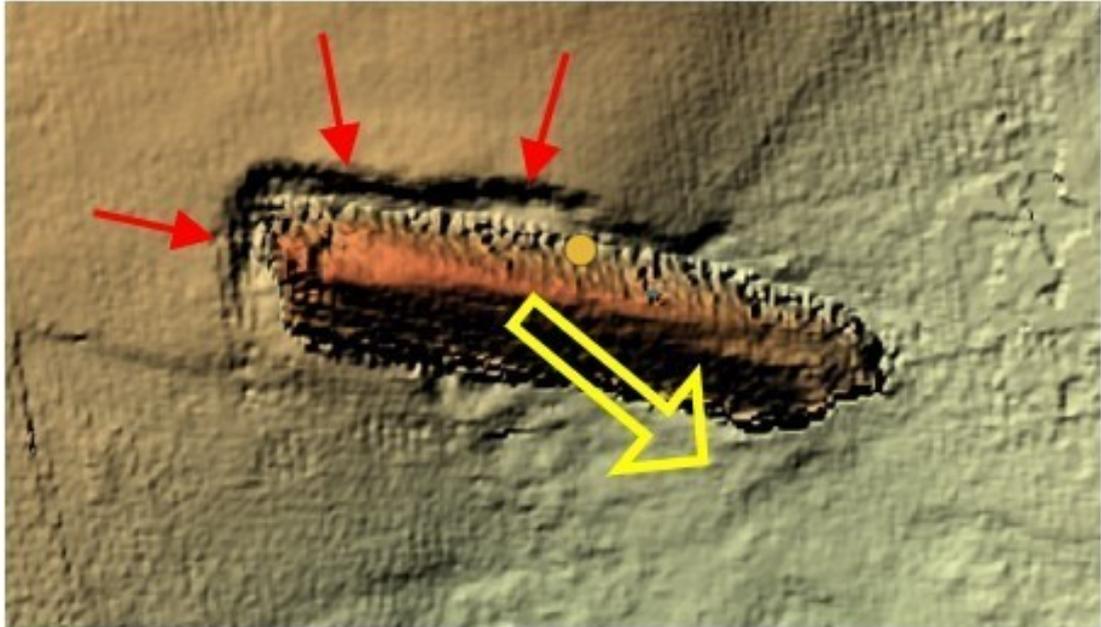
FIG. 2.1: Depression around the vessel (red arrows) and expected direction of movement of the vessel (yellow arrow), based on Traficom (2006). Image from Rudebeck and Kennedy [2].

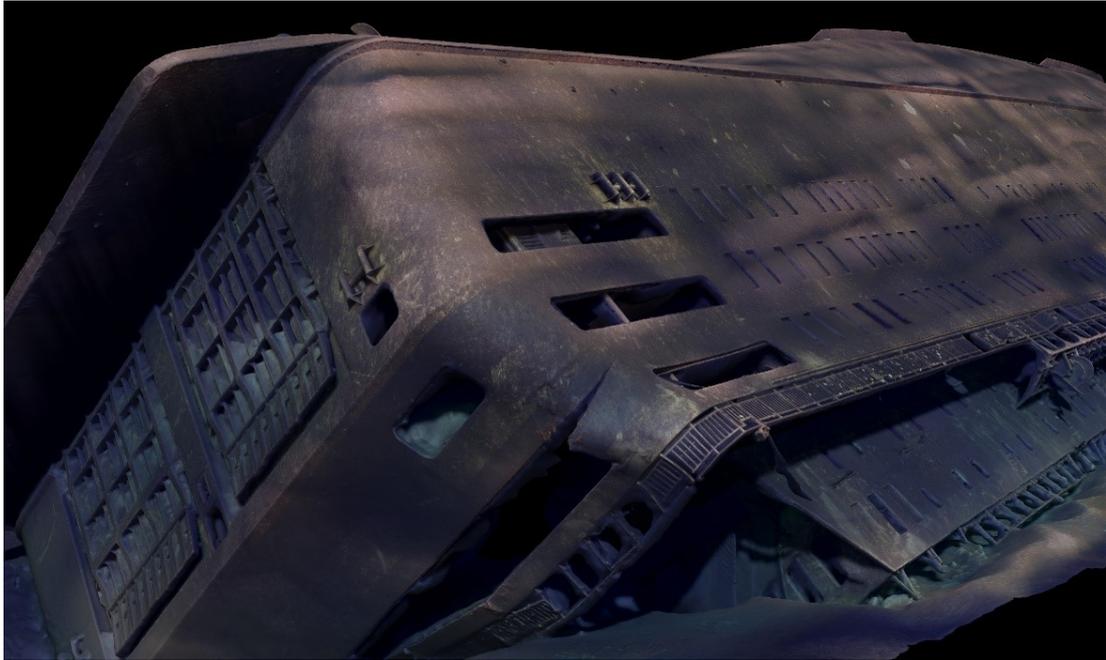
- Numerous deformations and cracks were observed near the edge of Deck 6 on port side;
- A rupture was observed in the stern corner of Deck 6.

FIG. 3.2: Port side stern of MV ESTONIA, showing a crack on deck 6. From the crack, the vessel is twisted along deck 6 and forward. Image from photogrammetry.

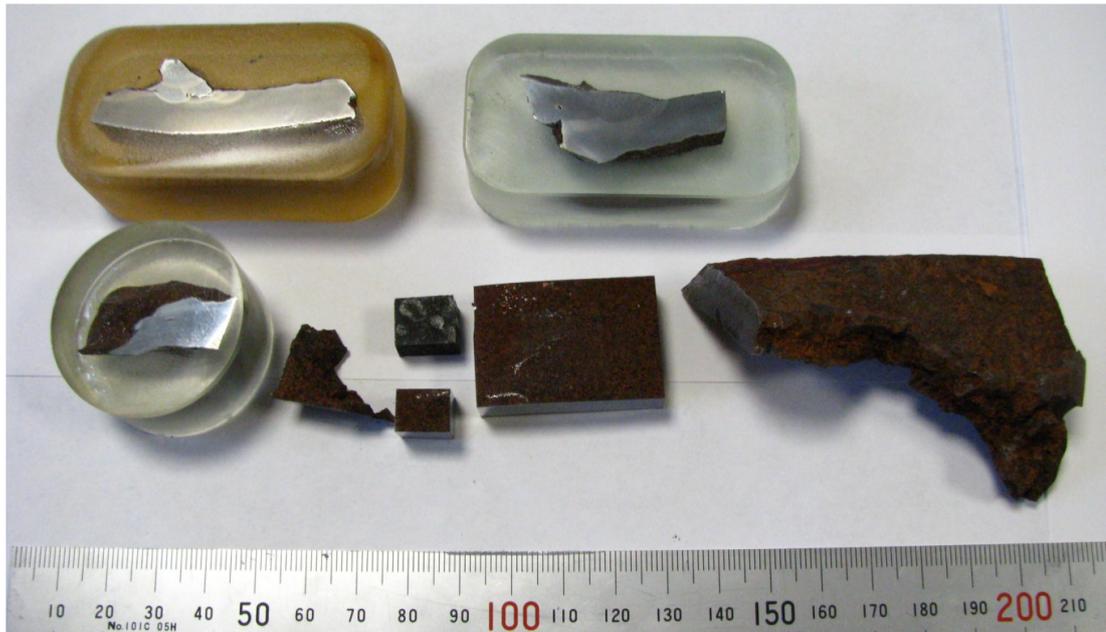
FIG. 3.4: Samples from the bow visor, subject of examination by Norwegian University of Science and Technology as well as Element Material Technology AB. Photo: Element Material Technology AB.

from the bow visor of MV ESTONIA. According to the report, the examined samples had been exposed to high temperatures. These temperatures may have occurred either during construction or maintenance of the vessel.

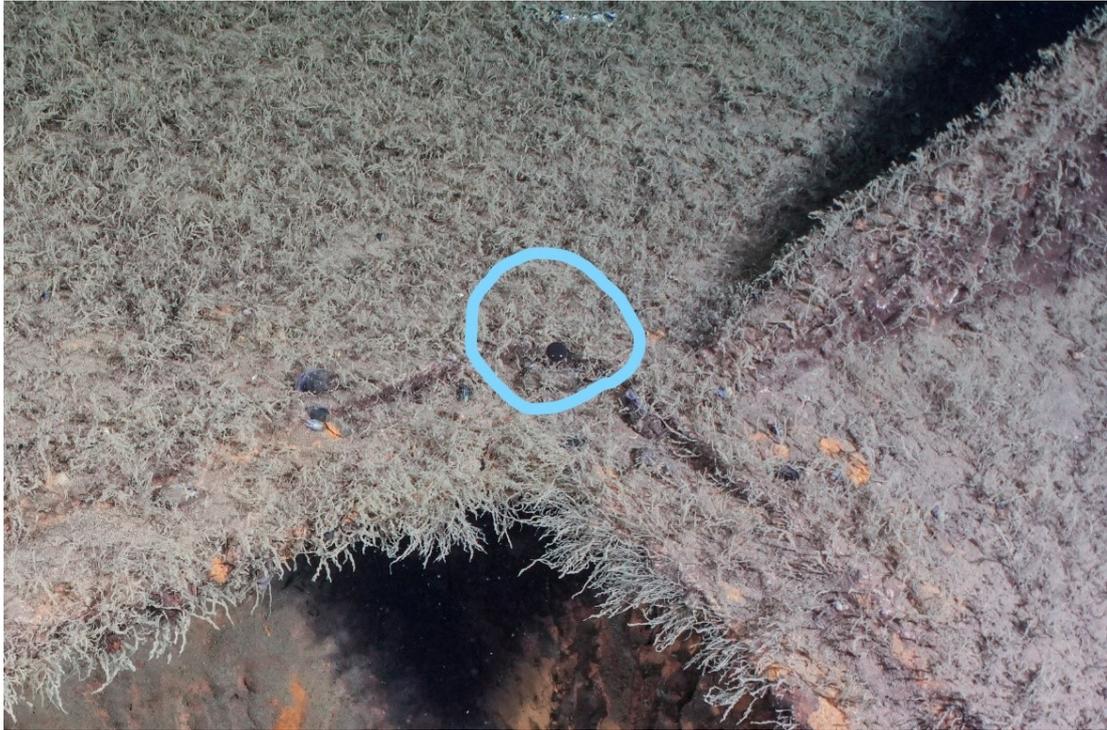
Indications of an oil leak were observed during on-site surveys in 2021. The minor leak was located in the hull's aft section during on-site surveys conducted in 2022 (Figure 5.1). The Finnish Border Guard conducted an aerial survey and subsequently took samples of the oil for analysis.

The results of the analysis indicated that the samples mostly contained lubricating oil mixed with some fuel oil. Effective surface response activities cannot be conducted as the leakage is minimal.

FIG. 5.1: The blue circle shows where a drop of oil is bubbling to the surface. Photo from photogrammetry.

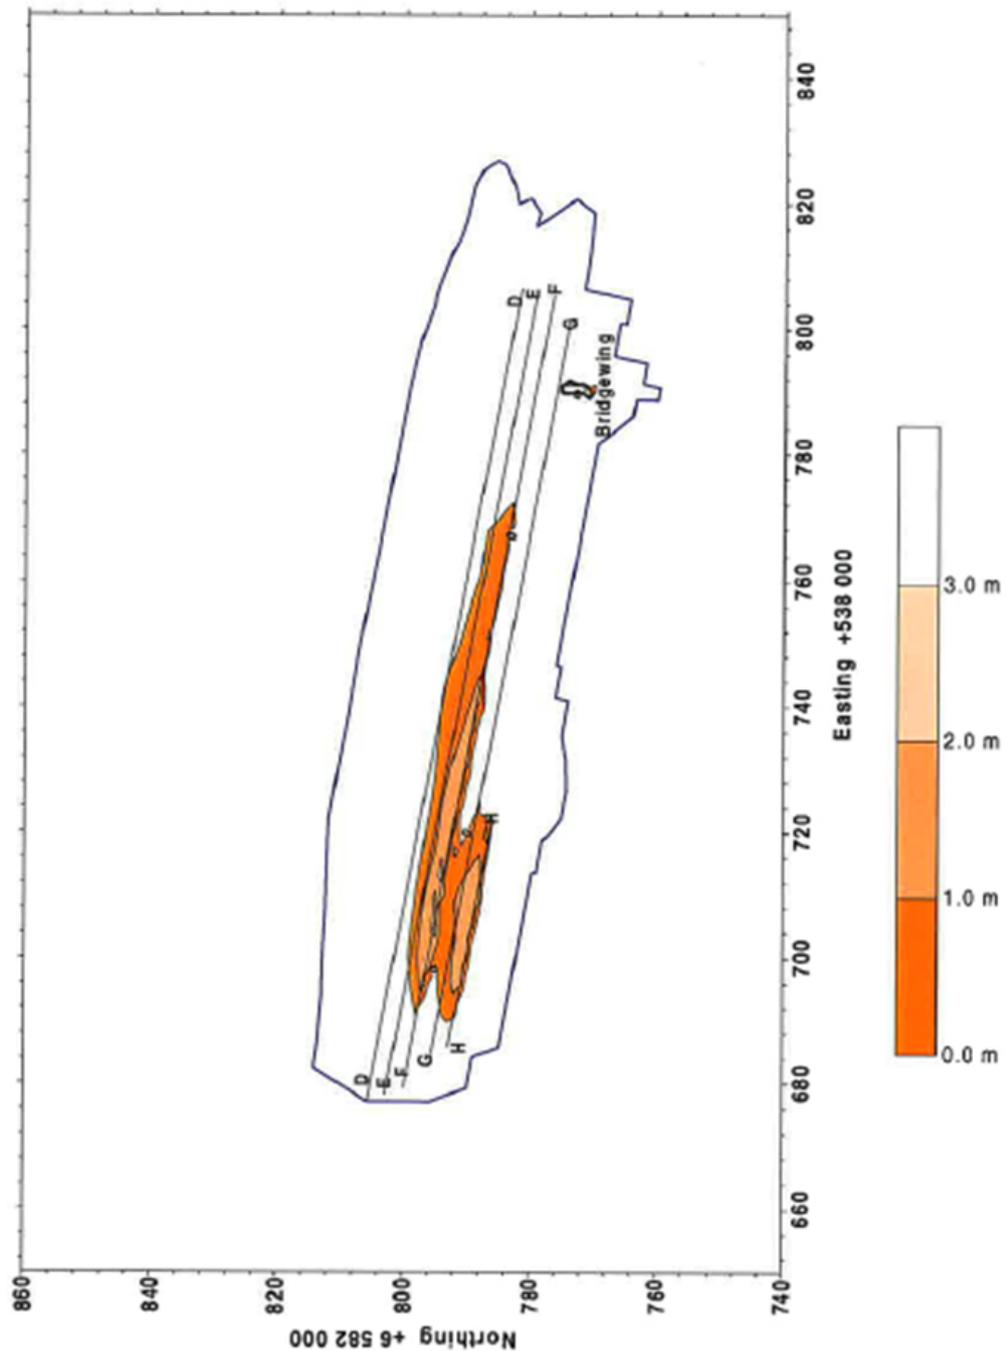
FIG. A.1: The plan shows areas of the hull where the clay layer is thinnest, i.e., where underlying layers are shallowest, based on interpretation in 1997. These areas could be expected to be the most damaged. Image from Velde [13].

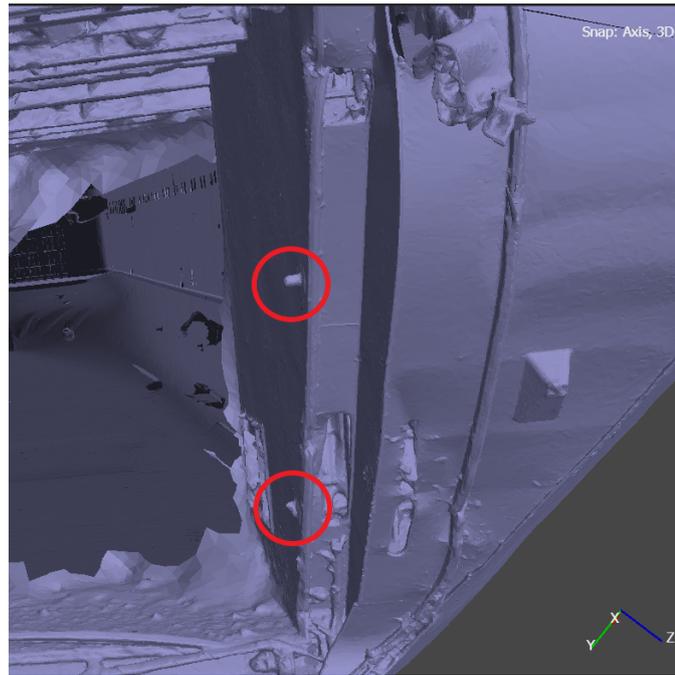
FIG. B.2: An image from the photogrammetry acquired in 2022. The lower red circle displays the same locking as Figure B.1, i.e., the port side lower bow ramp locking.

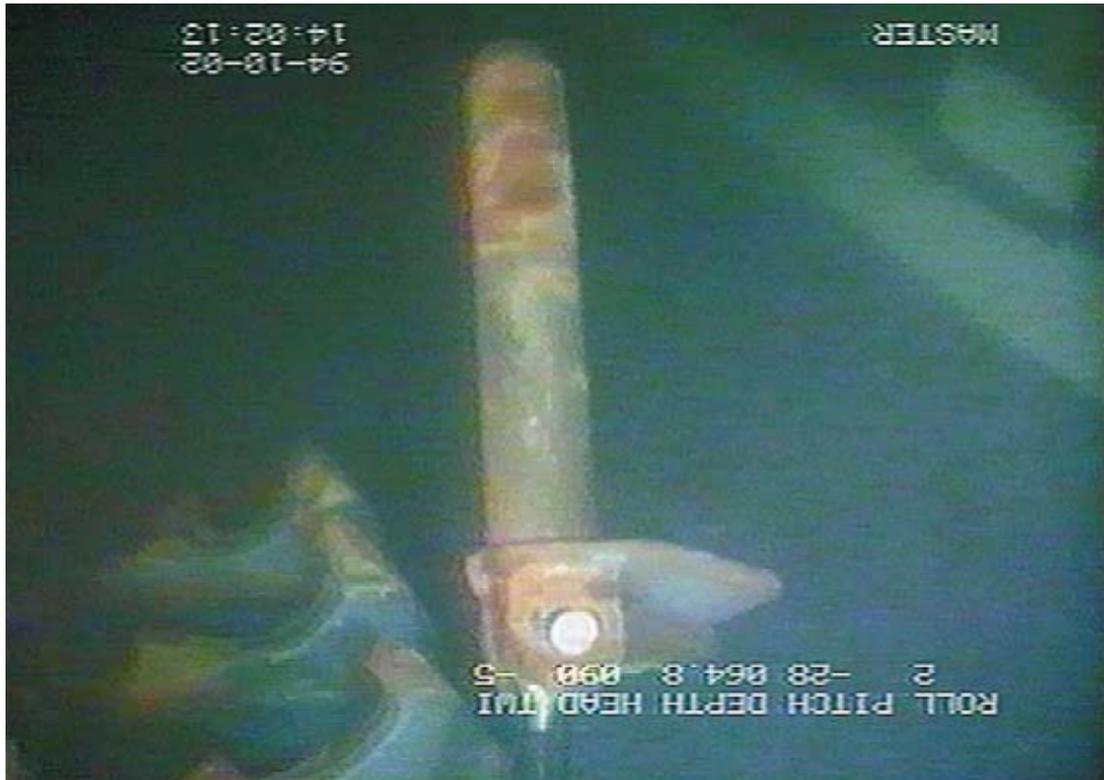
FIG. B.3: The locking bolt for the bottom lock, filmed on the wreck. The bolt was salvaged and examined by investigators, but was not saved. To the left bottom of the picture, the remains from the three broken attachment lugs are seen. The image is from the JAIC report, Figure 8.15, and is turned upside-down (to compensate for the vessel lying effectively upside-down when filmed).

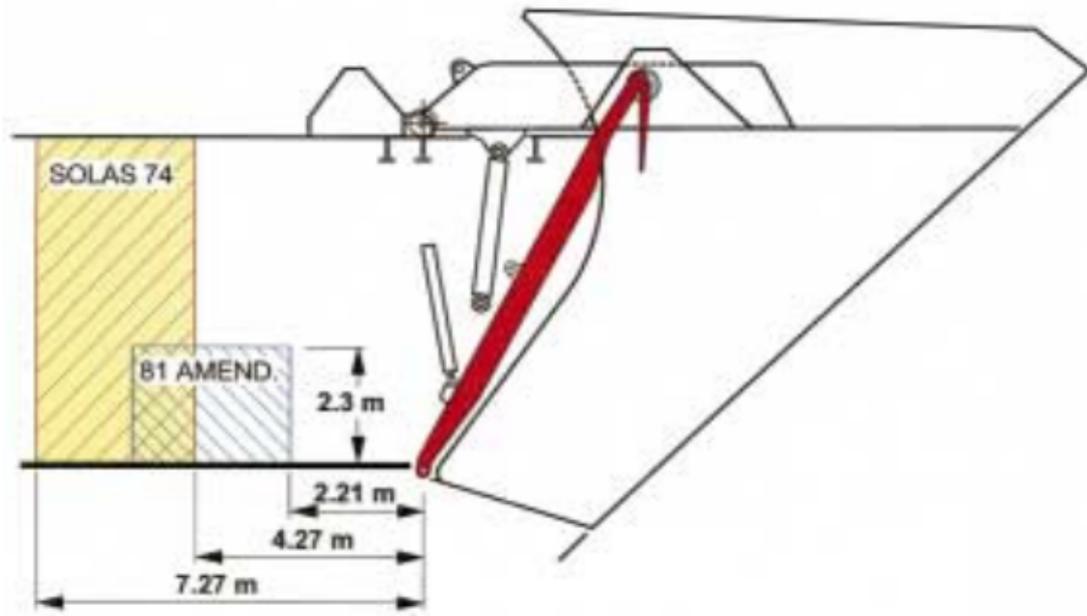
The SOLAS Convention requires a collision bulkhead with a certain distance from the forward perpendicular (a technically defined longitudinal position for each individual vessel). On MV ESTONIA the collision bulkhead was represented by the bow ramp. She was built with an exemption from the SOLAS Convention requirement in regards to the placement of the collision bulkhead. Such an exemption is conditioned with a limitation in trade, i.e., the vessel is not allowed to trade an area

FIG. B.4: Placing of the collision bulkhead in accordance with the SOLAS Convention. The bow ramp (marked red) was more than 2 m fore of accepted placing. In addition, it towered above the forecastle deck, thus requiring to be housed partially inside the visor. This meant, that when the visor came loose, it was hanging on the bow ramp. Reproduced from the JAIC report, Fig. 3.13.
