INVESTIGATION REPORT No 23U-AR0075

10 August 2023

Investigation applicant	Director of the Estonian Safety Investigation Bureau Märt Ots
Circumstances	During the preliminary assessment of M/S Estonia in the period from 19 July to 25 July 2023, a piece of metal was cut out of the edge of a hole in the starboard side of the wreck of the vessel.
Letter No	27-2/2023/3775-1
Letter	Compiled on: 27 July 2023 Arrived on: 27 July 2023
Presented for the investigation	<p>Investigation object A piece of metal cut from the edge of a hole in the hull of the wrecked ship</p> <p>Information material Submitted by the Estonian Safety Investigation Bureau: 1. video screenshots and photogrammetric drawings (27 digital files) of the wreck of M/S Estonia; 2. 3D photogrammetric model of the wreck (online).</p>
Investigation type	Metals survey
Assignment	Does the submitted metal piece show any signs of contact or collision with a metal item/object?
Experts	Forensic Expert Meelis Toomet phone 663 6718, email meelis.toomet@ekei.ee

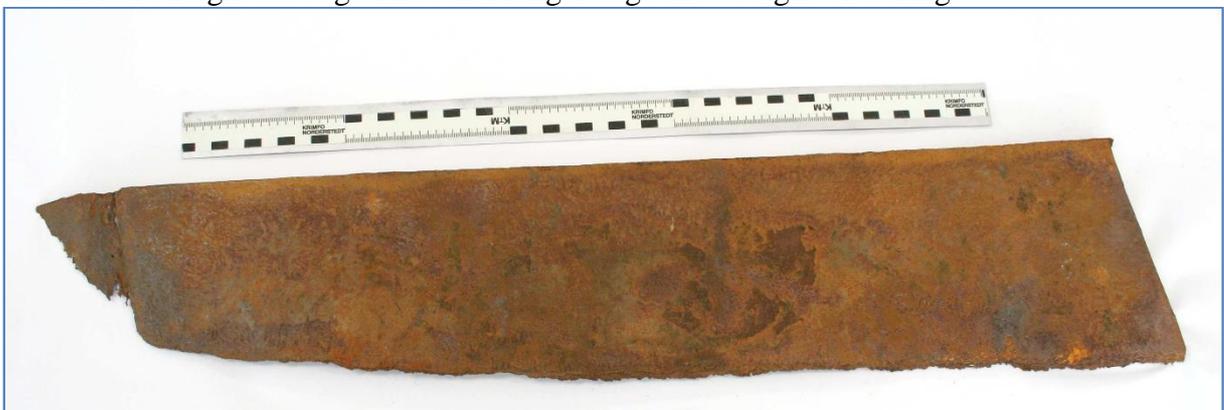
An elongated strip-shaped piece of a metal plate was submitted for examination (Figure 1). The thickness of the plate is between 13–13.5 mm, the approximate length is 66.5 cm and the width at the widest point is 14.5 cm. The strip is rectangular in shape, with one longer straight cut edge and one shorter straight cut edge. The other longer edge shows signs of tearing.

Photo 1. Piece of metal submitted for examination, view from the curved side

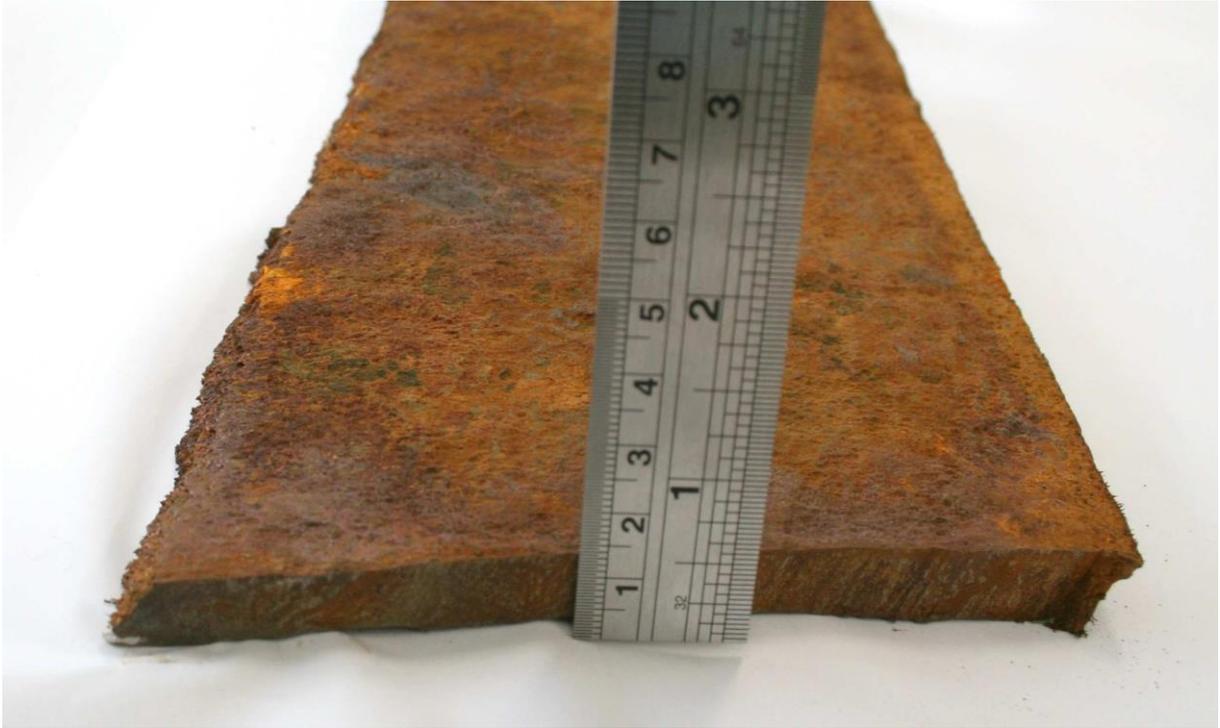
strip is curved and the paint coating has probably separated (Photo 2).

Photo 2. Curvature of the metal strip

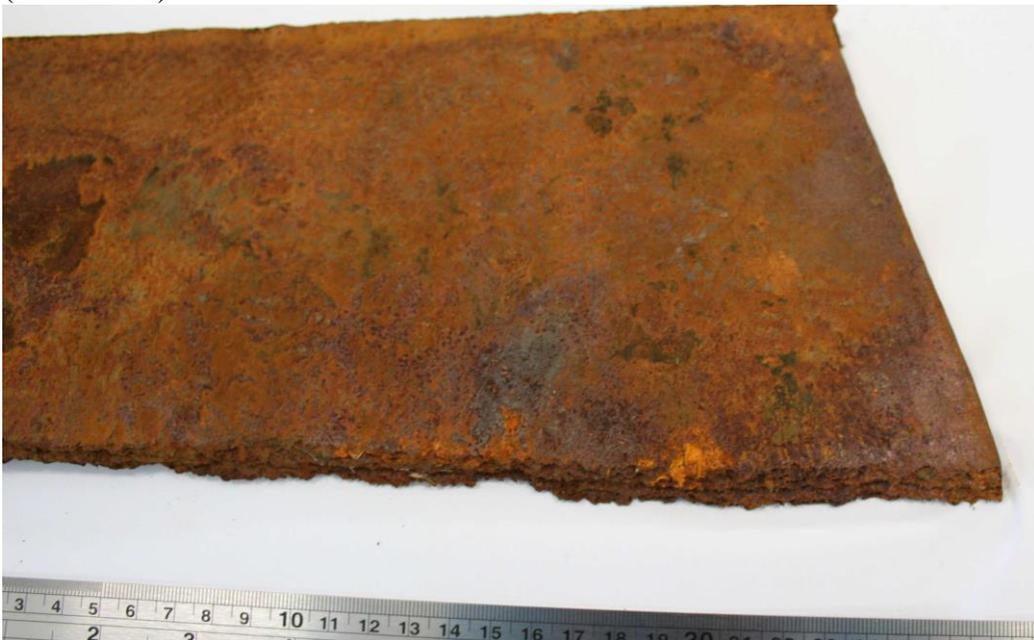
Photo 3. Torn edge of metal strip, view of hull exterior.

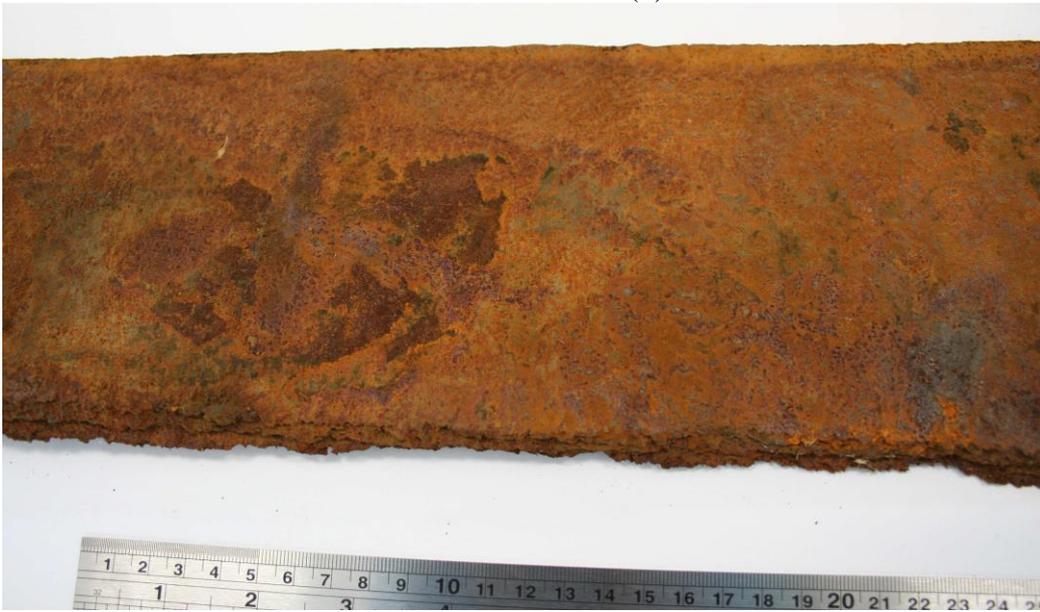
Photo 4. Torn edge of metal strip, view of hull exterior.

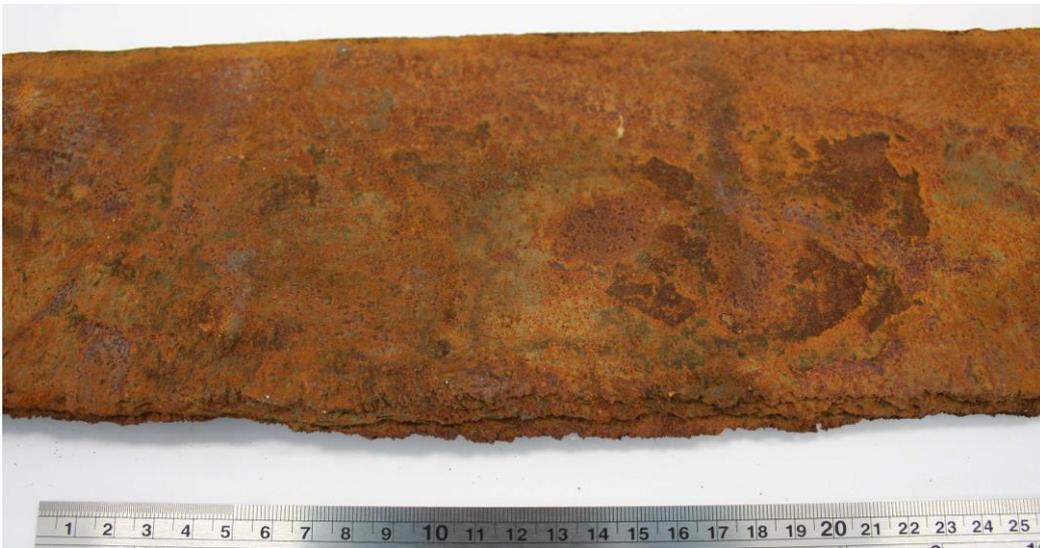
Photo 5. Torn edge of metal strip, view of hull exterior.

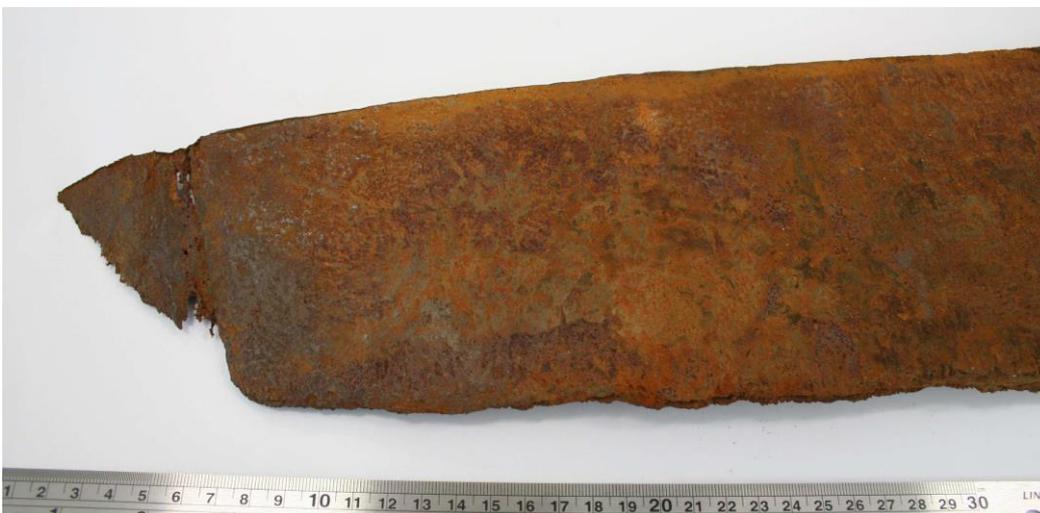
Photo 6. Torn edge of metal strip, view of hull exterior.

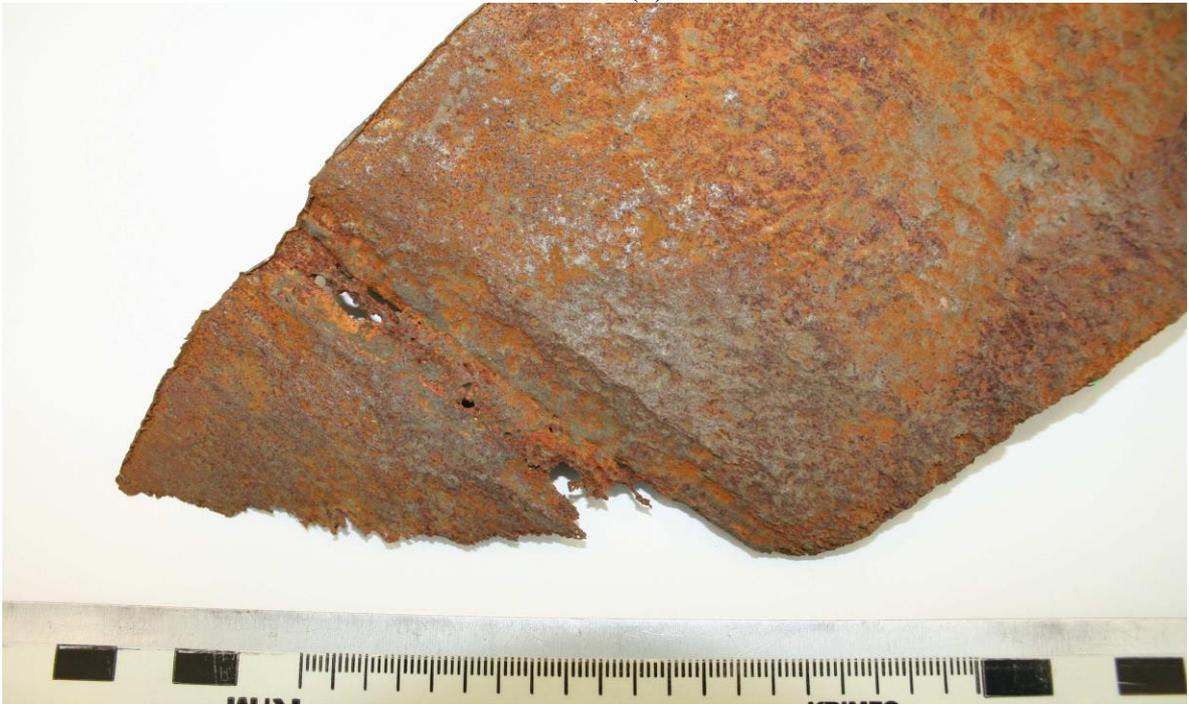
Photo 7. Torn edge of metal strip, view of hull exterior, possible joint.

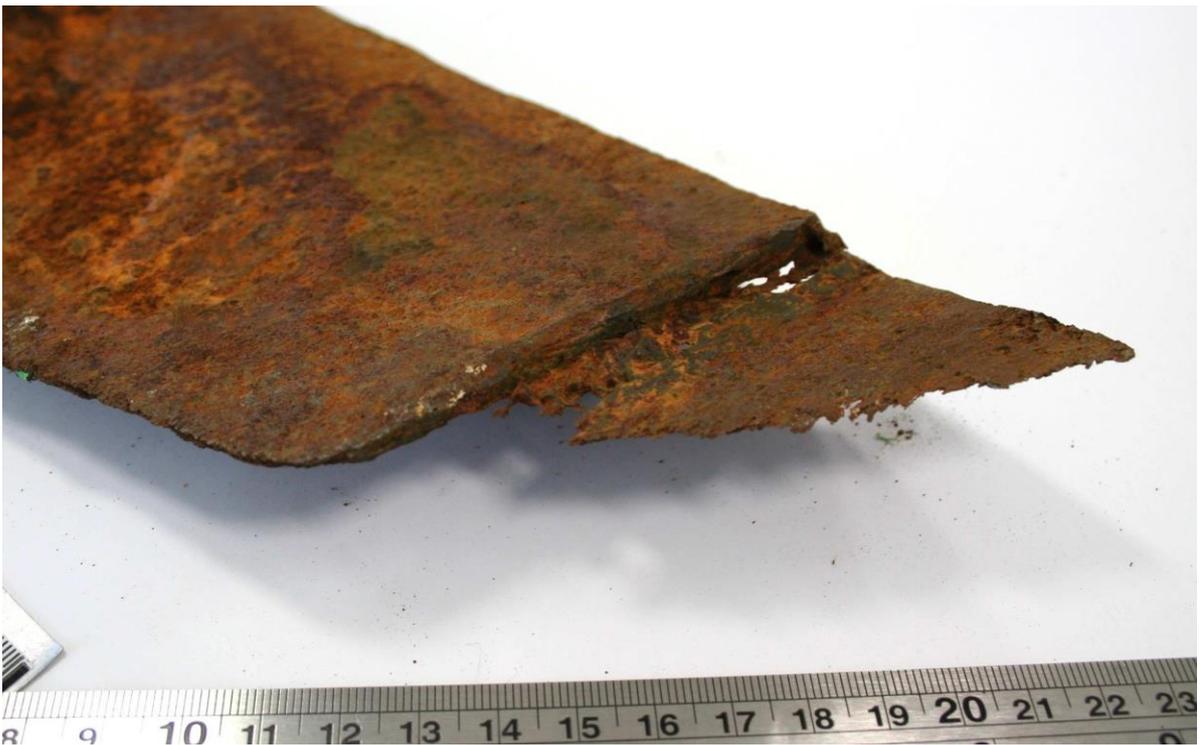
Photo 8. Torn edge of metal strip, view of hull interior, possible joint.
