### **Examination of Salvaged Bow Ramp, m/s Estonia** *Translation to English of TEK23-0101*

**ELEMENT MATERIALS TECHNOLOGY AB**

**Swedish Accident Investigation Authority**

**TEK24-0010**

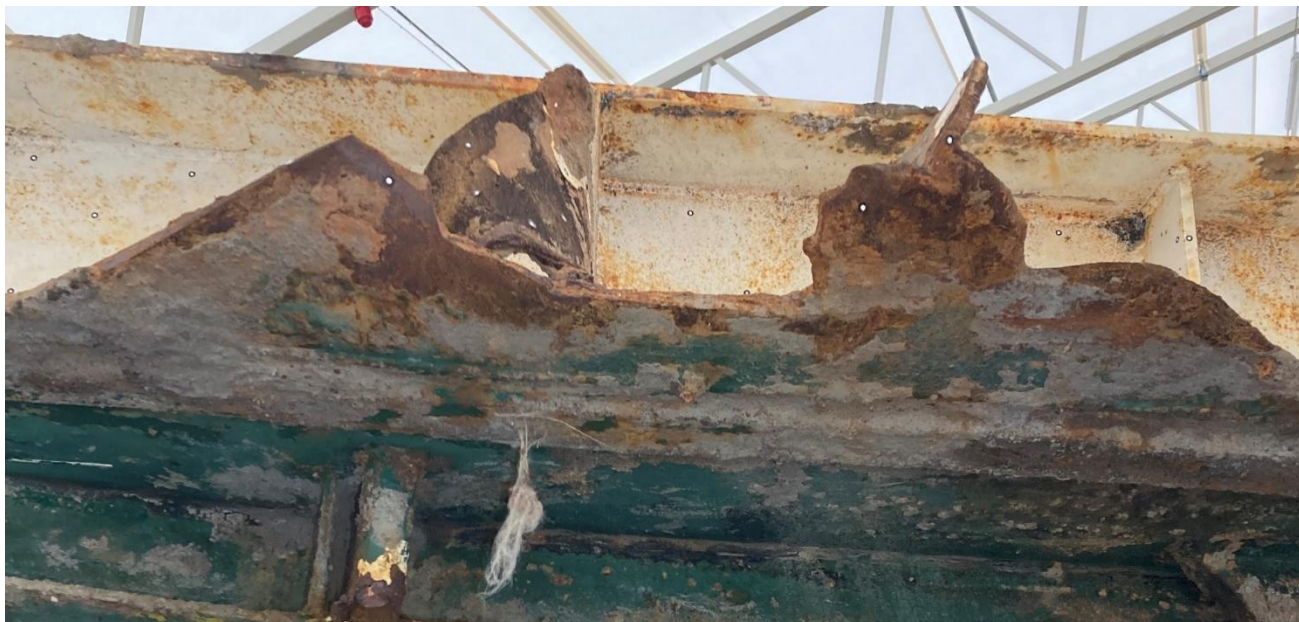
It is concluded that the locking hooks have been latched at the time of the accident as the bracket on the starboard side has separated from the bow ramp (missing), see Figure 1 and on the port side the bracket is very severely deformed, see Figure 2.

Figure 1. Missing bracket for the ramp locking hook on starboard side.

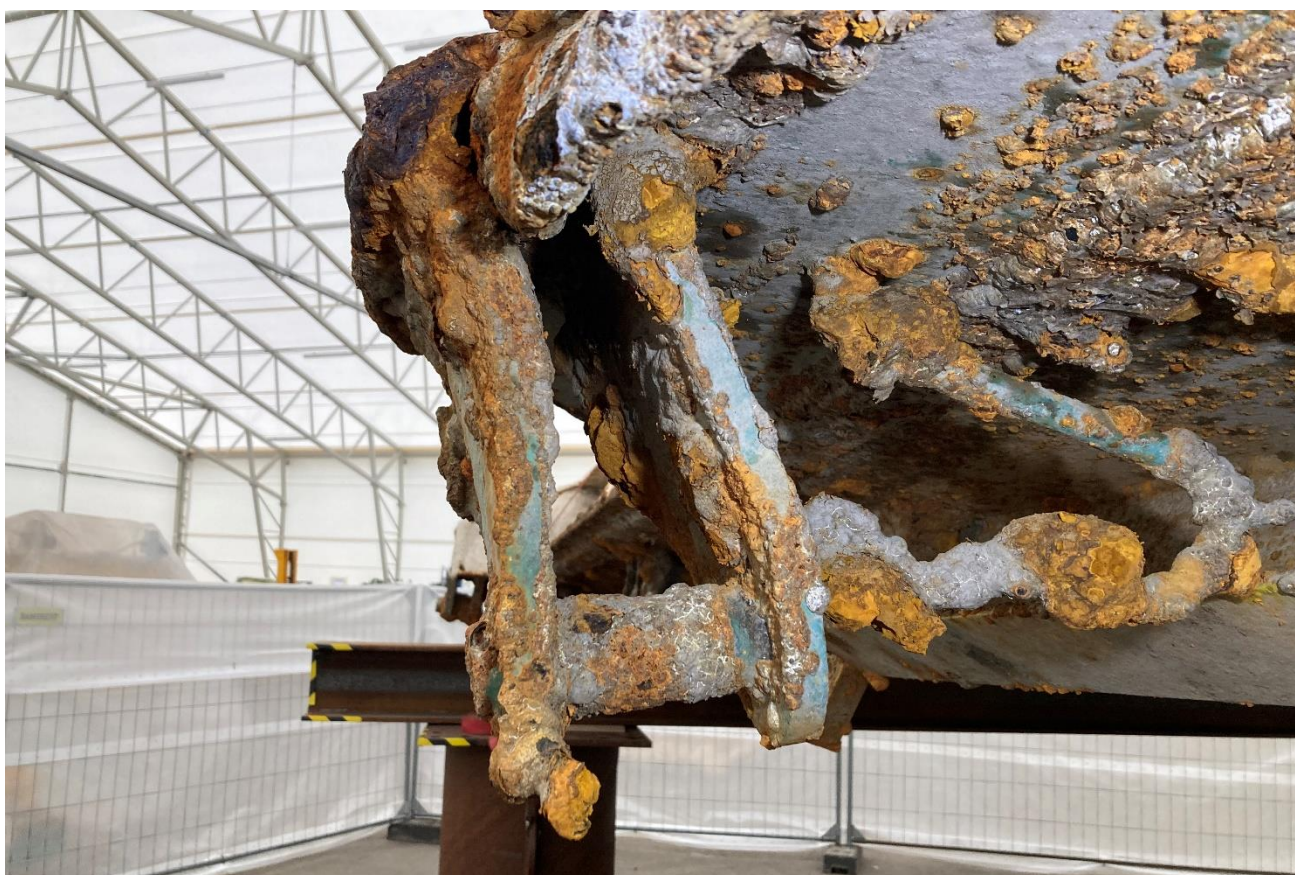
Figure 2. Bracket for the ramp locking hook on port side.

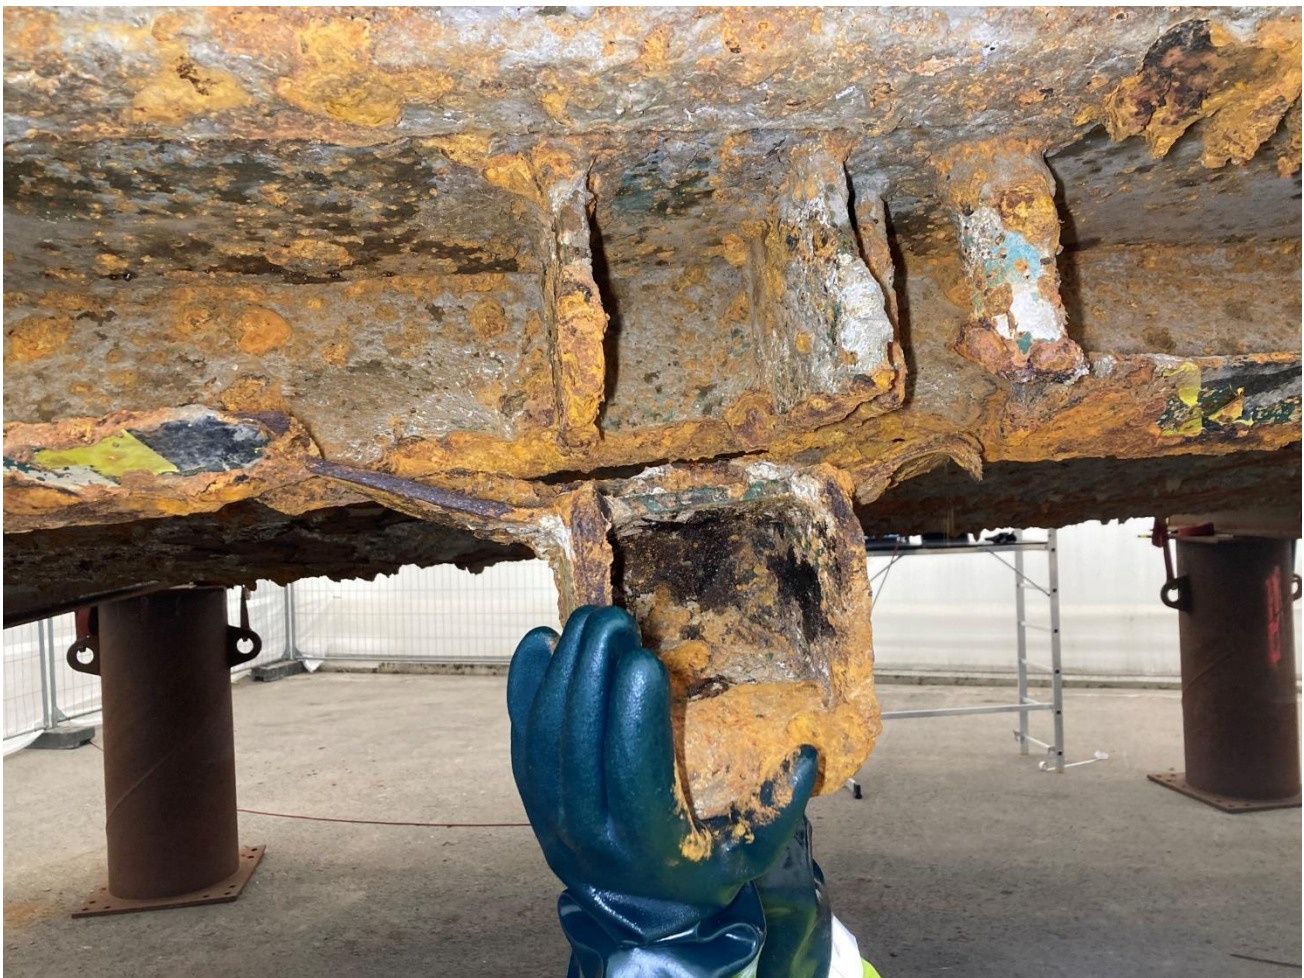
The lock boxes on the port side have failed with more bending than on the starboard side. Figure 3 and Figure 4 show the port side lock boxes and Figure 5 and Figure 6 show the starboard side lock boxes. On the starboard side, it looks like the lock boxes has had a evenly distributed pressure against the inside of the lock boxes and pulled the boxes off in a straight direction. This may be because, as stated in the documentation, that the lower lock piston on the port side has not been fully extended.

It may also be a consequence of the sequence in which they fracture which is as follows. First, the locks on the port side breaks because of the bow visor not hitting the upper edge of the ramp quite evenly.

Figure 3. Port side upper ramp side lock box.

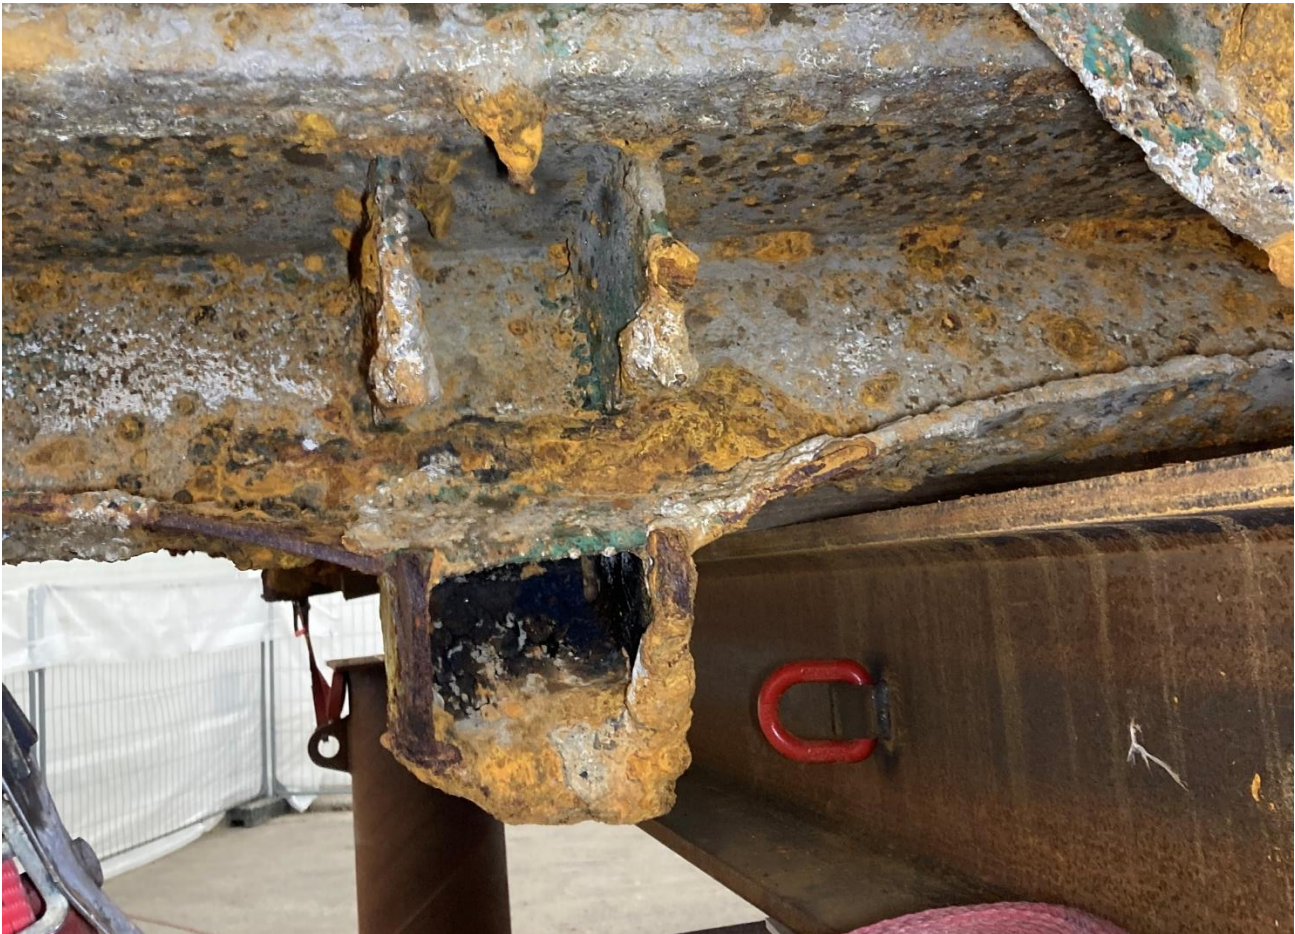
Figure 4. Port side lower ramp side lock box.

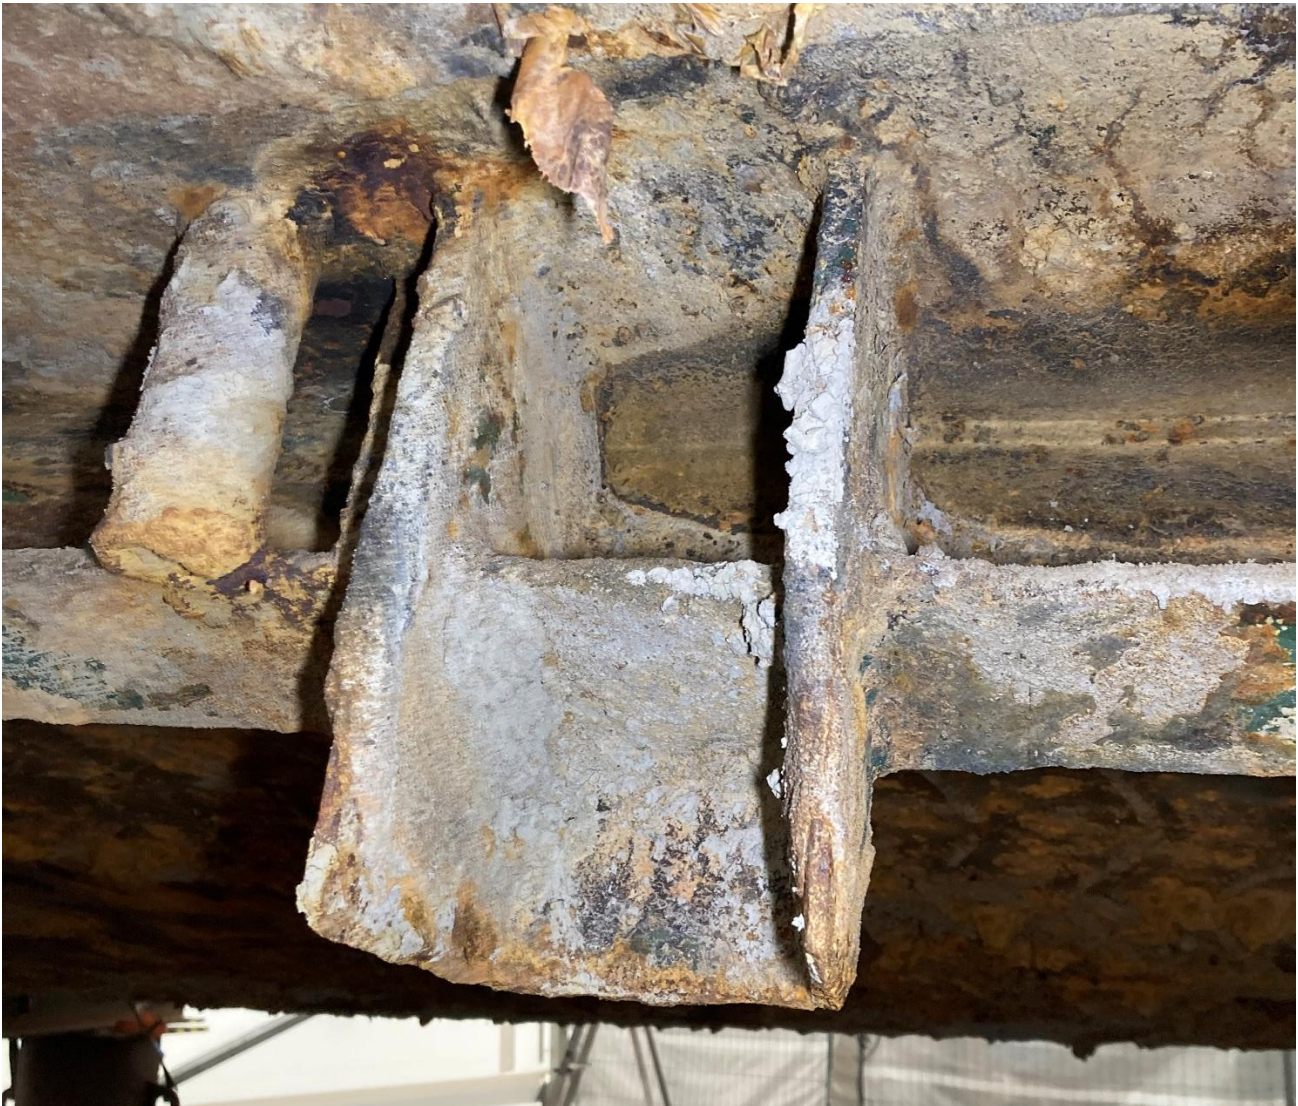
When the port side locks are broken, lateral movement/tilting of the ramp is permitted. This movement causes the starboard side lock pistons to slide out of the lock box slightly before they fracture due to overloading. As a result the force against the lock box also gives rise to a torque that bends the lock housing down before the fracture occurs.

Figure 5. Starboard side upper ramp side lock box.

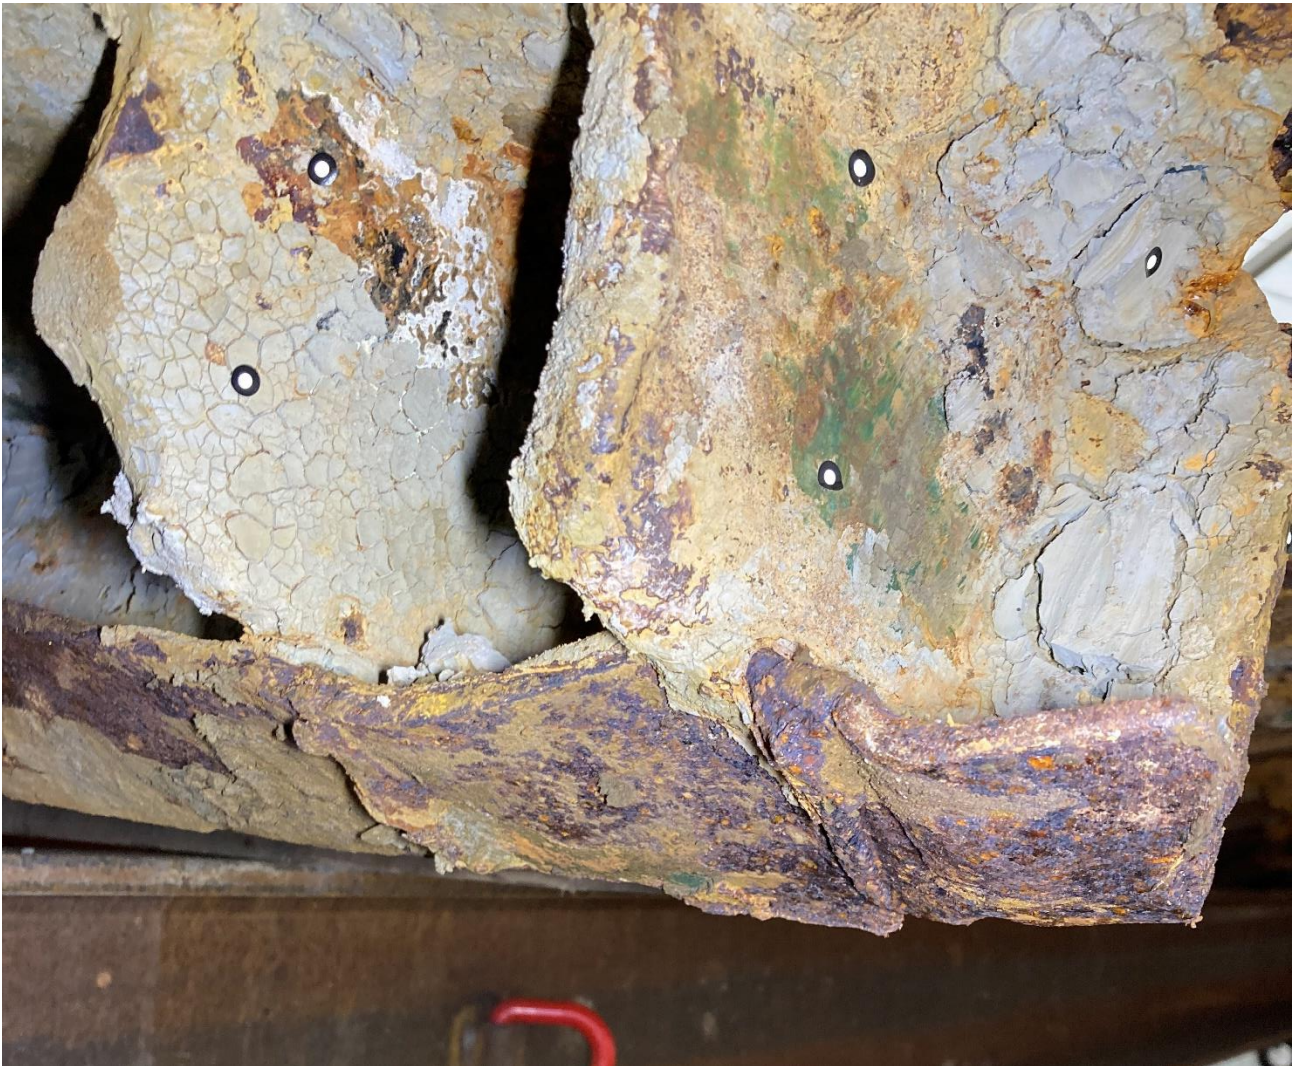
Figure 6. Starboard side lower ramp side lock box.

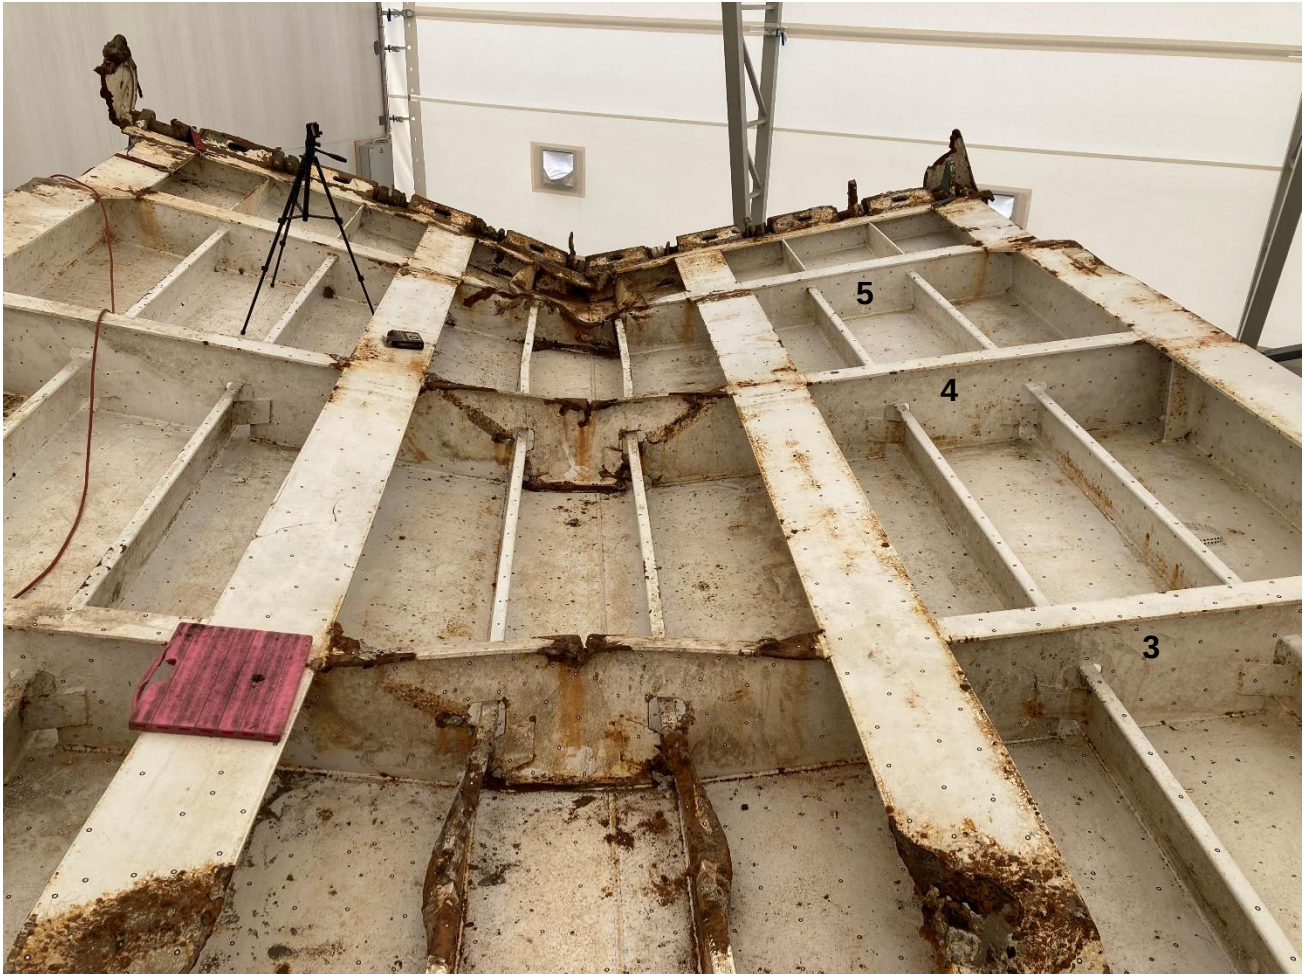
Damage on the sea side of the bow ramp is consistent with the description given in the document with damage both from impacts into the bow visor and bulb stem. Damage from when the bow visor falls back to its closed position also matches the description in the document, Figure 7 shows an overview of the damage to the upper part after hitting the ship's bulb.

Figure 7. The sea side of the bow ramp seen from the hinge side, transverse beams 3, 4 and 5 marked.

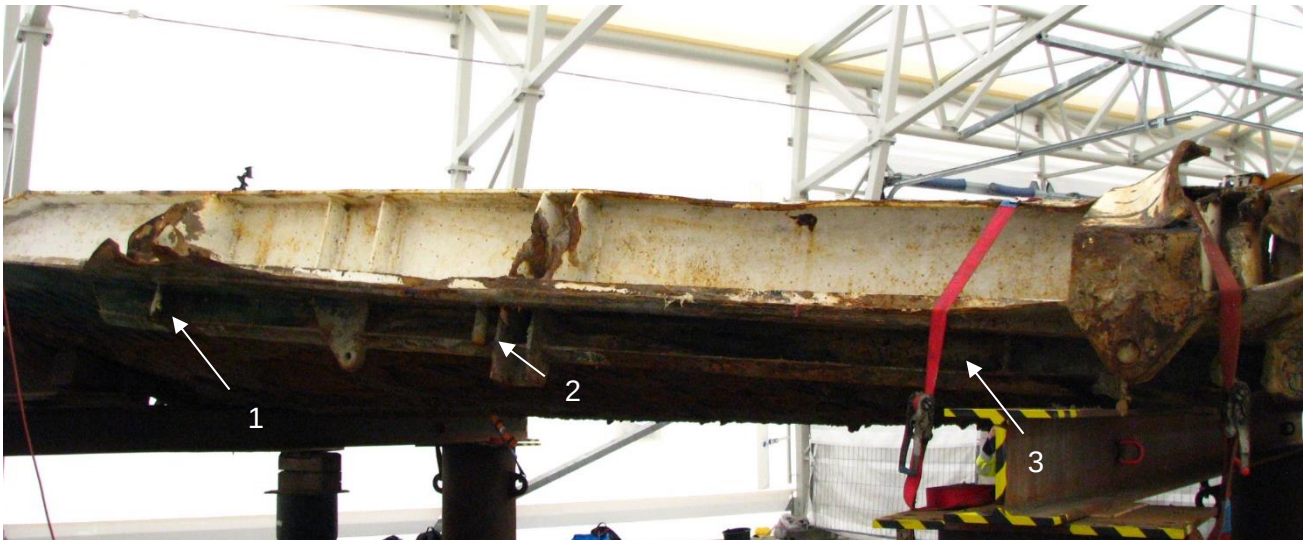
The railing on the bow ramp is assessed to have separated from the bow ramp in the accident and not cut or dismantled in any other way before/after the accident. This assessment is based on the deformation (occurrence of bending and shearing of the remaining parts) that does not occur when cutting with machine tools or thermal cutting. The damage is consistent with the protruding locking bolts holding the railing in place when the bow ramp is fully opened as described in the documentation. The surrounding structure also has severe deformation in several of the positions from being hit with great force by other parts and the railing may also have been broken off during these hits.

It is also an indication that they ruptured in relatively different ways, two of the examples below have, for example, ruptured in the weld against the bow ramp where it would not be natural to cut the railing for access reasons. Seven of the attachments are seen in Figure 8 to Figure 16.

Figure 8. Three attachment positions for railing on the starboard side.

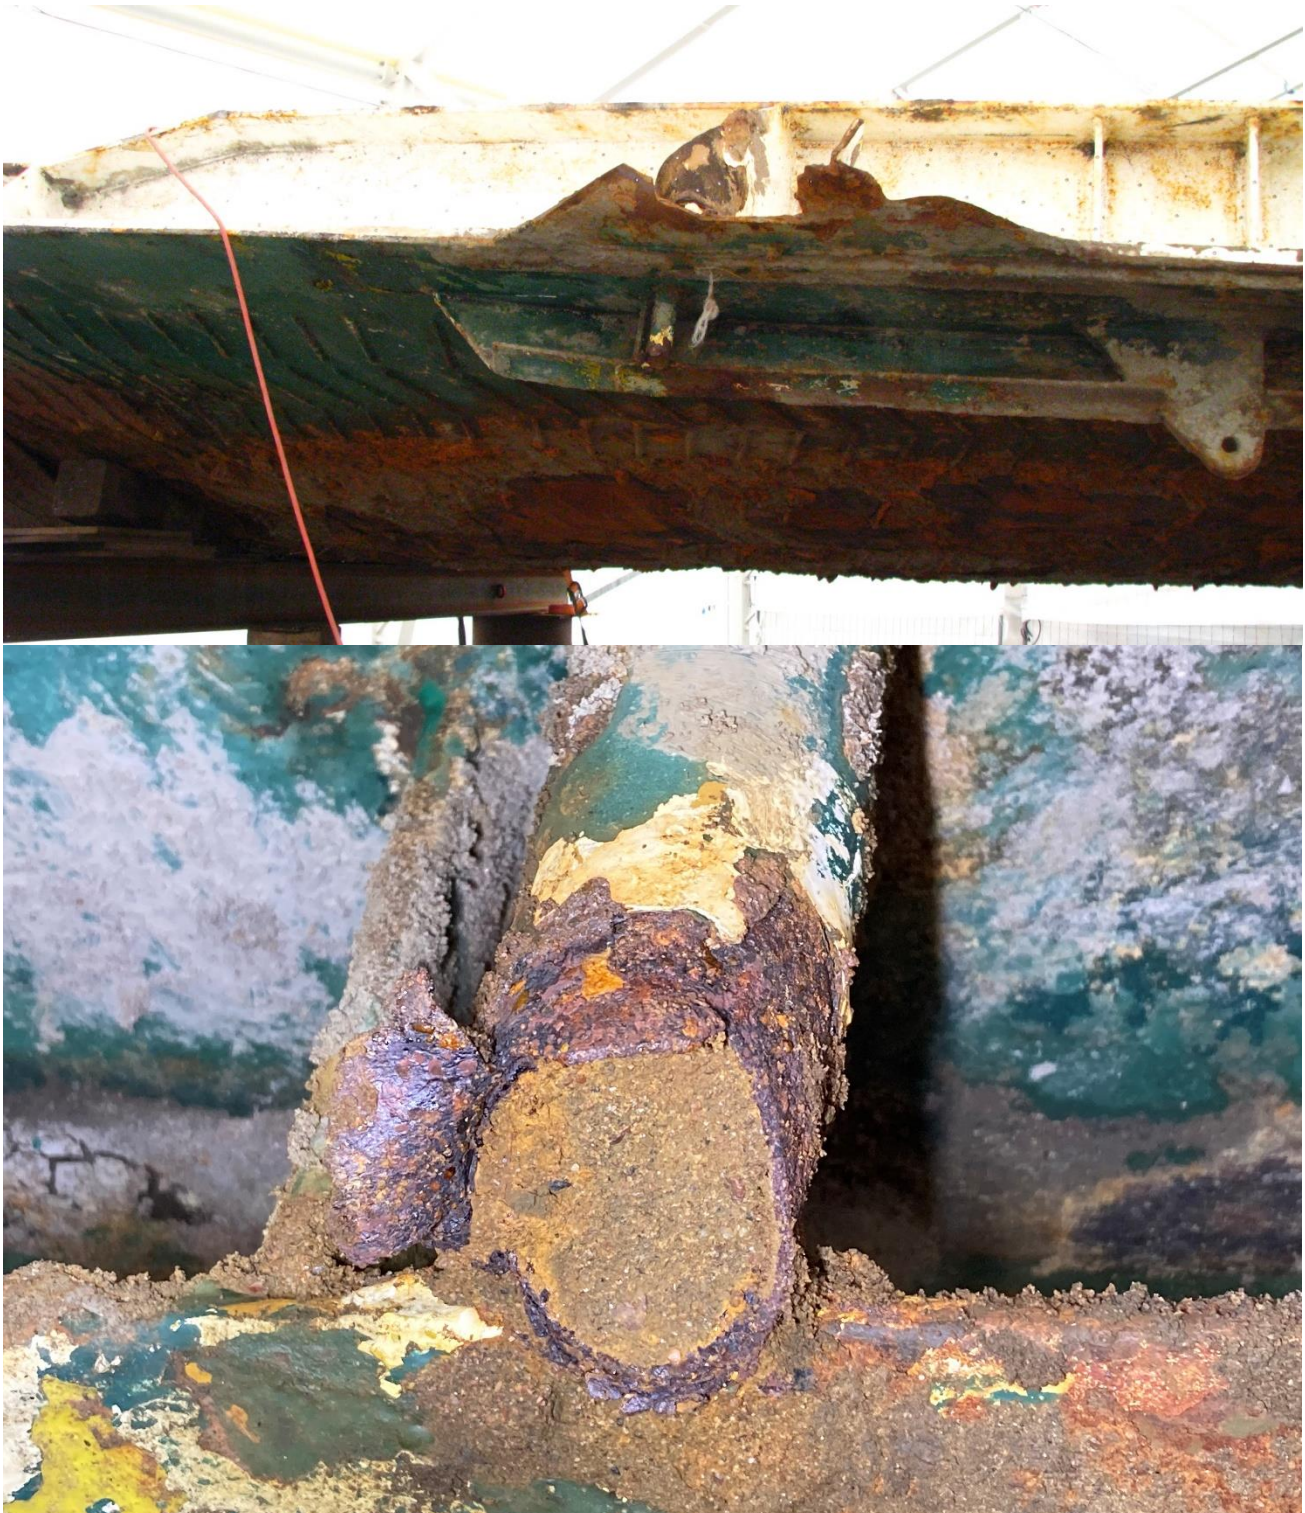
Figure 9. Starboard uppermost attaching position for railing (1 in Figure 8).

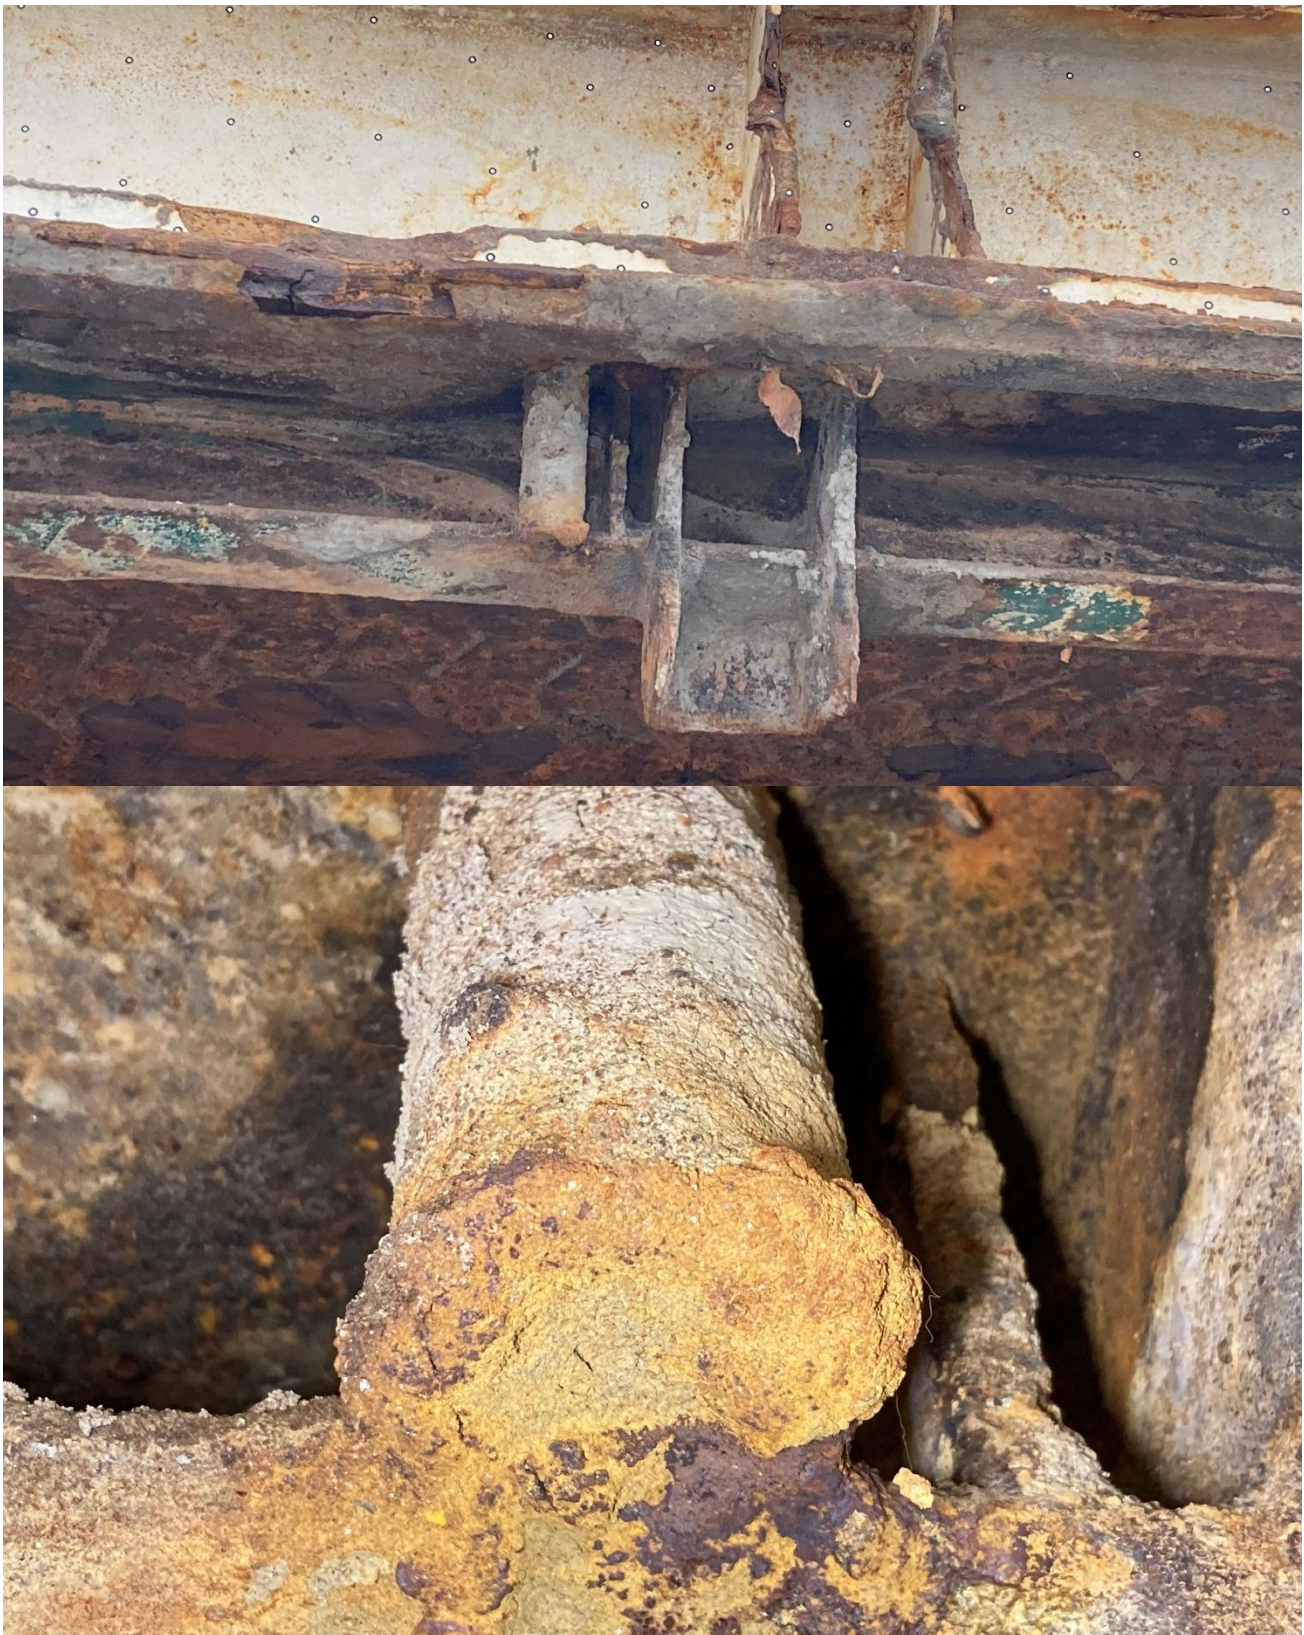
Figure 10. Starboard attaching position for railing (2 in Figure 8).

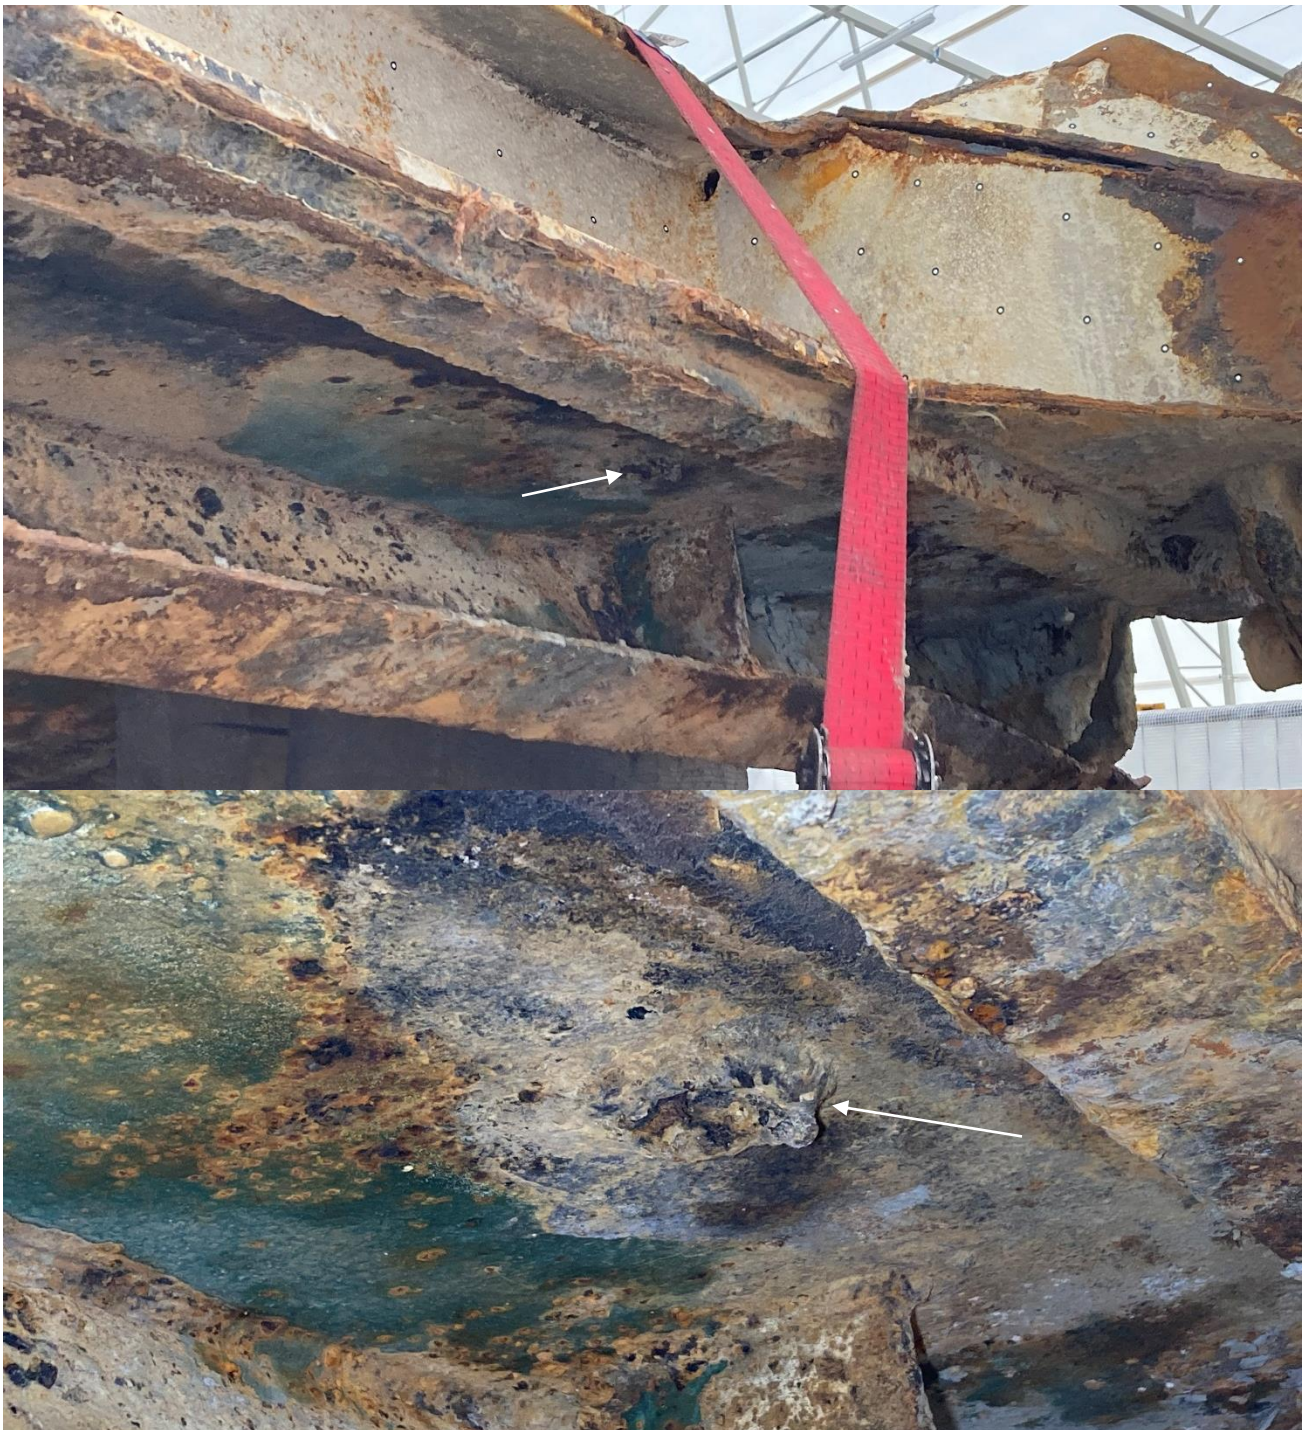
Figure 11. Starboard attaching position for railing, only the weld fillet remains on the bow ramp (3 in Figure 8).

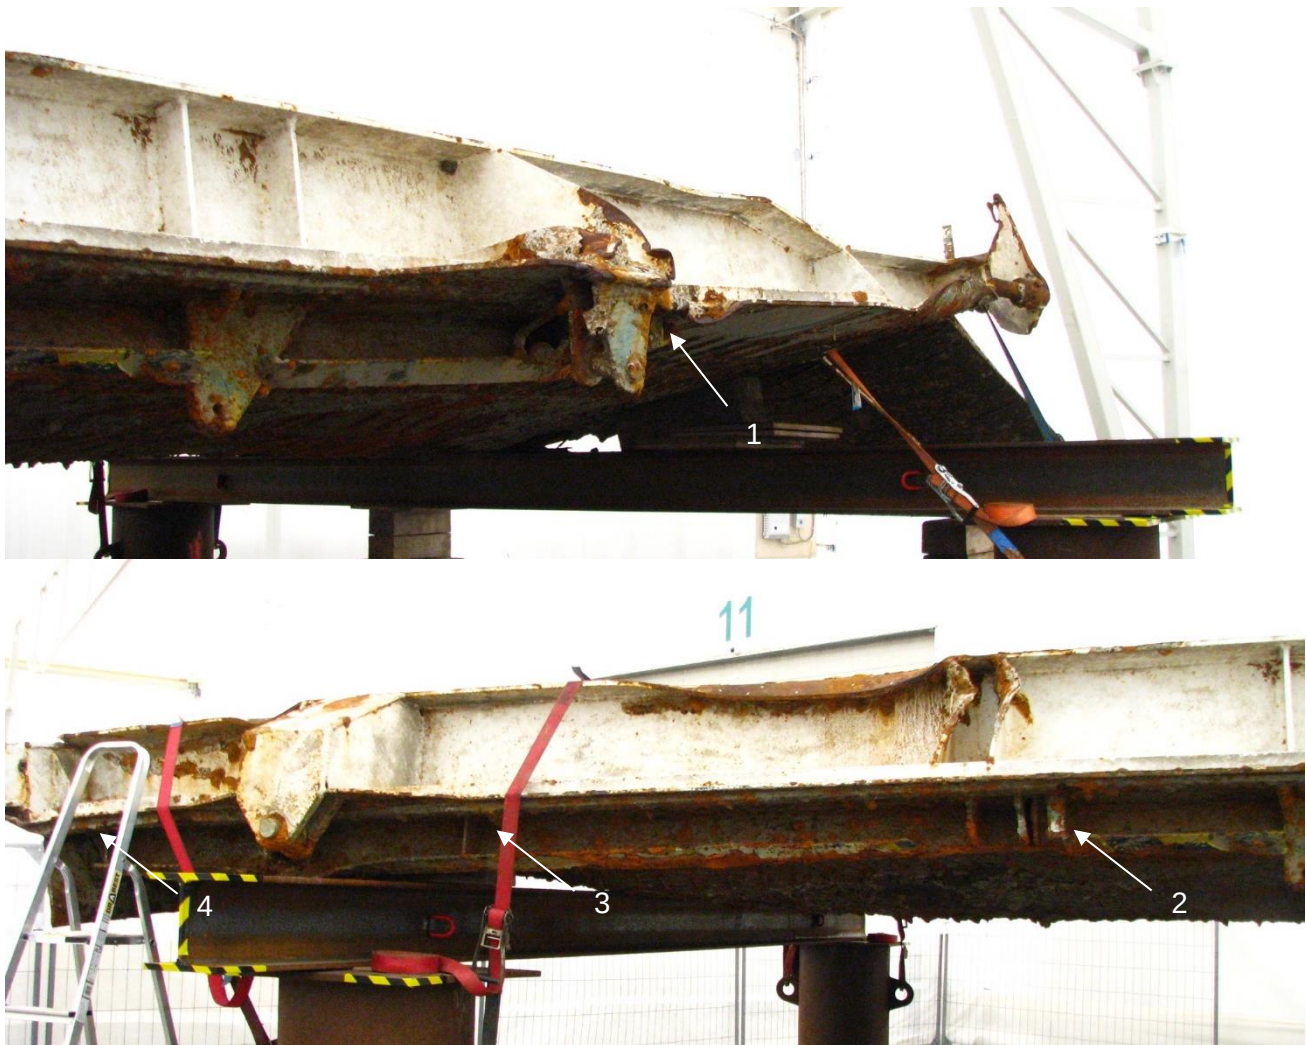
Figure 12. Four attachment positions for railing on the port side.

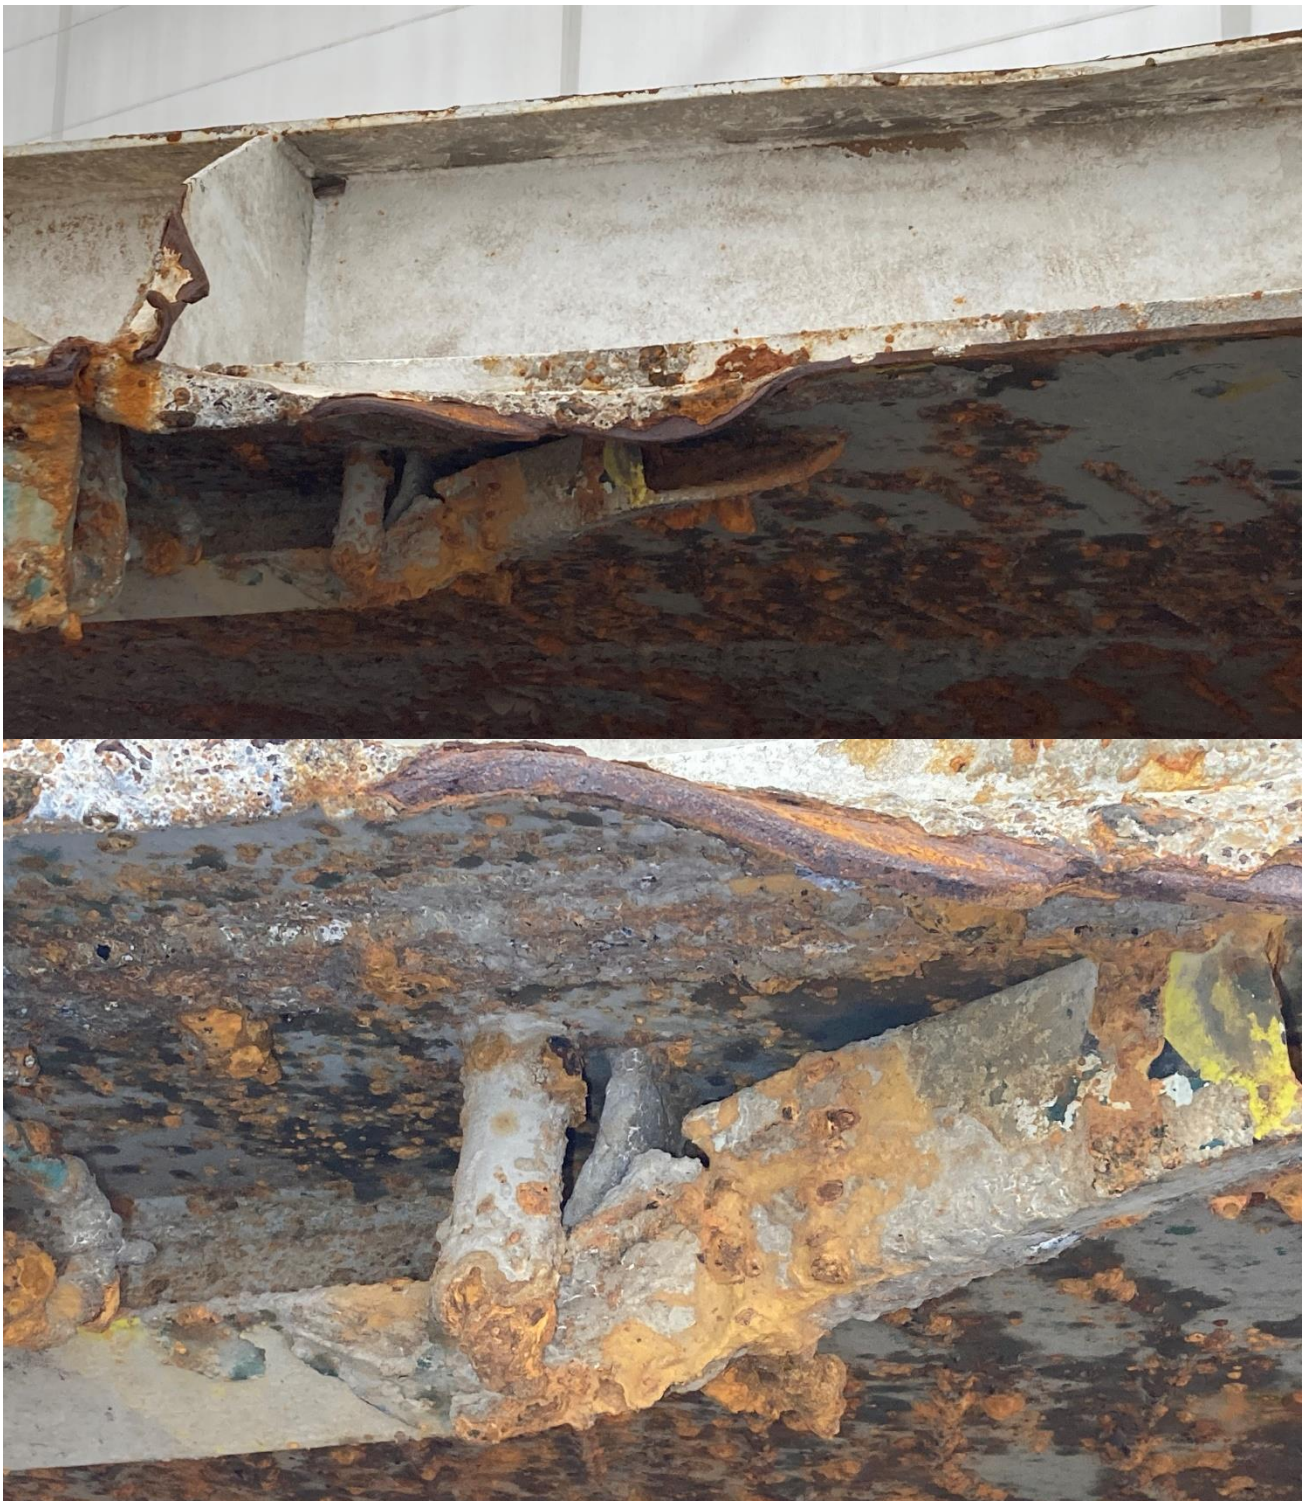
Figure 13. Port side attaching position for railing (1 in Figure 12).

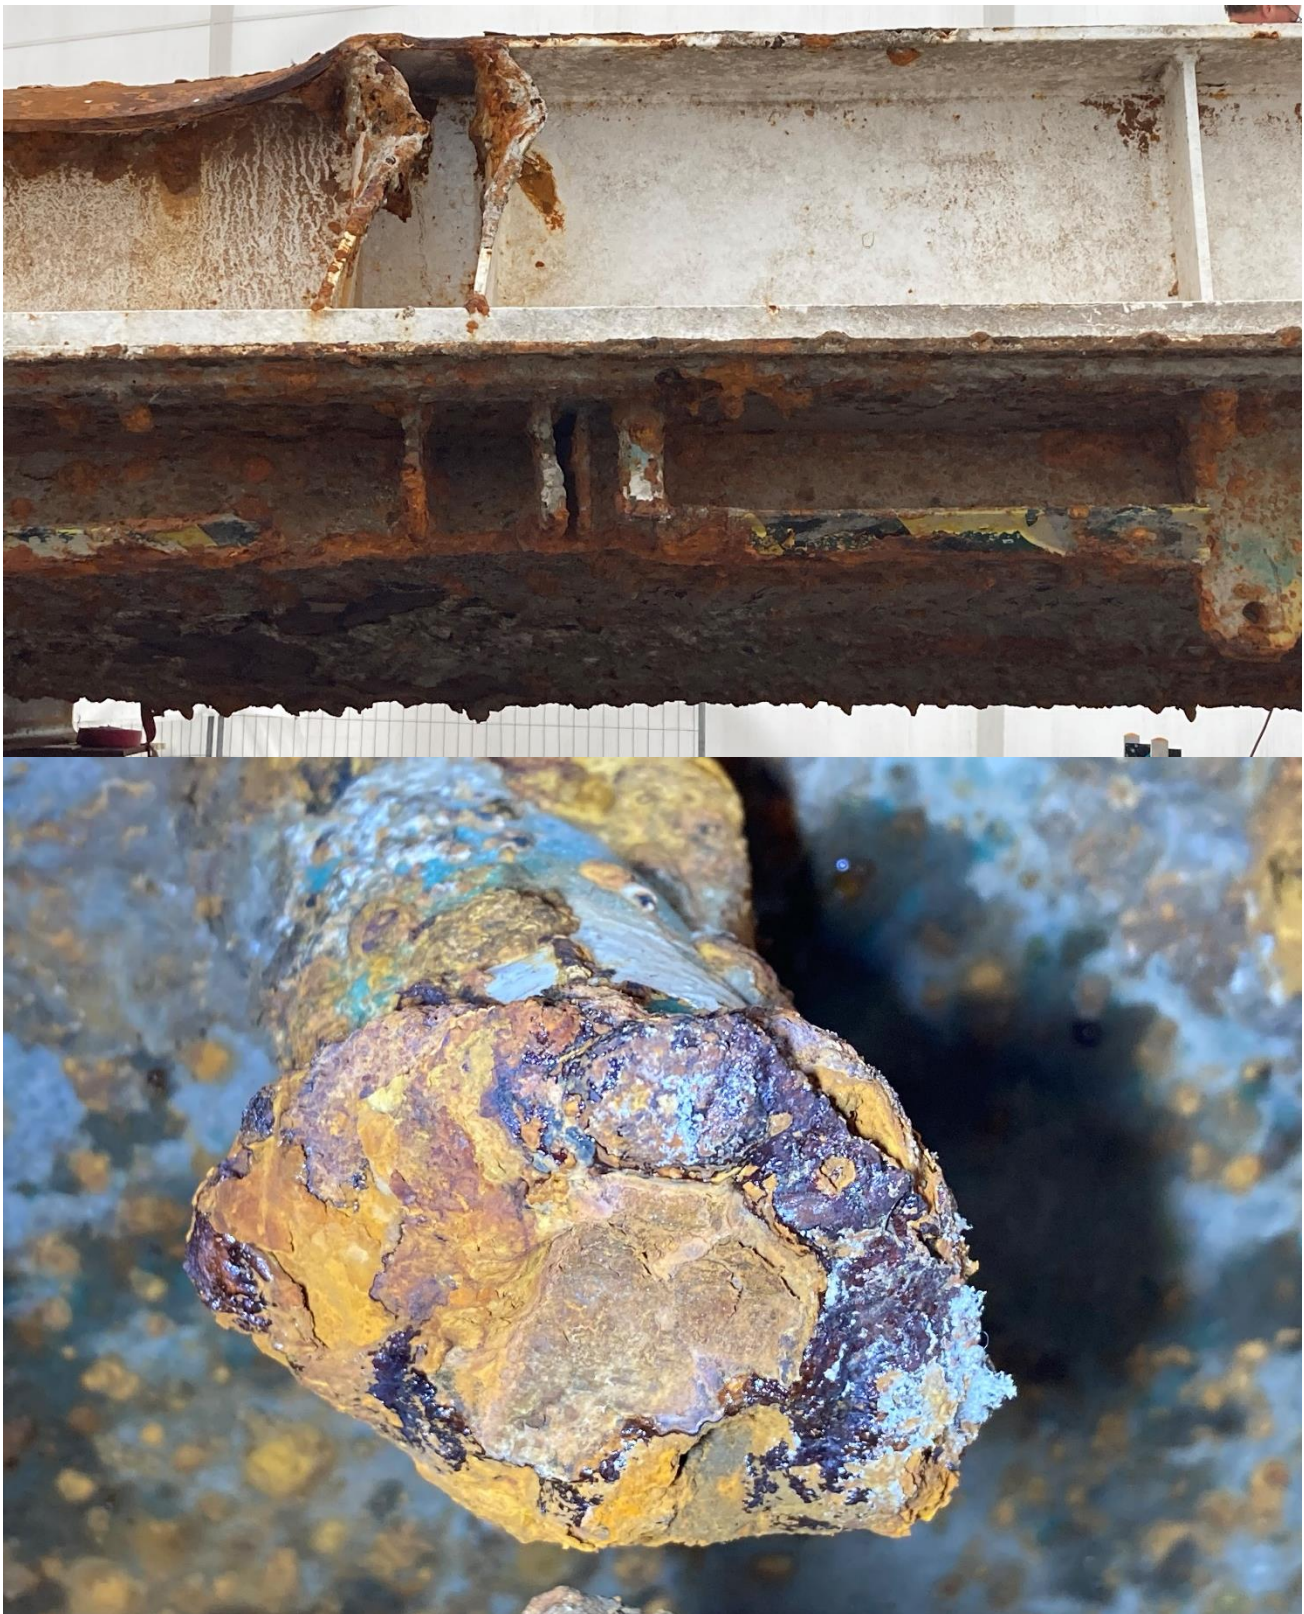
Figure 14. Port side attaching position for railing (2 in Figure 12).
