### **Examination of Salvaged Bow Ramp, m/s Estonia** *Translation to English of TEK23-0101*

**ELEMENT MATERIALS TECHNOLOGY AB**

**Swedish Accident Investigation Authority**

**TEK24-0010**

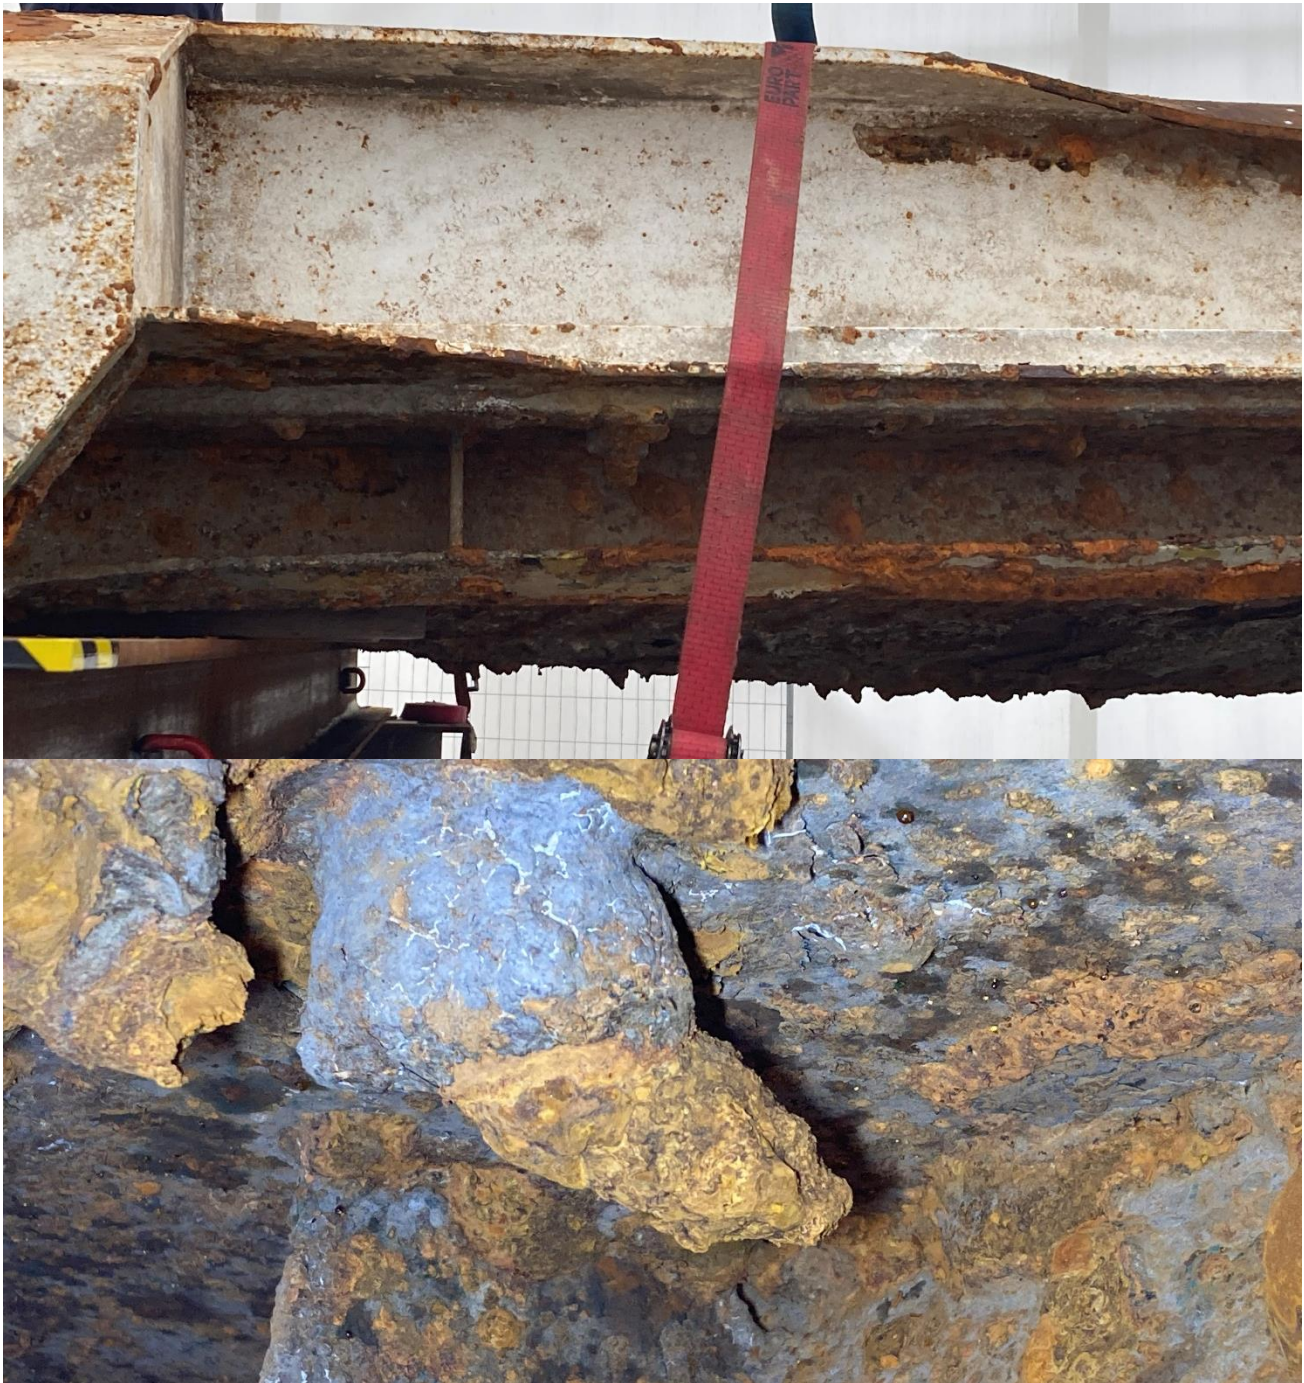
Figure 15. Port side attaching position for railing (3 in Figure 12).

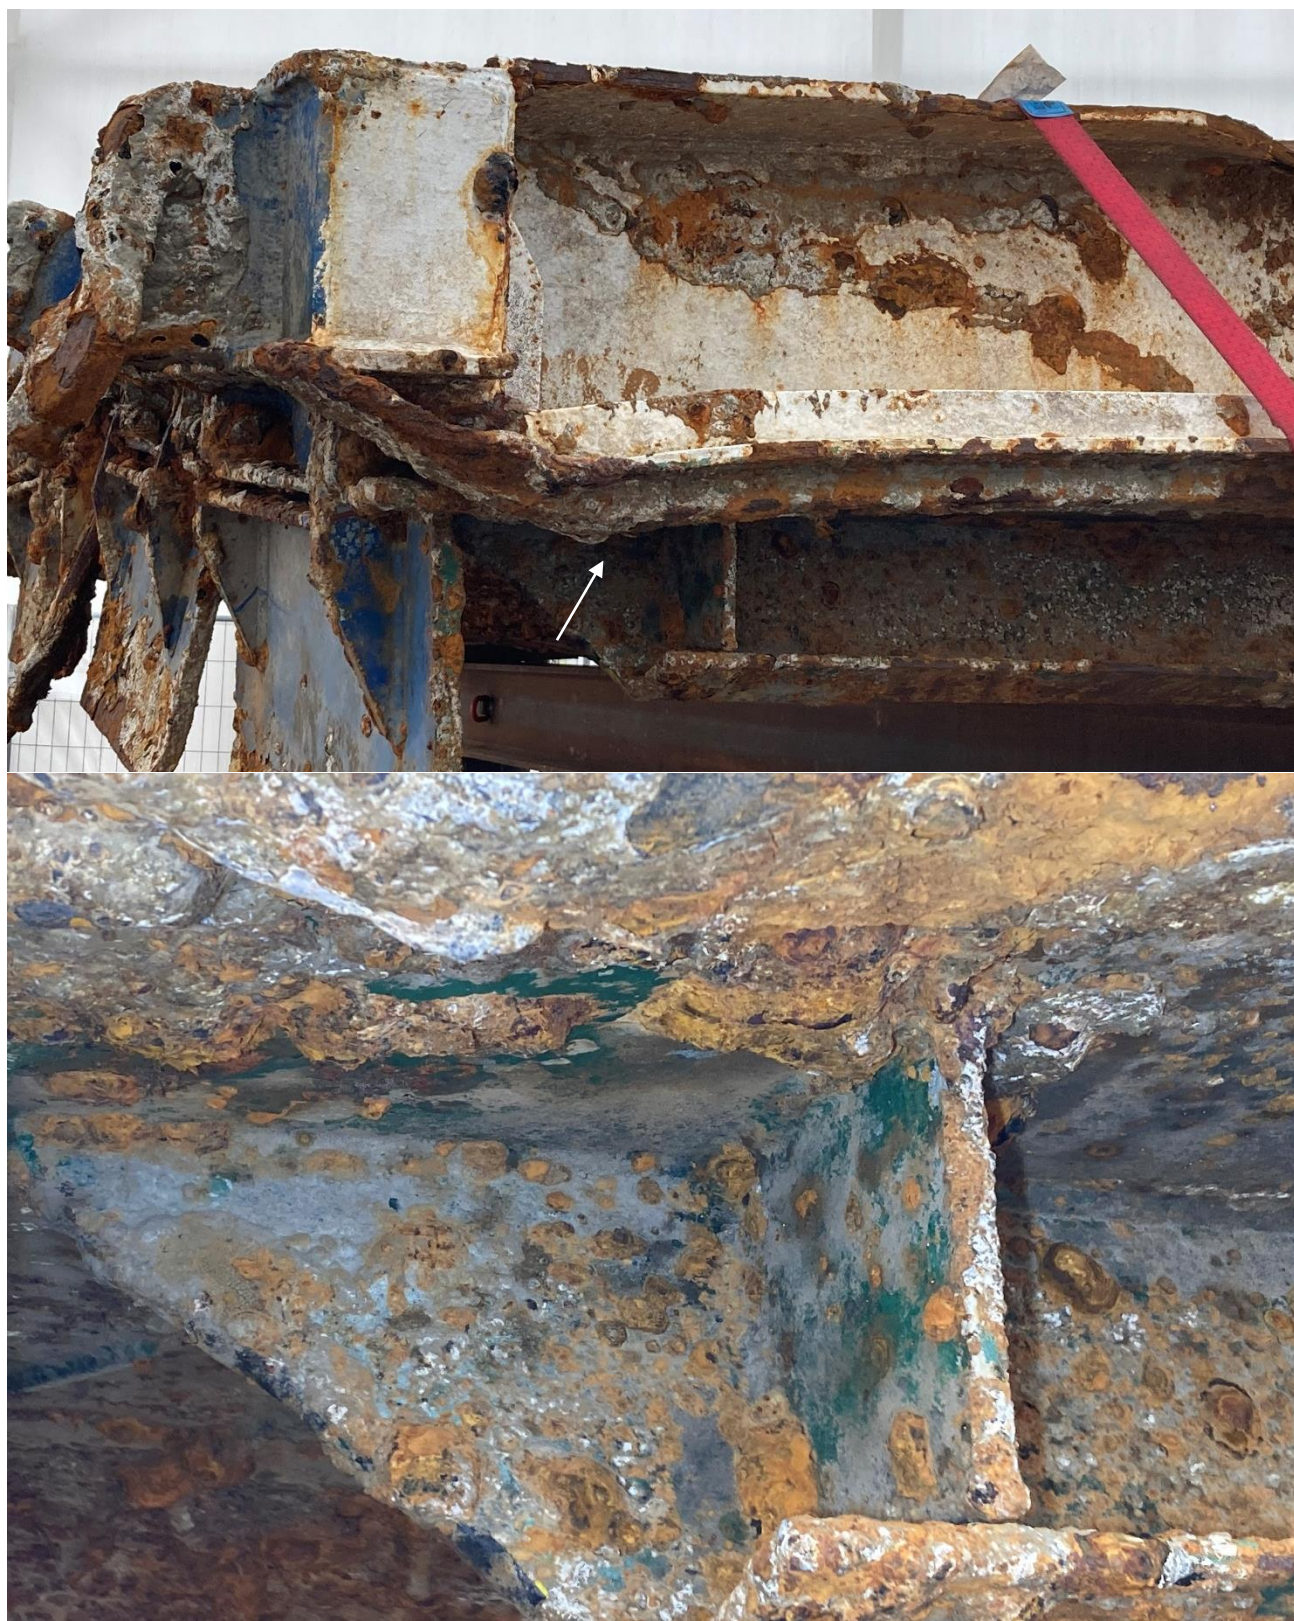
Figure 16. Port side attaching position for railing, no part of the railing remains, the weld has been somewhere below the heavily corroded area (4 in Figure 12).
