THE FINAL REPORT ON THE CAPSIZING ON 28
SEPTEMBER 1994 IN THE BALTIC SEA OF THE
RO-RO PASSENGER VESSEL MV ESTONIA

The Joint Accident Investigation Commission
of
Estonia, Finland and Sweden

SUPPLEMENT

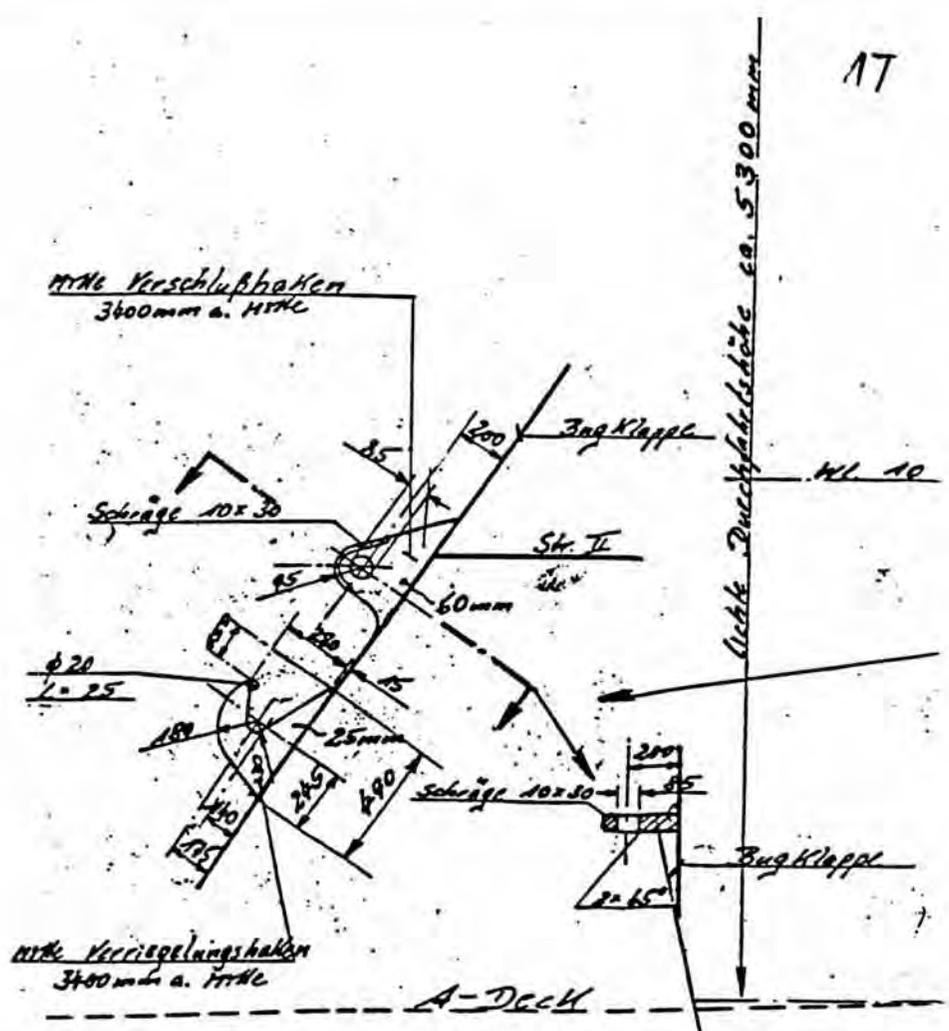
Fig. 9

All of the three lugs of the bolt housing and the support bushing of the bottom lock are broken. The lug of the bow visor did not fail but tore apart the lugs attached to the forepeak deck (I, II, III) and was then separated.

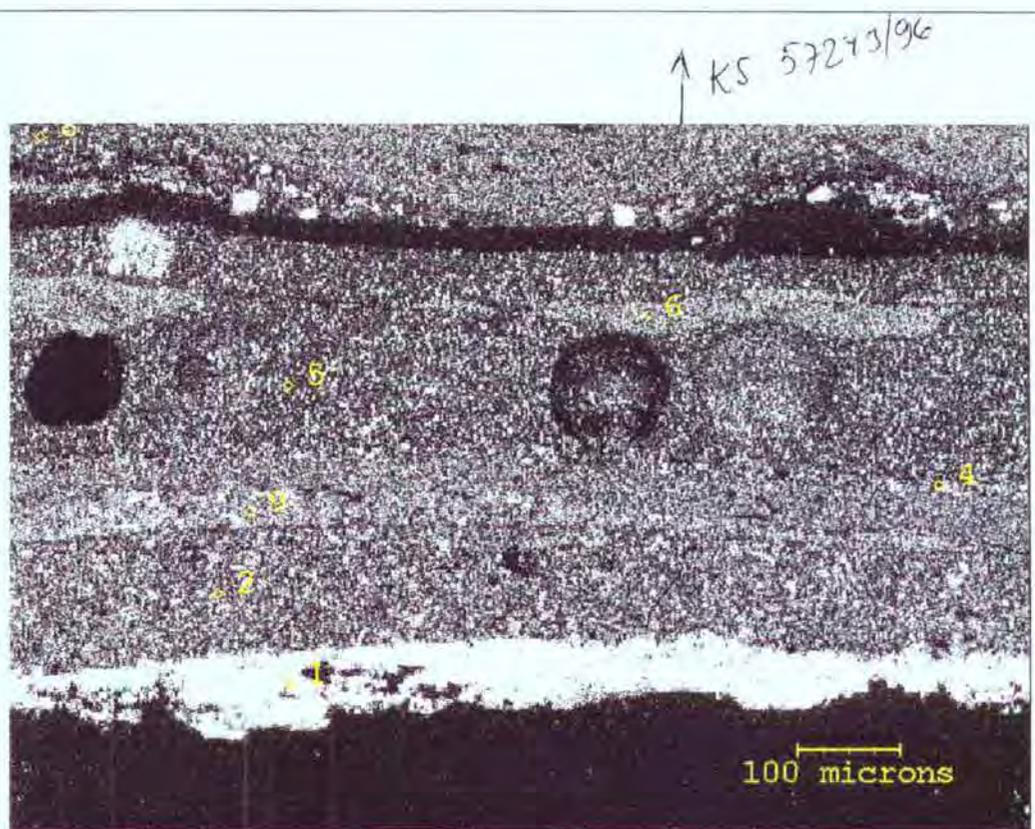
Figure 10 . Visor lug, paint system sample, cross section. Layer 1-rust; layer 2-yellowish; layer 3-white; layer 4-grey; layer 5-red; layer 6-white; layer 7-white; layer 8-grey; layer 9-light brown. Layers 8 and 7 were poorly adherent to the previous paint surface and rust was found underneath these layers.

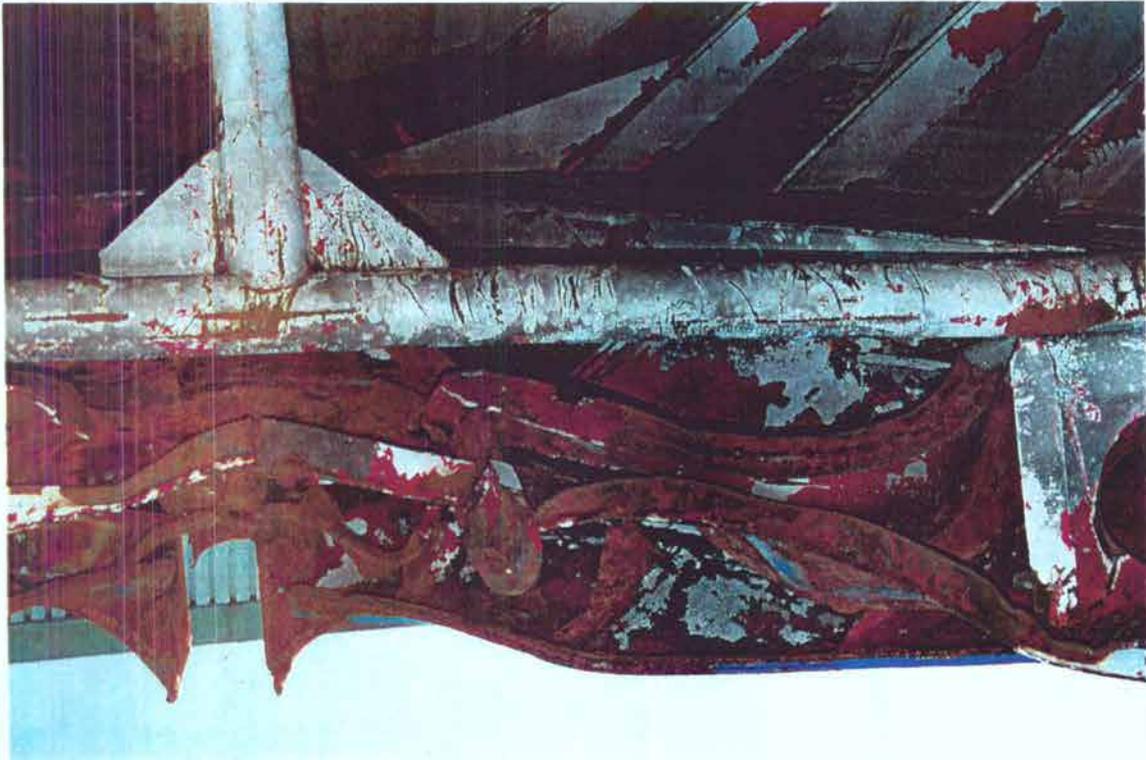
The aft end of the lug is bent to starboard and the surrounding base plating of the visor has fractured on port and has buckled at starboard. This suggests that a fairly high starboard facing load in the bottom part of the visor has acted sometimes and apparently during the accident. Such a situation could have developed if a clockwise twisting rotation around the ship's longitudinal axis of the visor occurred due to a lifting action at the port side. Contact marks in the bottom locating horn recess on starboard suggest that the lower portion of the visor has been forced to port at some stage of the sequence of events. The resulting and remaining total sideways displacement of the aft end of the lug is on the order of 10 cm.

Figure 12. Atlantic lock lug site in the visor after visor recovery.

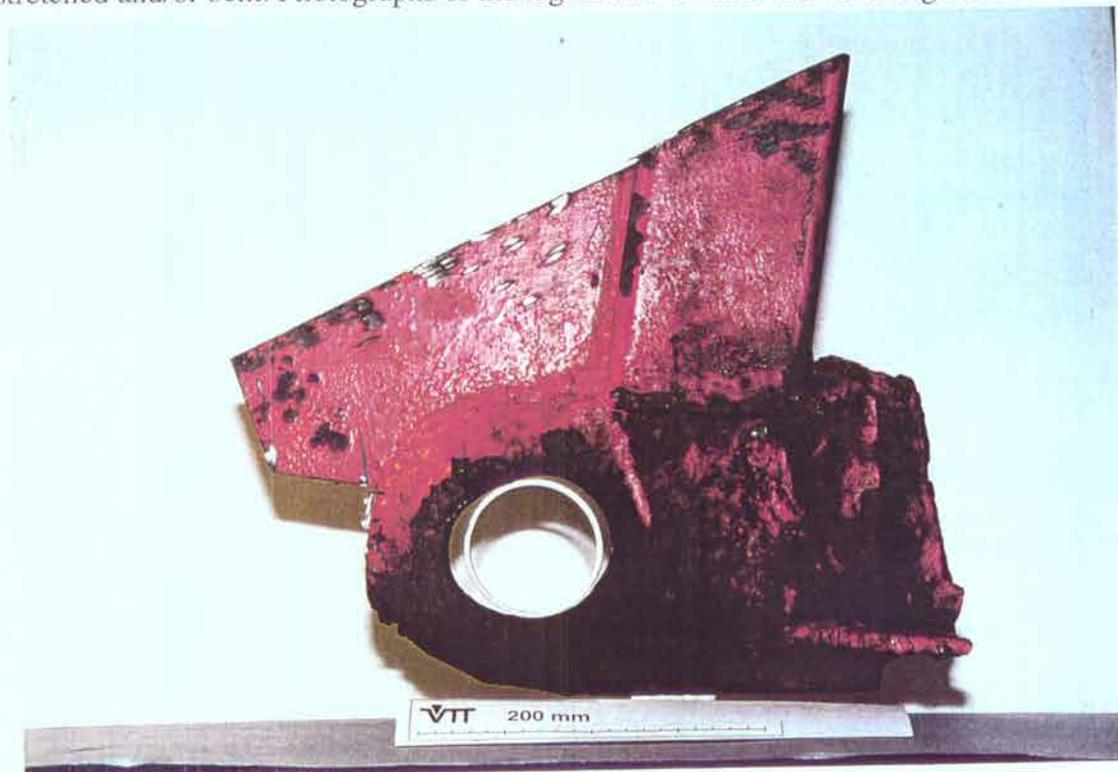
Figure 18. The Atlantic lock visor lug from the MV DIANA II. Part of the added plating surrounding the lug tip has been removed for measurement purposes.

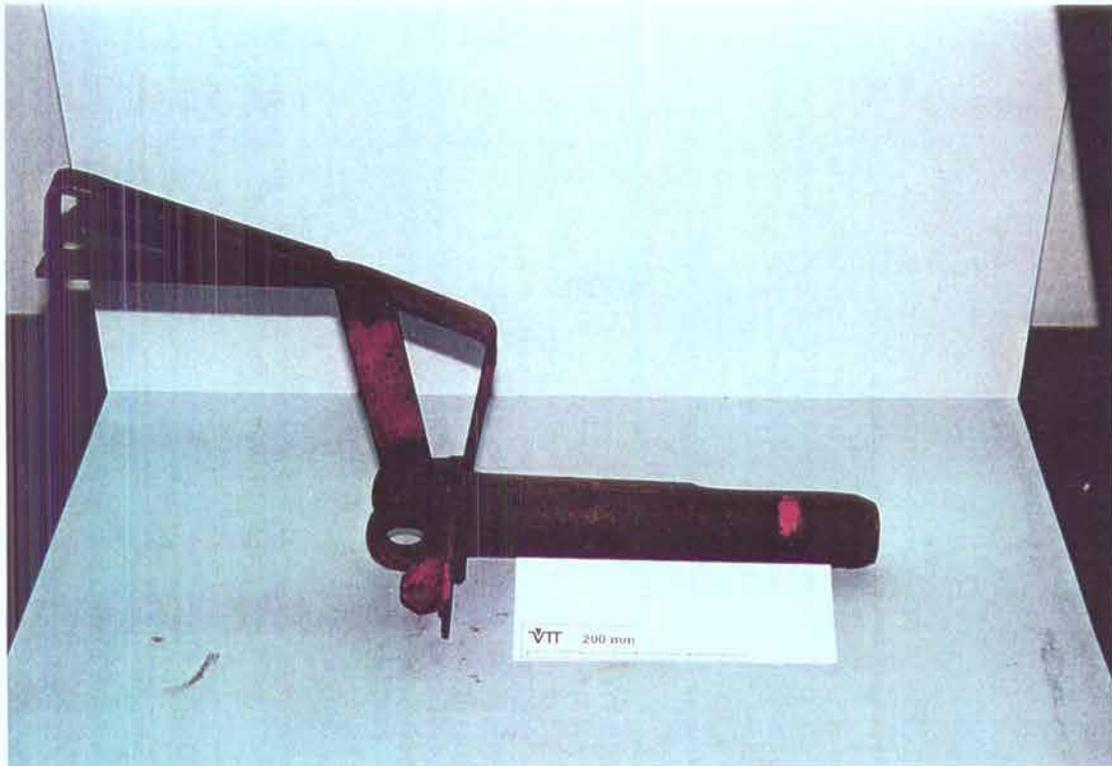
Figure 19. The Atlantic locking bolt from MV DIANA II. View from the upper aft sector.

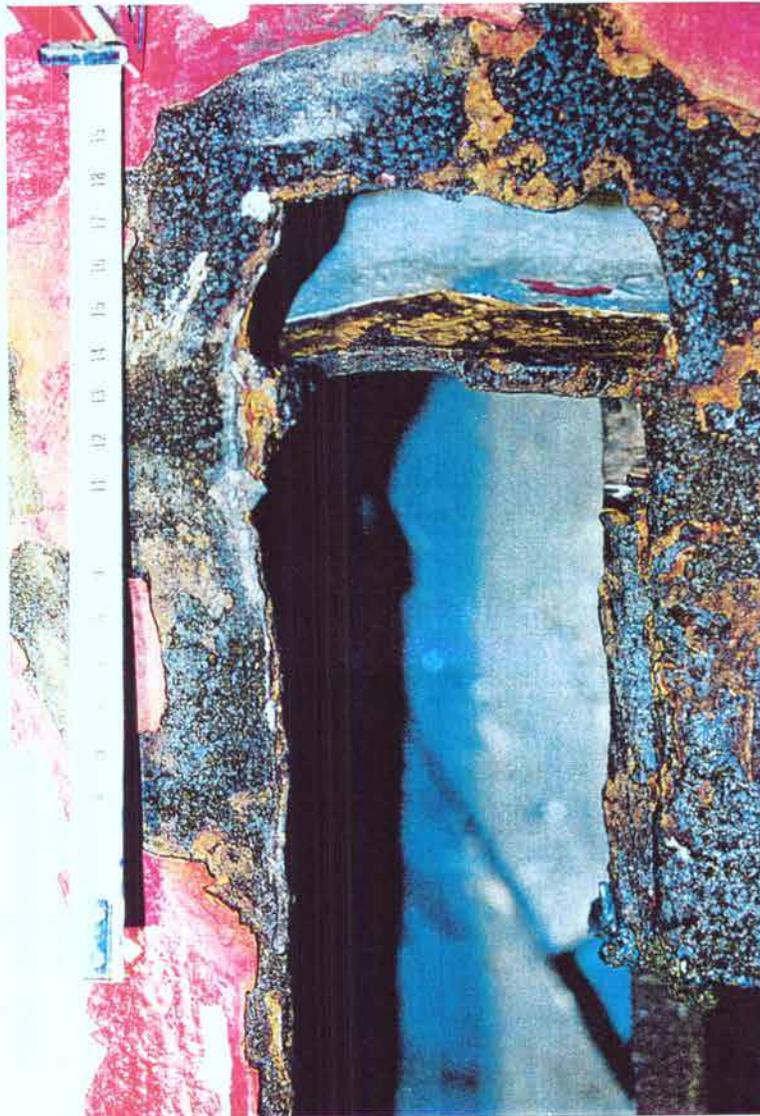
Figure 22. Side lock region on port side as found on visor after the casualty.

The general breaking mechanism had been by fracture of the horizontal stringer under the lug, vertical stiffener edge corner and tear (along the lug weld edge) of aft plating onto which the locking lug eye plate had been attached by welding. Apparently the lug to bulkhead-weldment had been stronger than the rest of the structure, judging from the fact that nothing of the lug related material had been left on the visor. The holes left in the visor aft bulkhead measured 390 mm * 85 mm, the foot print of the lug only being 380 mm * 60 mm. The width of the weldment along the plating outside of the lug plate footprint has thus been on the order of 12 to 13 mm.

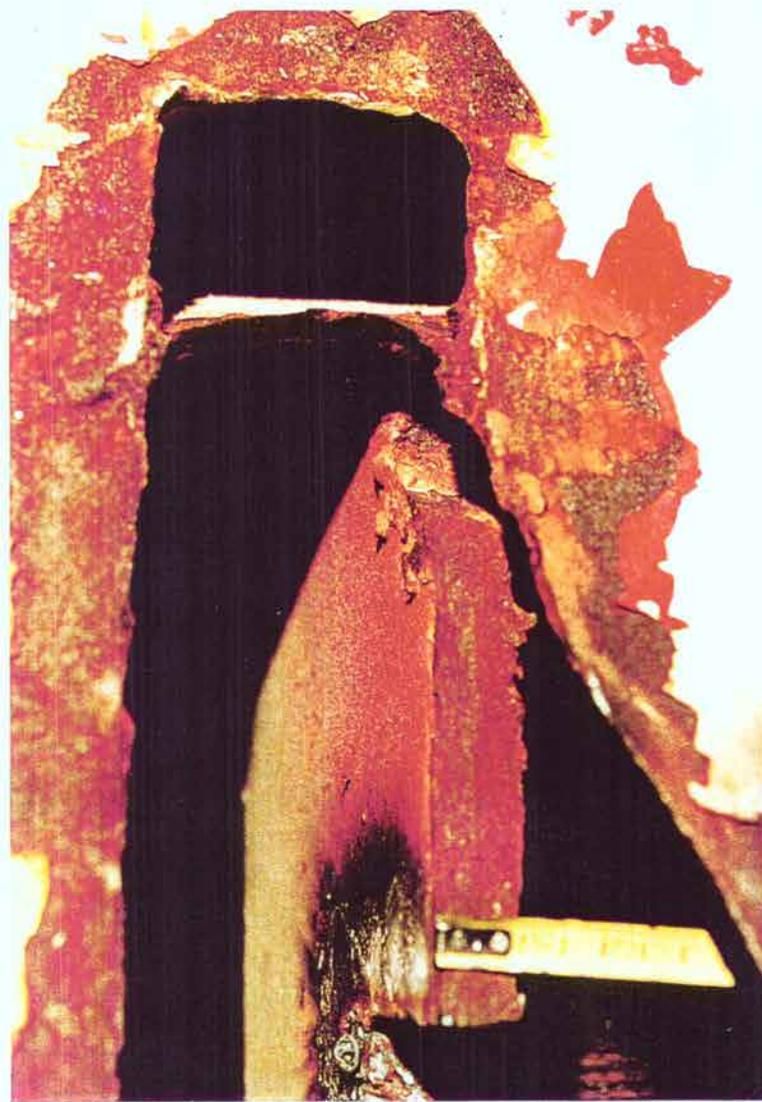
Figure 23. Starboard side lock site of the MV ESTONIA visor.

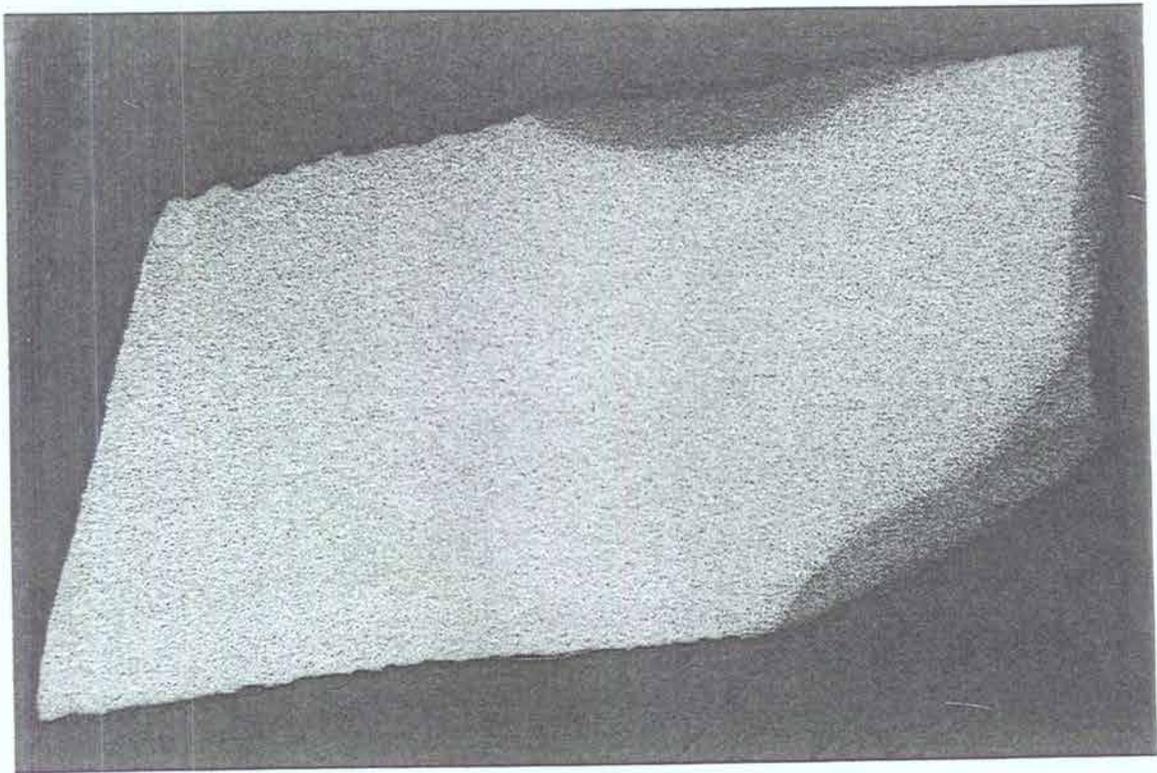
the upper side. The weld on the lower side was apparently too slim. Together they were unable to move the failure into the stringer plate.

Figure 24. Etched section through the horizontal stringer aft edge on port at the side lock displaying about 4 mm shear width on the low side (shear through edge corner) and 4mm shear width along plate surface on the top side.

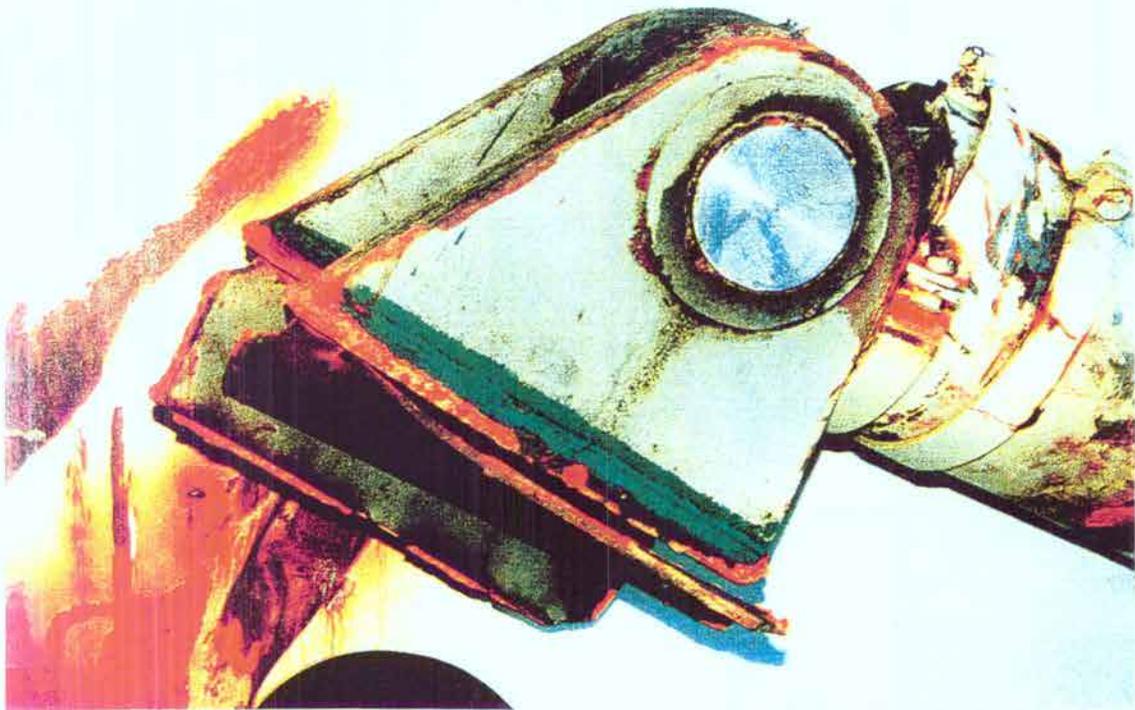
Figure 30. Port side lifting cylinder lower lug as recovered with visor.

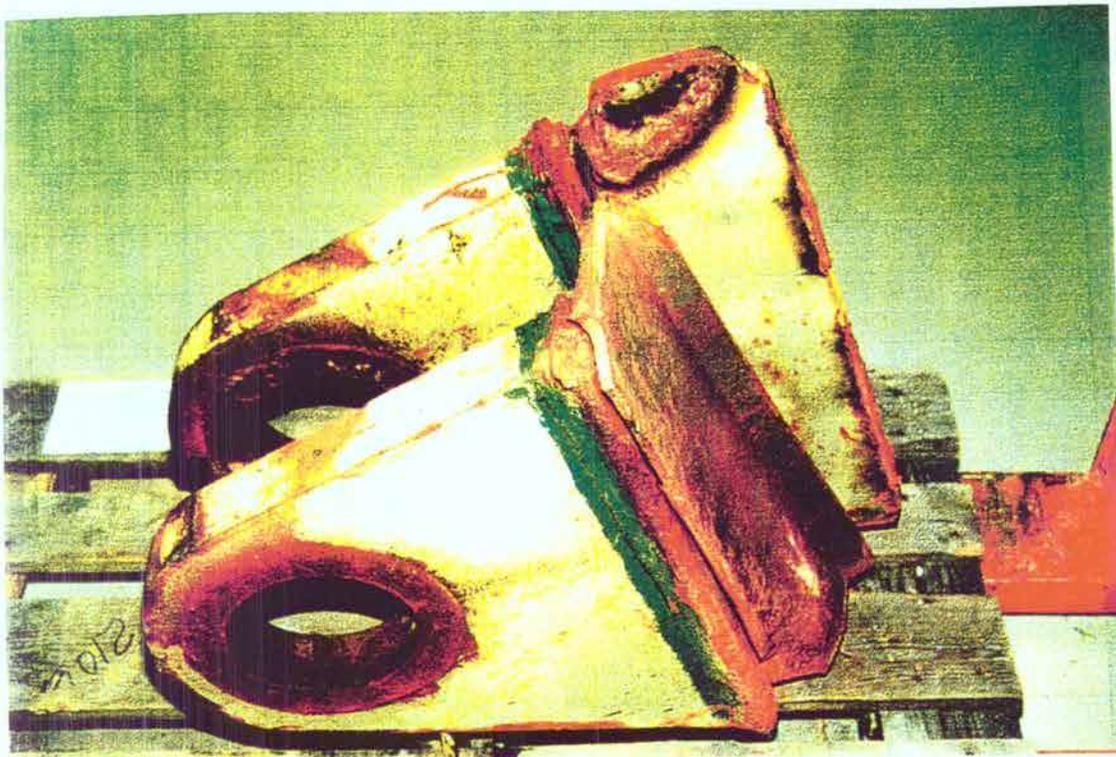
Figure 31 . Port lifting cylinder lower platform as seen from bow centre. Position tilted 120 degrees bow up. Bow end of lower port extreme stringer weld repaired. Centre stringer bent with broken fillet weld, nearest (centremost in ship) fillet weld missing.

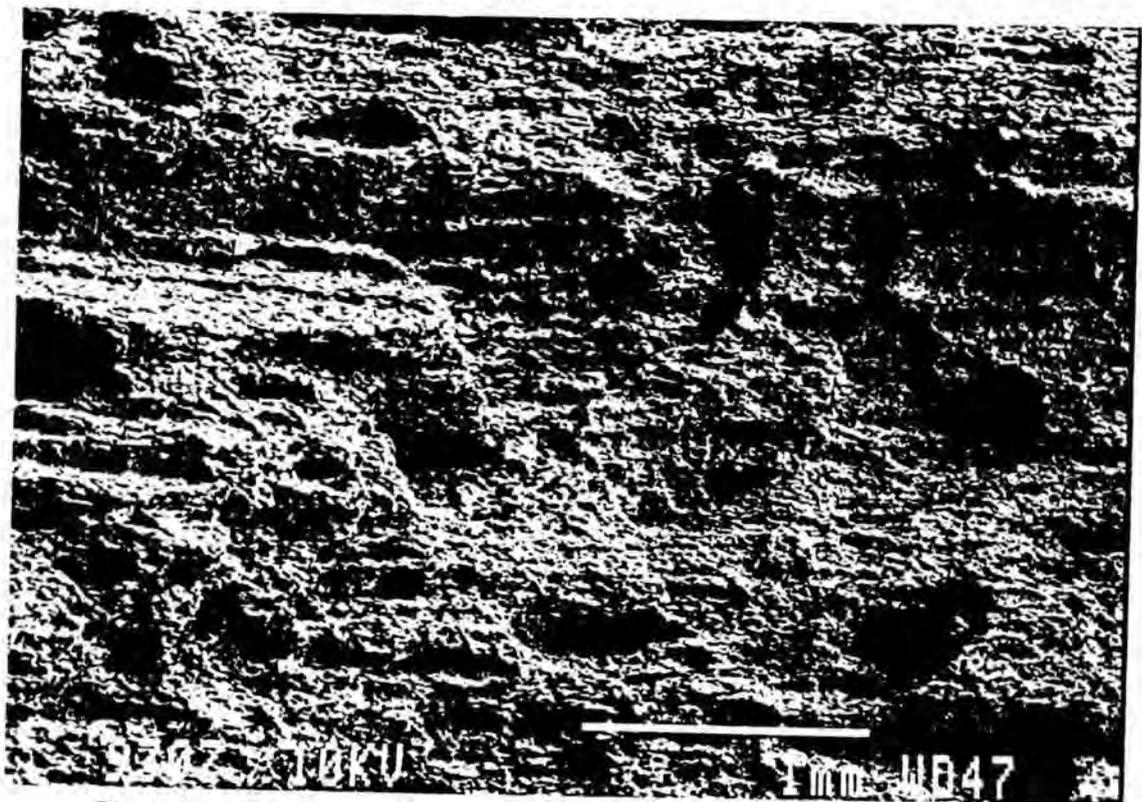
Figure 4. SEM picture of fracture surface of lug. The "striations" are oriented parallel with the slag inclusions. 38x.

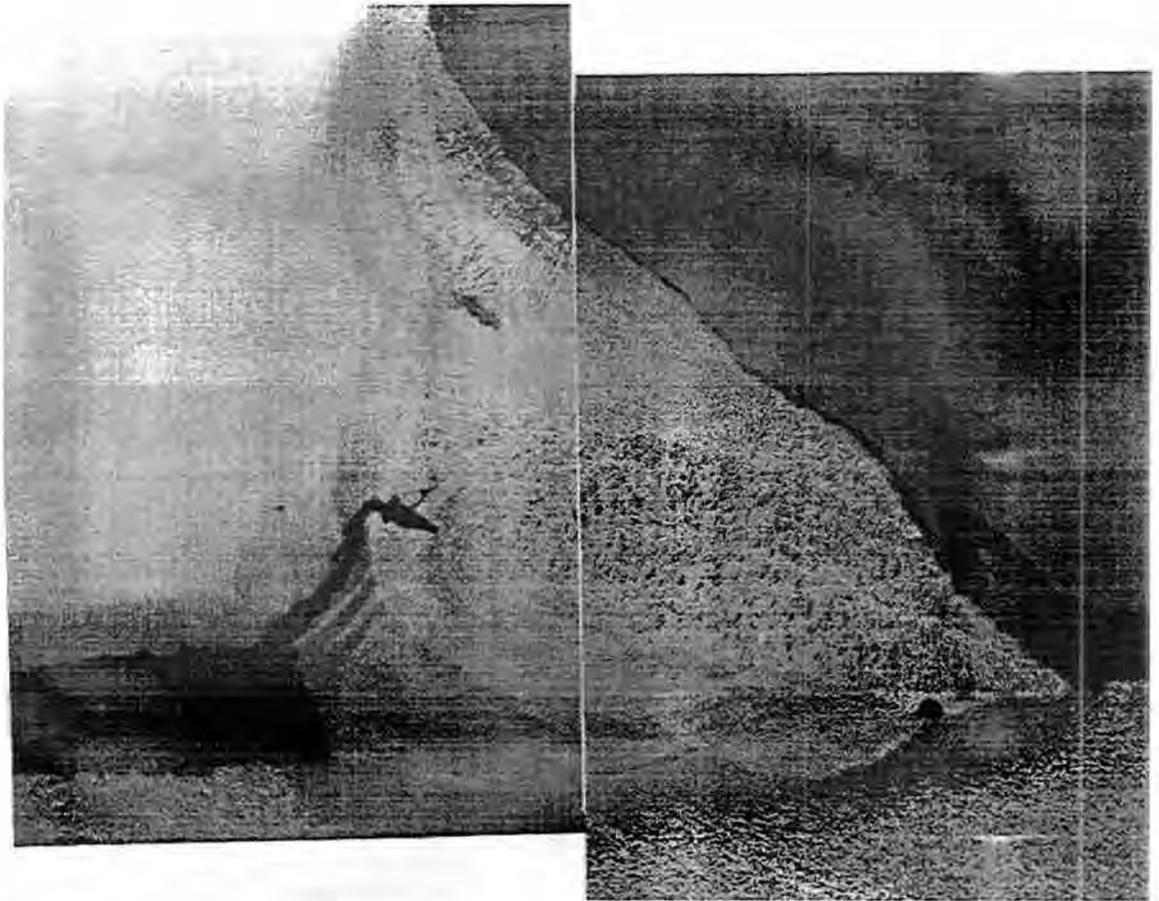
Figure 5. Cross section of weld between hinge plate and bushing on Mare Balticum.
7x.
