**PART-REPORT**

**MV ESTONIA**

Our date  
April 1995

**Part-Report on the ESTONIA Disaster of 28 September 1994**

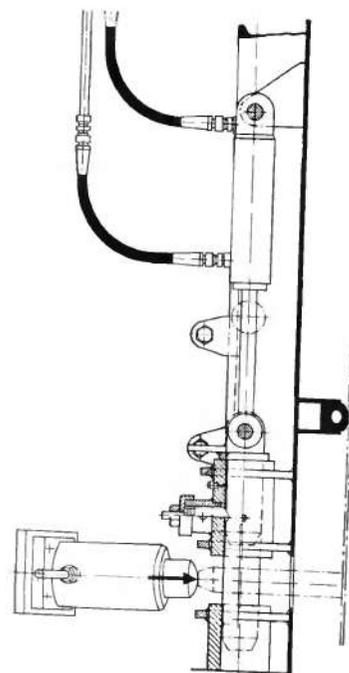
FIG 4 Bottom locking device

The bottom locking arrangement is shown in Figure 4. It was sometimes called the "Atlantic lock" as it was not in common use in early ferries but was later introduced to enable similar ferries to cross open oceans. The "Atlantic lock" had become established by the time the ESTONIA was built. The locking device consisted of a locking bolt, movable horizontally in a transverse direction, guided in a bolt housing. In extended position the tip of the bolt engaged a support bushing. The bolt housing was fixed to the forepeak deck by means of two steel lugs and the bushing was installed in a third similar lug. A mating lug, attached to the visor itself, was located between the bolt housing and the support bushing when the visor was in the closed position and the extended bolt then engaged the hole in the mating lug.

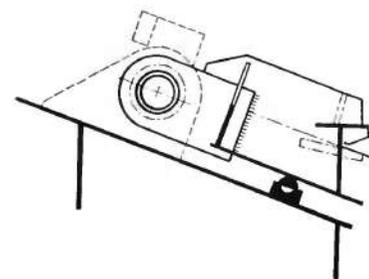
FIG 6 Side locking device, port and starboard

The side locks consisted of two lugs, mounted to the aft bulkhead of the visor and extending, when the visor was closed, into two recesses in the front bulkhead of the hull, one at each side of the ramp opening. In the closed position hydraulically operated bolts engaged holes in the visor lugs. The arrangement is shown in Figure 6. The hydraulic bolt installations were similar to that of the bottom lock, i.e. a bolt moving in a bolt housing and, when extended, engaging a support bushing. The visor lug inserted between the bolt housing and the support bushing. The bolt was moved by an hydraulic actuator. A mechanical friction plunger was installed. The position of the bolt, fully retracted and fully extended, was sensed by magnetic-type limit switches.

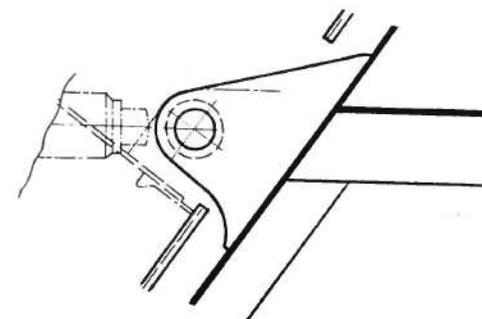
FIG 5 Lug of visor, mating the bottom locking device

The mating lug in the bottom structure of the visor consisted of a single steel lug, welded to a transverse beam of the visor bottom structure and supported by a bracket as shown in Figure 5. The lug had a hole for the locking bolt with an original diameter of 85 millimetres. The diameter of the hole had increased in service and after the accident the hole was oval with dimensions about 90 x 105 millimetres. The elongation may have been caused by wear or by yielding during the failure of the locking device.

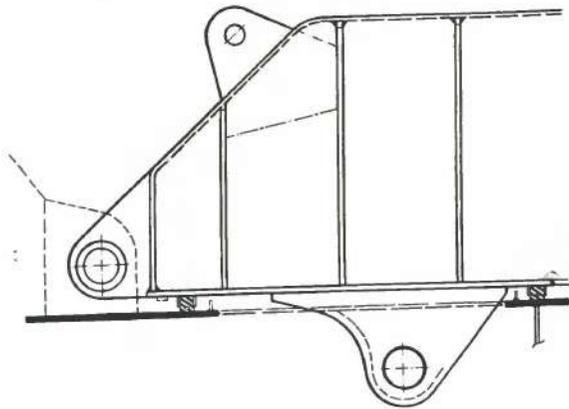
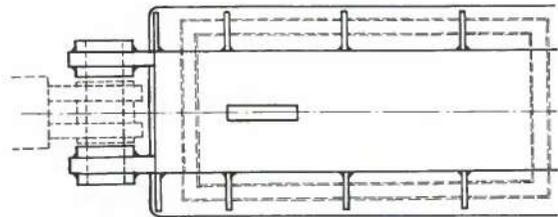
FIG 8 Manual locking device, port and starboard

Two manual locks were installed, one at each side and mounted just below the hydraulic side locks. Each lock consisted of two lugs welded to the aft side of the visor and a hinged eye bolt with nut, mounted between two lugs in the front bulkhead. In closed position the eye bolt was swung into position between the two lugs in the visor and the nut was tightened down. The arrangement is shown in Figure 8. The locks had no remote position indicating devices.
