# The Vessel M/S Estonia

## Review of geotechnical investigations

Commissioned by: Swedish Accident Investigation Authority

14/09/2021

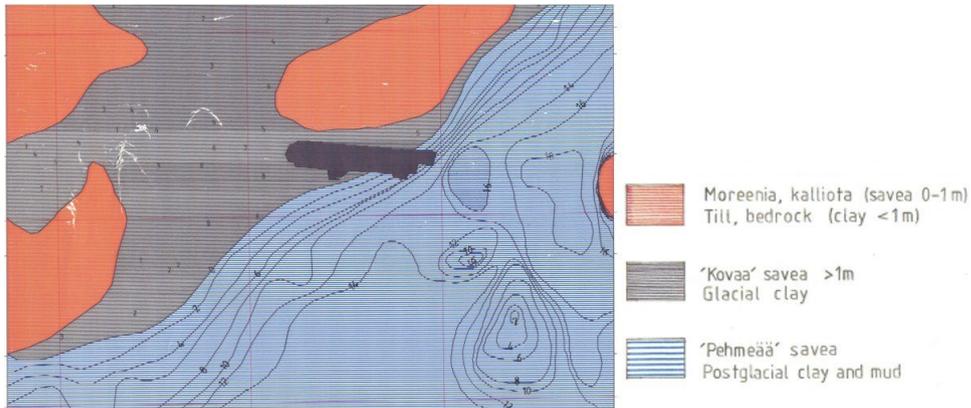
The seabed around Estonia consists of a surface layer of extremely soft sediments with very soft clay beneath. Beneath the clay is solid glacial till. Figure 2 shows that the vessel is lying in a boundary zone between very soft post-glacial clay to the east and south of the vessel and a somewhat more solid glacial clay to the west and north of the vessel (but still very soft). Approximately 100 m north of the vessel, the surface of the seabed is stated as consisting of glacial till with rocky outcrops also having been observed in the immediate

Figure 2. Soil type map with an outline of depth contour lines for post-glacial clay (Naval Research Institute, Finland, 1995).

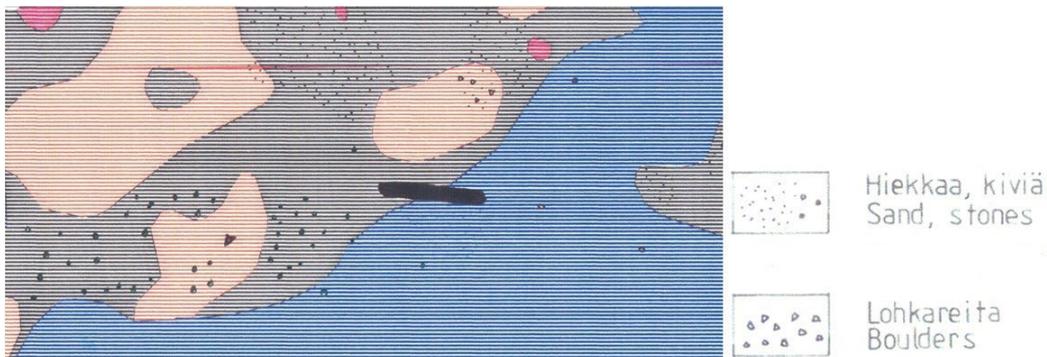
surroundings (the red field in Figure 3). Figure 3 also indicates that stones and rocks are present on the surface of the seabed in the area immediately surrounding the vessel. The details in Figure 2 and Figure 3 should be considered an outline. The rocks and stones on the map should not be primarily interpreted as specifically determined positions of individual boulders and stones, rather as representing areas where these fractions are present on the surface of the seabed.

Figure 3. Soil type map indicating stones and rocks on the surface of the seabed (Naval Research Institute, Finland, 1995).

The group of Estonian experts state that very little of the seabed was possible to observe in the video material (2020) but that the seabed appears to be relatively hard and solid without obvious larger rocks. However, Figure 3 does show the presence of rocks on the surface of the seabed within a larger area surrounding the vessel, primarily to the south-west of the vessel. When laying the forced penetration strings south of the vessel, the blast stones sank into the seabed sediments themselves until they reached a deeper, more stiff clay layer ([1] point 27). This sinking can also be expected to have occurred in the case of rocks that have been deposited on the seabed. In order for rocks to stick out, these need to be sitting on top of more stiff layers of soil. This may explain why the rocks in Figure 3 are primarily documented within the more solid glacial clay to the north and east of the vessel.

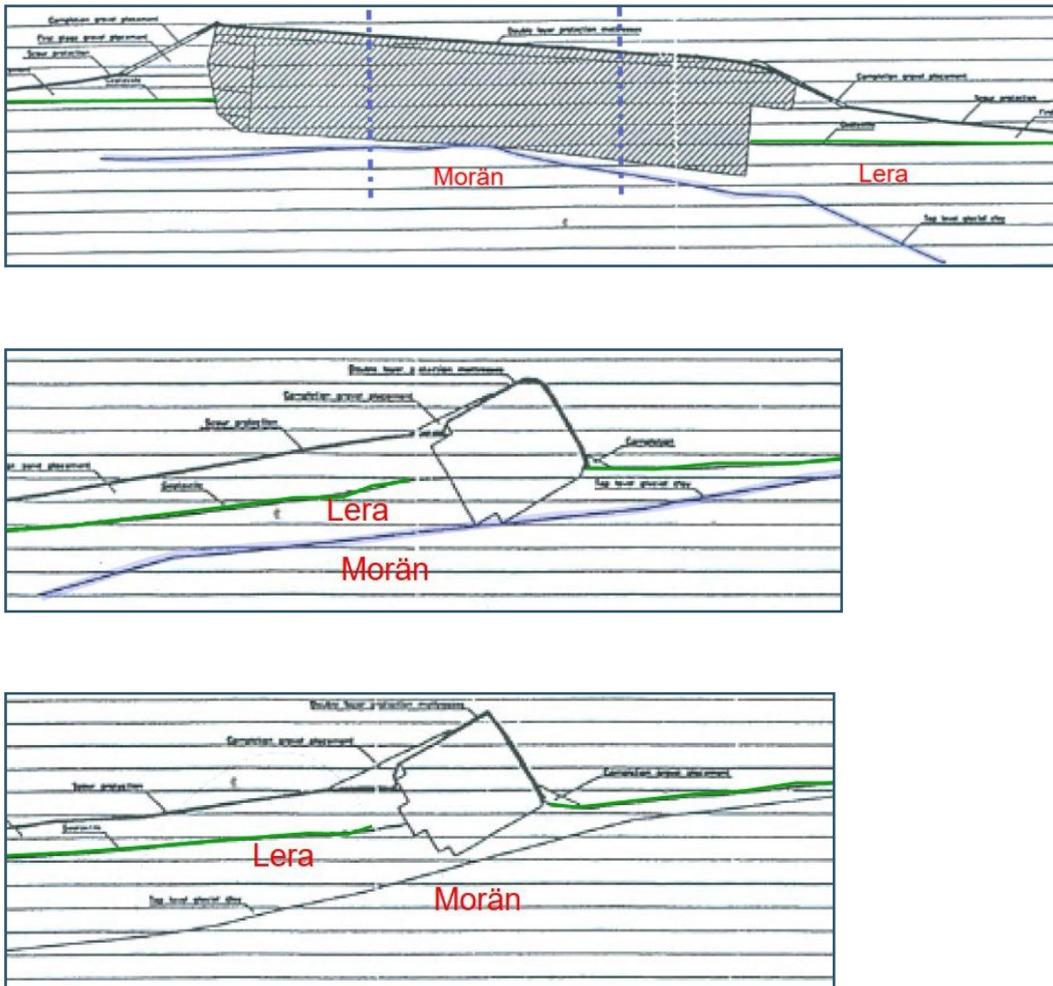
On the basis of geotechnical site investigations, the clay layer is estimated to vary in thickness between approximately 6 and 20 m. Figure 4 shows extracts from tender documents from the contractor Nordic Marine Contractors (NMC) (dated January 1996) in the form of a longitudinal section and cross-sections of the vessel, together with an interpreted soil layer sequence. The vessel is assumed to have some contact with the glacial till in its deeper part (NMC, 1996). The green line indicates the upper edge of the clay layer, which is a general representation of the previous surface of the seabed. Above the clay layer is a layer of fill material that was intended as a stabilisation measure ahead of the vessel being covered. The contracted works began on 19/04/1996. A government decision was made on 19/06/1996 to discontinue the covering of the vessel. The contractor ceased work on 27/07/1996.

The action proposal presented in the tender documents (Figure 4) were later adjusted, which means that both the interpreted geotechnical conditions and the planned

Figure 4. Top: longitudinal section through the centreline of the vessel. Middle: cross-section through the western part of the vessel. Bottom: cross-section through the eastern part of the vessel. Green line: upper edge of the clay layer. Vertical dashed line: approximate position of cross-section. The drawings refer to proposal to cover the vessel with concrete mattresses in tender documents from NMC (1995).

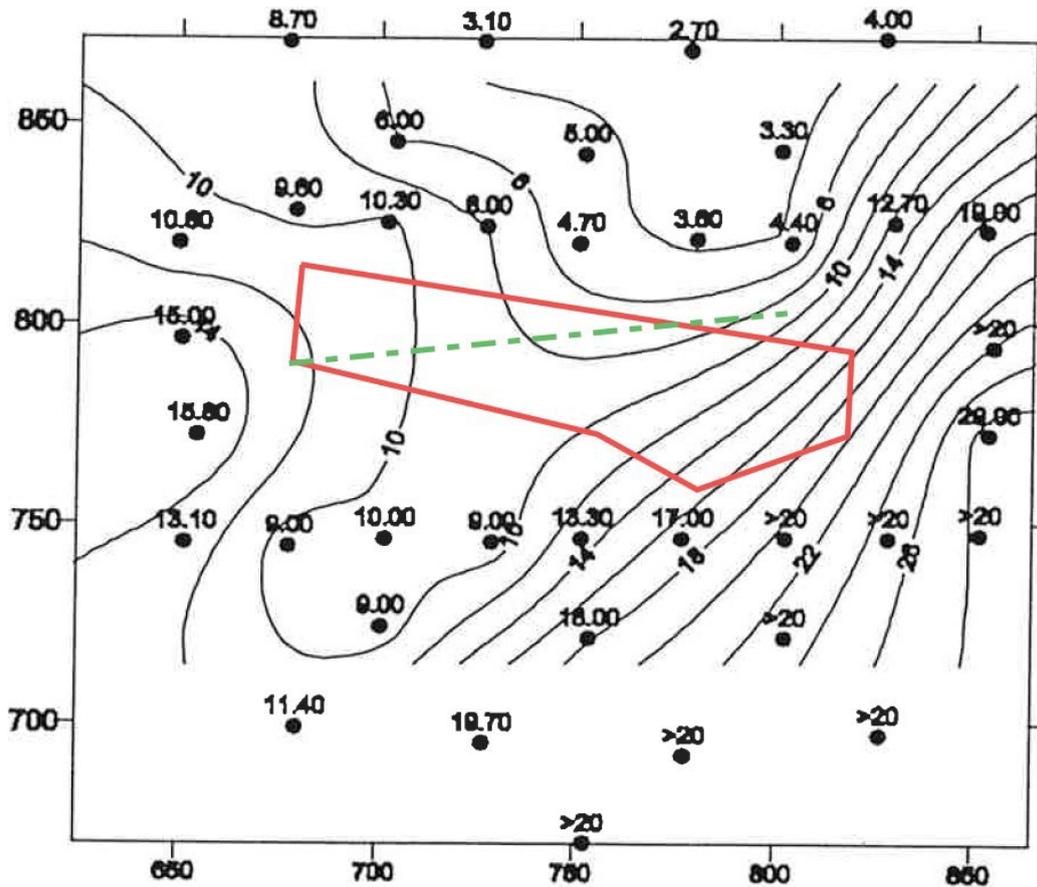
The thickness of the clay under and around the vessel has been interpreted by Delft Geotechnics (1996) and is shown in Figure 5. The thickness of the clay has been interpreted from the results of CPT soundings, which is a sounding method that is especially suitable for soft clays. The thickness of the clay is estimated to be a minimum of approximately 6 m at the north side of the vessel at its middle longitudinally. The thickness of the clay increases in a westerly and easterly direction to approximately 11 to 12 m at the stern and approximately 16 to 20 m at the bow. There is very stiff glacial till under the clay. Glacial till has been observed on the surface of the seabed approximately 100 m north of the vessel.

Figure 5. Interpreted clay thickness from geotechnical site investigations (CPT soundings) in boreholes and interpreted contour lines for clay thickness with equidistance of 2 m. Red line: the approximate position of the vessel. Green dashed line: interpreted boundary between glacial clay (to the north) and post-glacial clay (to the south). The figure is based on results from Delft Geotechnics (1996).

Figure 5 shows that the interpreted thickness of the clay under the vessel varies between approximately 6 and 20 m.

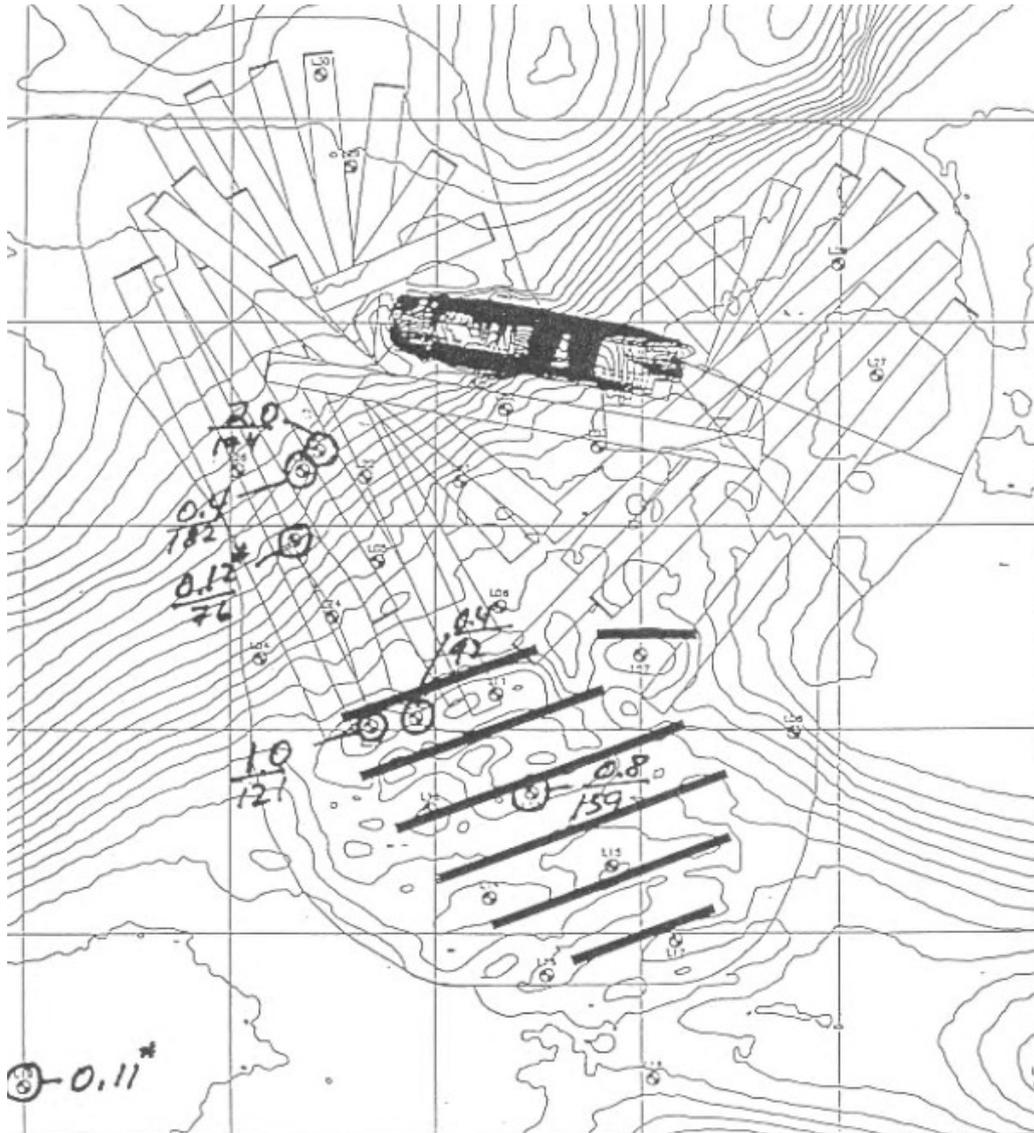
The covering process was discontinued on 27/07/1996. Figure 7 shows a description of the estimated measures that were probably completed around the vessel. The reliability of this description is uncertain as the status of the drawing is unknown.

Figure 7. 'Seabed soil samples, Locations', Delft Geotechnics (19/09/1996). Dark, broad lines=forced penetration strings, rectangular=geotextile, circular=sampling points. Notes: evaluated shear strength (value above line), water content (value below line).

According to Figure 7, the surface of the seabed to the east, west and south of the vessel is largely covered by geotextile. According to documents from NMC dated 26/01/1996, the geotextile is made of a woven polyester fibre with a tensile strength of 500 kN/m. This is due to its intended load transfer function. The geotextile is equipped with interwoven loops that allow it to be reinforced, when necessary, with reinforcing bars of the same type used in concrete. However, the supporting documentation does not indicate whether reinforcing bars have been used.

The presence of the geotextile may cause problems when performing any seabed sampling or soundings and may potentially affect the results of seismic measurements. Supplementary information about which type of geotextile was finally chosen, whether reinforcement took place and where it has been laid should be sought out.

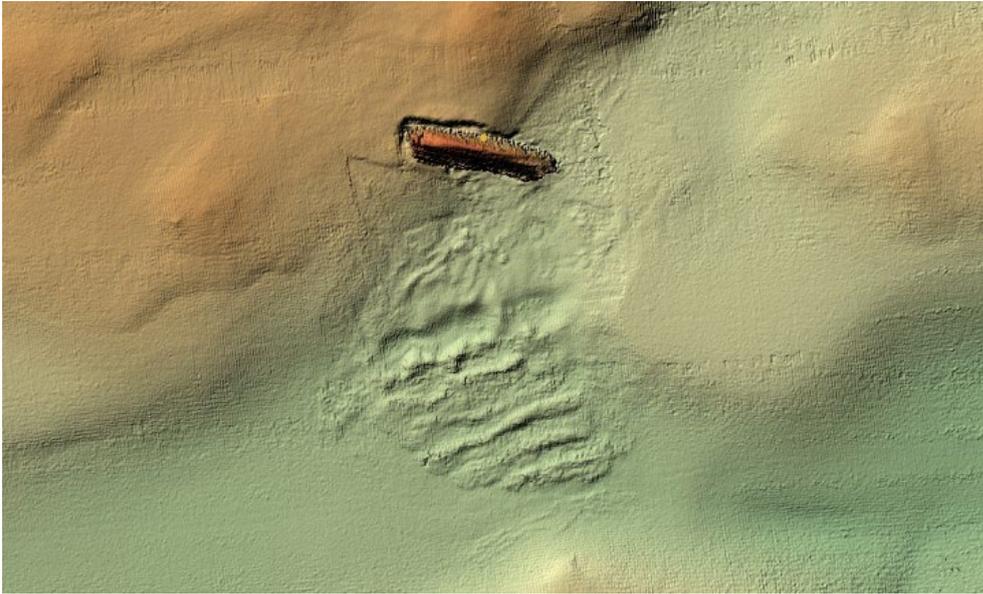
The level of the seabed, evaluated from bathymetric surveys performed in 2006 (Traficom), is shown in Figure 8. The surveys are reasonably consistent with the reinforcement measures that are presented in the drawing by Delft Geotechnics (1996), see Figure 9. The positions of the forced penetration strings presented in the drawing are consistent with the

long, thin embankments running in an east-west direction that are visible in the hill shading approximately 200 to 400 m south of the vessel.

Figure 8. Seabed topography evaluated from bathymetric survey (Traficom, 2006).

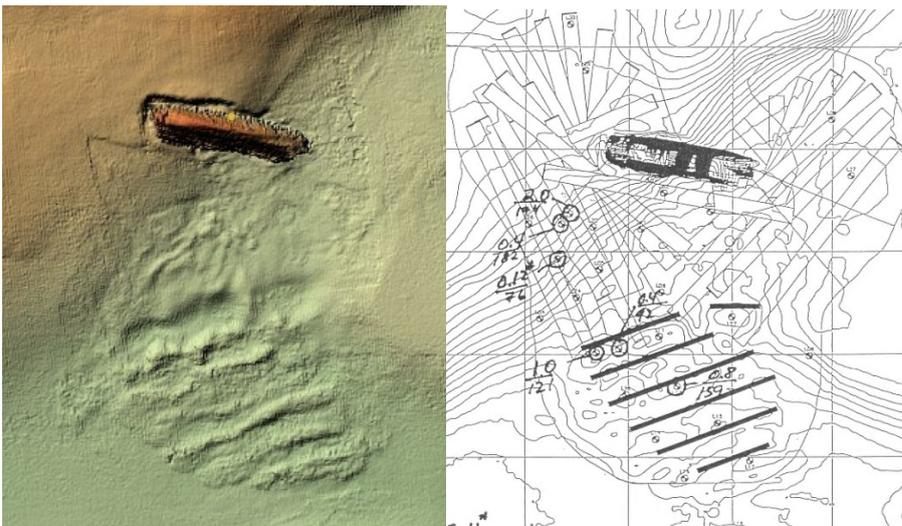
Figure 9. Comparison between reported completed reinforcement measures (1996) and seabed topography (2006).

When the covering and reinforcement measures were discontinued, the construction of forced penetration strings and geotextile had been under way for approximately three months and filling with sand for approximately six weeks. The length of the forced penetrations strings is shown in Figure 8 and Figure 9. It has not been possible from the material studied so far to see in which areas fillings with sand have taken place. The sand fills can also be expected to have moved due to the landslides.

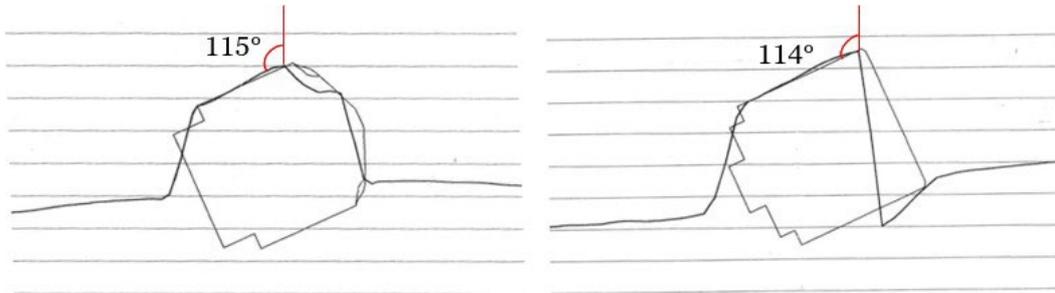
The position of the vessel on the seabed is N59°22.9', E21°41' with a starboard list of approximately 120°, with the stem pointing east (Joint Accident Investigation Commission of Estonia, Finland and Sweden, 1998). The angle of the list is stated in [2] point 29 to have been obtained from calculations performed using depth soundings from a remotely operated vehicle (ROV). Figure 10 and Figure 11 show the results of bathymetric surveys from 1996 (NMC and Jepsens-ACZ). The reported sections show that, on the basis of this data, the angle of the list is approximately 114 to 115°.

Figure 11 Interpreted angle of the vessel's list based on the results of bathymetric surveys. Based on Jebsens-ACZ (1996). Left: section D-D. Right: section G-G. The positions of sections is shown in Figure 10.

It is recommended that an assessment of the accuracy of the previous information that the vessel's initial list was 120° be checked. SGI has been unable to deduce with what accuracy the inclination has been stated from the supporting documentation obtained. It

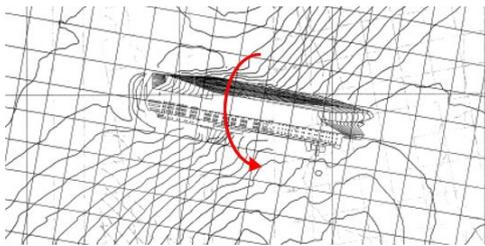
Given the orientation of the vessel in an east – westerly direction, the rotation has, in that case, occurred in a southerly direction, see Figure 15.

Figure 15. The vessel's stated rotation towards the south (based on NMC, 1996).

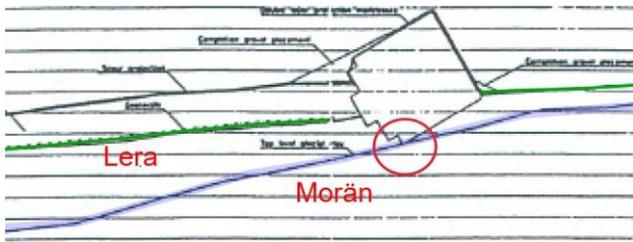
In conjunction with the planning of the reinforcement and covering measures, the assessment was made that the vessel is in contact with the glacial till at the deepest part of the vessel, which is the upper deck on the starboard side, see Figure 17.

Figure 17. Interpreted area of contact between the vessel and glacial till (NMC, 1995).
