REPUBLIC OF ESTONIA  
SAFETY INVESTIGATION BUREAU

Statens haverikommission  
Swedish Accident Investigation Authority

# Intermediate Report of the Preliminary Assessment of MV ESTONIA

2023

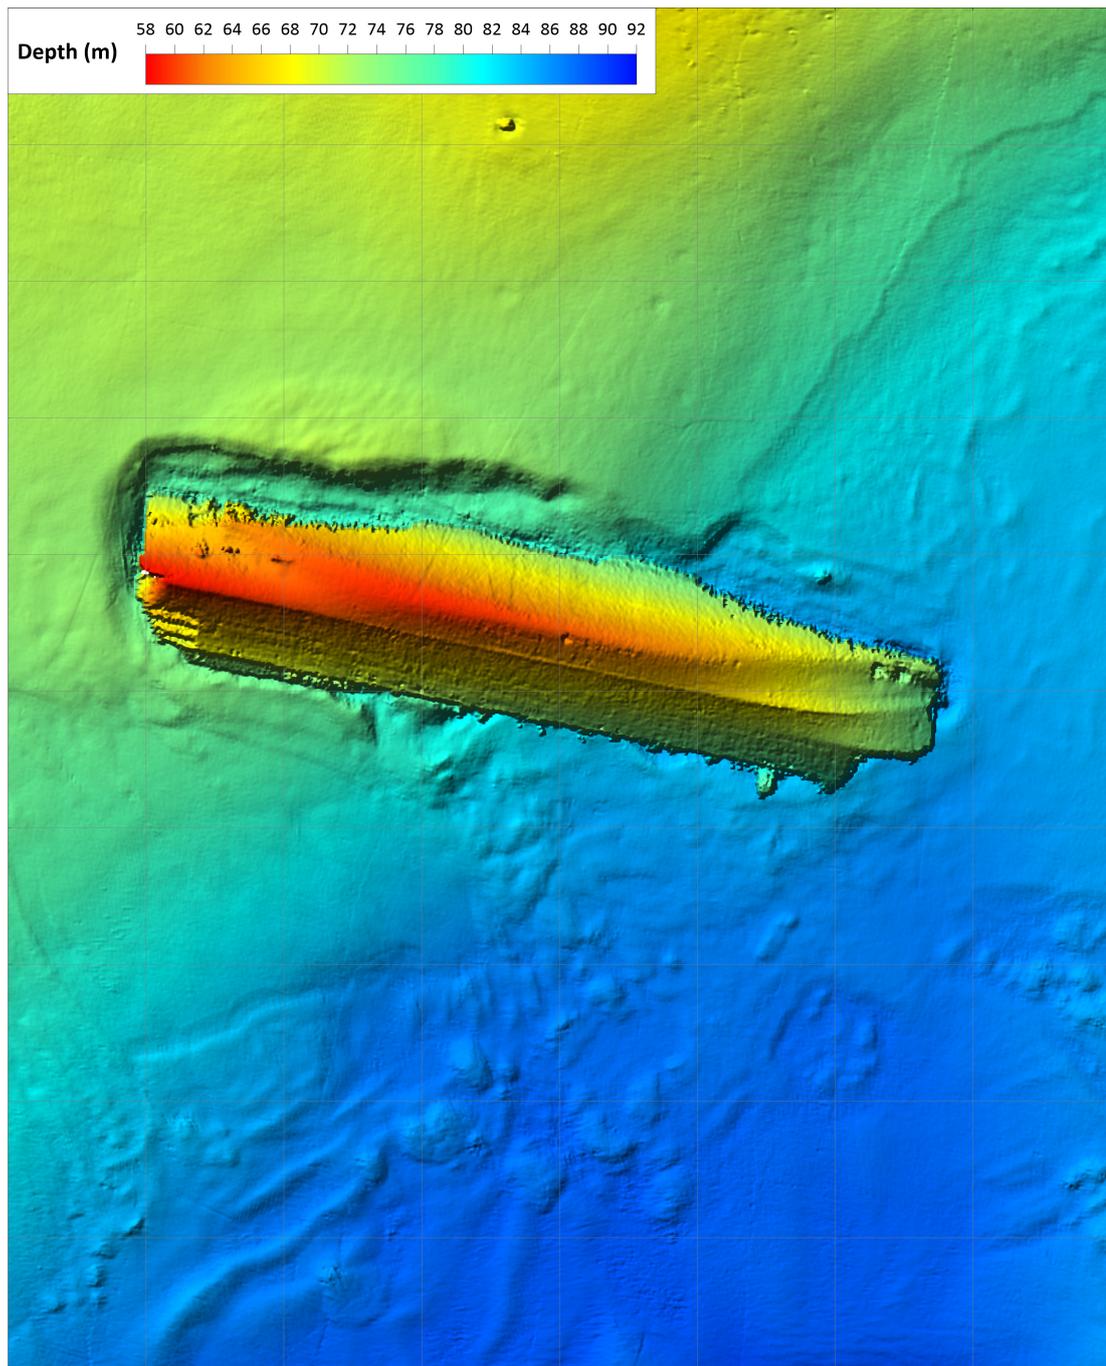
- A trench between 8 m and 1 m wide exists on the north side of the wreck.
- The ship's hull, at approximately mid-ship, seems to rest on an outcrop of bedrock.
- The bow ramp is detached from the ship and lies against the starboard side of the bow.
- The car deck seems to have a barrier of debris approximately 30 m from the entrance.

FIG. 2.2: MV ESTONIA as imaged in the 2021 MBES dataset.[3] Image by Ohutusjuurdluse Keskus.

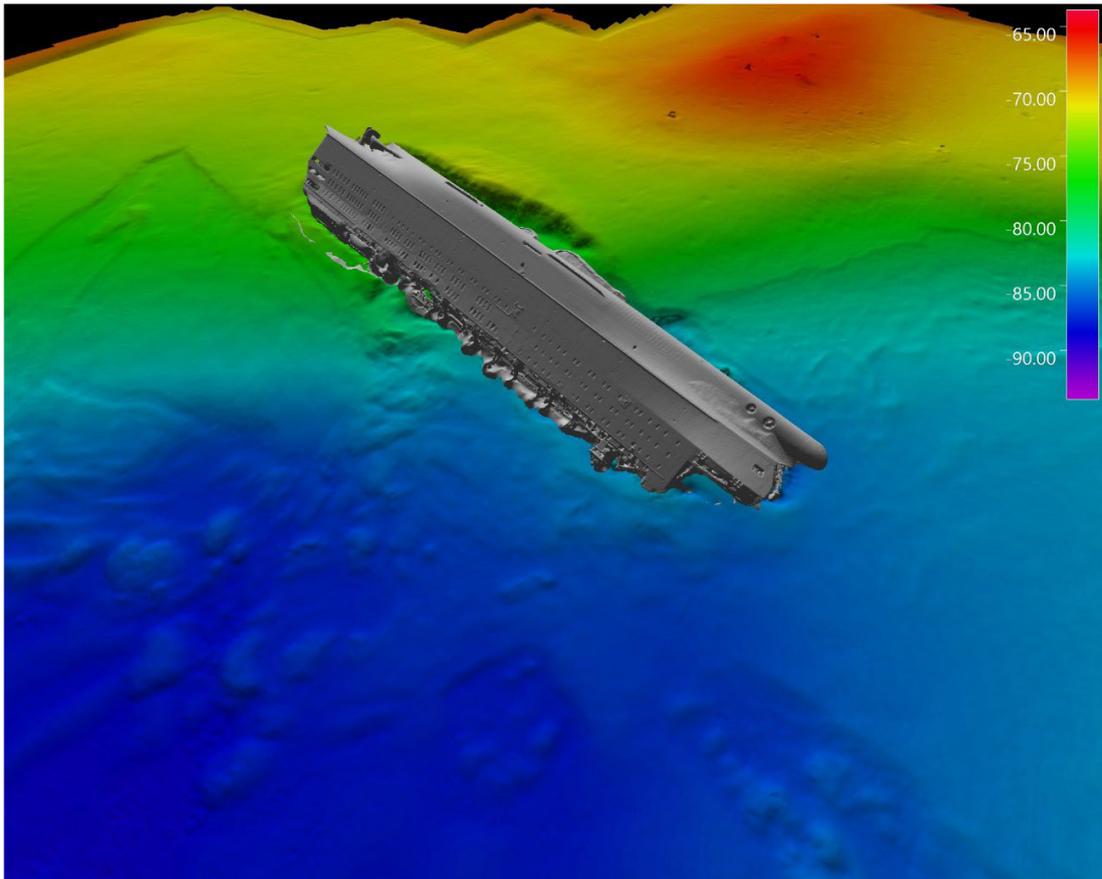
FIG. 3.1: MV ESTONIA portrayed with a mesh created at a resolution of 7 cm from the photogrammetric data; the bathymetry is represented by a 0.25 m x 0.25 m grid from the MBES survey in 2021. Visualization in QPS Fledermaus. Image by the Stockholm University.
