THE FINAL REPORT ON THE CAPSIZING ON 28
SEPTEMBER 1994 IN THE BALTIC SEA OF THE
RO-RO PASSENGER VESSEL MV ESTONIA

The Joint Accident Investigation Commission
of
Estonia, Finland and Sweden

SUPPLEMENT

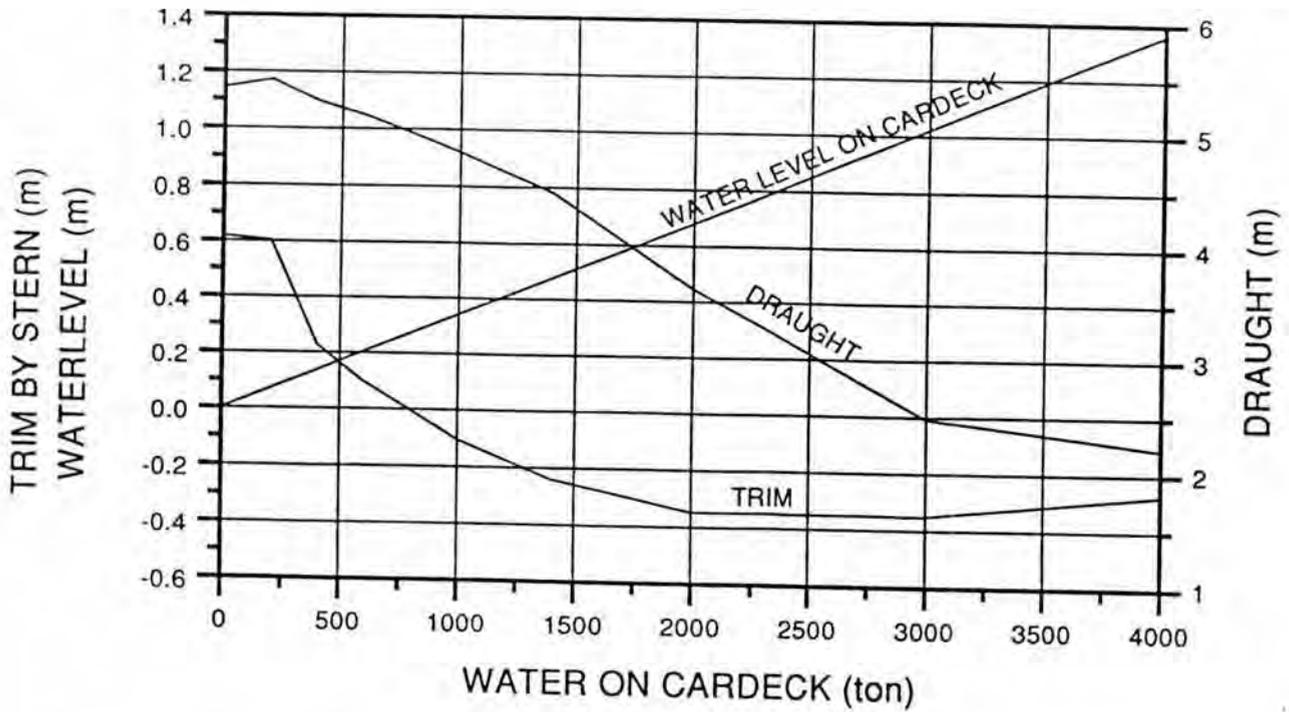
Figure 4.3 The water level on the cardeck, draught and trim as functions of water amount on the cardeck, side included.

The static and dynamic stability for the case with side above the 4th deck included were calculated with 0, 200, 400, 600, 1000, 1400, 2000, 3000 and 4000 tons of water on cardeck. The draught and trim of the ship and the water level on the cardeck assuming neither heel nor trim angle, are shown in Figure 4.3 as functions of water amount on the cardeck. The effect of cargo on water level was not taken into account. Draught is defined at midships as in Figure 4.1. Trim is the difference of draughts at after and fore perpendiculars. In Figure 4.4 the static (solid line) and dynamic heel angles are shown as functions of water amount on cardeck. The actual values of ship main particulars excluding the visor were used. The h_ϕ and e_ϕ values as functions of heel angle are shown in Figures 4.5 and 4.6, respectively. The static heel angle and the inflooded water for four cases is visualised in Figure 4.7 corresponding 1000, 2000, 3000 and 4000 ton water on cardeck. The frames drawn in each case are #6, #80.5 and #156 with x-coordinates of 3.6, 69.0 and 134.8 m from AP, respectively. These drawings as well as the h_ϕ and e_ϕ values were calculated using the actual values with the visor but the influence of the visor on the results is insignificant.

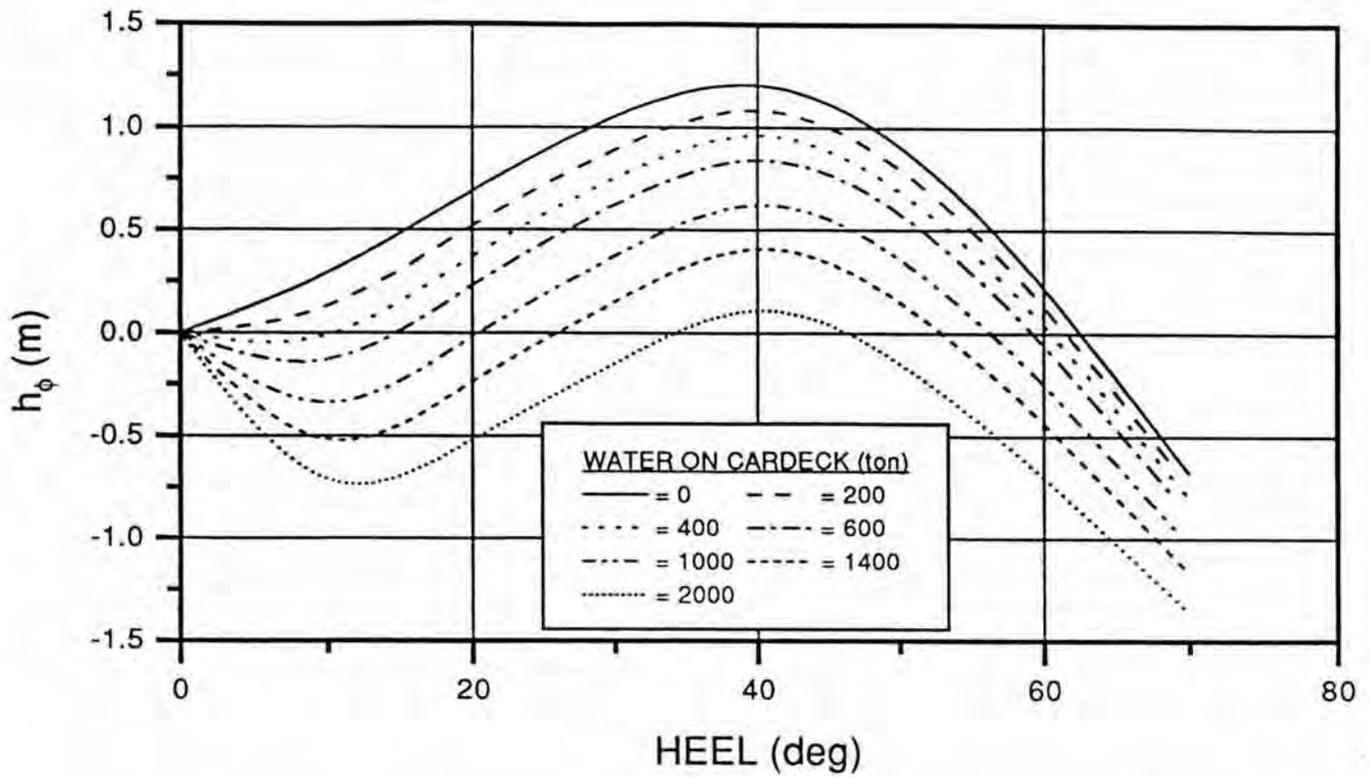
Figure 4.8 Static stability curves. Side above 4th deck not included, preliminary load condition.

The stability for the case with side above the 4th deck not included was calculated with 0, 200, 400, 600, 1000, 1400 and 2000 tons of water on cardeck. The h_ϕ and e_ϕ values as functions of heel angle are presented in Figures 4.8 and 4.9, respectively. The static and dynamic heel angles as functions of water amount on cardeck are shown in Figure 4.10 where the last dynamic heel angle corresponding to 1350 ton water is interpolated using the adjacent values. The preliminary values of ship main particulars were used.

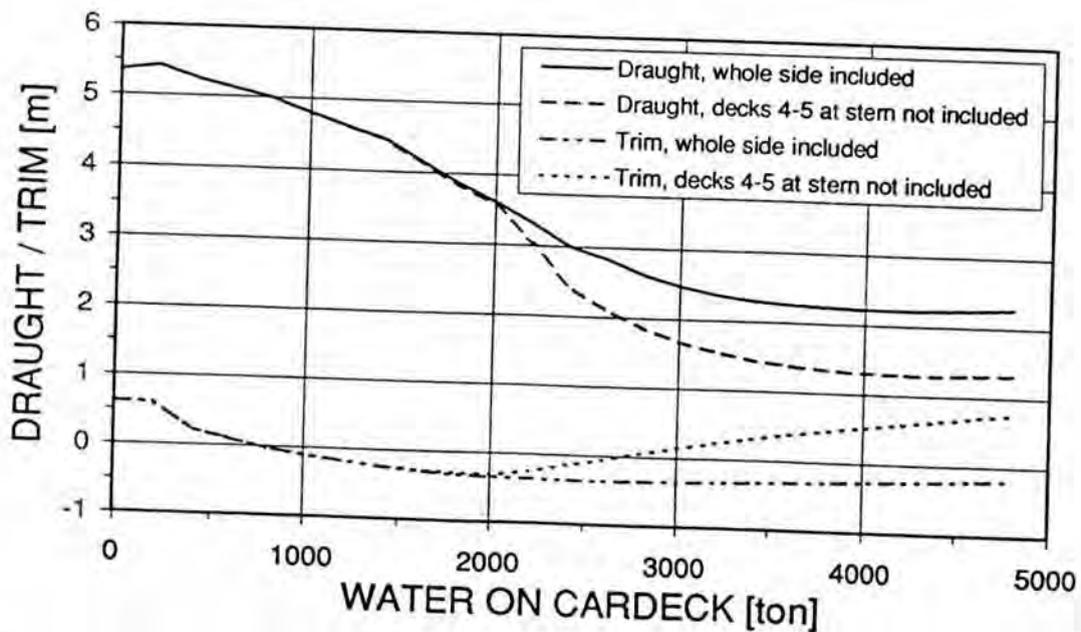
Figure 4.11 Draught and trim, whole side included and decks 4-5 at stern not included, actual load condition without the visor.

Assuming that some of the large windows on the 4th and 5th deck broke being the first openings through which the water flooded on these decks, a damage case where a large space between the 4th and 6th deck in the aft part of the ship was excluded from the watertight hull volume was also analysed. On the 4th deck, the hull volume from the aft bulkhead to the cabin department, i.e. to the frame no. 44, was disregarded. On the 5th deck, the disregarded space extended from the aft bulkhead to the frame V just aft from the main stairway. The static heel angle in the case when these spaces do not contribute any more to the stability is shown in Figure 4.4 (dotted line). The draught and trim compared to the

intact hull case are shown in Figure 4.11. These calculations were done using the actual values of ship main particulars but without the visor.

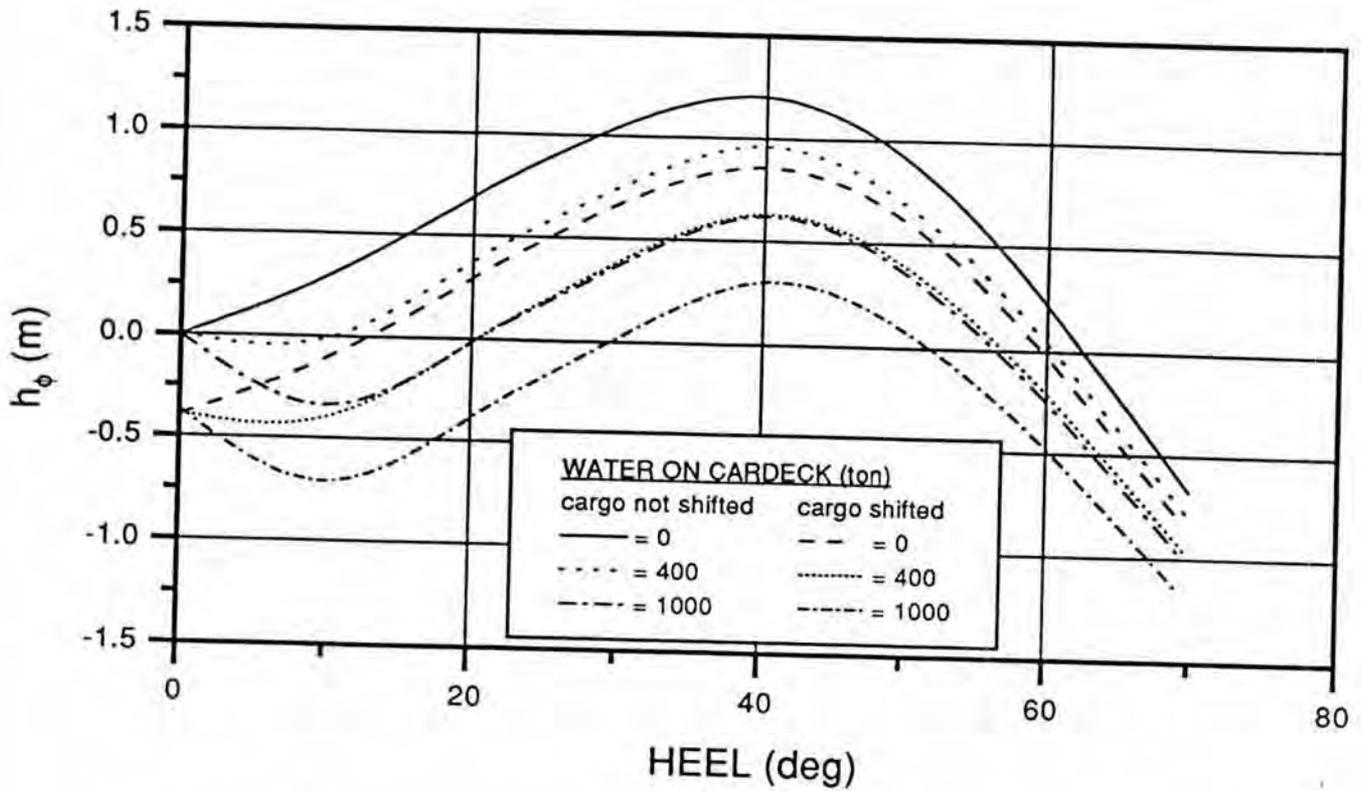
Figure 4.13 Static stability curves, effect of cargo shift. Side above 4th deck not included, preliminary load condition.

The h_{ϕ} and e_{ϕ} values for the case where the cargo on the cardeck was assumed to be shifted were calculated in cases with 0, 400 and 1000 tons water on the cardeck. The side above the cardeck was not included in the righting moment calculations. The weight of cargo in both sides of the cardeck was 300 tons. The transverse locations of the centre of gravity for shifted cargo were conservatively estimated as 11.0 m on starboard side and -3.0 m on port side measured from ship centreline. These values are somewhat conservative because in reality the cargo could not move that much. It has been estimated that during the MV Estonia accident the cargo was able to move only about 1 m sideways. The static and dynamic heel angles are shown in Figure 4.12. The h_{ϕ} and e_{ϕ} values together with the corresponding results of unshifted case are presented as functions of heel angle in Figures 4.13 and 4.14, respectively. The preliminary values of ship main particulars were used.

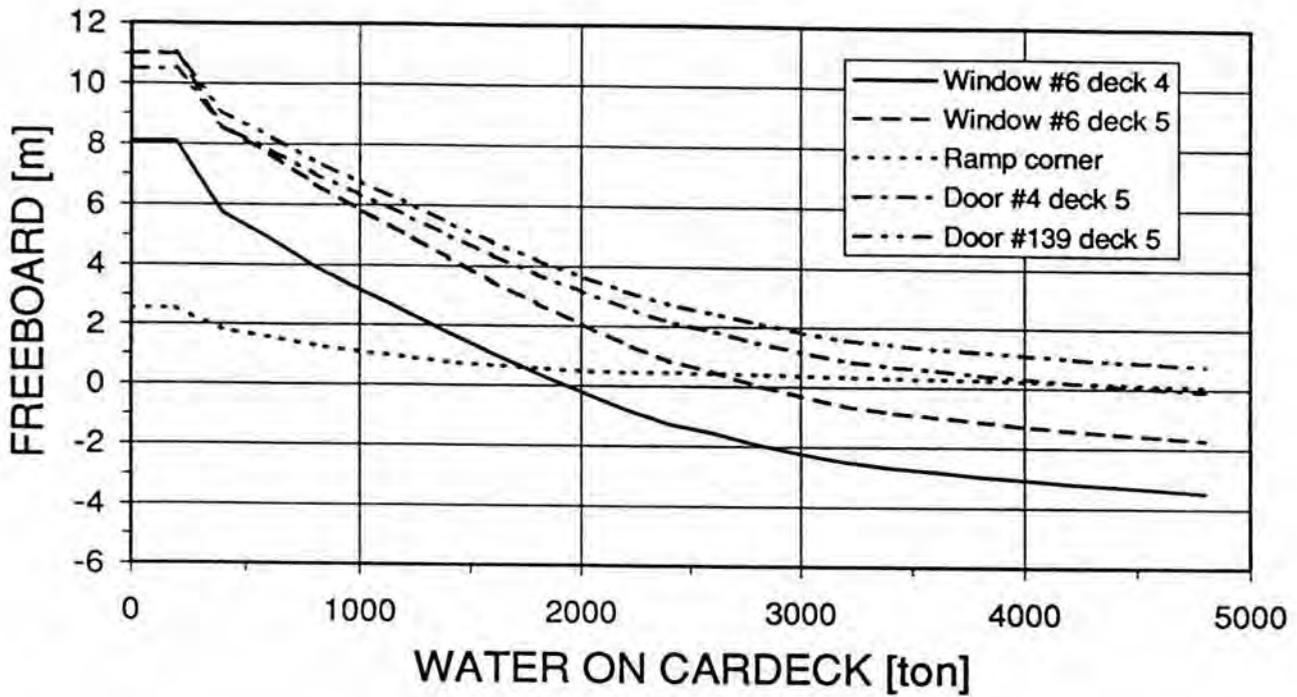
Figure 4.15 Freeboard to some critical openings.

The calculated freeboard values at the first five openings as functions of water on cardeck are drawn in Figure 4.15. It shows that the first openings which go under the calm water level are the side windows on the 4th deck. This occurs when there is about 2000 tons of water on the cardeck and the heel angle is about 40 degrees. At this stage, the lowest corner of the ramp opening is about 0.4 m above the calm water surface and it remains slightly above the water level until there is over 5000 tons of water on the cardeck.

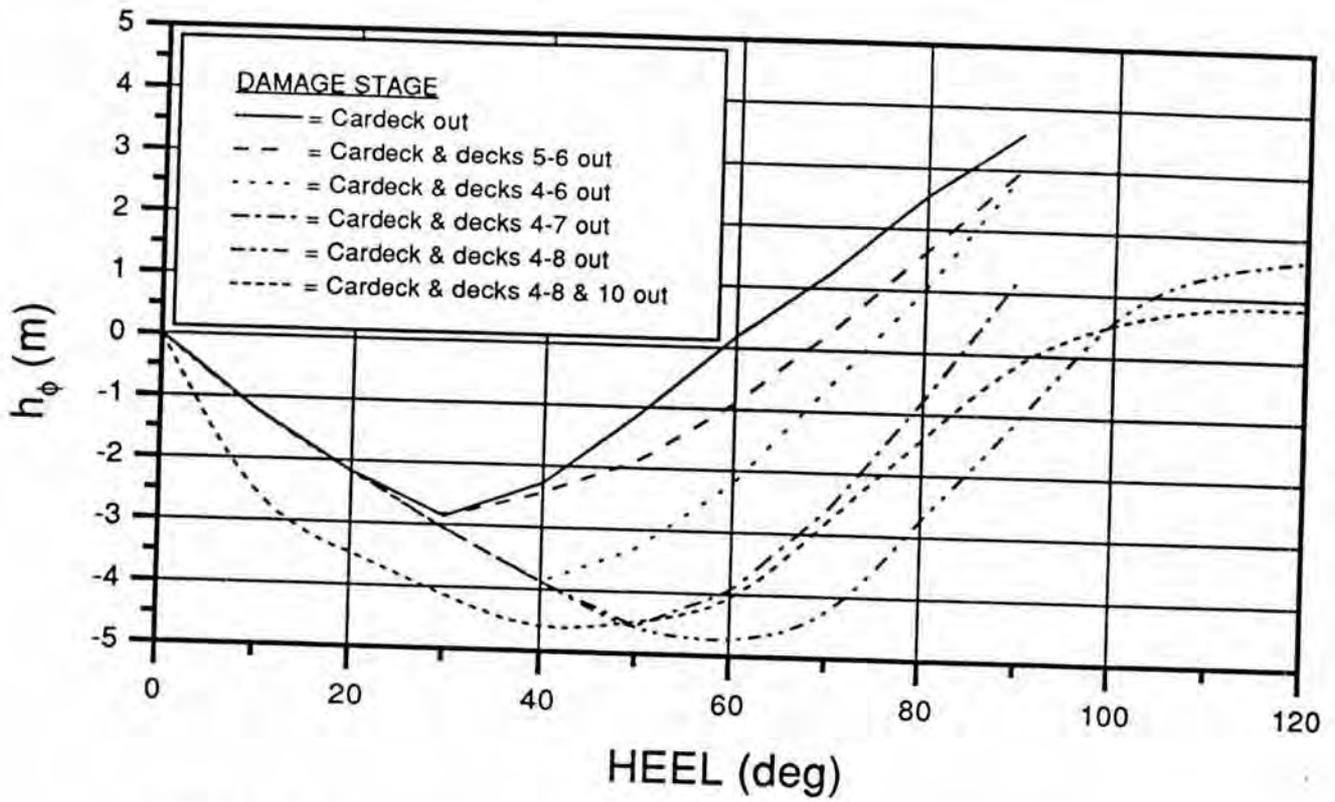
Figure 4.16 Static stability curves, effect of damage stage, 3200 ton water on cardeck.

Though it is impossible to predict how the flooding of the vessel hull and the superstructure developed, some simplified flooding cases have been analysed. The h_{ϕ} and e_{ϕ} values as functions of heel angle for different damage stages are presented in Figures 4.16 and 4.17, respectively. The static stability was calculated for cases where watertight hull volume above the cardeck gradually decreases as the ship heels and more water flows inside through openings. The notation of first damage stage 'cardeck out' in the figures means that water can flood in to the cardeck through the lower corner of the opened bow

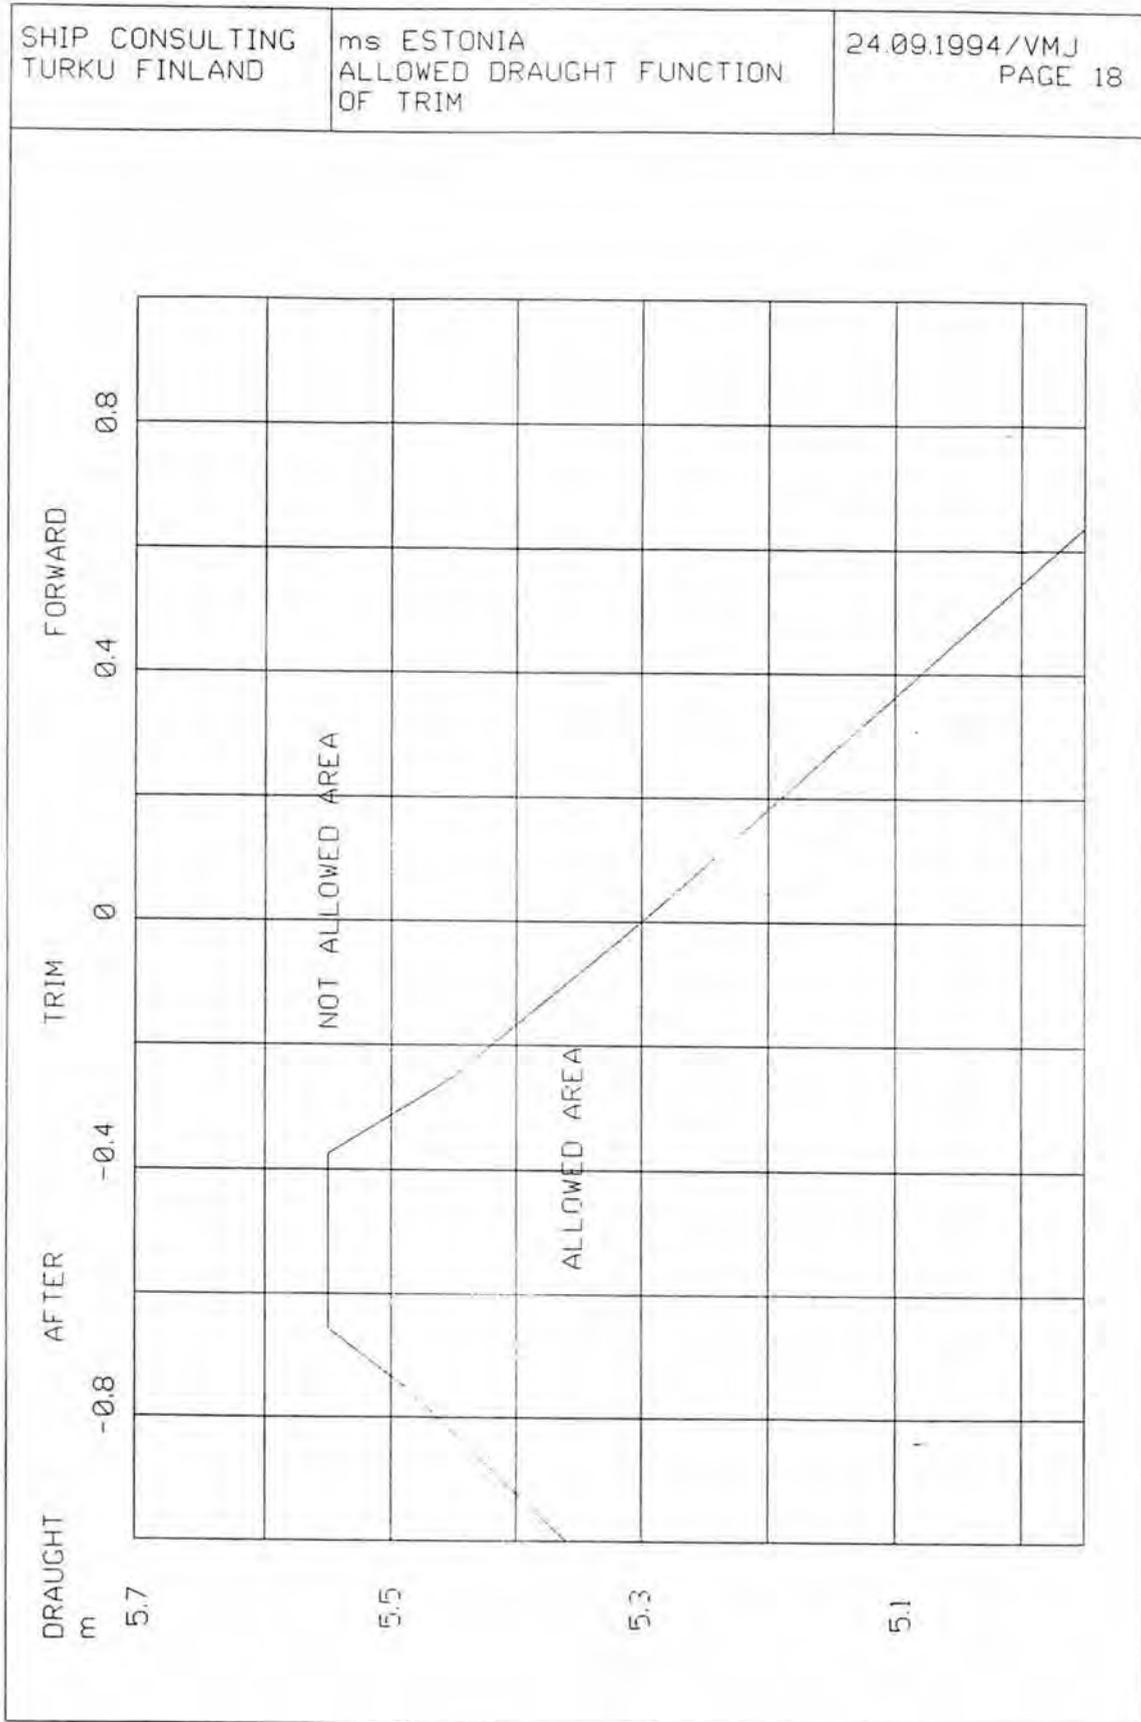
Figure 4.18 The allowed and not allowed trim/draught combinations for MV Estonia.

The allowed and not allowed trim/draught combinations for MV Estonia are shown in Figure 4.18. In Figure 4.19 the equilibrium floating position of the ship is shown for the case when the cardeck and decks between 4-6 are out. The cross-section is at the longitudinal coordinate $x=79.4$ m from the after perpendicular.

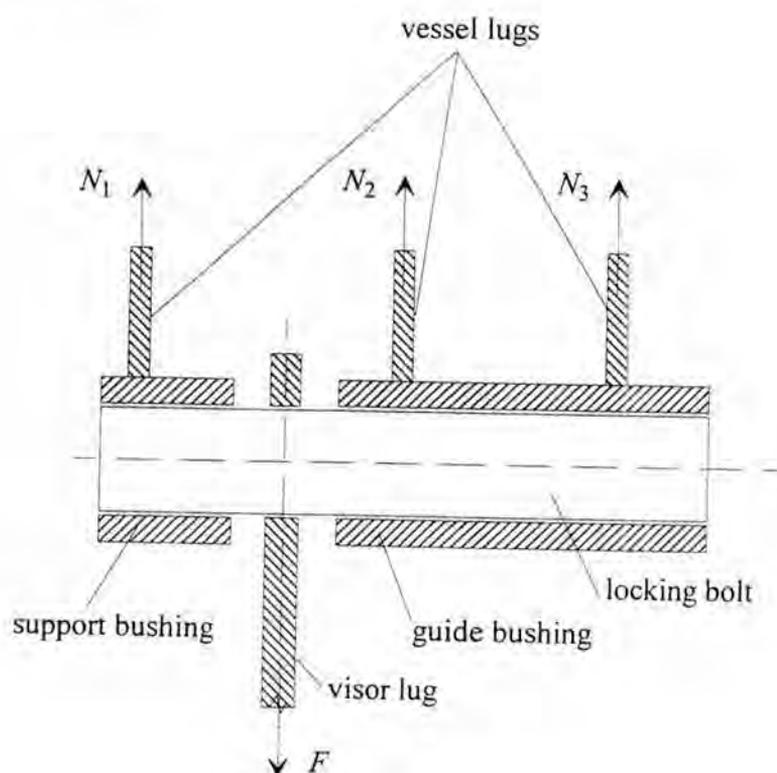
Figure 1.

The Atlantic lock (bottom lock) consists of a locking bolt, guide bushing and support bushing. The lock was fixed to the vessel by three lugs. One lug attached to the visor was locked by the bolt (Figure 1).

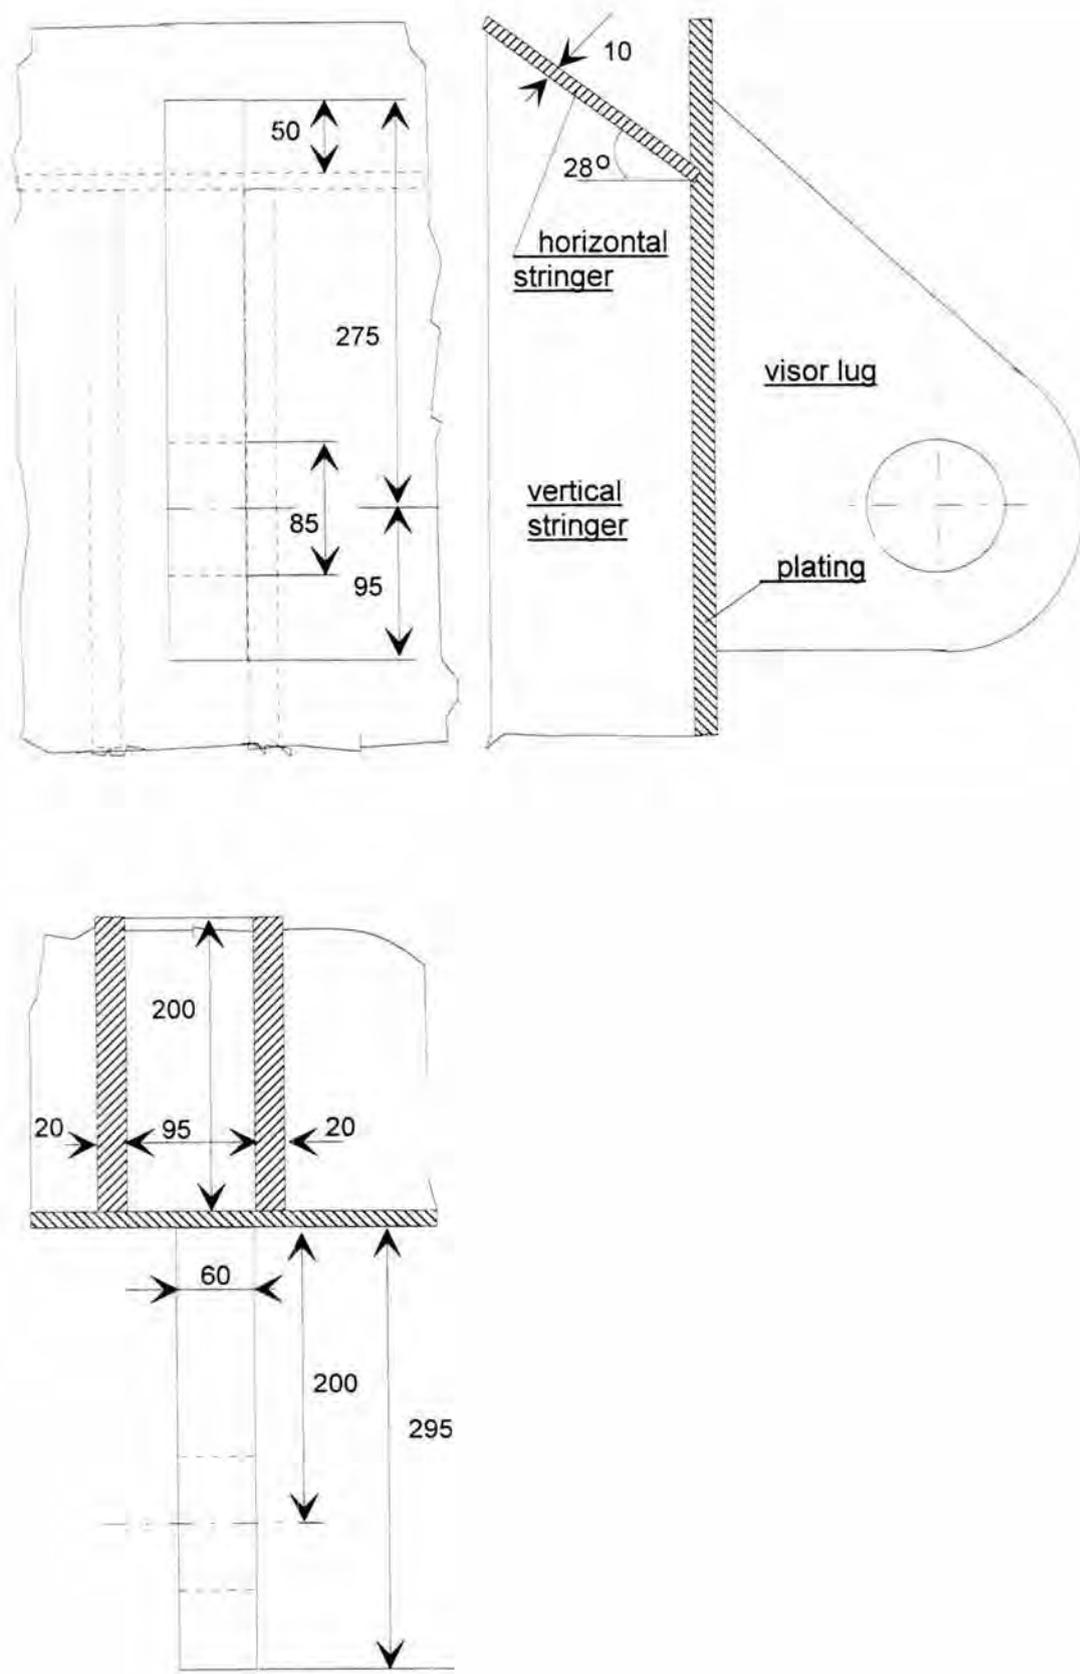
The side locks are similar to the atlantic lock, but they are loaded in different directions and therefore the failure took place in another way. The visor lugs of both side locks have been torn out of the aft bulkhead of the visor, leaving rectangular holes in the bulkhead. The design of the visor lug and the aft bulkhead of the visor are presented in figure 6. The lug is welded to the plating of the bulkhead, which is reinforced by one horizontal and two vertical stringers. The failure surfaces of the side locking are shown in figure 7. Dimensions of the rectangular hole in the bulkhead plating are approximately 390 x 80 mm.

Figure 6. Design of the side locking

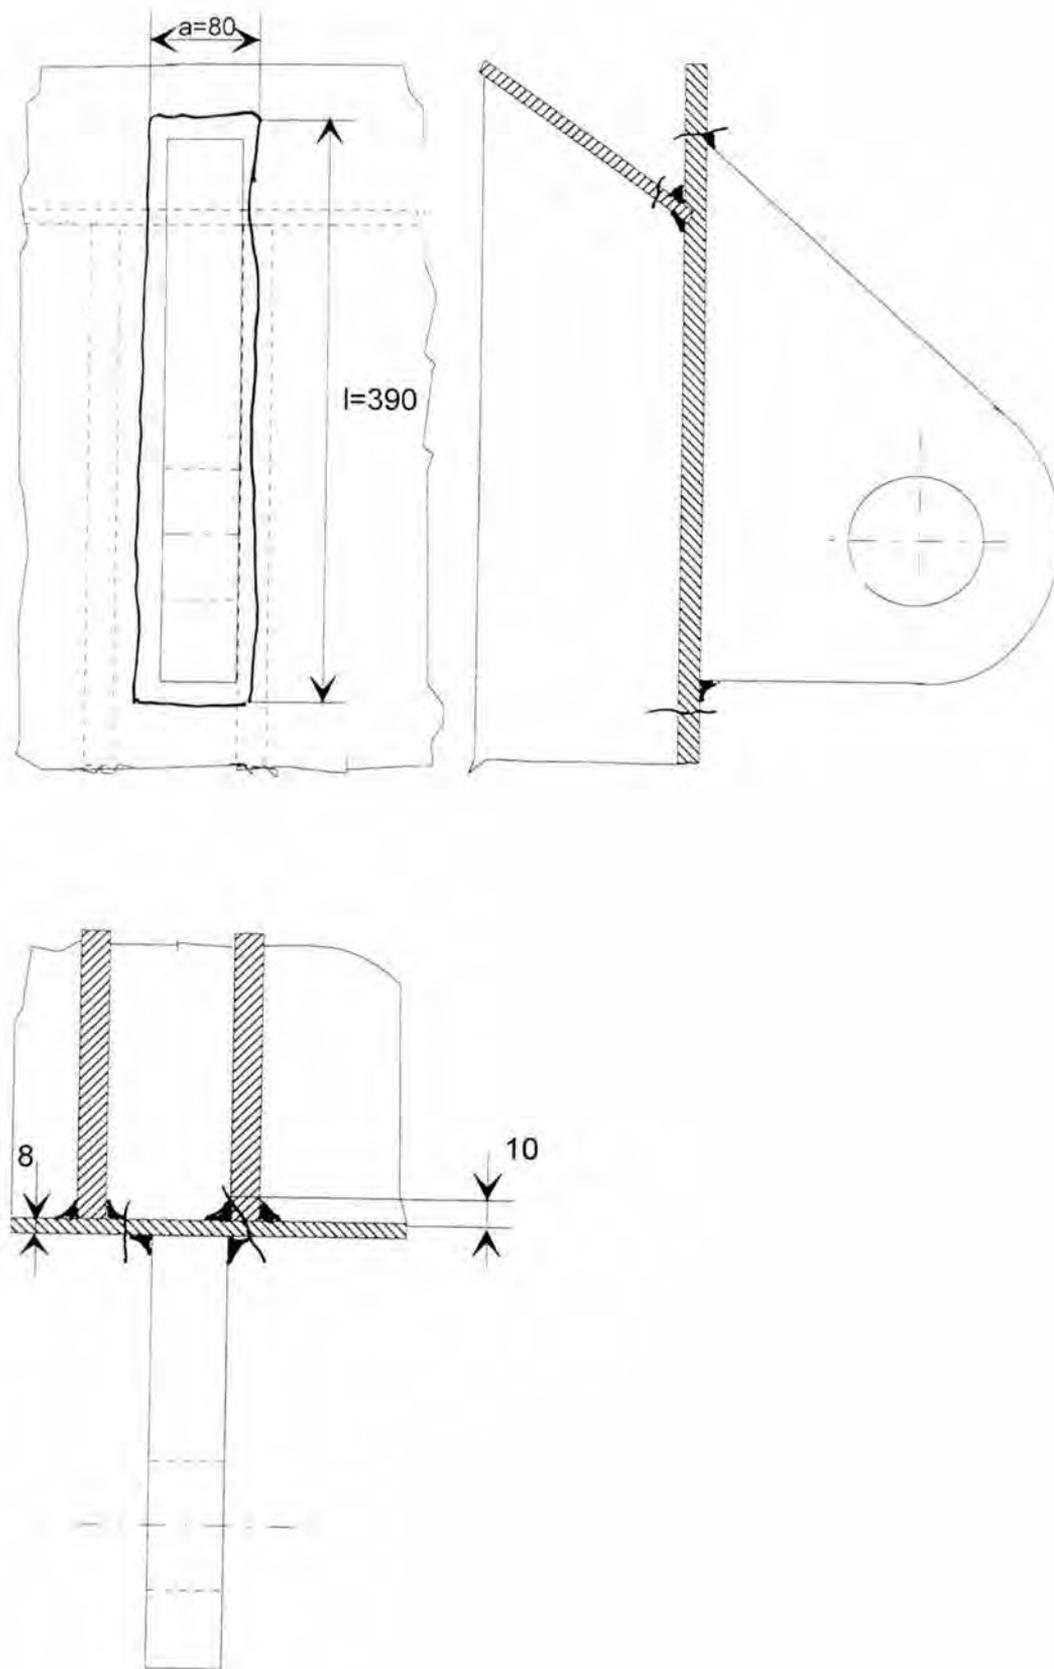
Figure 7. Failure surfaces of the side locking

In these calculations we supposed that there were no cracks in structure and that the shear stresses are distributed linearly along the failure surface. By observations on the recovered bow visor we can not say with full certainty, whether the cracks in the structure existed or not. If there were cracks, then the load-carrying capacity of the side lock might have been considerably lower. As the side lock is statically undetermined complicate structure, it is difficult to say, which was the real distribution of the shear stresses and which was real value of the parameter α . The real distribution of the shear stresses before the failure may in fact have not been linear and the parameter α somewhat different. Consequently, the calculated load-carrying capacity is only the approximate value for this force. The real load carrying capacity of the side lock is probably lower.

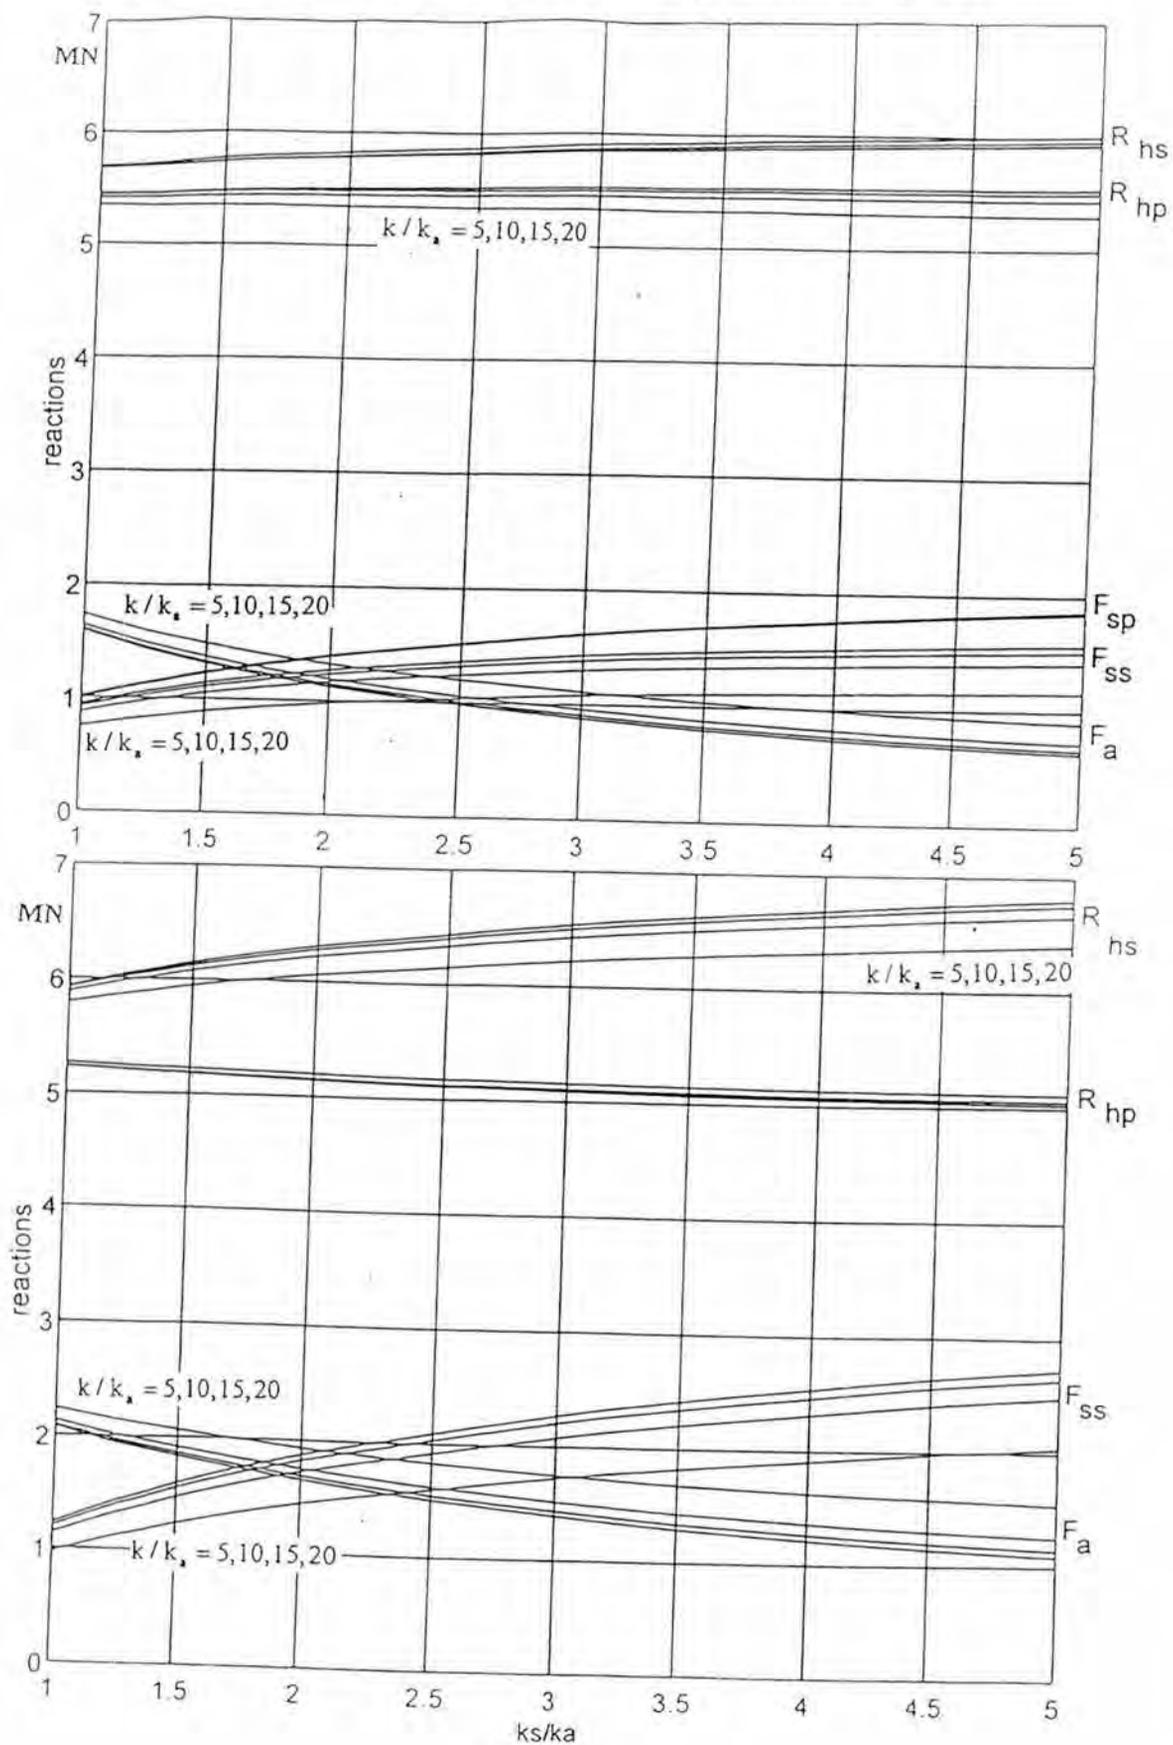
Figure 11.

The calculated reactions of atlantic and side locks F_a, F_{sp}, F_{ss} and full reactions of hinges R_{hp}, R_{hs} , which are directed forward and down, are presented in Figure 11 and 12 as function of stiffness ratio k_s / k_a for five different stiffness ratio values k / k_a in two different combinations of sea loads. The results are presented in two cases: a) if all locking devices are in order (above);

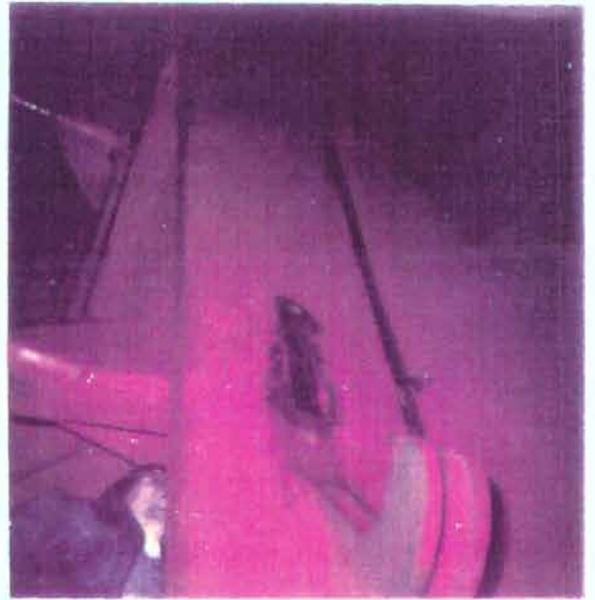
Fig. 6

SB VISIT Lissuing
930116 DIANA II

BB VISIT Lissuing
930116 DIANA II

Hence the side lock is underdimensioned by a factor of $10.5 \div 7.1$ using calculational allowable stresses and by a factor of 1.8 using failure stresses. When conducting an analyses on the stress situation during tension (opening of the bow visor) and pressure (the closing direction of the bow visor) it becomes apparent that the upper edge of the lug is always under heavier load (Fig. 17). Hence the failure initiates at the upper edge. This is further confirmed by the damages to the side locks of DIANA II on Jan. 16th, 1993, Figs 5 and 6.

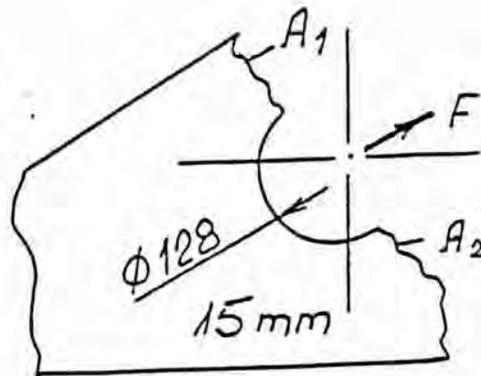
Fig. 13

The dimensions of the failed lugs are shown in Fig. 13.

where A is the failure surface of the weld joint (Fig. 13). The leg of the weld joint k is approximately 3 mm [2], hence

The lugs break with breaking surfaces A_1 and A_2 (Fig. 13).

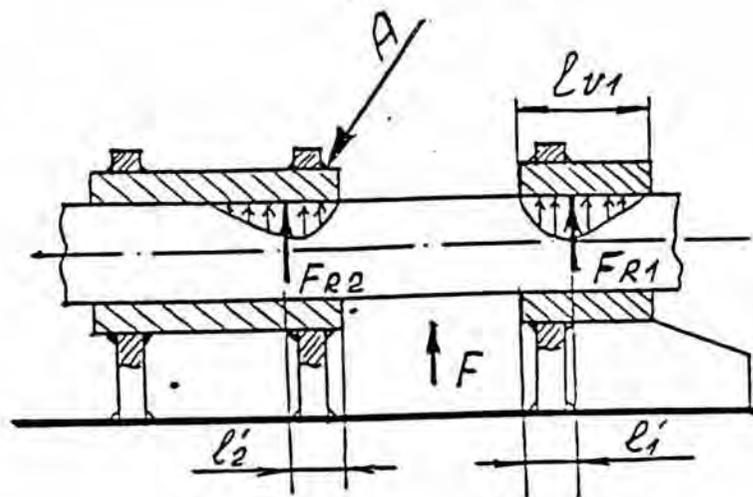
Fig. 14

The calculation scheme of the bottom lock is shown in Fig. 14.

The failure of the bottom lock can be viewed as the failure of the weld joints between the bushings and the lugs (Fig. 14 arrow A) and the failure of the lugs with surfaces A_1 and A_2 .

Let us now calculate the breaking force to tension F_{Tu} , when the breaking stress to tension is $\sigma_u = 400$ N/mm² for two lugs if $F_{R1} = F_{R2}$, See Fig. 14.

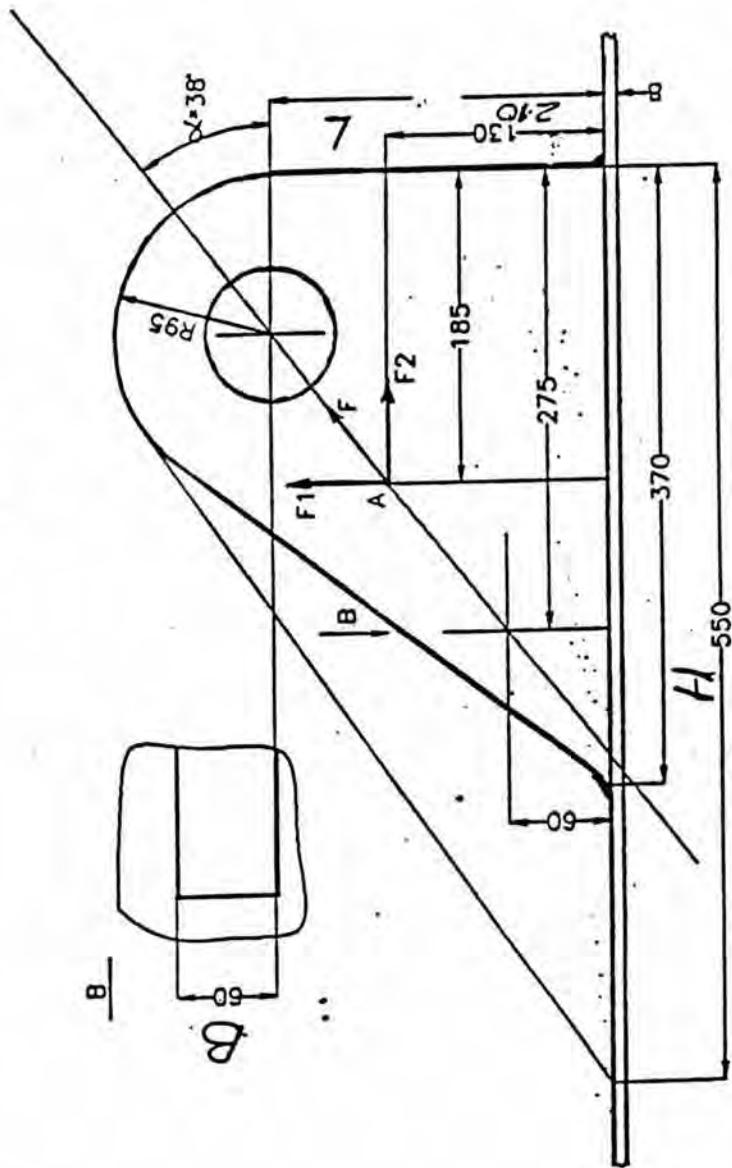
Fig. 16 A

Such fillet joints are calculated for shear stress τ and are calculated for a plane at a 45° angle at the leg k of the weld, hence the width of the weld is $0.7k$ (Fig. 16).

The scheme of the calculations is shown in Fig. 16. When calculating shear stresses at sign-changing loads, a 180 degree change in the direction of the force does not affect the stress state of the weld.

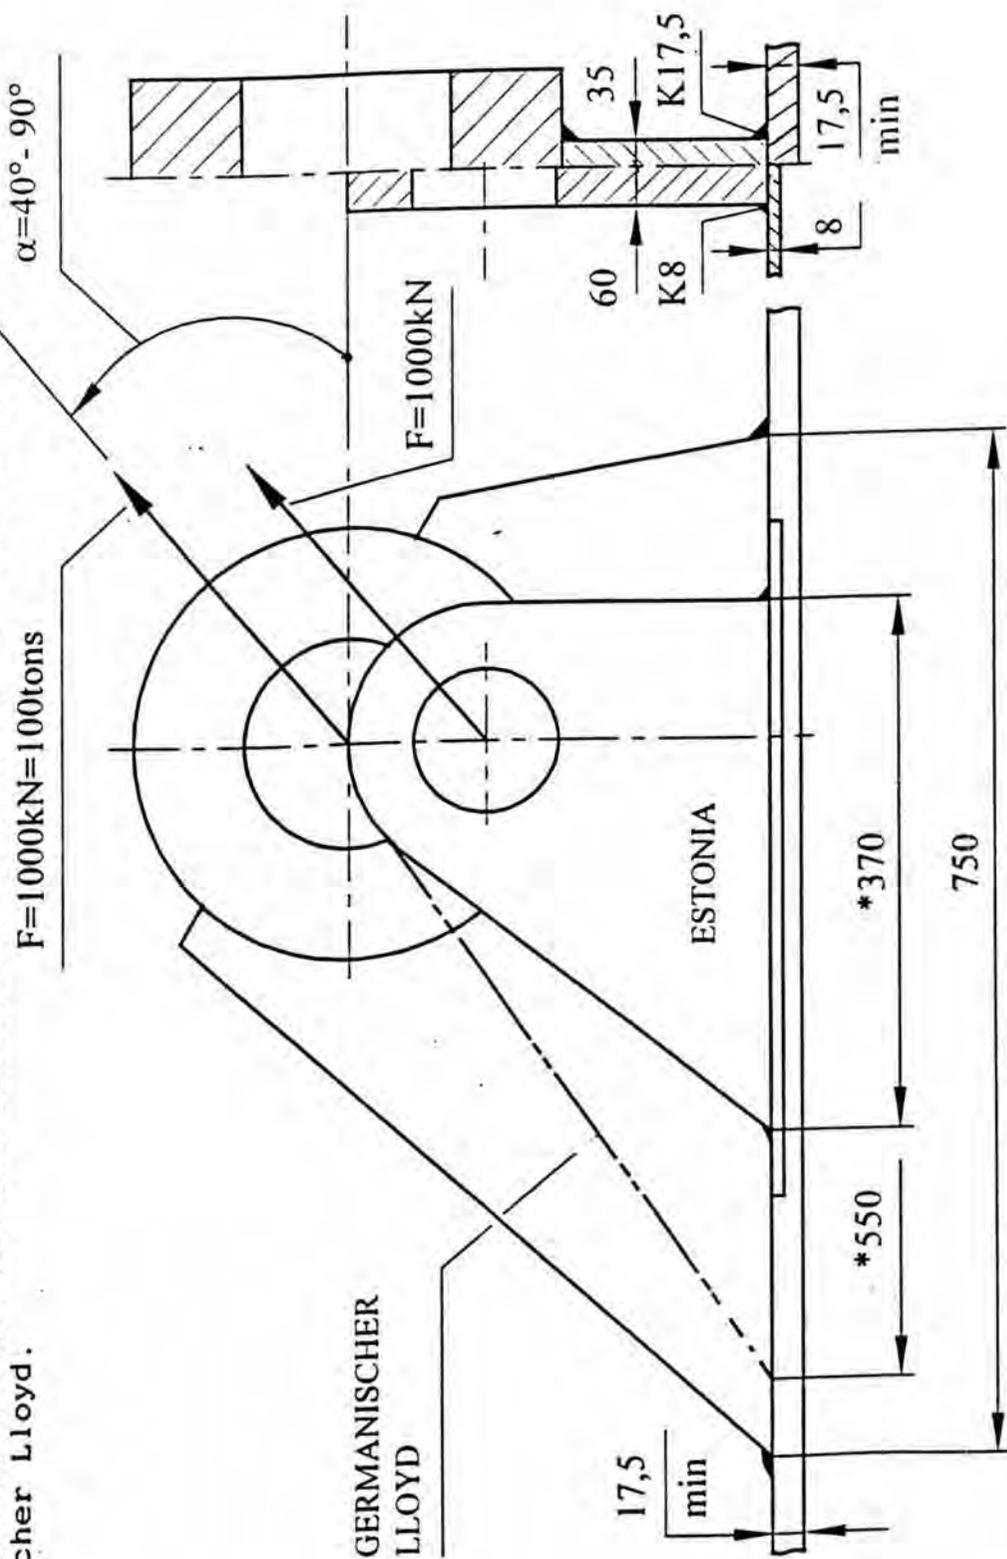
Fig. 18

The larger construction is ROUND EYE PLATES from table 25 with nominal size 100 - permissible load 1000 kN. ["Regulations for the Constructions and Survey of Lifting Appliances", 1992 Edition. Published by: Germanischer Lloyd.] The smaller construction is of a side lock of the MV ESTONIA. Both of the constructions are similar and have the same safety working (calculated) load capacity SWL=F=1000 kN (100 tons). I have made strength calculations on both of the constructions. SWL for a side lock of a visor of the MV ESTONIA is 4.6 times less than calculation for the construction of ROUND EYE PLATES by Germanischer Lloyd.

* The actual dimension of a side lock of the M/V Estonia is 370, and the same dimension of the assembly described in 550

Both constructions are shown in Fig. 18. The strength calculations for the lug are presented, which made it possible to derive the allowable stresses used at design (Fig. 19).

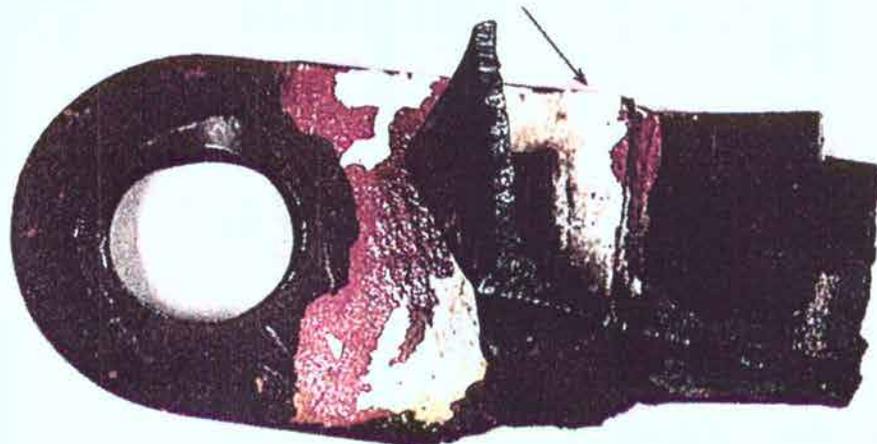
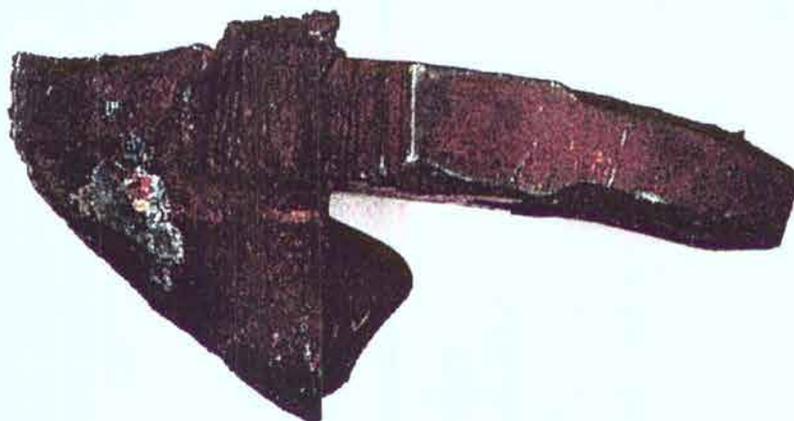
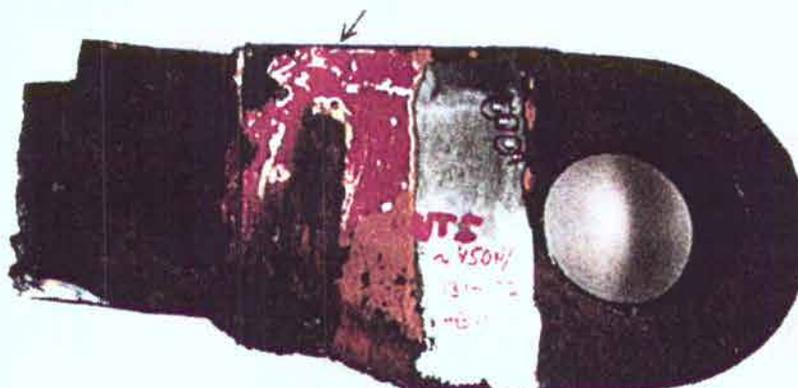
Figure 1. Visor lug, KTH sample nr 4511, view from starboard.

Figure 2. Visor lug, KTH sample nr 4511, bottom view.

Figure 3. Visor lug, KTH sample nr 4511, view from port.

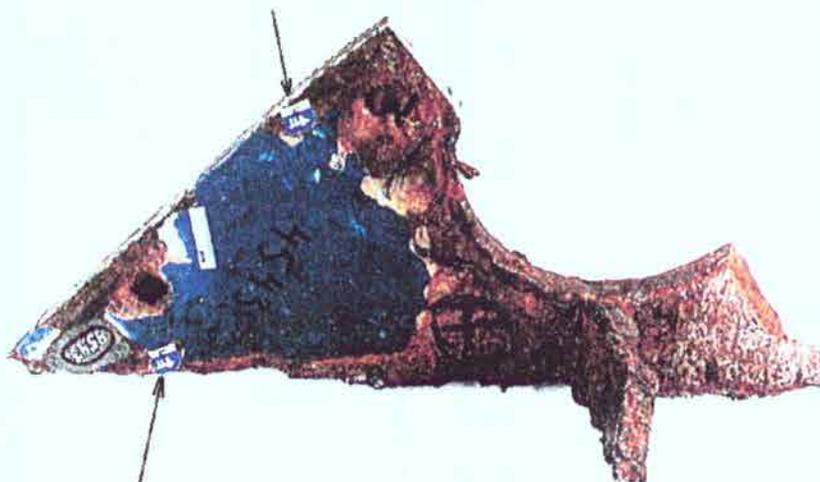
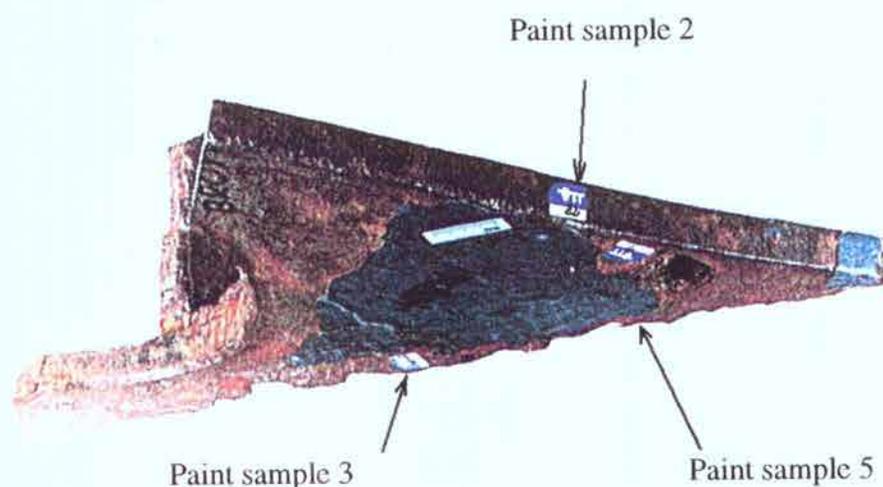
Figure 4. Forepeak deck starboard lug, KTH sample nr 4543, view from starboard.

Figure 5. Forepeak deck starboard lug, KTH sample nr 4543, view from above aft port.
