THE FINAL REPORT ON THE CAPSIZING ON 28
SEPTEMBER 1994 IN THE BALTIC SEA OF THE
RO-RO PASSENGER VESSEL MV ESTONIA

The Joint Accident Investigation Commission
of
Estonia, Finland and Sweden

SUPPLEMENT

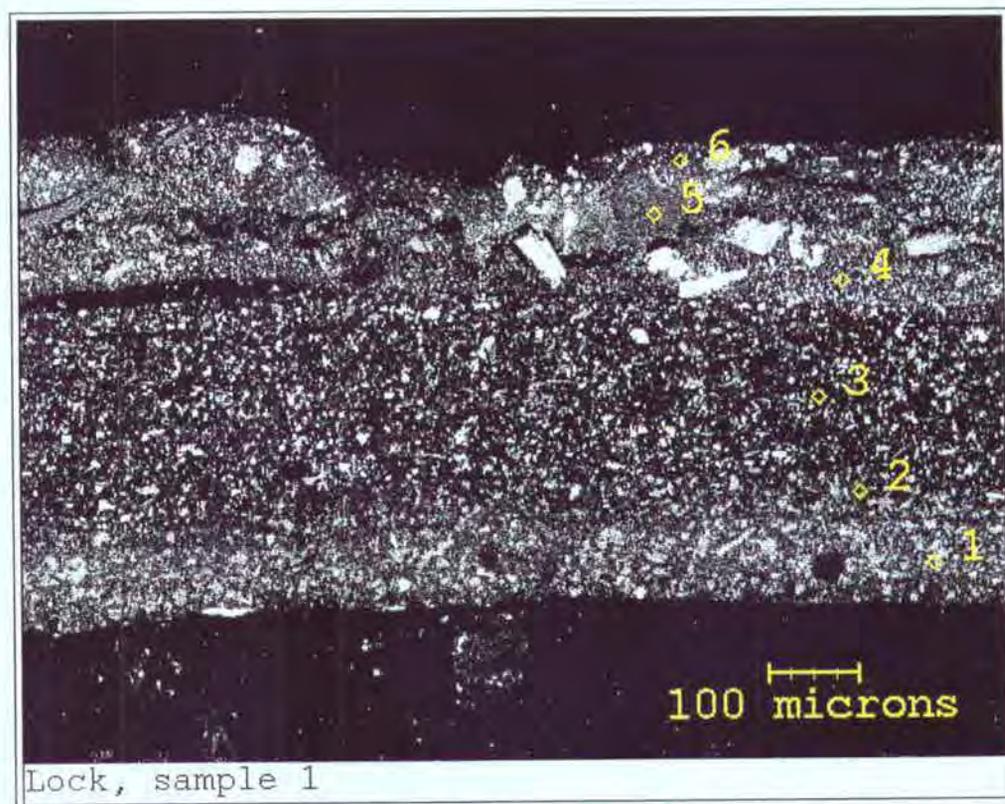
Six paint layers were found. The BSE-image of the cross section of the sample is given in figure 6 and the corresponding EDS-analyses of the paint layers are given in Appendix 1 in figures A1-1 to A1-6.

Figure 6. Forepeak deck starboard lug, paint sample 1, cross section. The paint layers and the analysis spots are numbered from 1 to 6. Shades of the layers: 1-white; 2-grey; 3-blue; 4-red; 5-white; 6-blue

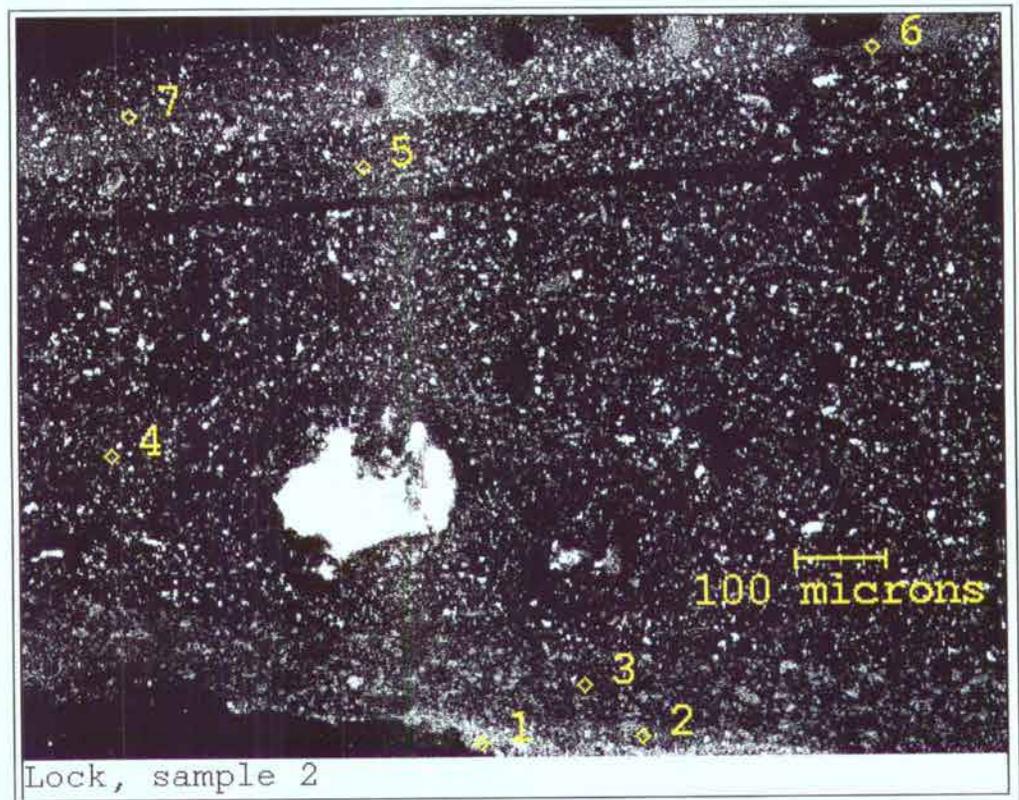
Seven paint layers were found. The BSE-image of the cross section of the sample is given in figure 7 and the corresponding EDS-analyses of the paint layers are given in Appendix 2 in figures A2-1 to A2-7. According to the appearance and the results of the EDS-analysis the layers 4 and 5 seem to be identical.

Figure 7. Forepeak deck starboard lug, paint sample 2, cross section. The layers and the analysis spots are numbered from 1 to 7. Shades of the layers: 1-light brown; 2-white (discontinuous), 3-grey; 4- blue; 5-blue; 6-white (discontinuous); 7-blue. Black crevice between layers 4 and 5.

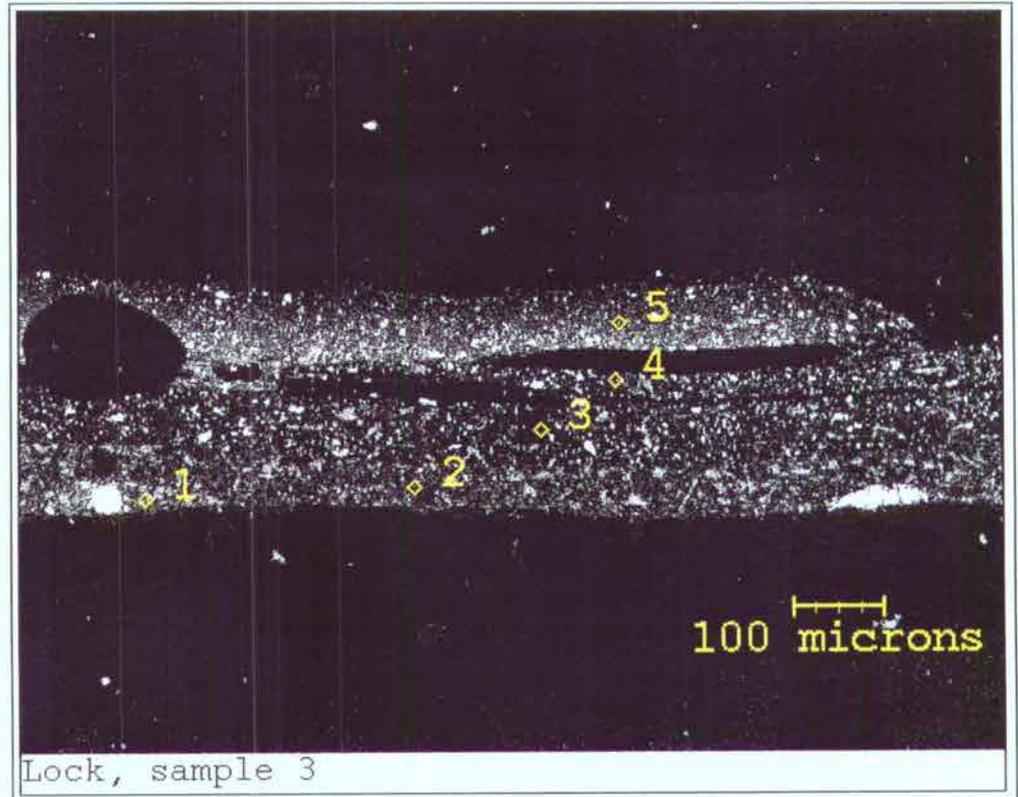
Five paint layers were found. The BSE-image of the cross section of the sample is given in figure 8 and the corresponding EDS-analyses of the paint layers are given in Appendix 3.

Figure 8. Forepeak deck starboard lug, paint sample 3, cross section. The layers and the analysis spots are numbered from 1 to 5. Shades of the layers: 1-white (discontinuous), 2-grey; 3- blue; 4-blue; 5- blue. Black crevice between the layers 3 and 4 as well as between layers 4 and 5.

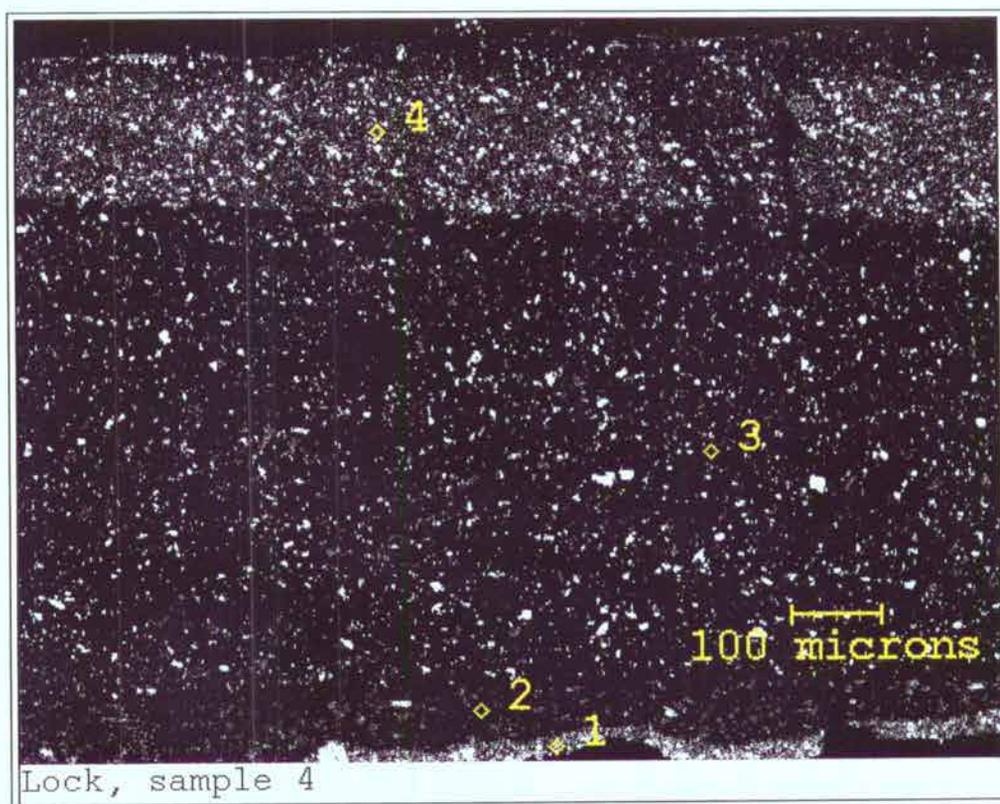
Four paint layers were found. The BSE-image of the cross section of the sample is given in figure 9 and the corresponding EDS-analyses of the paint layers are given in Appendix 4.

Figure 9. Forepeak deck starboard lug, paint sample 4, cross section. The layers and the analysis spots are numbered from 1 to 4. Shades of the layers: 1-light brown, 2-grey; 3-medium blue; 4-blue. Black crevice between layers 3 and 4.

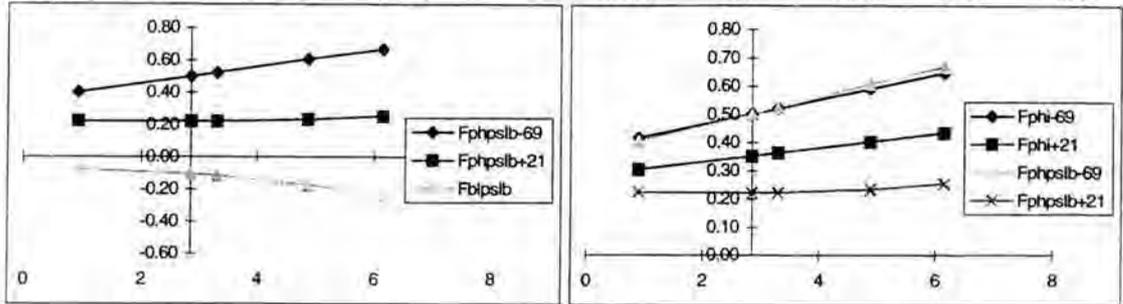
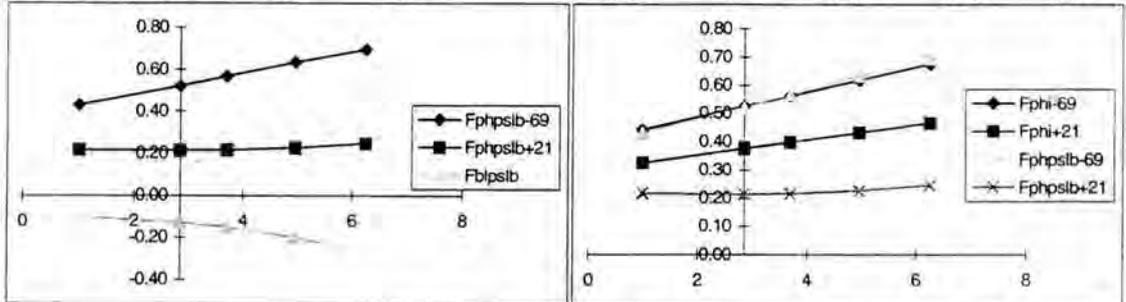
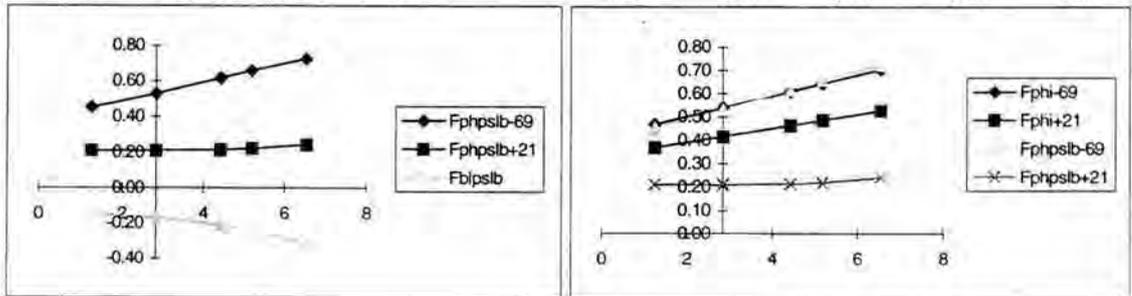
The calculation results indicate that the reactions at the visor side attachments obtain an increasing value as the point of wave action is assumed to lie more forwards. This sensitivity of the reactions to the position of the bow load action centre is essentially a result of the property of the geometrical layout of the attachment system which sets the condition for the choice of moment arm for the transverse F_y -load component. Had the visor been locked by a centrally positioned bottom lock only, sensitivity of reaction to bow load action centre would not have occurred. This is also evidenced by the b-lock load for the "all intact"-case. The side lock load is most sensitive to the assumed position when all attachments are holding. In port wave encounter the weakest of the locks – the p-side lock – is expected to break first leading to redistribution of reaction mainly to the bottom lock with some relief of load at the hinges.

Figure 7b. Load reactions at visor attachments after port side lock failure. Note induced sensitivity of bottom lock reaction to choice of action location.

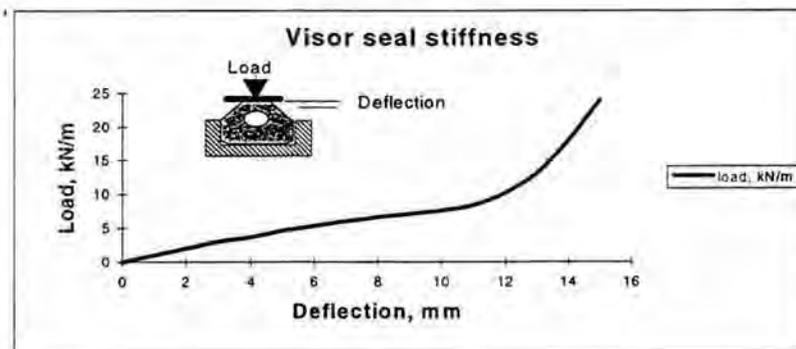
The flexibility of the seal was measured in order to facilitate comparison and quantification of reaction of visor support elements to wave-induced forces. The visor seal was found to have progressive stiffness, such that a 10 mm compression was reached with a 10 kN load per metre of seal length and the following 5 mm needed 15 kN more, see Figure 8.

Figure 8. Visor seal stiffness as measured for 1 m length of seal.

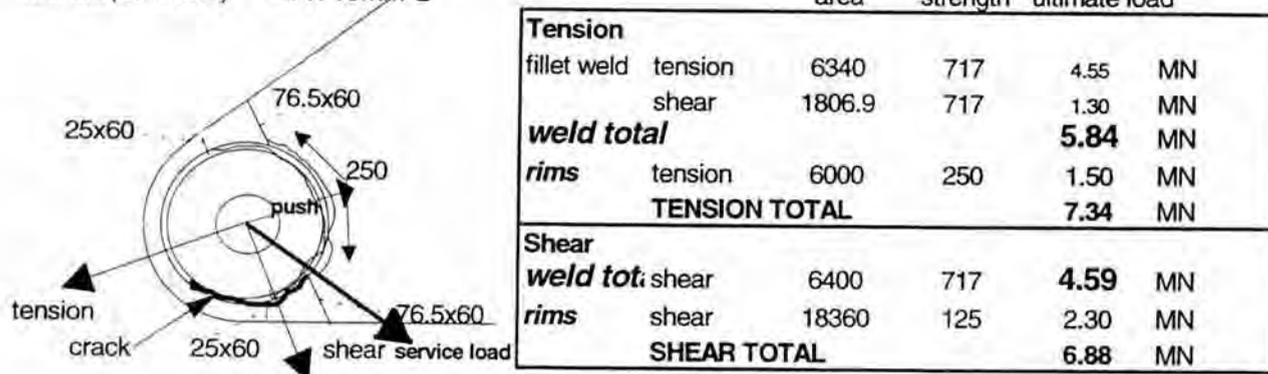
Hinge strength assessed according to result by Royal Institute of Technology from testing authentic weldment $120000/(2 \times 14 \times 6.4) = 717 \text{ N/mm}^2$

Figure 9. Hinge details and strength estimates for tension and shear. Effect of noted fatigue crack in the lower sector has been accounted for. Loads expected in service would cause push and shear components.

Accordingly, and referring to Figure 9, in loading vertically (called shear) and in aft directed tension (an irrelevant loading mode if locks are holding), the hinge is estimated to be able to carry load from 4.6 MN up to about 7 MN depending on hinge bushing to lug clearance, the weaker result applying to a larger clearance. Fatigue as noted in the lower sector of the bushing to lug weldment has been accounted for in the ultimate strength estimate but its effect is small. Progression of the fatigue damage, may, however, continue in cyclic load of lesser load amplitude. A large clearance between the bushing and the lug plate would increase the effect of fatigue and could lower the strength numbers from 4.6 MN.

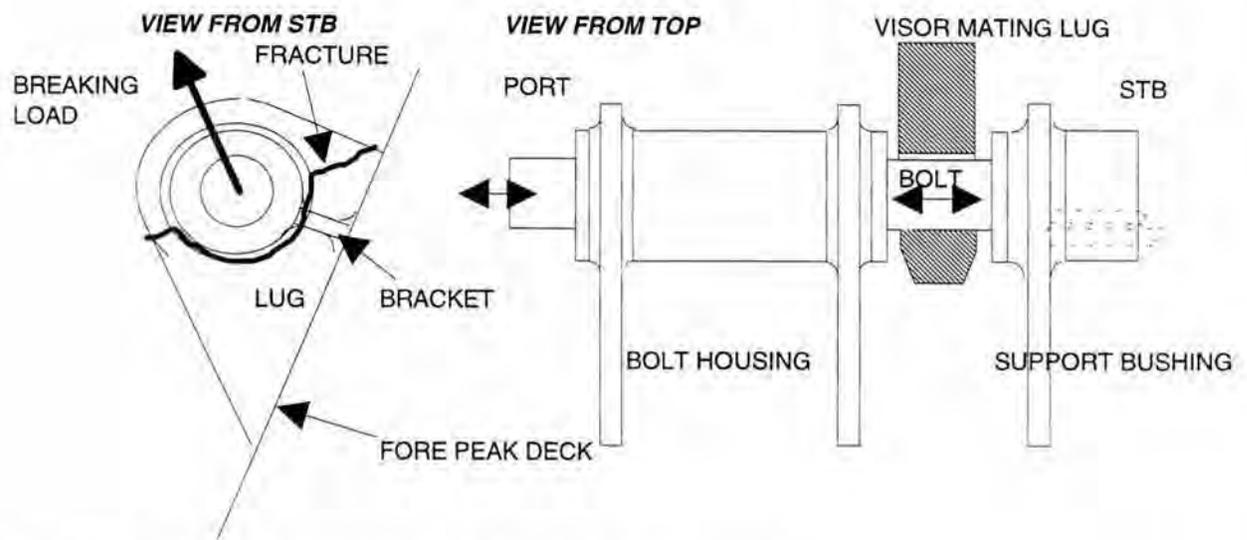
Breaking of the Atlantic lock of MV Estonia occurred in the forepeak deck structure by fracture of weldments between locking bolt guiding and mating bushings and their holding lugs and bracket that held the bushings to the forepeak deck. Those fractures and the associated lug materials have been analysed and identified elsewhere. The mating lug on the visor had stretched and bent. The total lock is shown in Figure 10.

Figure 10. Atlantic lock fore peak deck structural components.

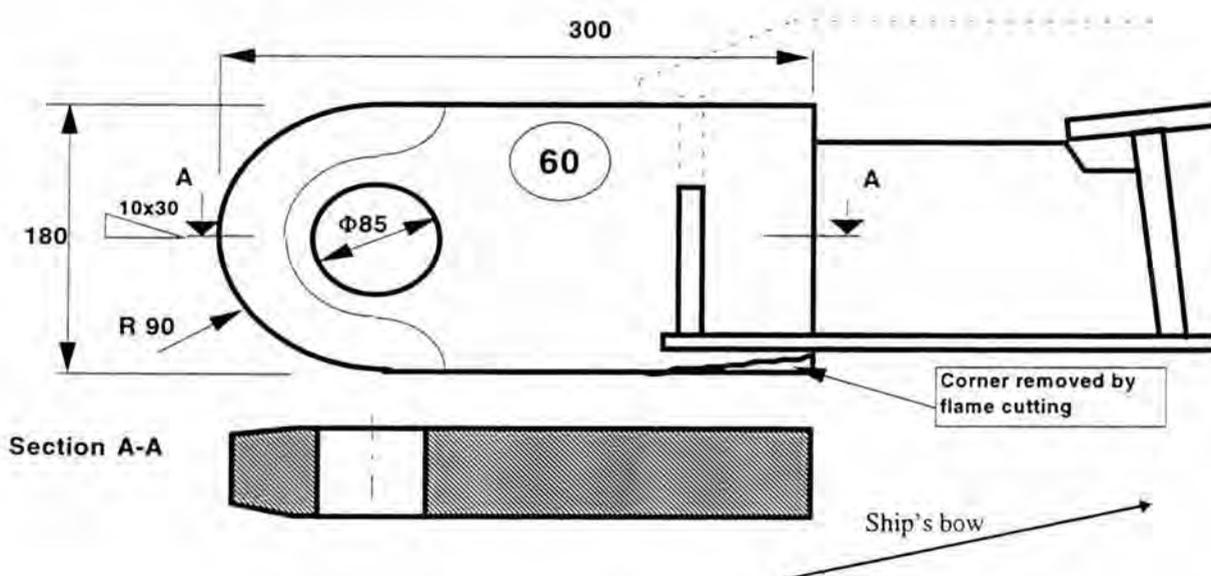
Figure 11. Atlantic lock visor lug as designed. The dashed part of the vertically positioned longitudinal stiffener to the visor bottom plate was missing in the actual visor above and to ship's bow from the lug.

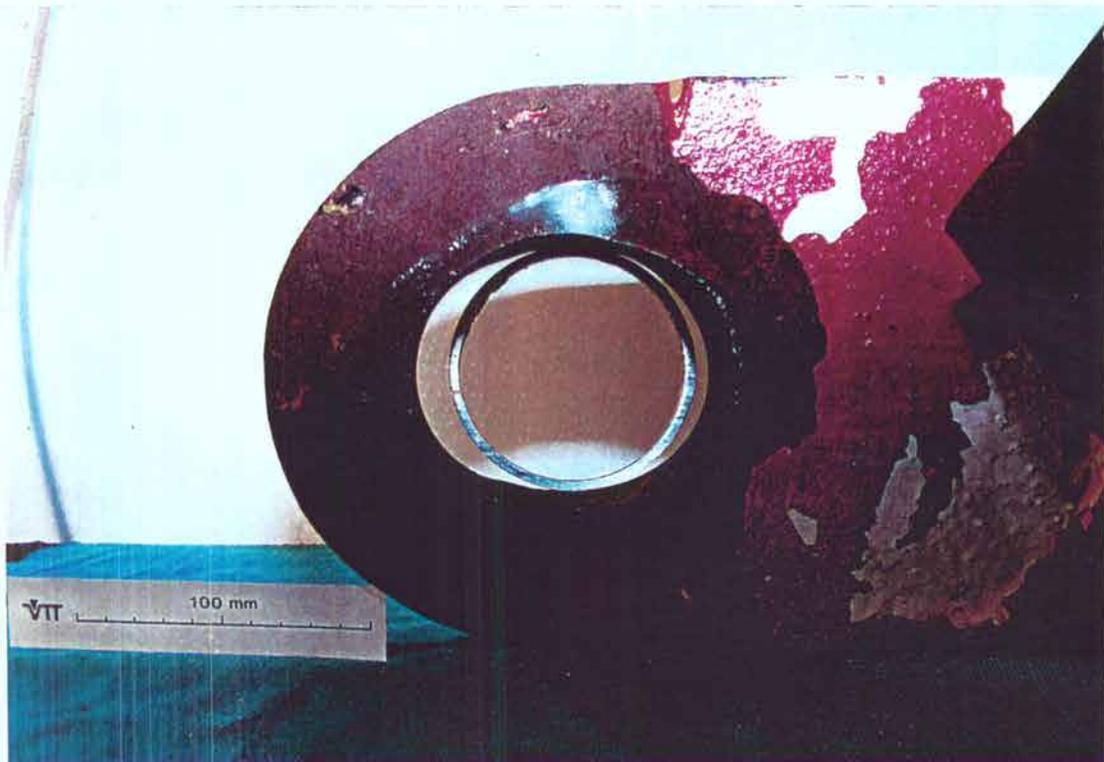
Figure 13. Side view from starboard of Atlantic lock visor lug after removal from visor. Ring insert in eye denotes the approximate apparent position of the eye in its original shape.

tensile testing of mock-up and model lugs, elaborated in later sections of this report. An additional deformation of the eye is observed at its end towards the ship's bow as indicated by the ring insert. Compression and/or wear of the stem - or bow - end of the lug appears to have occurred and stretch of the aft end of the lug is apparent. The aft ligament of the eye along the lug is 47.5 mm, which is as designed and indicates no wear of the aft end. The "pear" shape of the deformed eye with the narrow end facing aft, is noted. The narrow aft facing eye sector occurs through the thickness of the lug. At the (vertical)"waist" of the "pear" the eye is about 80 mm wide and it is possible to fit a Φ 78 mm disc into the "bottom" (or aft end) of this end of the elongated eye. Φ 78 mm corresponds approximately with the diameter of the locking bolt. Hence it is judged that the lug has stretched and that the tension action has been caused by the locking bolt (or the reacting load held by its attachments).

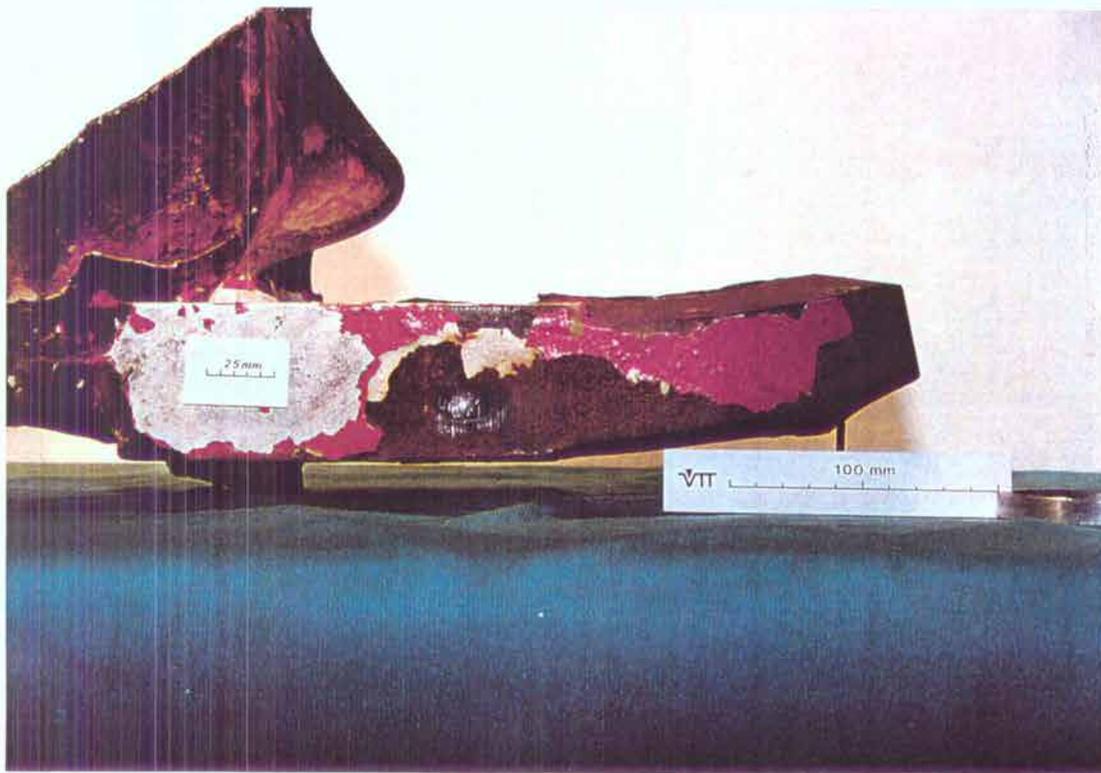
Figure 14. Top view of Atlantic lock visor lug after removal from visor. Lug aft end bent to starboard, bending of stem is very small and practically undetectable.

Photographs of the visor lug – as removed from the visor – are shown in Figures 13 and 14 from the side and from "top" respectively. Also here we may note deviation of the visor bottom plate stiffener dimensions from those marked on the drawing.

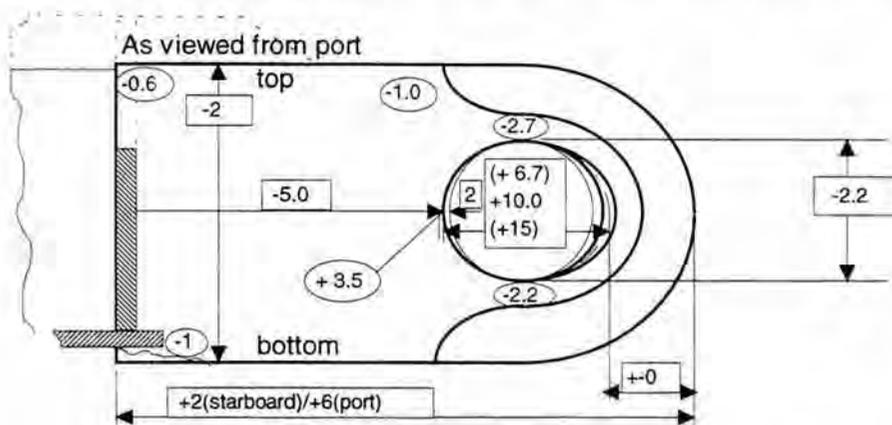
Figure 15. Lug dimensions as differences to nominal as drawn dimensions. Note also reduced thickness of eye ligaments above and below eye, which supports tensile stretch of lug.

Taken lug dimensions are given in Figure 15 as deviations from the nominal as drawn dimensions and in Figure 14 as actual millimetric dimensions of the lengthwise ("horizontal") through-thickness cross section of the lug.

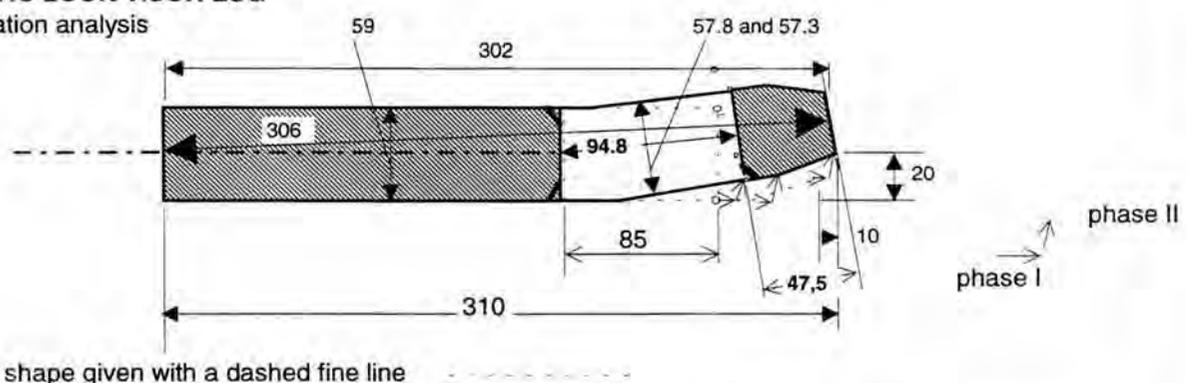
Figure 16. Longitudinal section of the deformed lug indicating also the path of assumed deformation. i.e. Phase I and Phase II. Crushed eye corners indicated.

An appraisal of the deformation of the lug end has been made. Here we observe that three of the eye hole corners (aft port and both bow corners) have been crushed leaving the stb aft corner unaffected. Apparently this crushing has occurred during later stages of the accident – i.e. the bending Phase II included – when the bending action by the locking bolt occurred after the forepeak deck side of the lock had broken. The bending has apparently occurred so that the locking bolt has been supported by the starboard bow end corner of the eye hole and the stern end port side corner has been pushed aft and to starboard by the bolt, the port end of the bolt having been held back by the hydraulic piston rod. The port bow corner crushing may have occurred during back and forth motions of the visor after all lockings and fastening sites had broken but with the locking bolt still in the lug eye and hanging on to the piston rod. This deformation can be produced with a comparatively low force and has been named Phase II. Analog crushing of eye corners at port aft and starboard bow corners of the eye were observed in all comparative mock-up tests.

Prior to this bending, stretching has occurred (Phase I) as evidenced most critically by the movement aft of the starboard aft corner of the lug. The shape of the eye prior to this bending, which also contributes some stretch, may be found drawing circles through the chosen stern midheight points of the eye ligament section using the supporting starboard bow corner of the eye hole as centre. The intersection of these circles with the corresponding profile lines of the unbent lug mark the locations of the eye hole ligament after phase I, i.e. at the end of the pulling phase, during which the critical forepeak deck lugs had broken. This "circular arc" deformation model was checked by back-calculating a 1/3-scale lug deformed by eccentric pulling at the Royal Institute of Technology". It was found that the elongation of the hole occurring due to this side bending is overestimated by the "circular arc"-model, and that a correction term equalling one tenth of the amount of side bending may be subtracted from the estimate of additional elongation for the side bending effect obtained by the circular-arc model to find the corrected elongated shape of the lug after phase I.

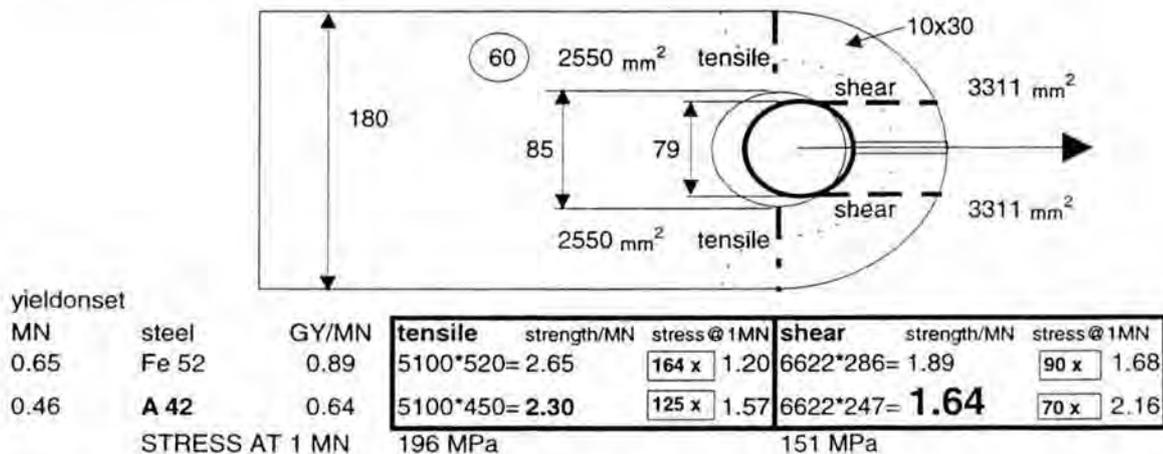
Figure 17. Ultimate strength and stresses at 1MN of visor lug.

The cross sections subjected to tensile stress are together $95 \times 60 - 10 \times 30 = 5100 \text{ mm}^2$. Taking that these could determine the ultimate strength a breaking loading capacity of 2650 kN or nearly 300 tons would be obtained. At design load the tensile stress would be $1 \text{ MN} / 5100 \text{ mm}^2 = 195 \text{ MPa}$, which is more than the used permitted design stress for high strength steel. The shear stress would be $1 \text{ MN} / 6622 \text{ mm}^2 = 151 \text{ MPa}$, which would be more than the shear yield strength for high strength steel and exceed a moderate permitted design stresses for both high strength (90MPa) and mild (70MPa) steel. The calculated lower bound shear fracture load would be 1.65 MN for mild steel grade A 42 and 1.89 MN for high strength Fe 52, the latter also being slightly lower than the test result of 2.04 MN obtained at the Technical University of Hamburg.

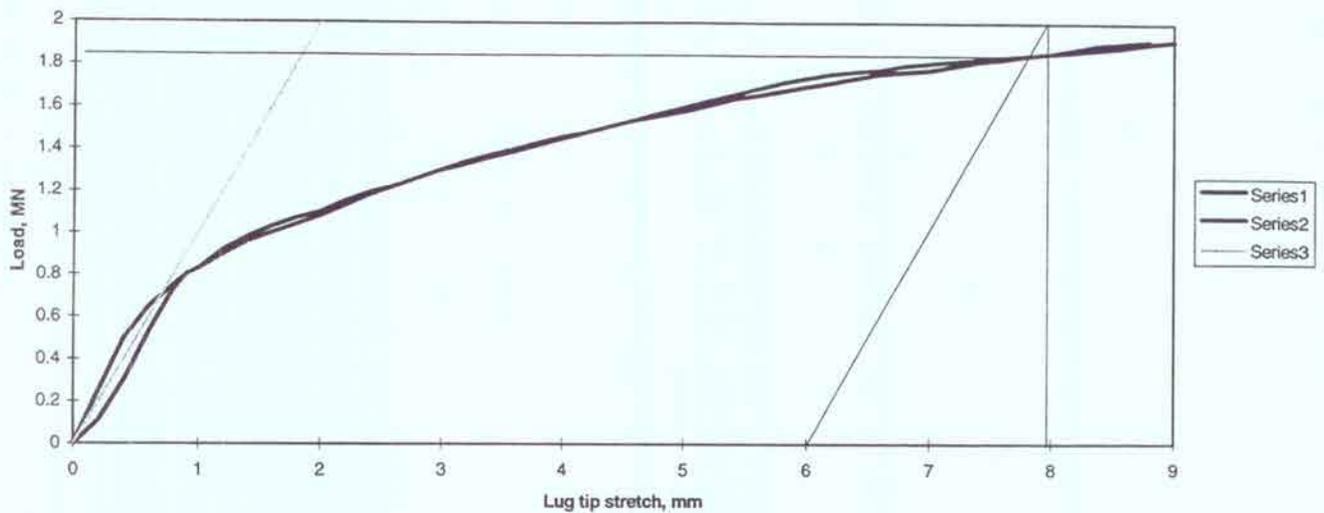
- **Centric full size Fe-52 tensile test:** The full size mock-up lug (both ends) was pulled to a total of 7.5 mm permanent elongation of each eye. The tensile eye elongation - load curve is shown in Figure 21. At final elongation of 7.8 mm for each hole the load was 1.92 MN. **In the range of deformation of interest for interpreting the authentic lug load, i.e. around 6mm eye elongation the curve is nearly linear according to load/tons = $172 + 8.5 \cdot (X-5)$ for Fe 52-grade steel, X being the permanent elongation in mm. A correcting term approximated by $(50/350) \cdot 172 = 24$ tons may be subtracted to obtain the number for A-grade steel (St42).**

Figure 21. Load- eye elongation curve of full size Atlantic lock visor lug model of St 52 high strength steel.

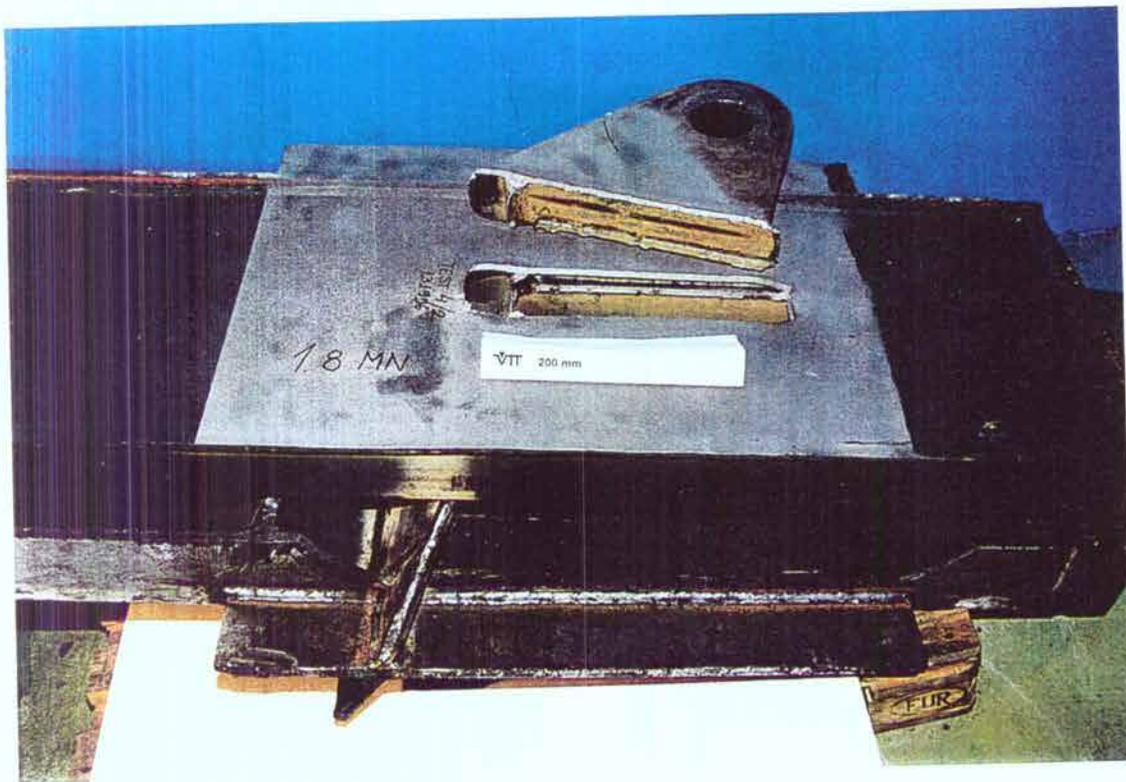
The structural arrangements and failure details of the fourth test resembled the starboard side lock of the visor best of all tests. The second mock-up is also relevant in displaying the failure load level and stress value for only the aft plating of the visor after failure of the horizontal stringer but without vertical stiffeners, i.e. in yard "designed" condition. This failure occurred when the theoretical ultimate shear strength of the plate was reached at the point of maximum tensile resistance of the mock-up after holding by the horizontal stringer had been lost. This

Figure 27. Side lock test mock-up 4/2 after testing.

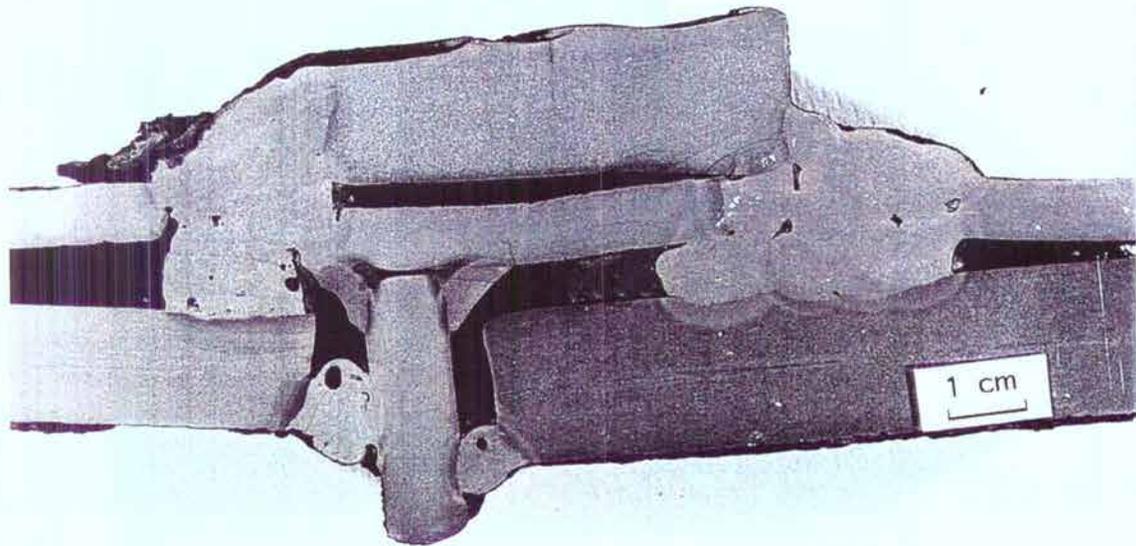
A side lock base left over from the bow modification for MV Mare Balticum was recovered for metallurgical survey of the remaining damages on the side locks of the January 1993 incident. Also the repair was observed, Figure 29.

The observation yielded remaining cracking in the original plating in several locations, one of them can be seen in the bulkhead plate starting at the toe of the fillet weldment of the vertical backing stiffener, Figure 29. Strengthening plate pieces had been added as part of the repair action, but the repair piece fit and welding quality of the repair appears poor. A strength estimate cannot be given.

Figure 29. Metallurgical horizontal section through side locking lug, aft bulkhead, vertical stiffener and repair pieces of side lock site in MV DIANA II.

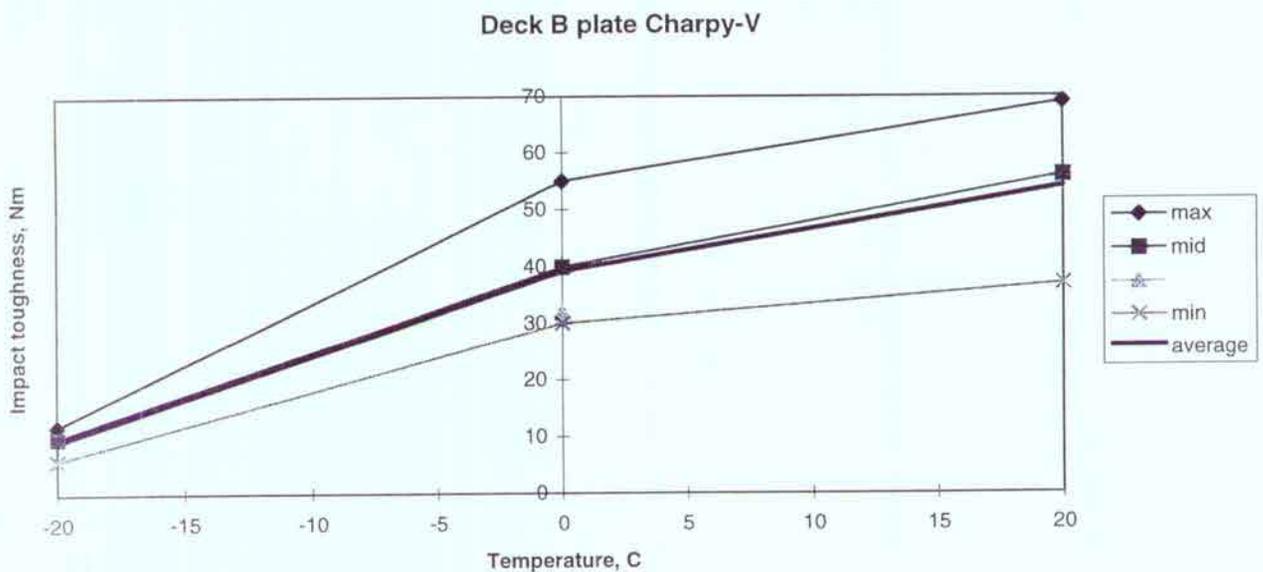
Figure 32. Deck B Charpy-V impact toughness values.

The remaining section had fractured by cleavage - a mechanism typical of cold brittleness. Deck B plate was also found by Charpy-V impact testing to have a tendency for cold brittleness, even at room temperature as indicated by impact toughness shown in Figure 32. The reduction of strength due to this possible source of weakness has not been assessed accurately, however.

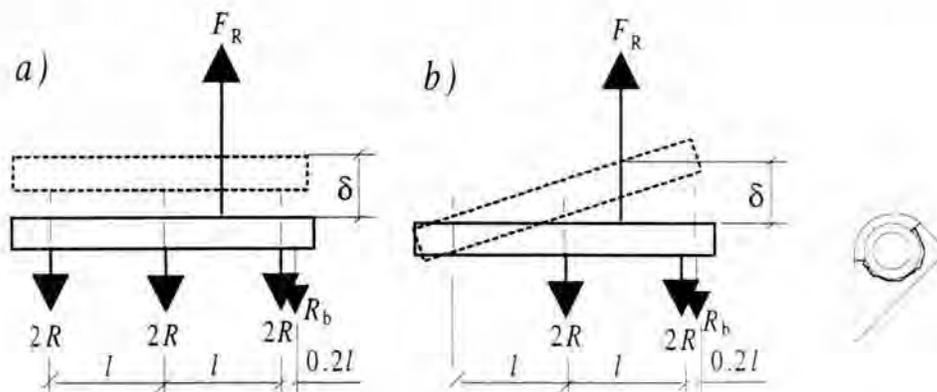
Fig. 1 shows two alternative failure mechanisms. The ultimate load, F_R , is resolved based on principles of plastic theory. Each lug is assumed to resist the deformation developing a total resistance of $2R$. The resistance value R is formed by flow load of the rim cross-section, in addition to the ultimate fracture load of two 90° fillet welds. The fracture load of the two starboard bracket welds is denoted R_b .

Fig. 1 Two alternative mechanisms. In case a) all three lugs are assumed as load-bearing but the static equilibrium condition is violated. In case b) the static equilibrium is maintained.

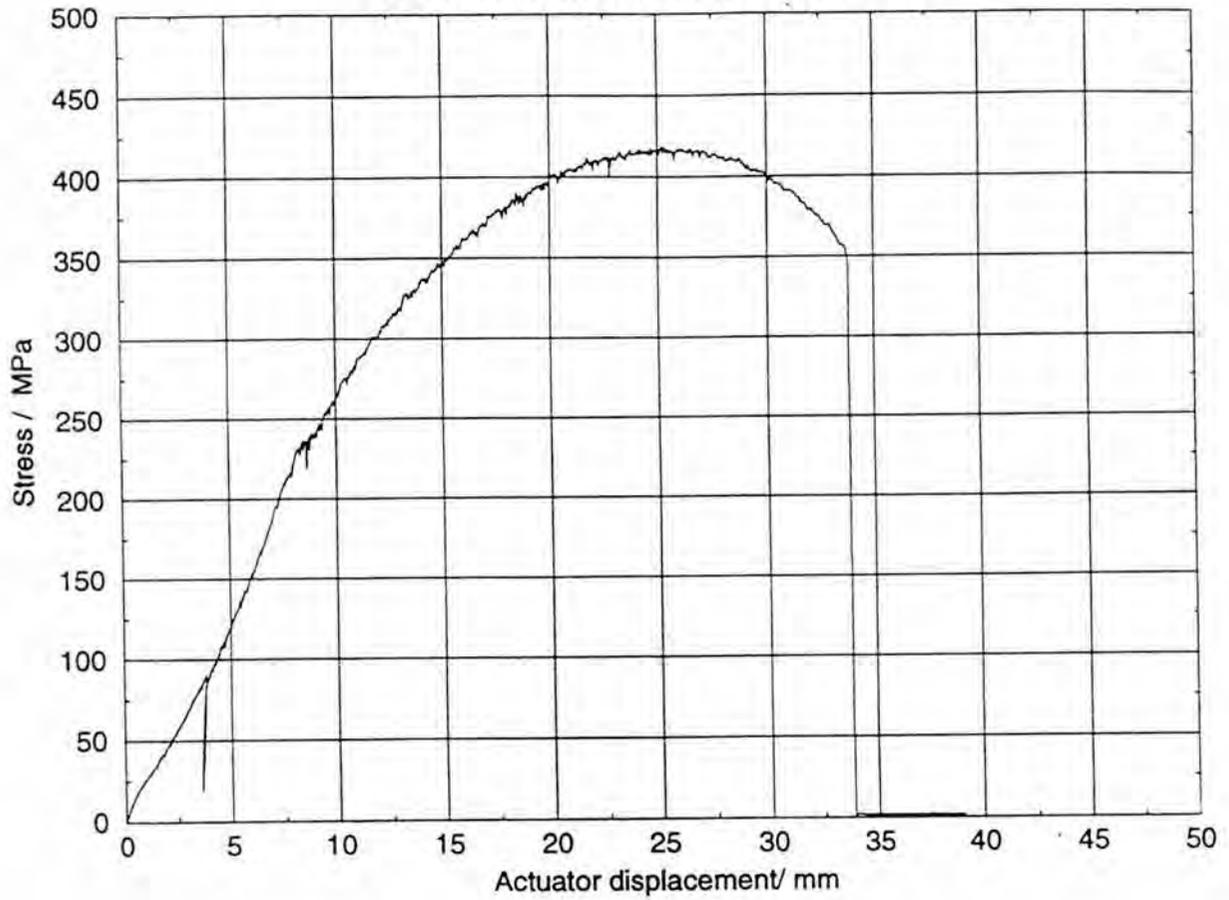
The failure load was 177 kN which is proportional to a stress of 417 MPa which is then taken as the ultimate tensile strength σ_u . This value is in reasonable accordance with the expected behaviour of the material. A stress-displacement diagram is enclosed (Fig. 1). The displacement shown in the diagrams is the sum of the elongation of the specimen and of the fixtures and the testing rig. From Fig. 1 the yield stress can be estimated to 230 MPa.

Fig. 1. Tensile testing of bottom lock material, rectangular specimen.

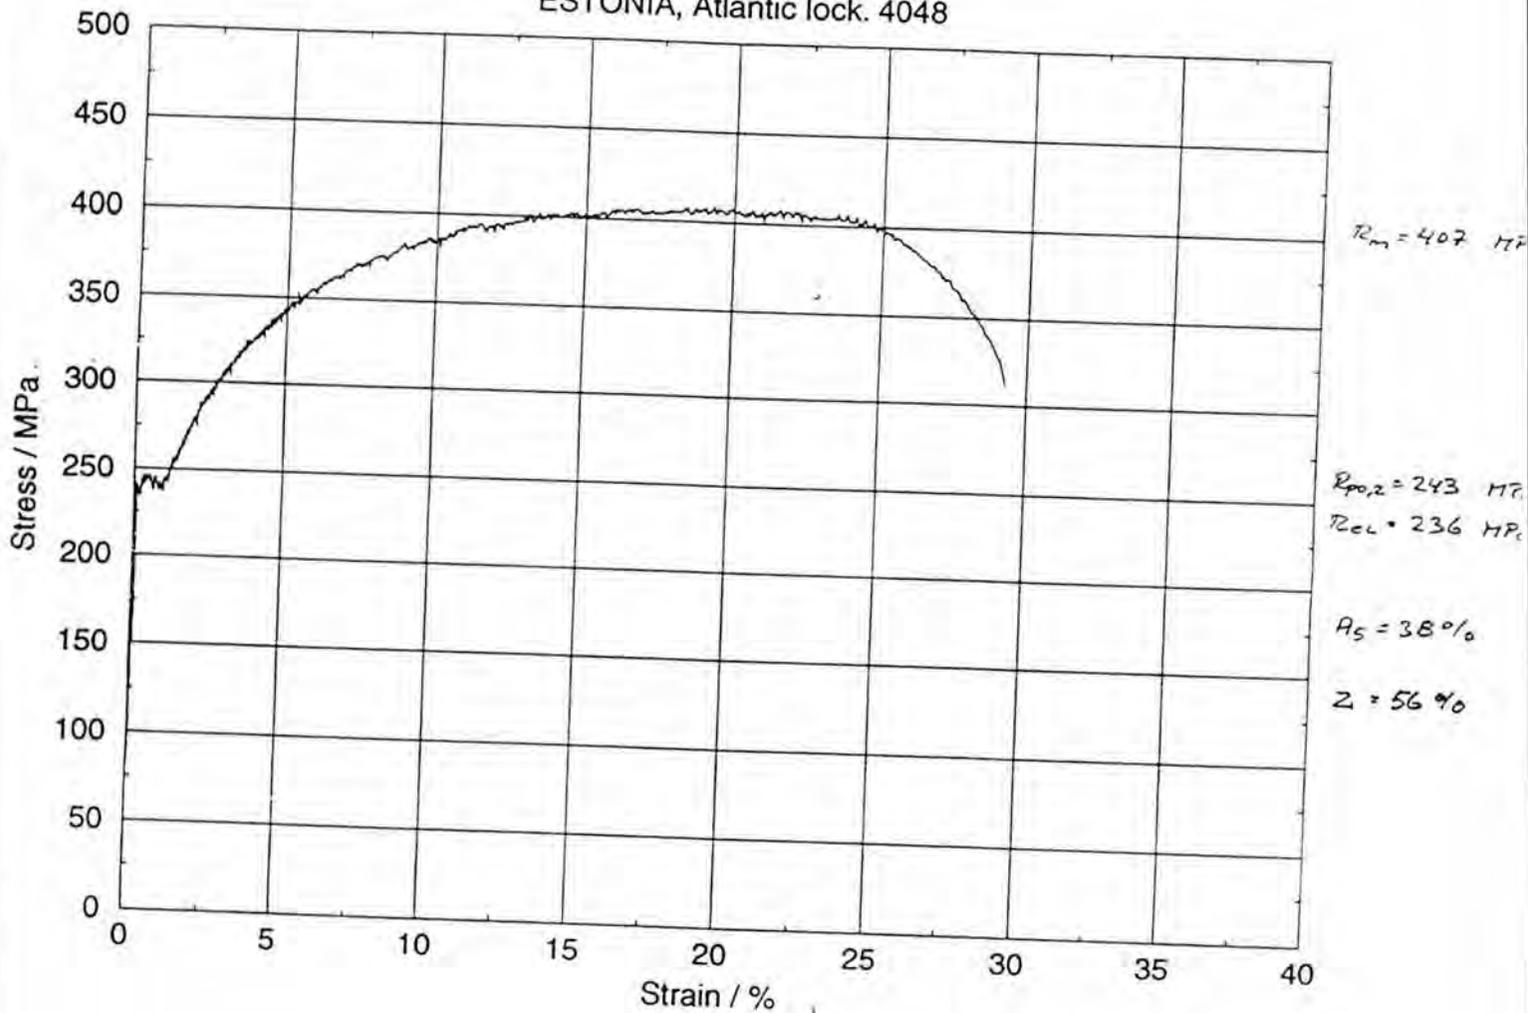
Two standard tensile specimens with a circular cross section were also cut out from the lug and tested. The object of this part of the testing was to determine the yield and the ultimate strength of the material according to standard procedures. The two tests yielded virtually identical information and the stress versus strain behaviour is shown in Fig. 3. The yield strength was determined to 243 MPa and the ultimate tensile strength to 407 MPa. This is in reasonable accordance with the previously described testing on rectangular specimens.

Fig. 2. Tensile testing of bottom lock material, standard cylindrical specimen.

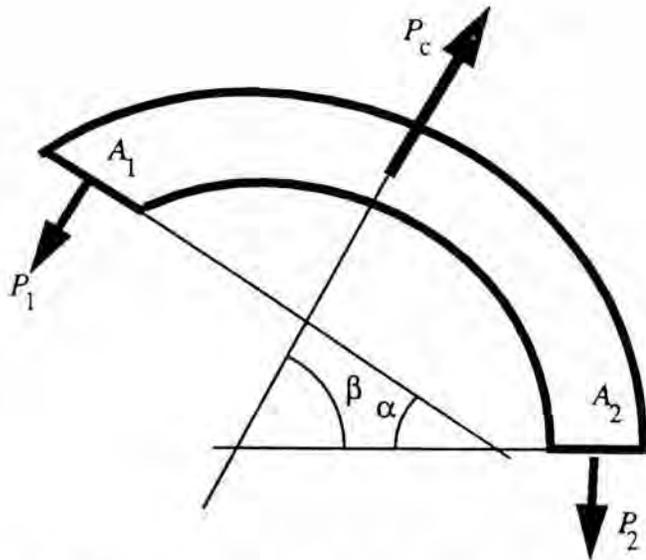
The collapse load for each plate is estimated in the following way. Each of the three plates exhibits two fracture surfaces having the overall appearance of tensile failure through a shearing mechanism similar to that of the performed tensile test. It is then simply assumed that at the point of failure the fracture surfaces resist by a purely normal load equal to the area of each fracture surface times the ultimate tensile strength σ_u . Possible in plane shearing forces will probably not be of any greater significance. Sketching the missing piece of a plate we then obtain the force geometry from Fig. 3.

Fig. 3. Assumptions for calculation of the collapse load

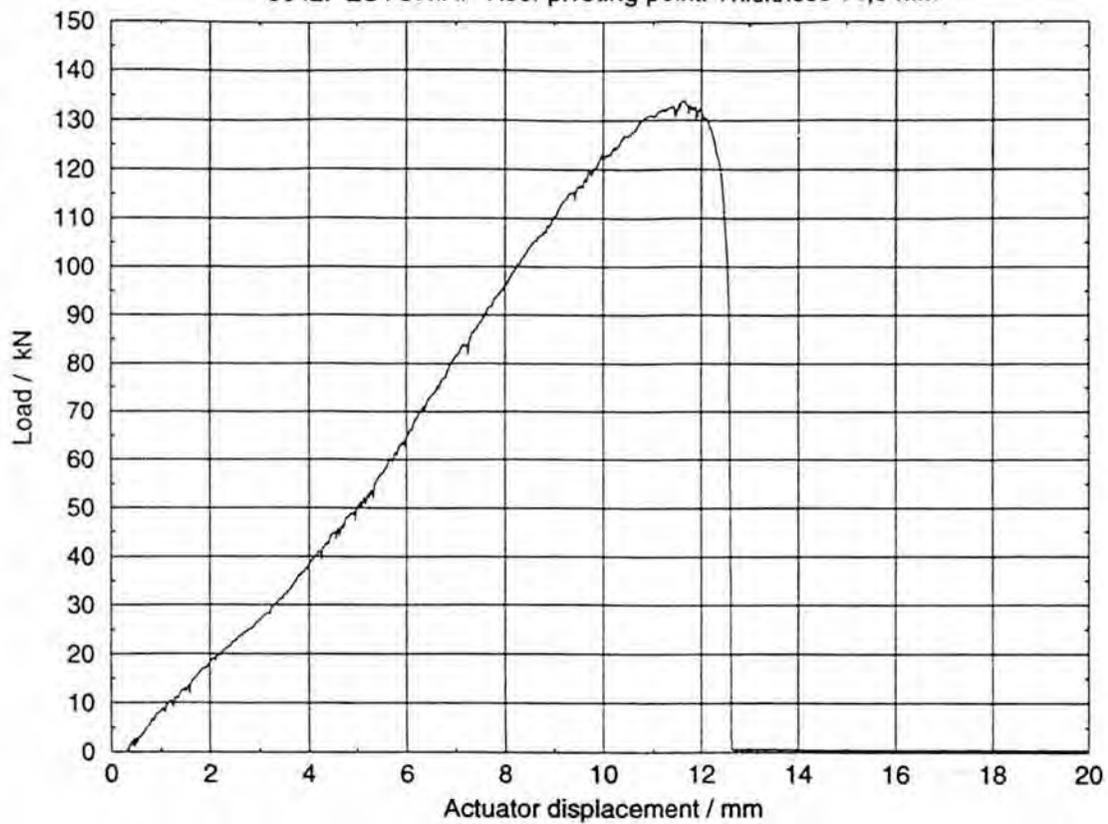
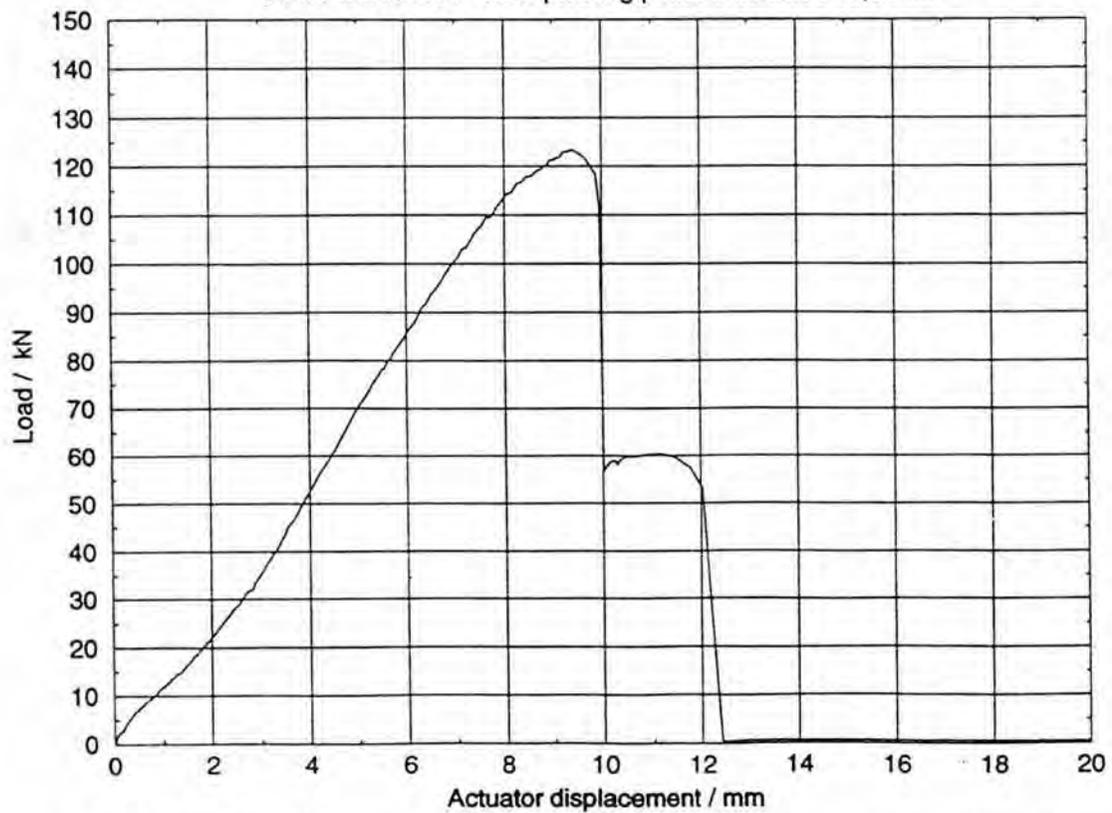
Welding defects could be seen in the broken welds. In spite of that, the load carrying capacity of the welds was good compared to that of the net section.

Fig. 4. Load vs displacement from testing of welds from visor pivoting point.
