THE FINAL REPORT ON THE CAPSIZING ON 28
SEPTEMBER 1994 IN THE BALTIC SEA OF THE
RO-RO PASSENGER VESSEL MV ESTONIA

The Joint Accident Investigation Commission
of
Estonia, Finland and Sweden

SUPPLEMENT

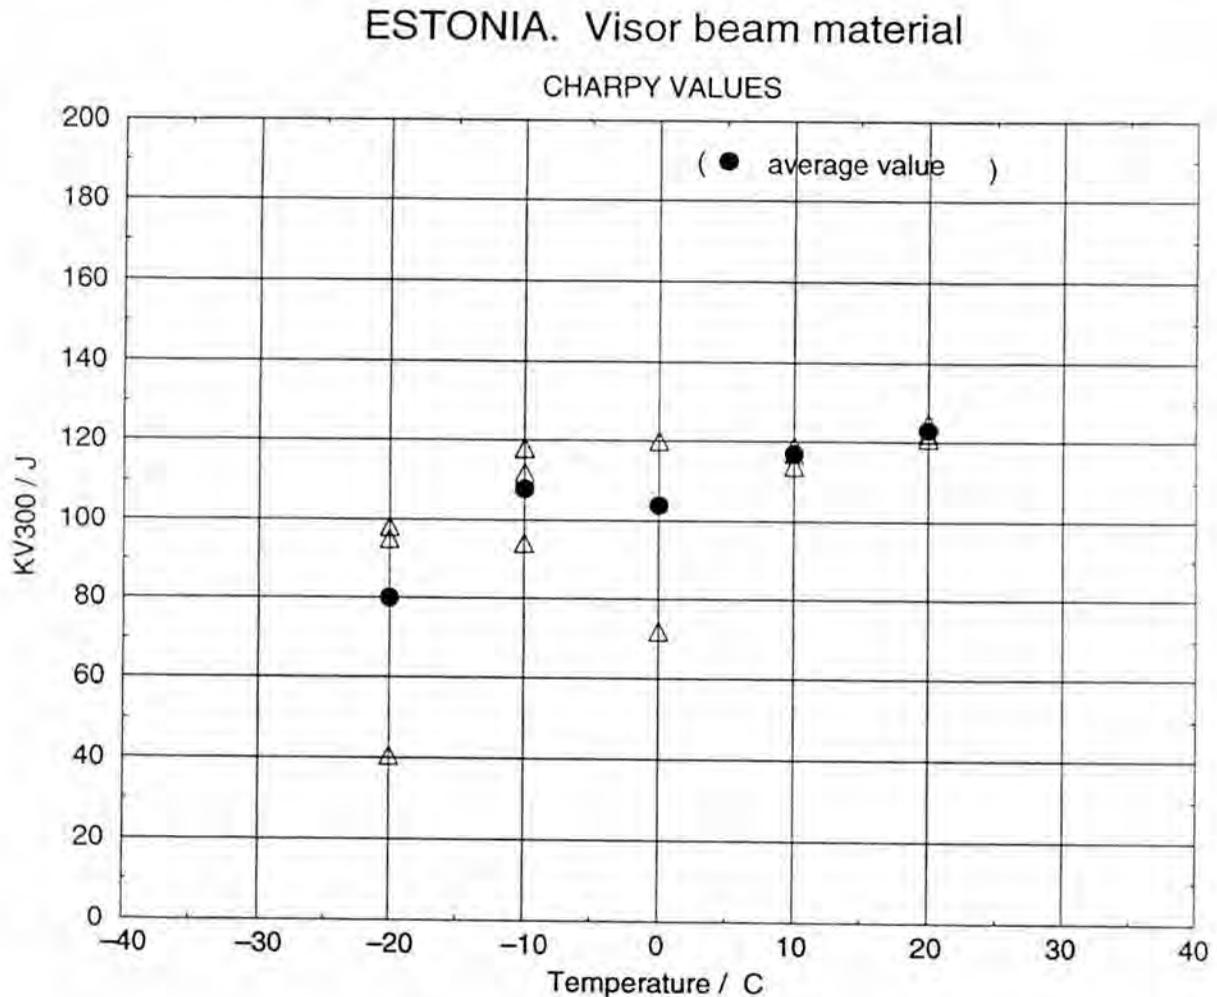
Impact testing using standard Charpy specimens machined from the visor beam was carried out in order to establish the toughness properties. The results from testing at different temperatures are shown in. The main conclusion is that the material possesses adequate toughness properties in the temperature interval considered.

Fig. 5. Charpy impact toughness.

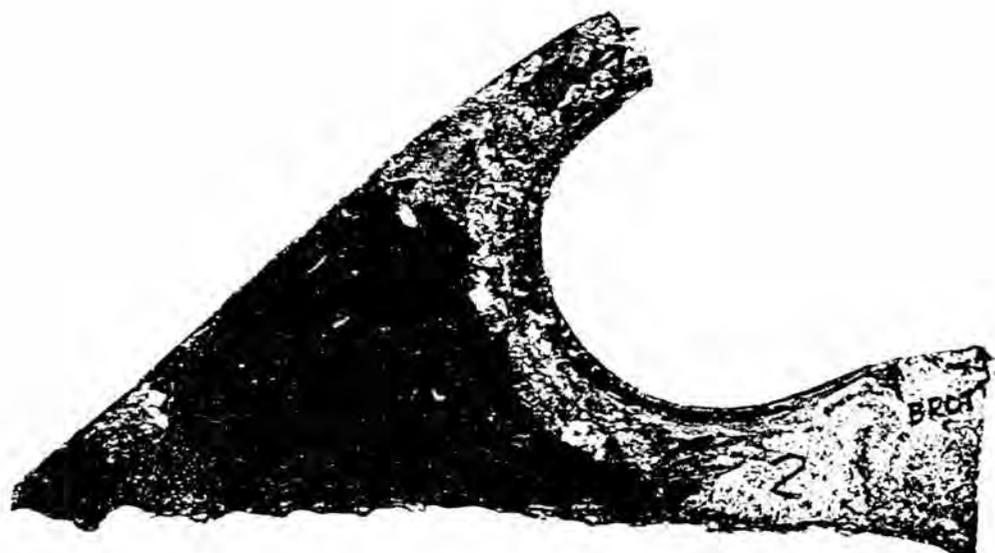
Figure 1. One of the lugs

Figure 1 shows one of the lugs. The slightly undulated lower edge is a result of the cutting under water. The edge to the right and the sloping edge are parts of the original shape of the lug. The lug has failed in the ligaments between the hole and the external edges. Around the hole there is the remains of a fillet weld which has served to keep a housing insert in place. The weld is apparently of low quality and has not had any significant load carrying capacity. The weld has a triangular cross section with a leg size of 4 – 6 mm. The superficial impression of the weld is that in parts of it there is insufficient penetration and lack of fusion. A cross section of the weld is shown in Figure 2. In figure 3 is illustrated the lamellar microstructure of the plate material used for the lugs. It is characterized by elongated slag inclusion with a typical interlamellar distance of 0.06 – 0.09 mm. In some of the specimens examined slag inclusions with a length of over 1 mm have been observed, the largest one being over 6 mm in length..

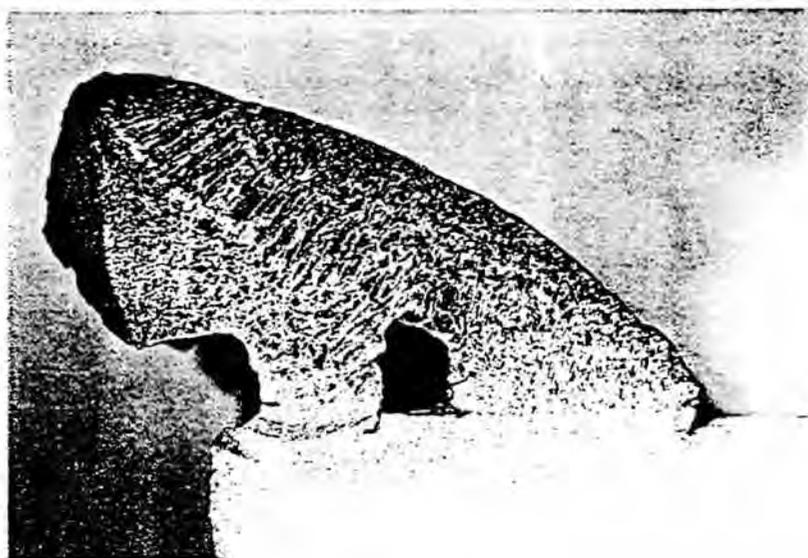
Figure 2. Cross section of fillet weld. Note the large pore, the undercut and poor penetration. 10x.

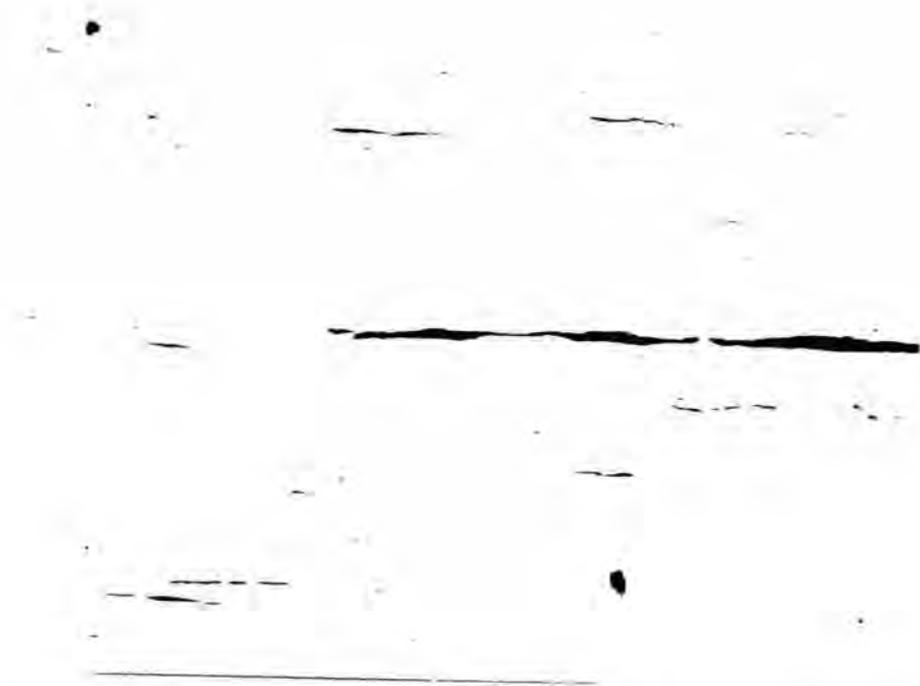
Figure 3. Metallographic cross section of the base metal. Note the elongated slag inclusions. Unetched. 66x.

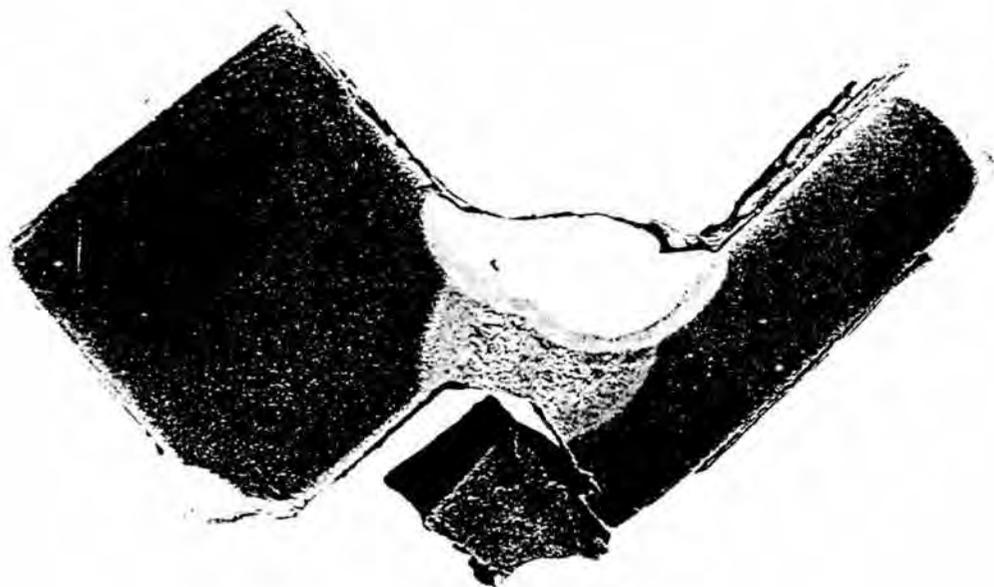
The other cross section, from a piece marked SL2, is shown in Figure 12. Here we note that the etchant has attacked the weld material differently, a difference which suggests that two different electrode materials have been used. The weld is however perfectly sound and there is no indication of any repair work, at least not any work which has impaired the integrity of the weld. The odd feature in Figure 12 is the small apparently loose piece of material just under the support plate. On inspection of the whole piece of 8 mm plate with attached support plate it became clear that the apparently loose piece of material is part of a tongue of material from the 8 mm plate just under the support plate which appears to have been hammered away from the rest of the plate by one or several severe blows to the plate. Such a conclusion is supported by several markings on the 8 mm plate. From the appearance of these markings it seems reasonable to conclude that the markings come from the lug plate which first have been pulled loose from the 8 mm plate and then as a result of movement of the bow visor has struck and slid against the 8 mm plate several times.

Figure 12 Cross section of side lock specimen marked SL2 (ca 2.5x)

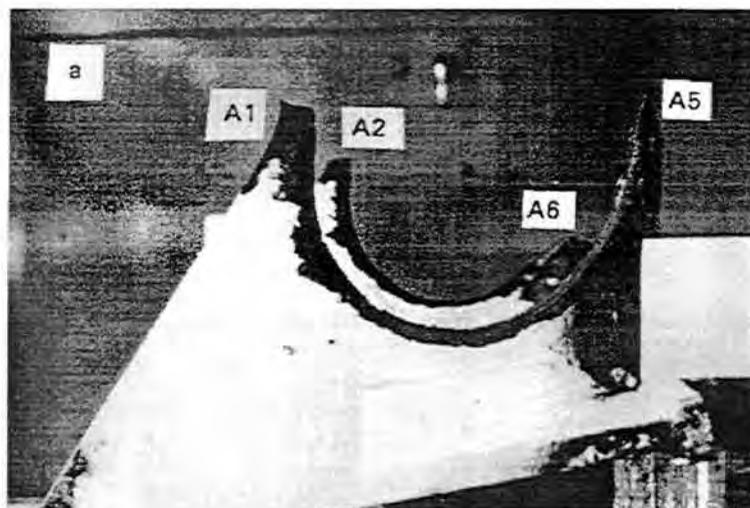
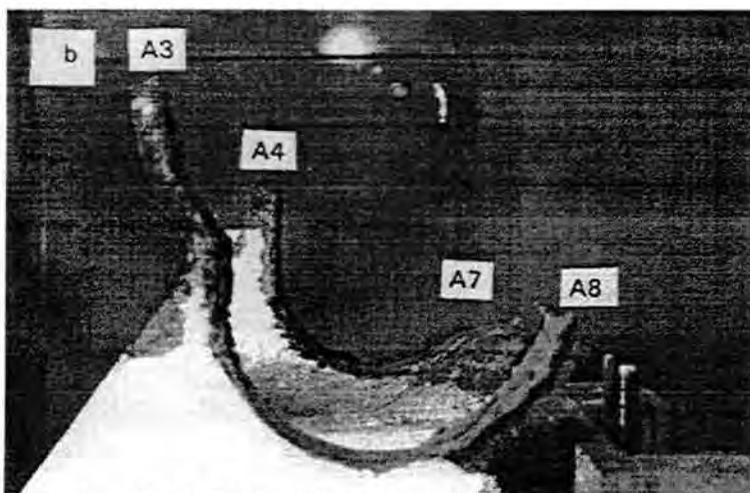
Figure 1. The failed visor hinge lugs. a) portside, b) starboard. Note that A7 is on the near side of the lug and A8 on the far side.

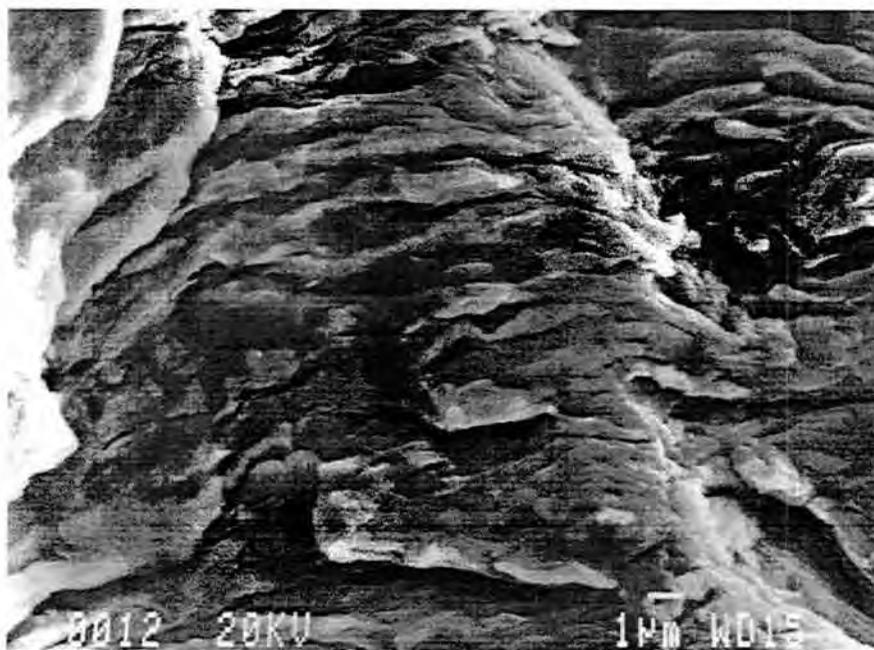
Figure 2. Fatigue fracture surface on laboratory specimen from visor hinge plate. 5000x.

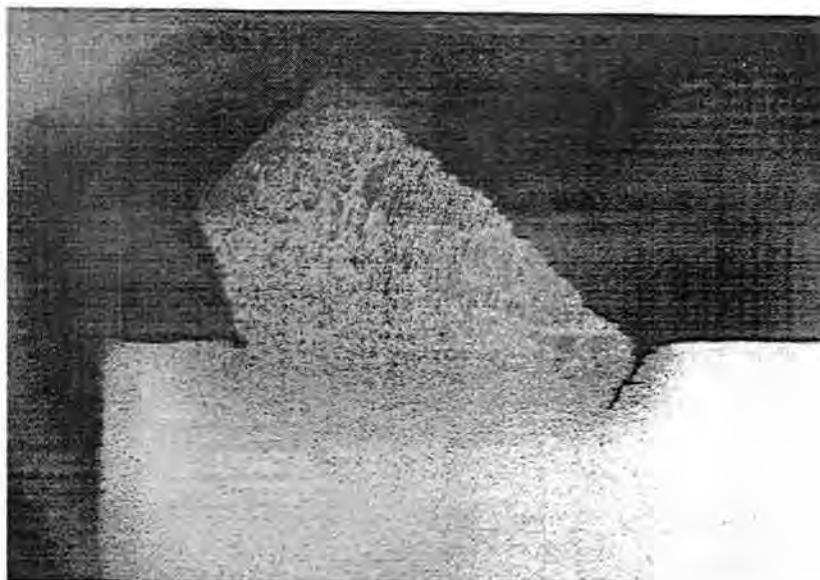
Figure 3. Metallographic cross section of crack in bottom lock weld. 8x.

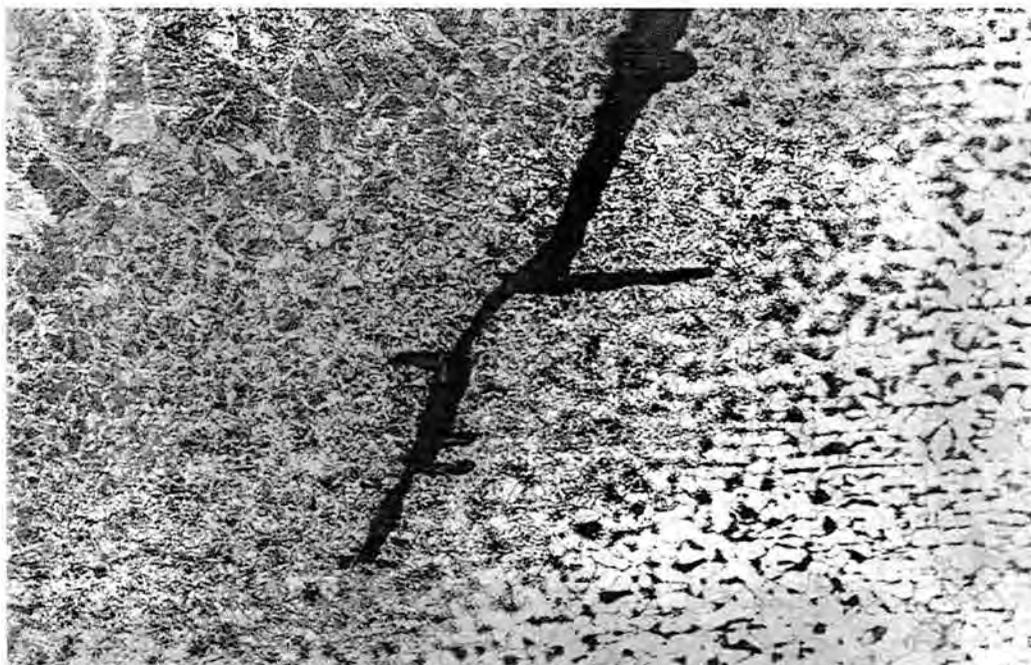
Figure 4. Metallographic cross section of crack in bottom lock weld. 100x.

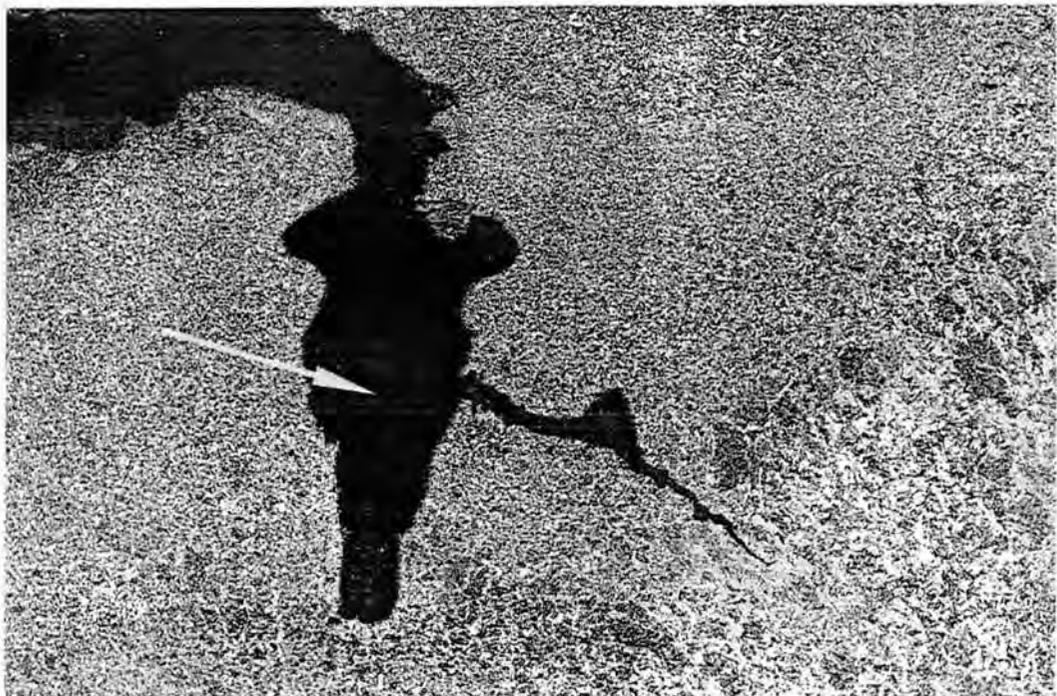
Figure 6. Cross section of weld in higher magnification. The wide part of the crack
is actually a pre-existing cavity formed during welding. 50x

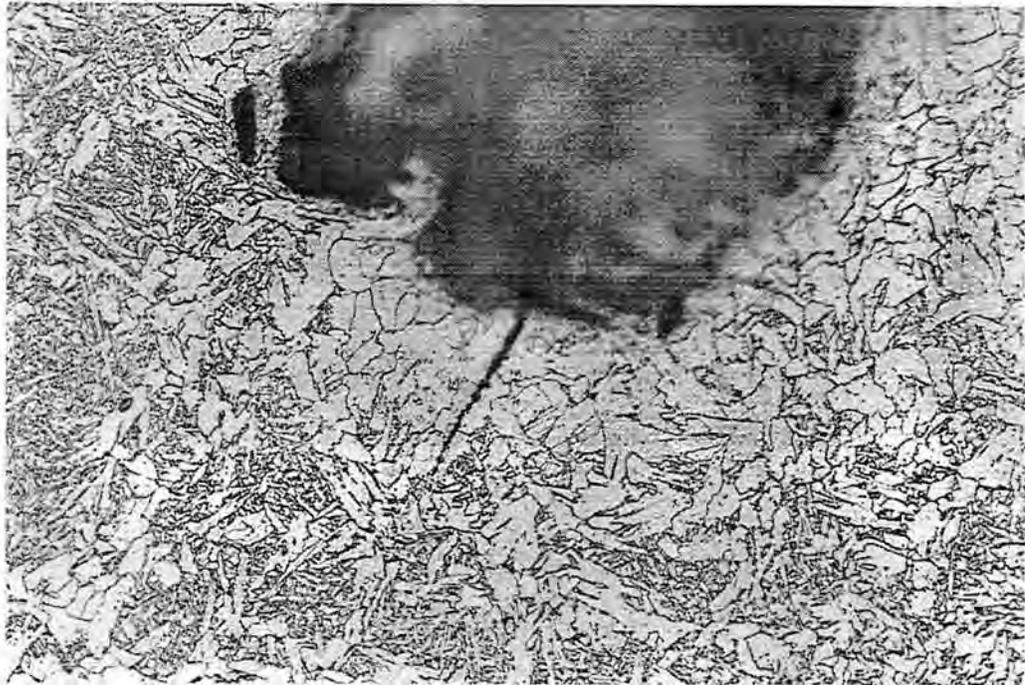
Figure 7. A sharp crack initiated in bottom of cavity, presumably by fatigue. 500x.

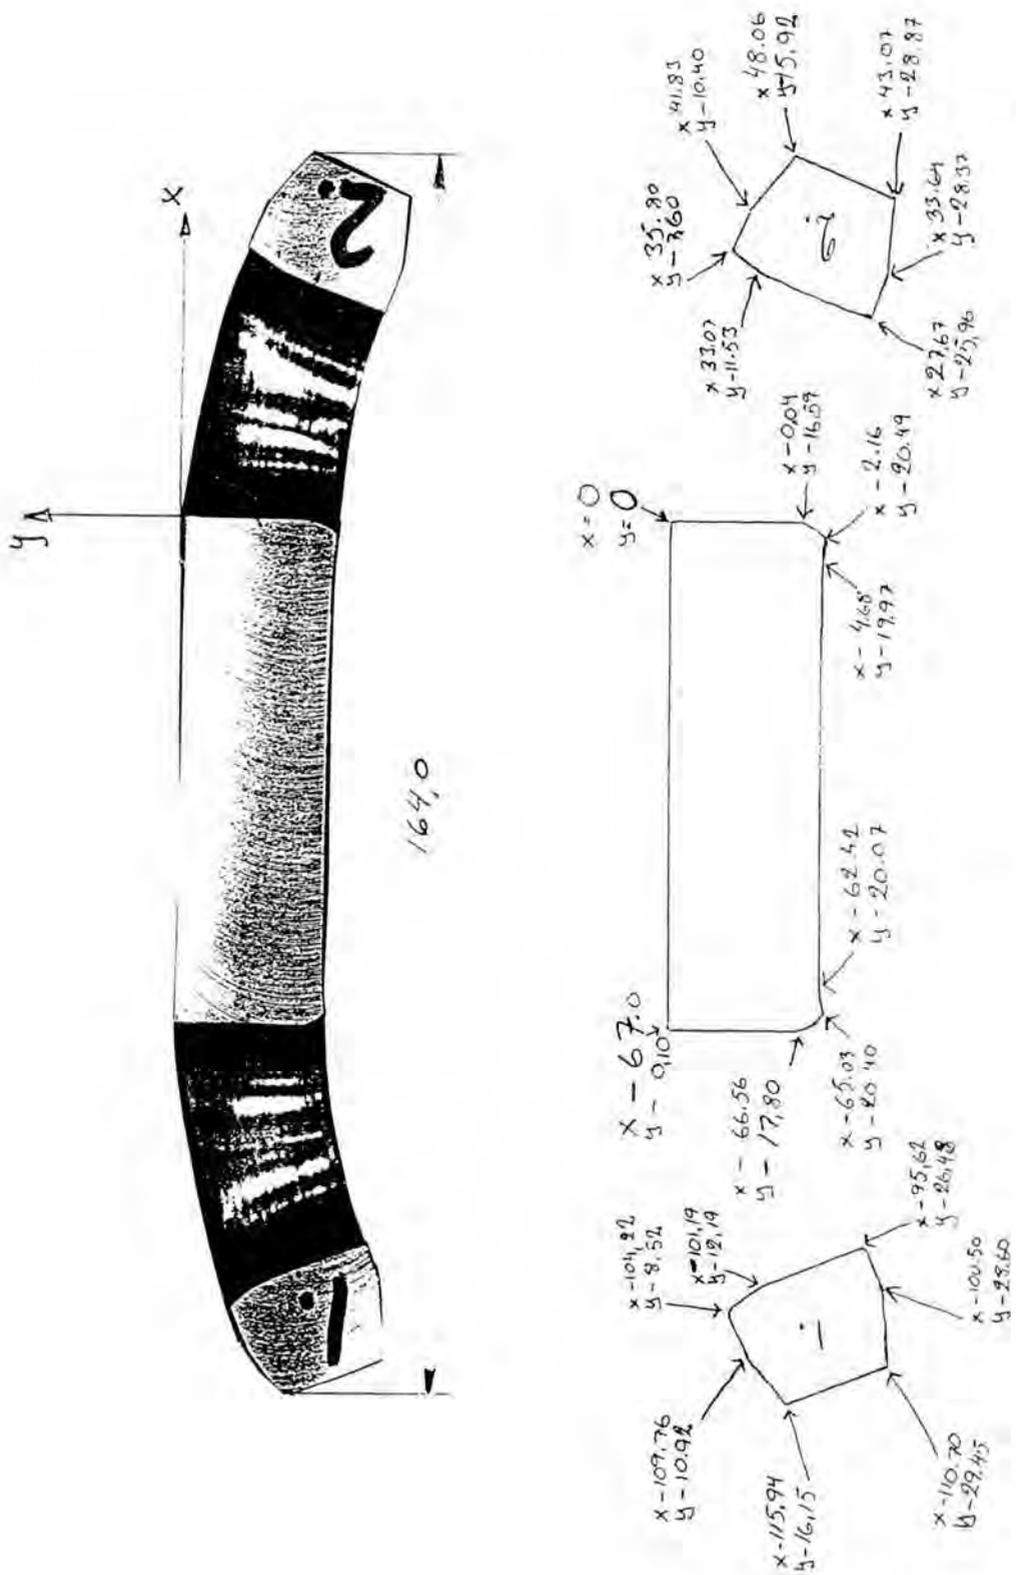
FIGURE 2 SYMMETRY SECTION AFTER TEST

It was observed that considerable elongation had taken place in the bolt holes, being close to 1.5 mm in the test scale at mid thickness of the lug. Detailed dimensions are shown in **Figure 2**. Considerable plastic deformation had taken place at the contacting points between the bolts and the edges of the holes. Some plastic deformation was also noted on the bolts, resulting in a smoothing of the contact pressure distribution. The elongation was not accompanied by any increase of the length of the entire specimen in the bent condition.

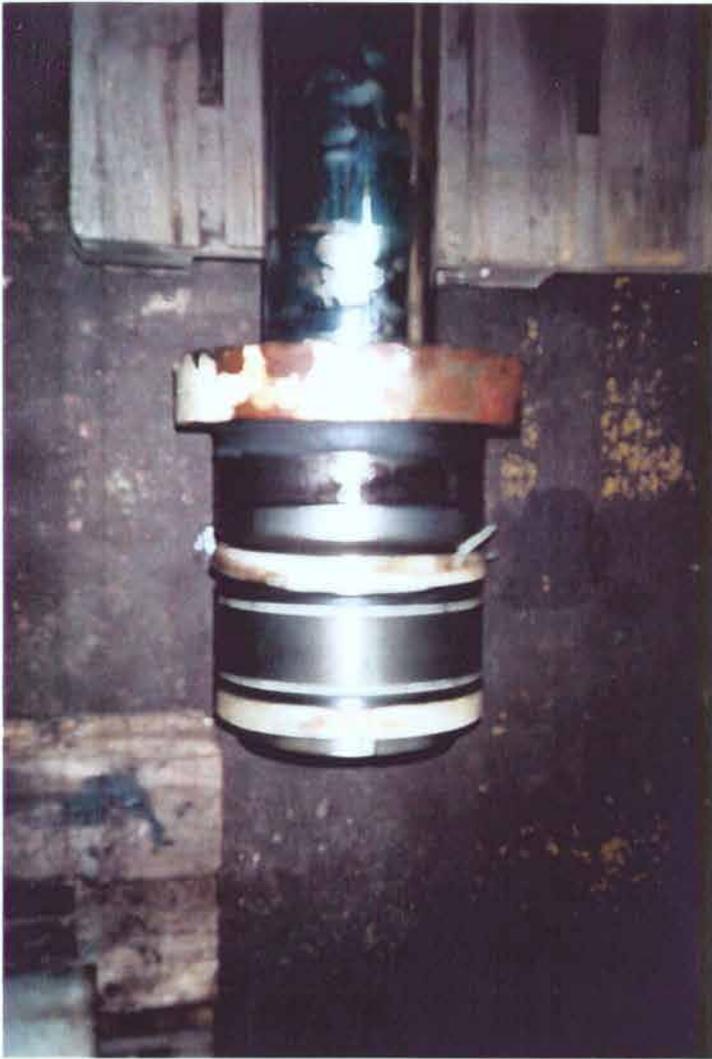
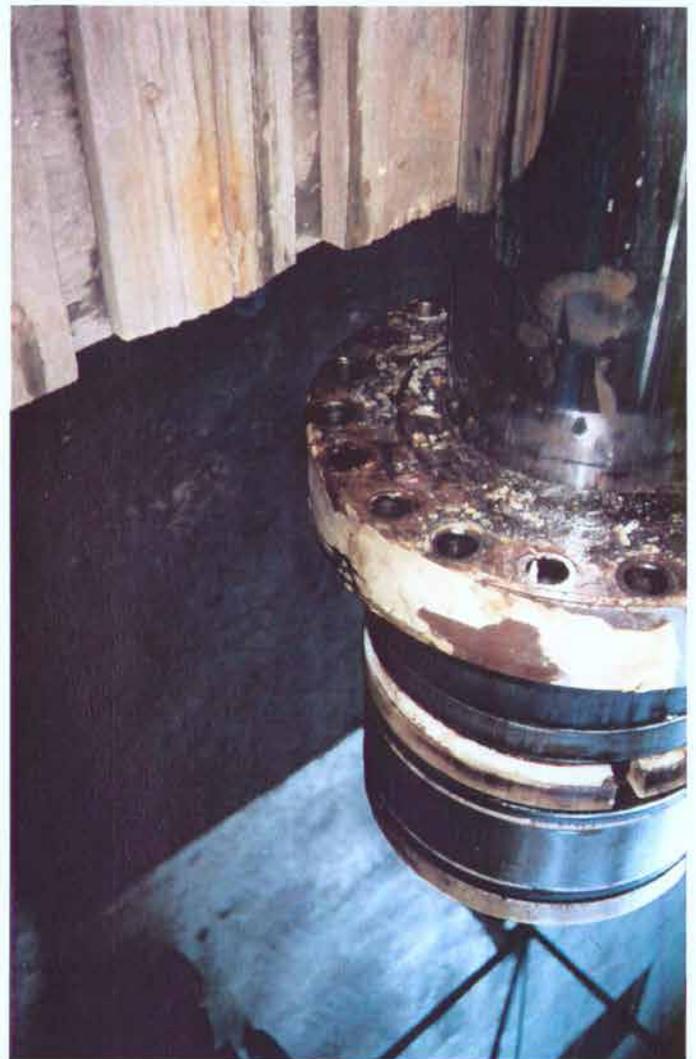
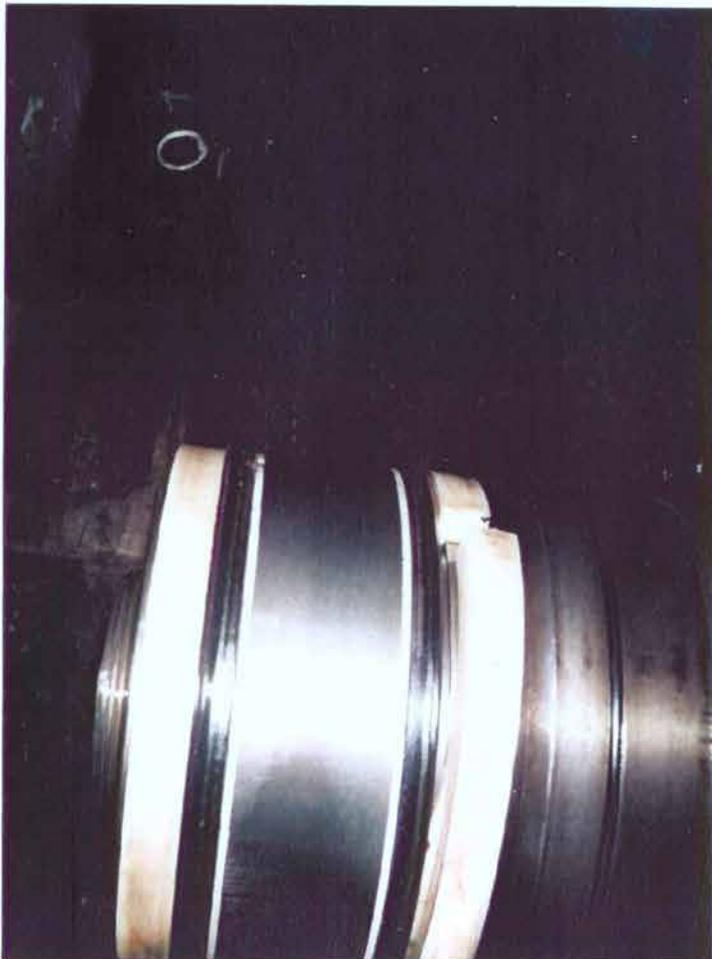
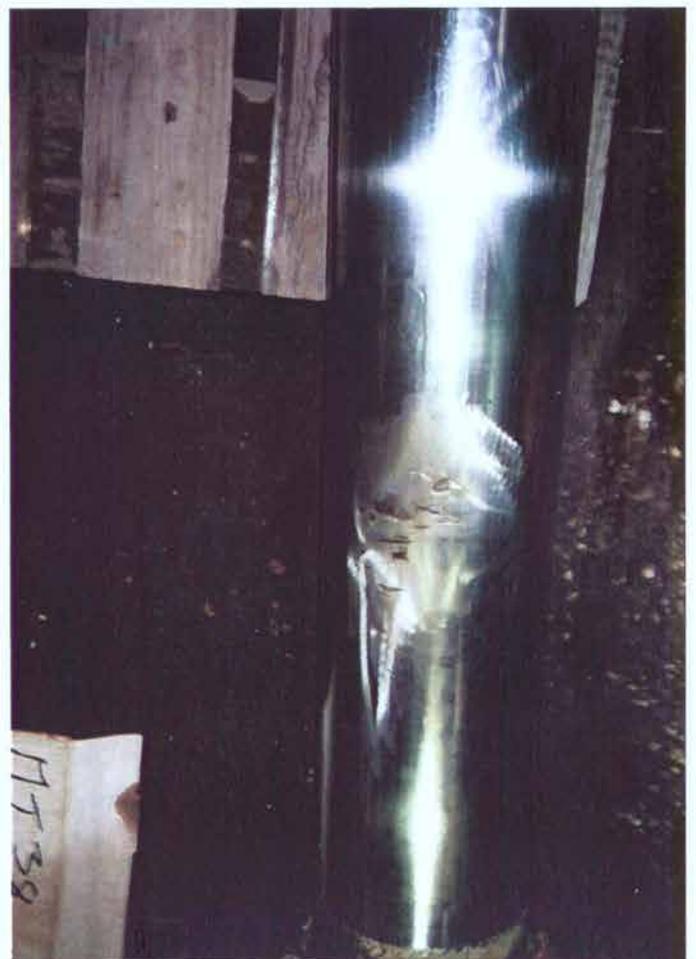
Before opening the cylinder it was pressure tested on both sides and it was noted that there was no leakage on lifting side, but the oil went thorough the piston seals from piston rod side to lifting side. The piston rod was after this pressed completely out to inspect the piston rod condition and it was noticed that there was heavy damages on at the distance when the piston rod is about 400mm open.

The damages were on side SB-side of the piston rod. it was also noticed damages on piston cover's fixing screws. The ends of these hexagon screws were like hammered.

When the am. cylinder was opened the only damage inside was that the support ring and pressure seal which keep the pressure on the piston rod side was damaged which is most probably caused by very high pressure on piston rod side.

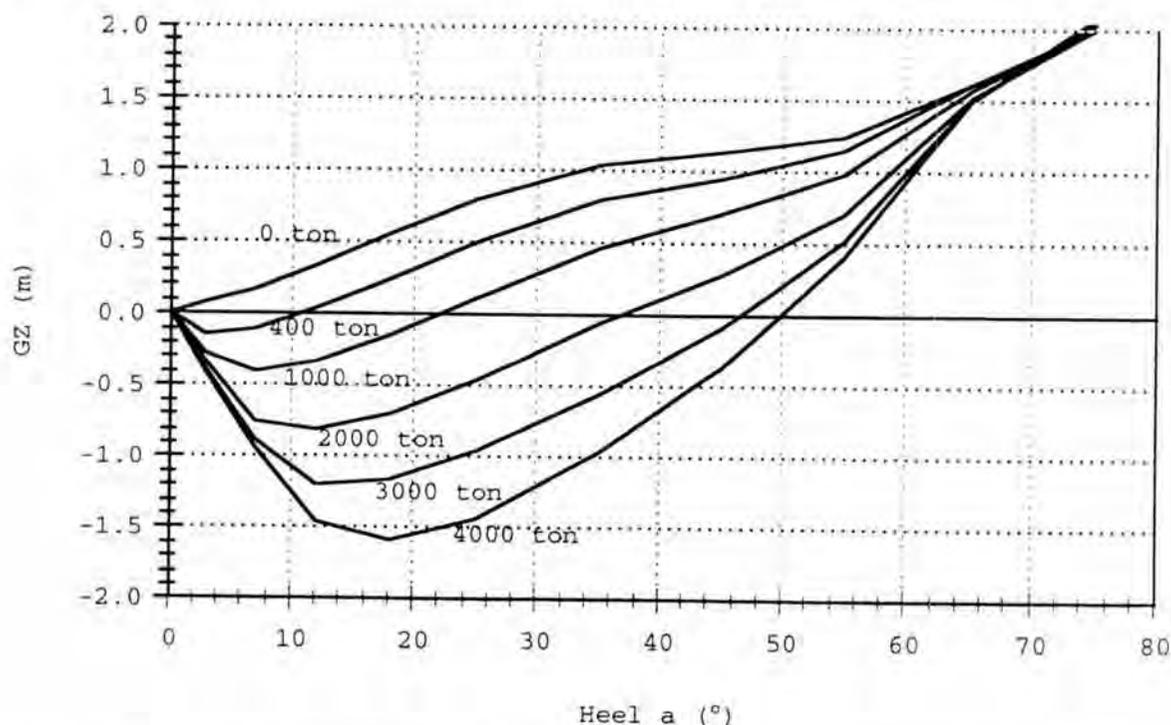
There has not been any attempt to model the flooded condition in the later stage of the capsizing. When water starts entering the C-deck (i.e. the passenger deck above car decks), the ship is predestined to sink. The stability curves show that if the decks above car deck would have been water tight, the ship would probably have continued to float with a heel angle less than 50° at least for a significant period of time.

Figure 2.2 Static stability curves for different amount of water on A-deck. Volume permeability of A deck 0.90. C-deck and above intact.

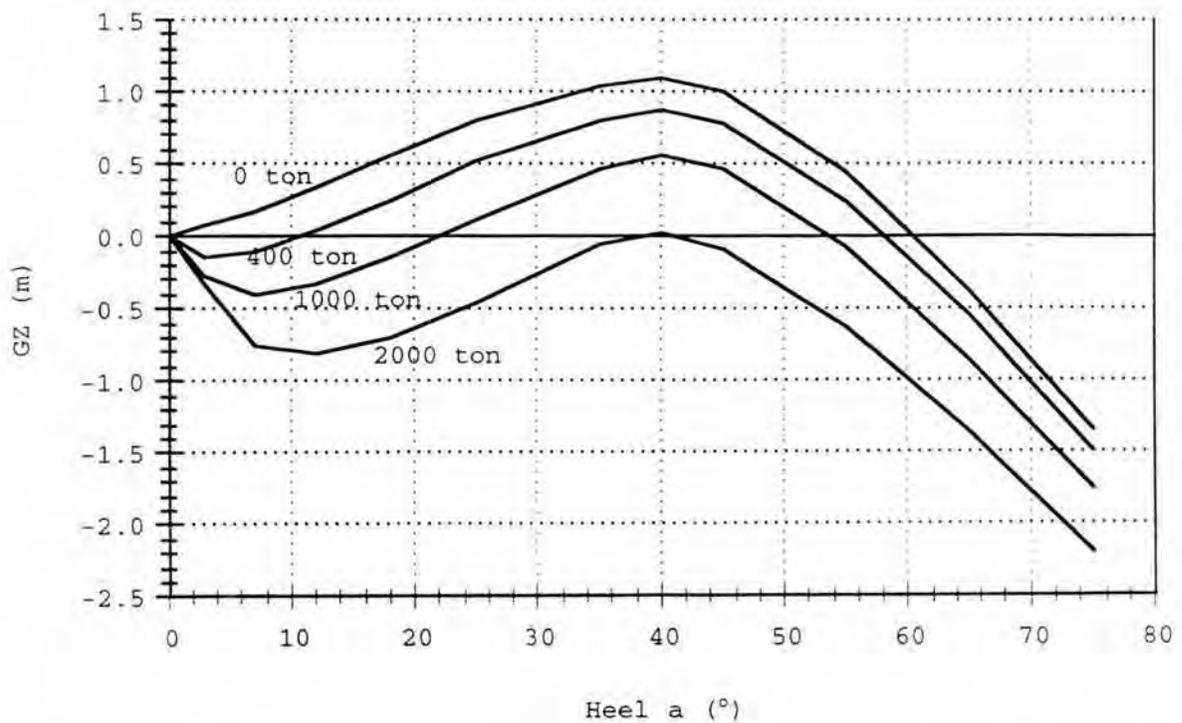
Figure 2.3 Static stability curves for different amount of water on A-deck.
Volume permeability of A deck 0.9.
C-deck and above open to free flooding (permeability 1.0).

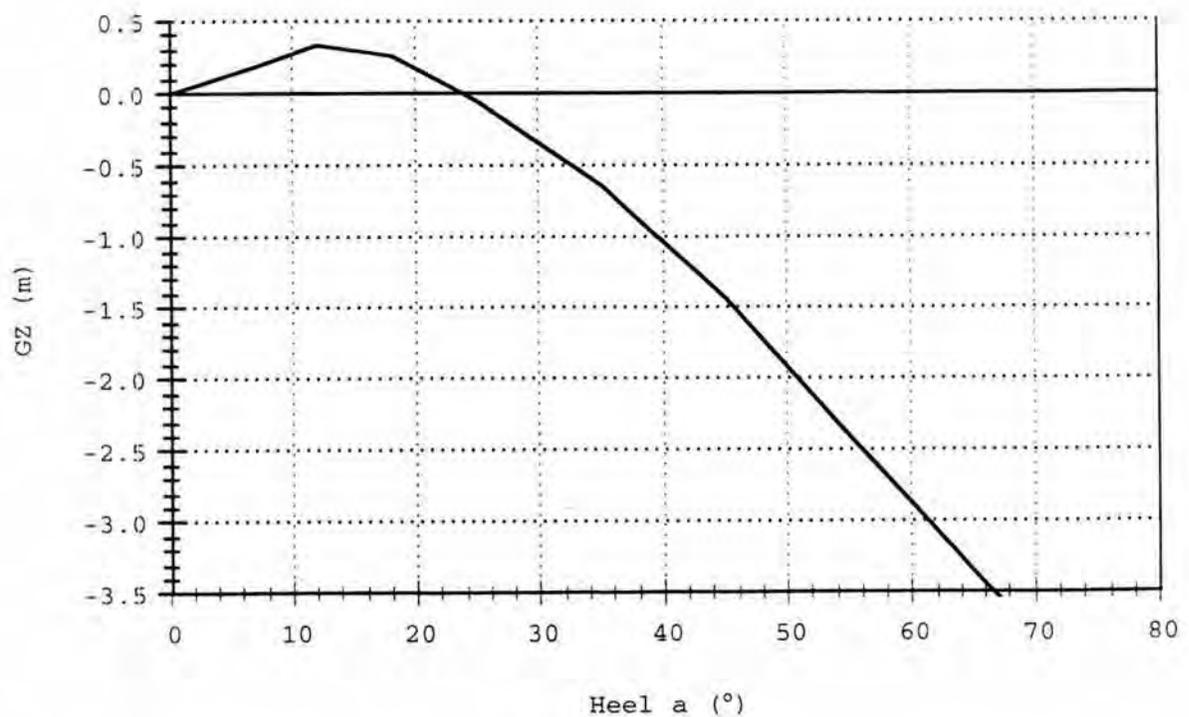
Figure 2.4 Static stability curves for A-deck and above open to free flooding.

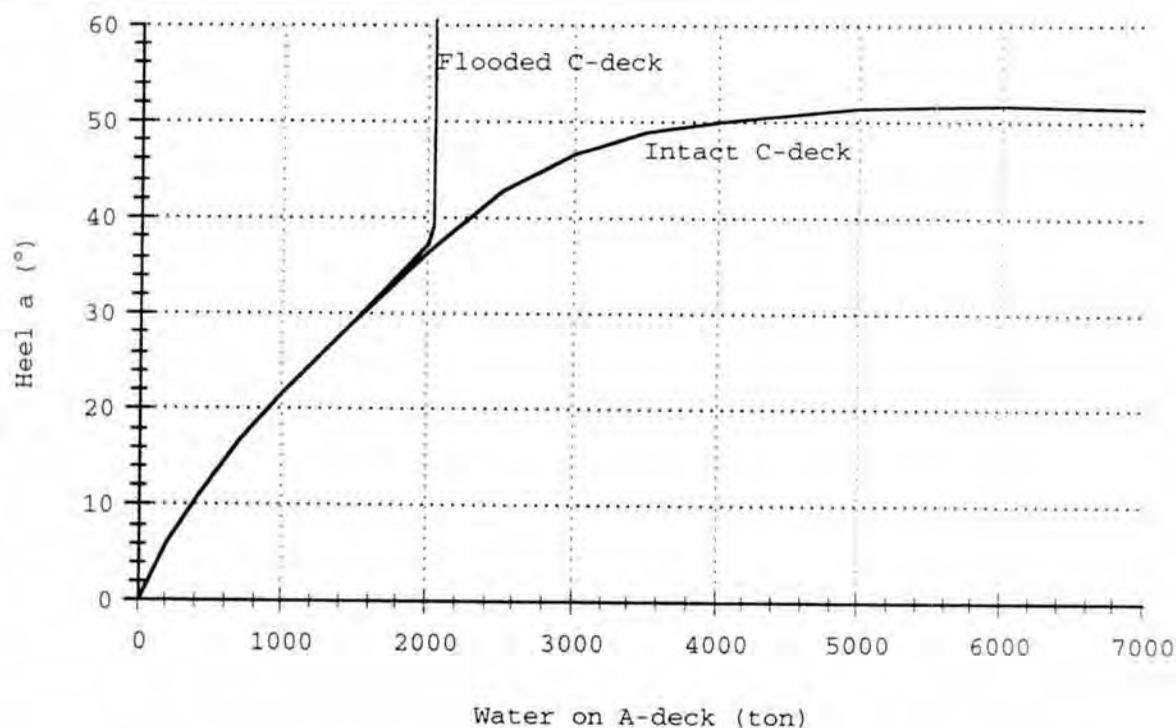
As is well known, a ship like the ESTONIA with a fully open vehicle deck is extremely sensitive to ingress of water. A relative small amount of water like 1000 ton (0.3 m water on the deck) will result in a heel angle of over 20°. Such a large heel will cause severe damage to the interior of the public areas, significant shift of vehicles and cargo, and presumably panic among the passengers. However, the water on the car deck is in itself not sufficient to make the ship capsize as long as the hull is intact below and above the open deck. The capsizing is fulfilled only when water starts entering other areas of the ship. According to the hydrostatic calculations, this condition appears when 1500-2000 ton has entered the A-deck and the heel angle is in the range of 35°-40°. Apparently there have also been some water leaking down through the centre casing doors before the flooding of upper decks. However, this is believed to have had no significant effect on the stability or heeling of the vessel.

Figure 2.5 Heel angle at static equilibrium as function of water on A-deck

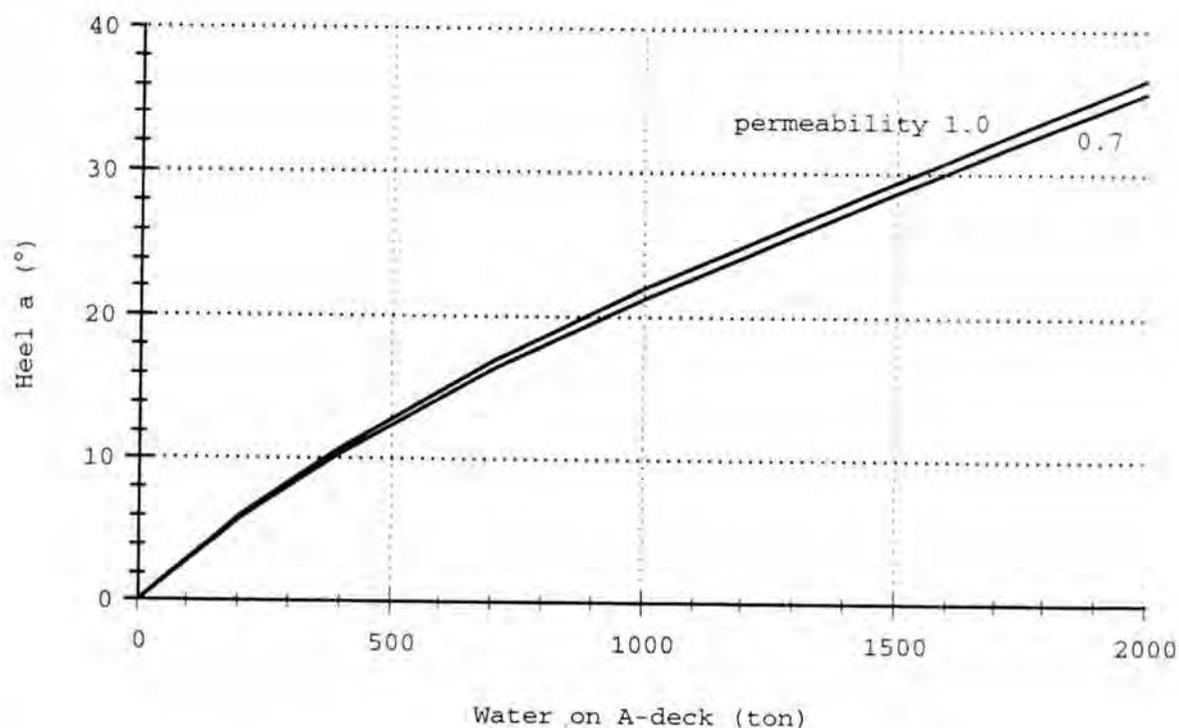
The filling rate or permeability of the cargo space will also have some effect on the stability characteristics during flooding. An assumed low permeability will result in lower heeling moments but at the same time in higher centre of gravity of the water. These two effects work contradictory, and the combined effect is very small. Figure 2.9 shows the effect of permeability on the static equilibrium heel angle. In all the previous figures, the permeability of car deck is assumed to be 0.9 and of the accommodation area 1.0.

Figure 2.9 Heel angle at static equilibrium as function of water on A-deck. Effect of different assumptions of volume permeability

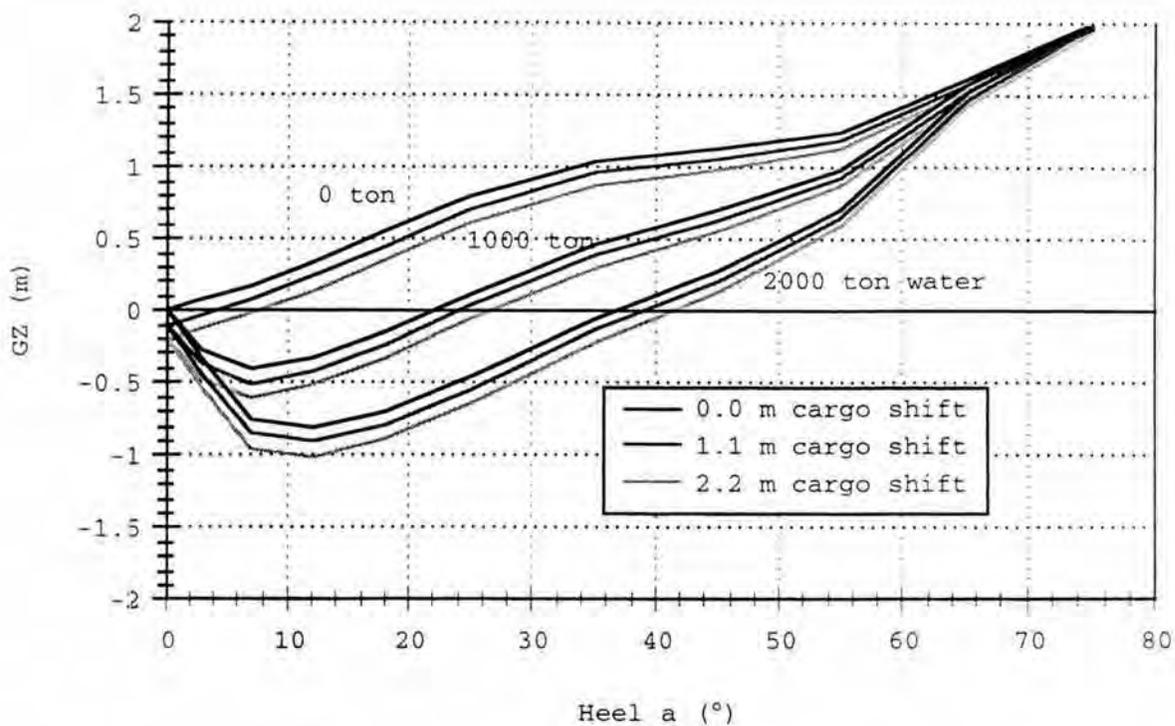
It is very difficult to ascertain how shifting of vehicles and cargo on car deck developed during the water inflow. The weight of all vehicles have been estimated to about 1070 ton in total. The maximum transverse shift is of the order of one or a few meter. Every 1.1 m of cargo shift would have the effect of 0.1 m shift of the ships total centre of gravity. The resulting effect on the static stability curves is illustrated in Figures 2.10 and 2.11 for intact C-deck and open C-deck respectively.

Figure 2.10 Effect of cargo shifting on static stability curves. C-deck and above intact.

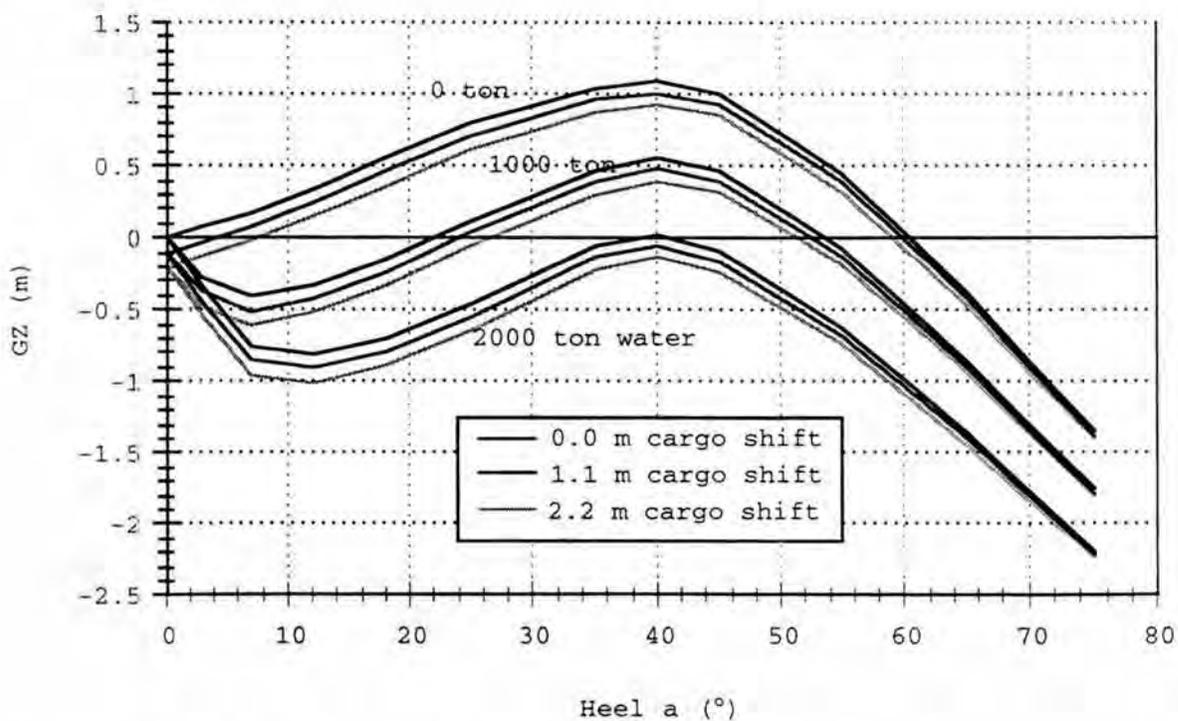
Figure 2.11 Effect of cargo shifting on static stability curves. C-deck and above open to free flooding.

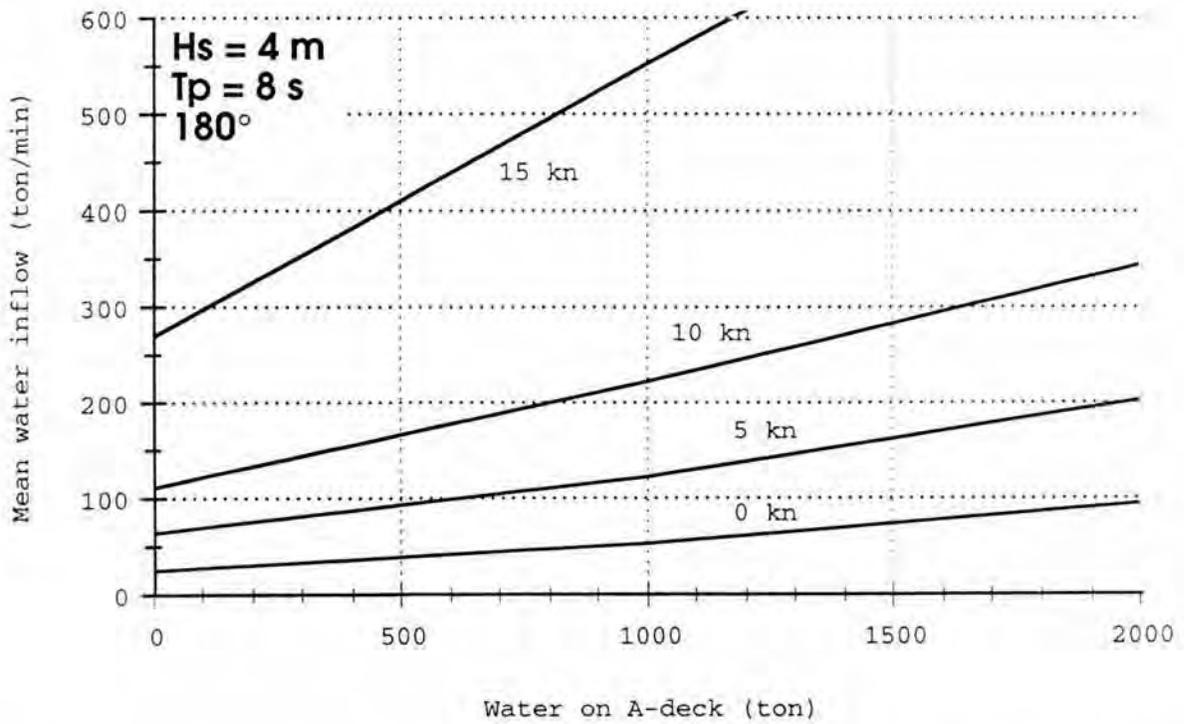
Figure 4.2 Mean water inflow as function of speed and amount of water on A-deck. Head sea 180°

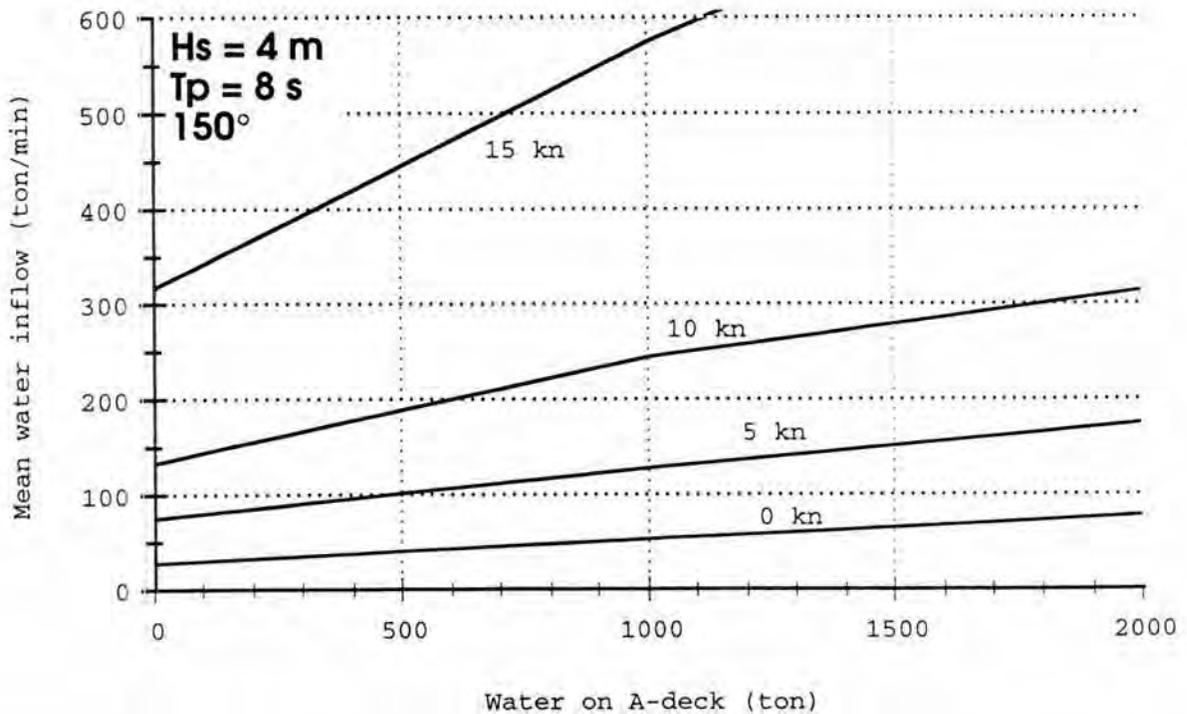
Figure 4.3 Mean water inflow as function of speed and amount of water on A-deck. Bow sea 150°

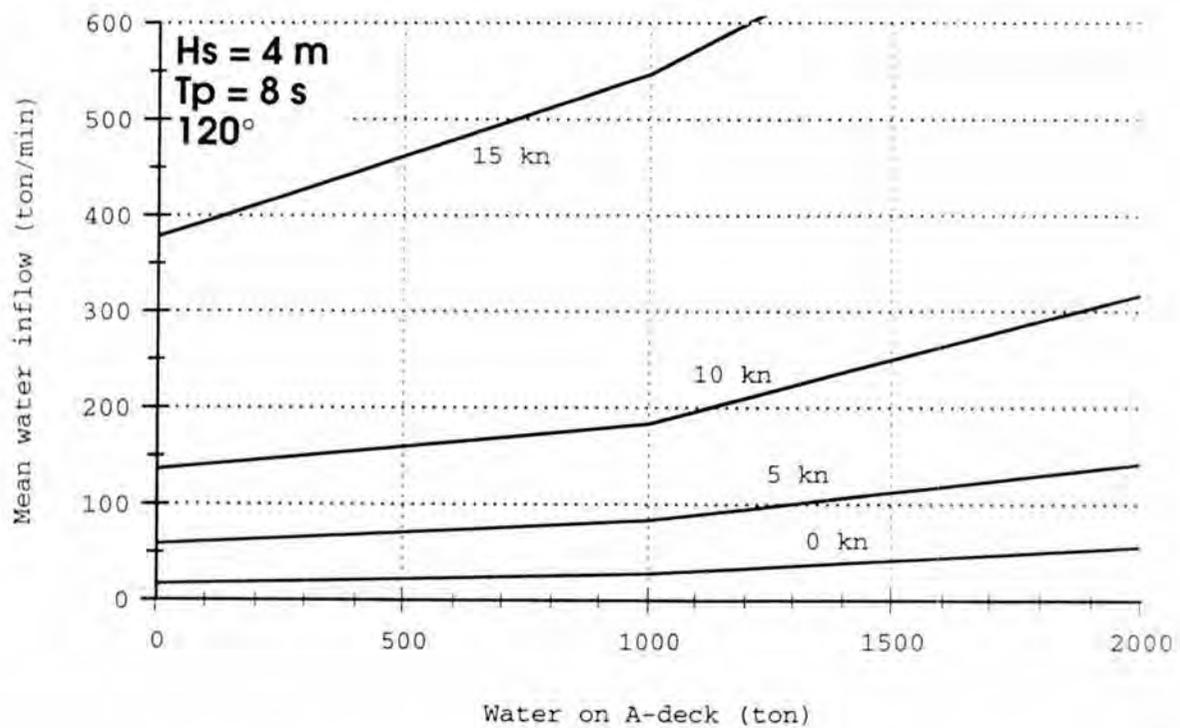
Figure 4.4 Mean water inflow as function of speed and amount of water on A-deck. Bow sea 120°
