THE FINAL REPORT ON THE CAPSIZING ON 28
SEPTEMBER 1994 IN THE BALTIC SEA OF THE
RO-RO PASSENGER VESSEL MV ESTONIA

The Joint Accident Investigation Commission
of
Estonia, Finland and Sweden

SUPPLEMENT

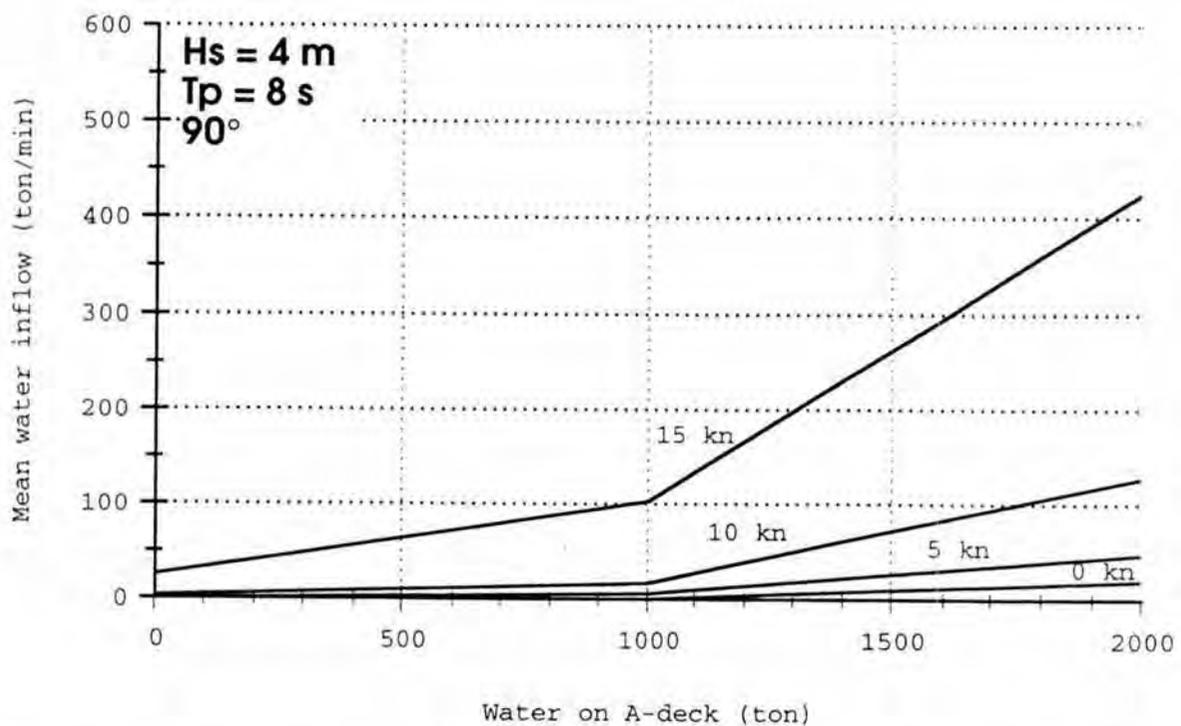
Figure 4.5 Mean water inflow as function of speed and amount of water on A-deck. Beam sea 90°

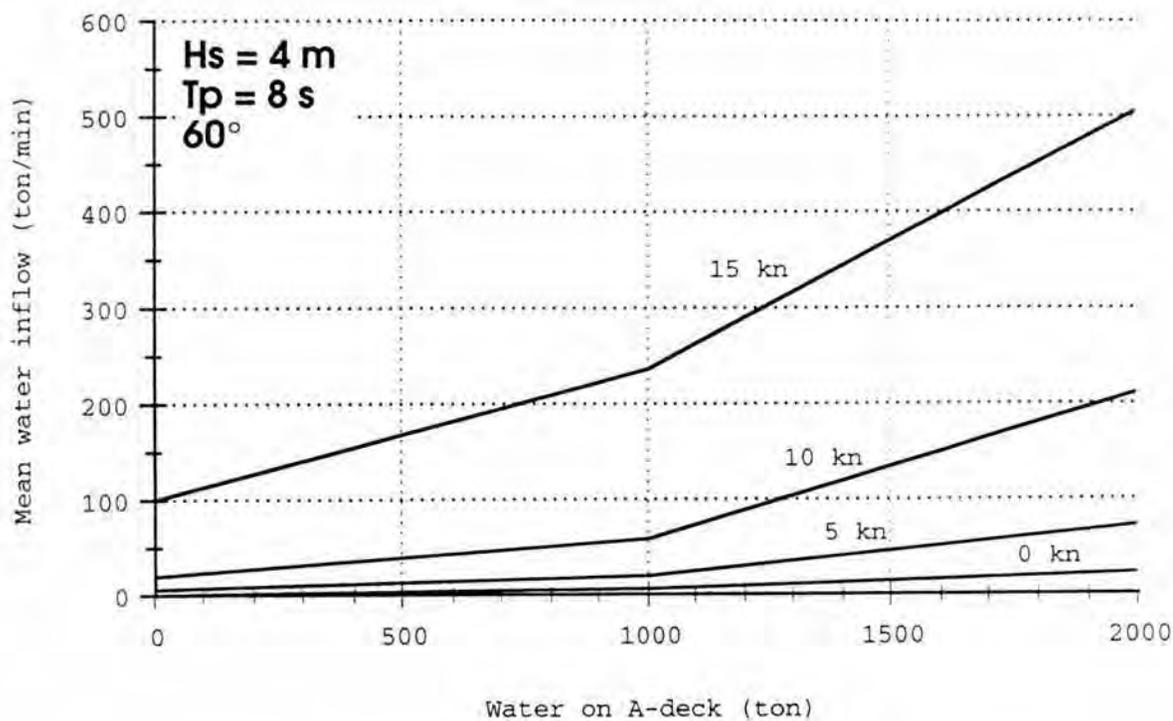
Figure 4.6 Mean water inflow as function of speed and amount of water on A-deck. Quarter sea 60°

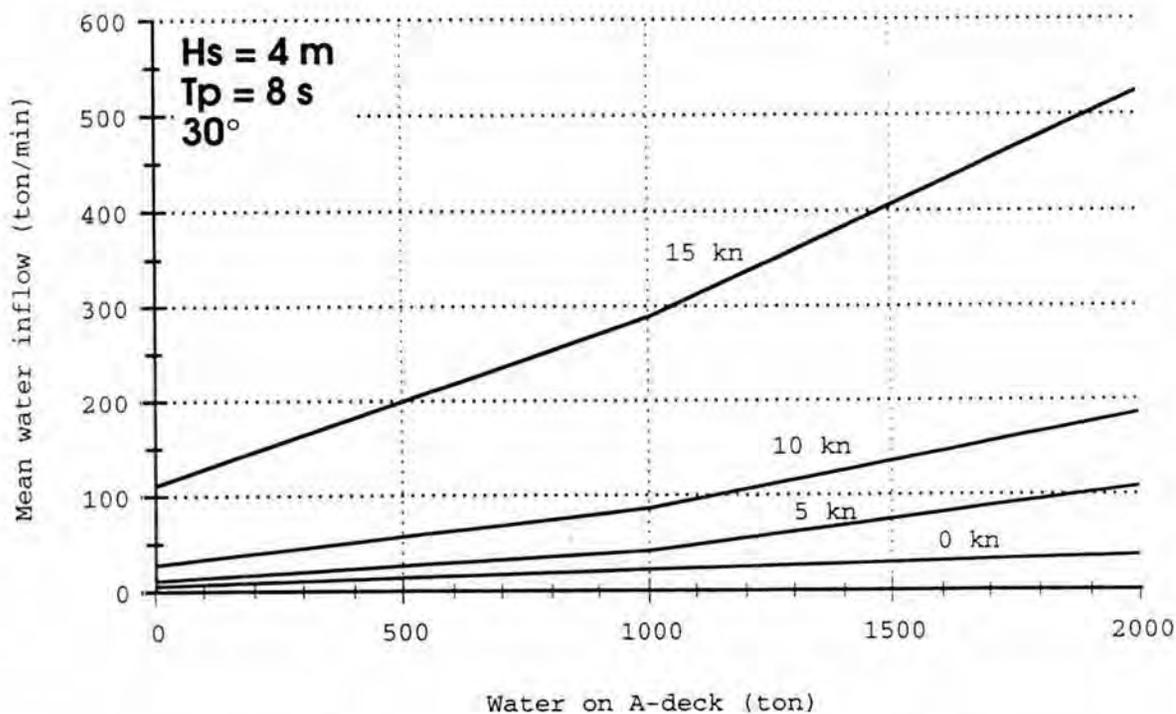
Figure 4.7 Mean water inflow as function of speed and amount of water on A-deck. Quarter sea 30°

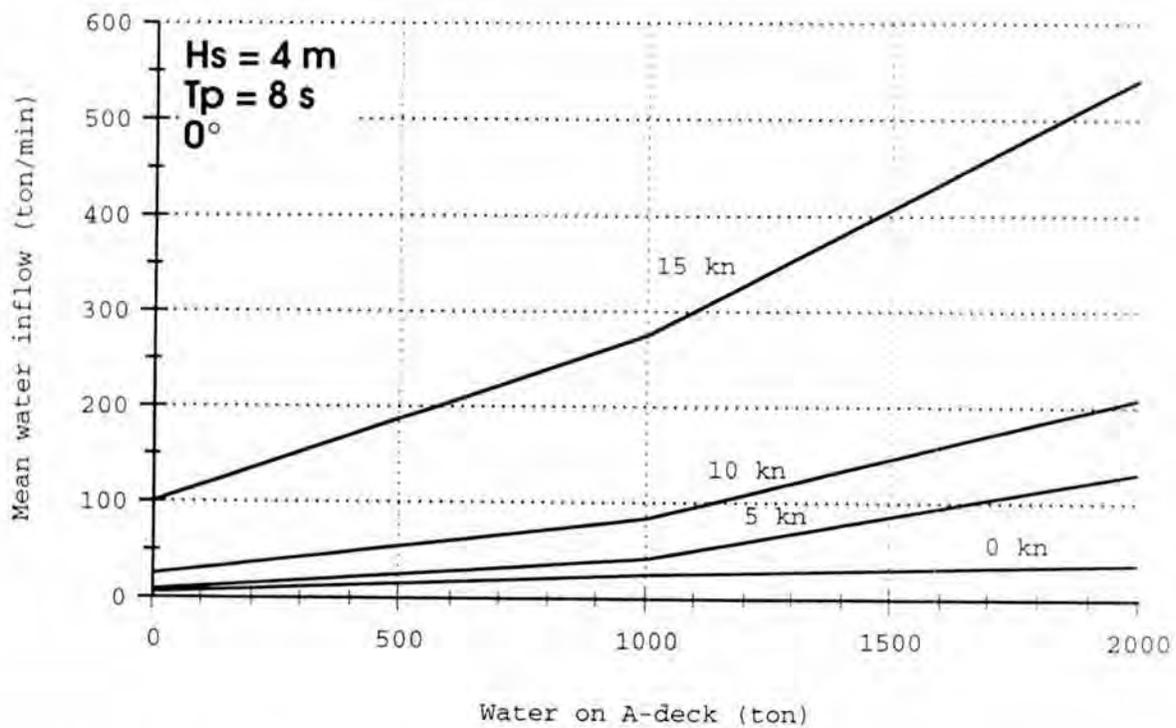
Figure 4.8 Mean water inflow as function of speed and amount of water on A-deck. Following sea 0°

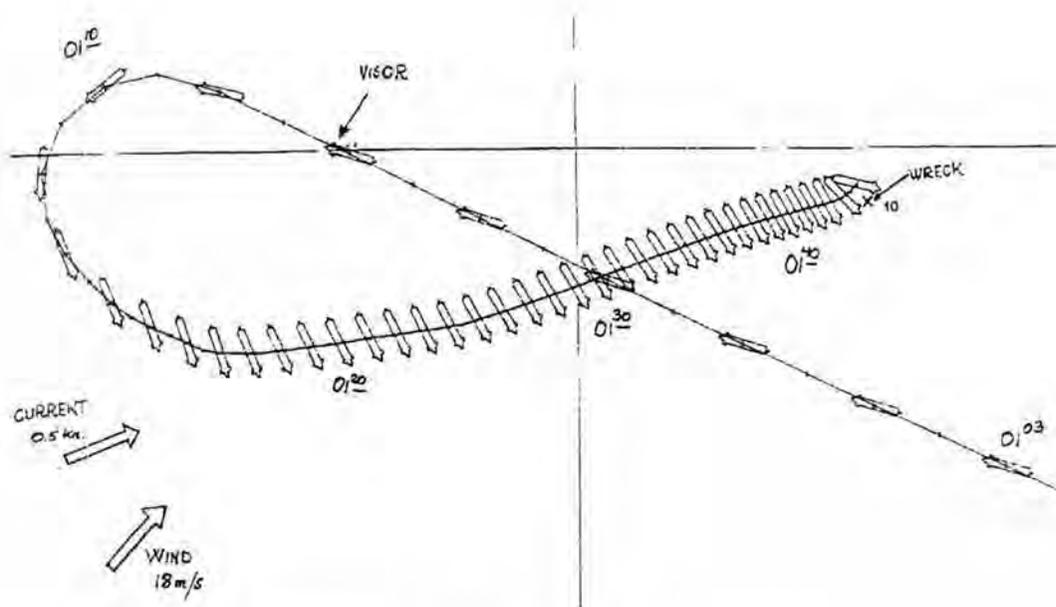
Figure 4.9 Plot of simulated track of the ESTONIA, Example 1.

Table 4.2 shows the different conditions used as base for the inflow simulation. The time, speed and heading fits approximately the sequence shown in Figure 4.9.

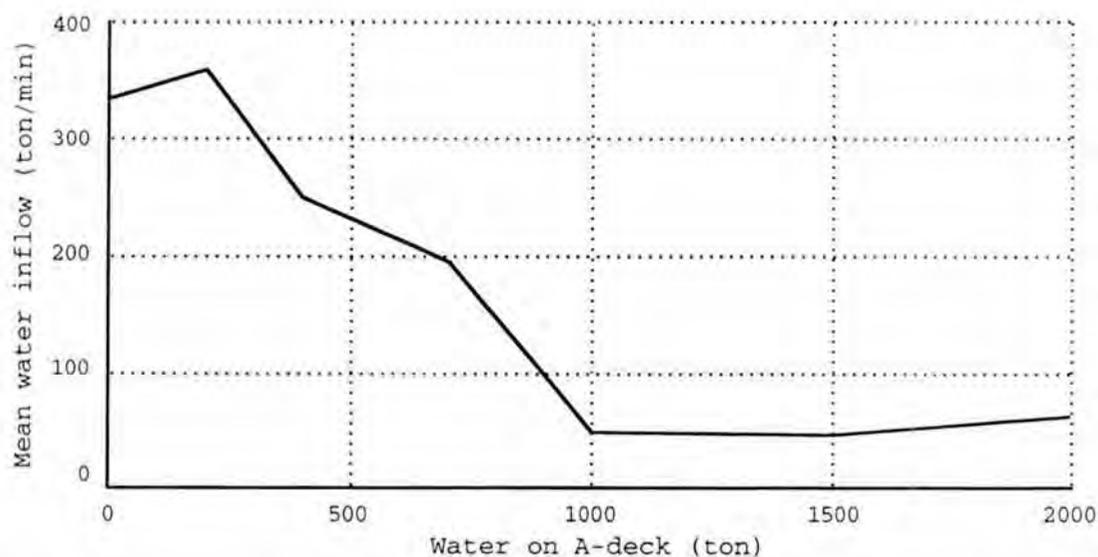
The result in terms of mean water inflow rate, accumulated water on A-deck and time is shown in Figures 4.10-4.11. According to this simulation it would have taken about a quarter of an hour from the first water ingress until larger amount of water started to enter the decks above car deck.

Figure 4.10 Mean water inflow per minute in simulation example 1.

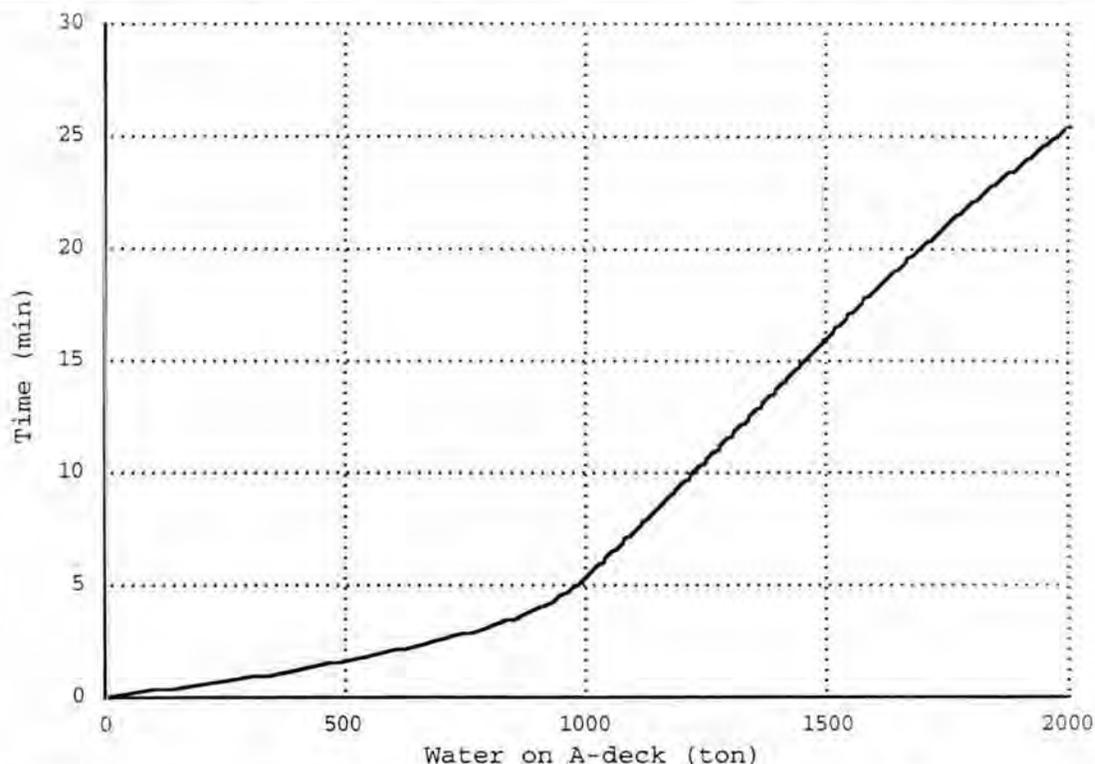
Figure 4.11 Time sequence of water inflow in simulation example 1.

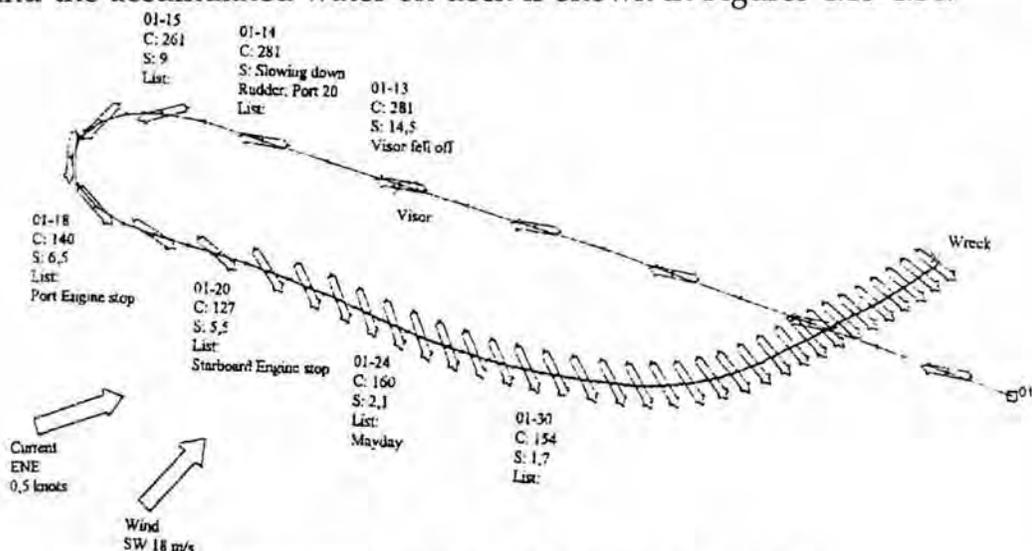
Figure 4.12 Plot of simulated track of the ESTONIA, Example 2.

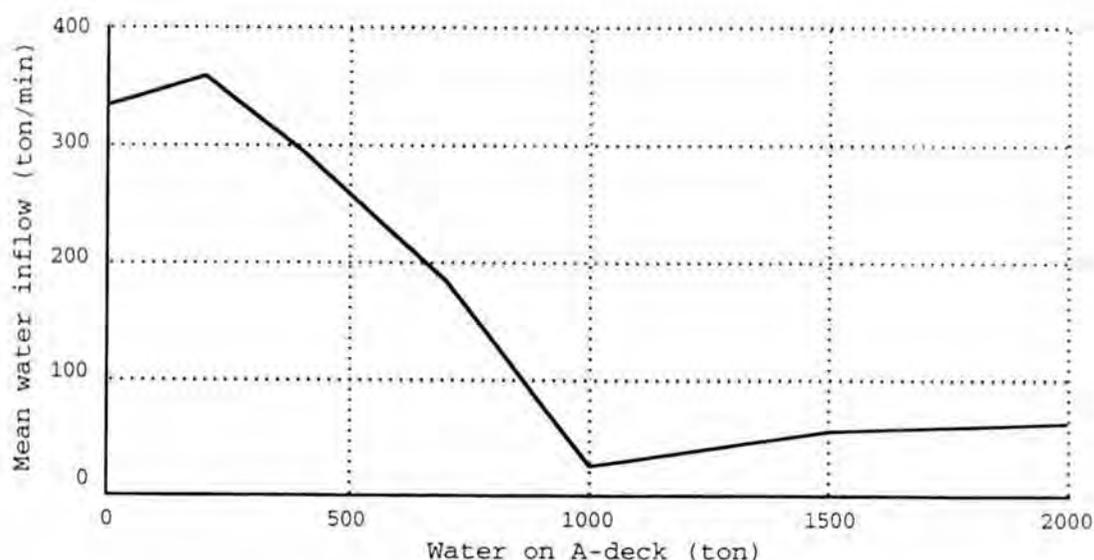
Figure 4.13 Mean water inflow per minute in simulation example 2.

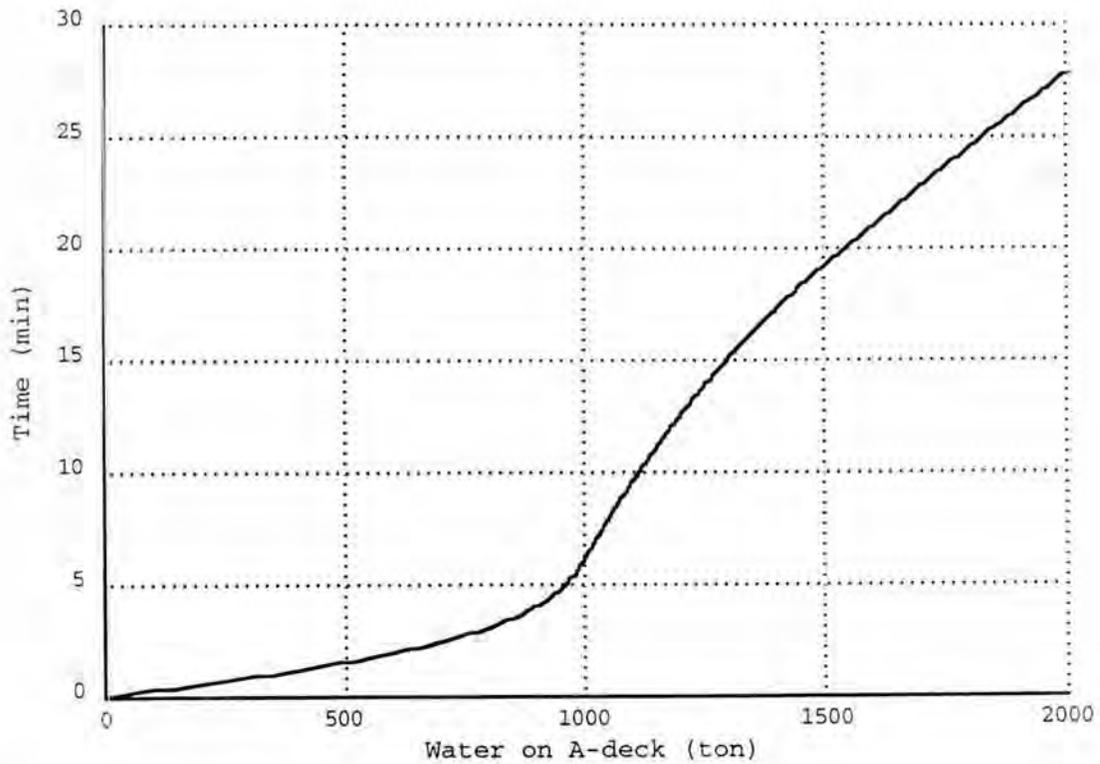
Figure 4.14 shows that in this simulation the water inflow is slightly larger in the beginning of the sequence but significantly less 6-9 min after the ramp is opened. During this period the ship has completed the port turn and is running at 6 knots with close to beam seas. Such a plateau in the development of the list is also reported by witnesses but is stated to have occurred at a list of about 30°. If the ship in this simulation example had continued for about one more minute in bow or head sea, then the results would have fit these statements quite well, both with regard to the timing and to the development of the list.

Figure 4.14 Time sequence of water inflow in simulation example 2.

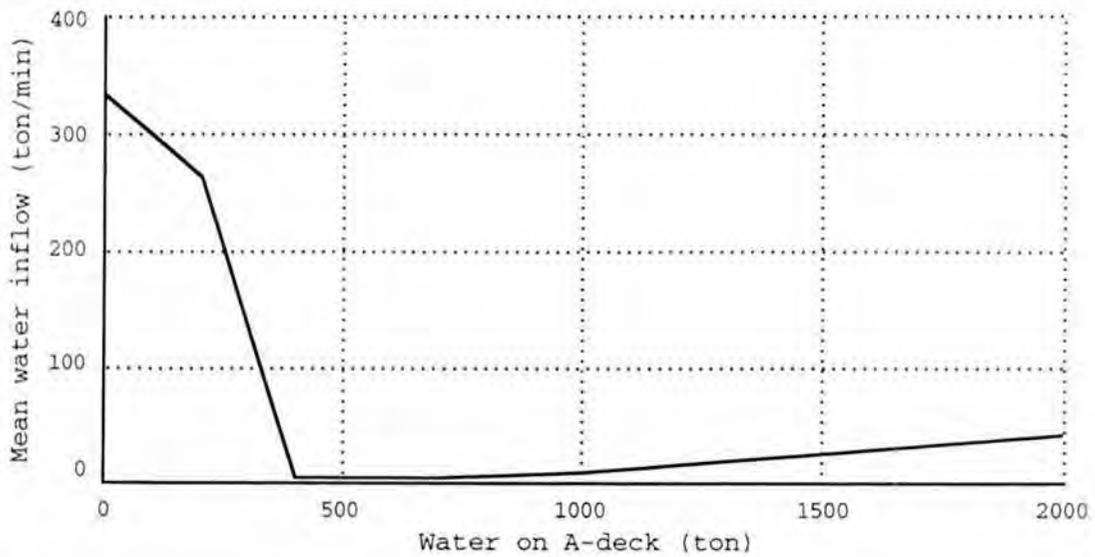
Figure 4.15 Mean water inflow per minute in hypothetical simulation example 3.

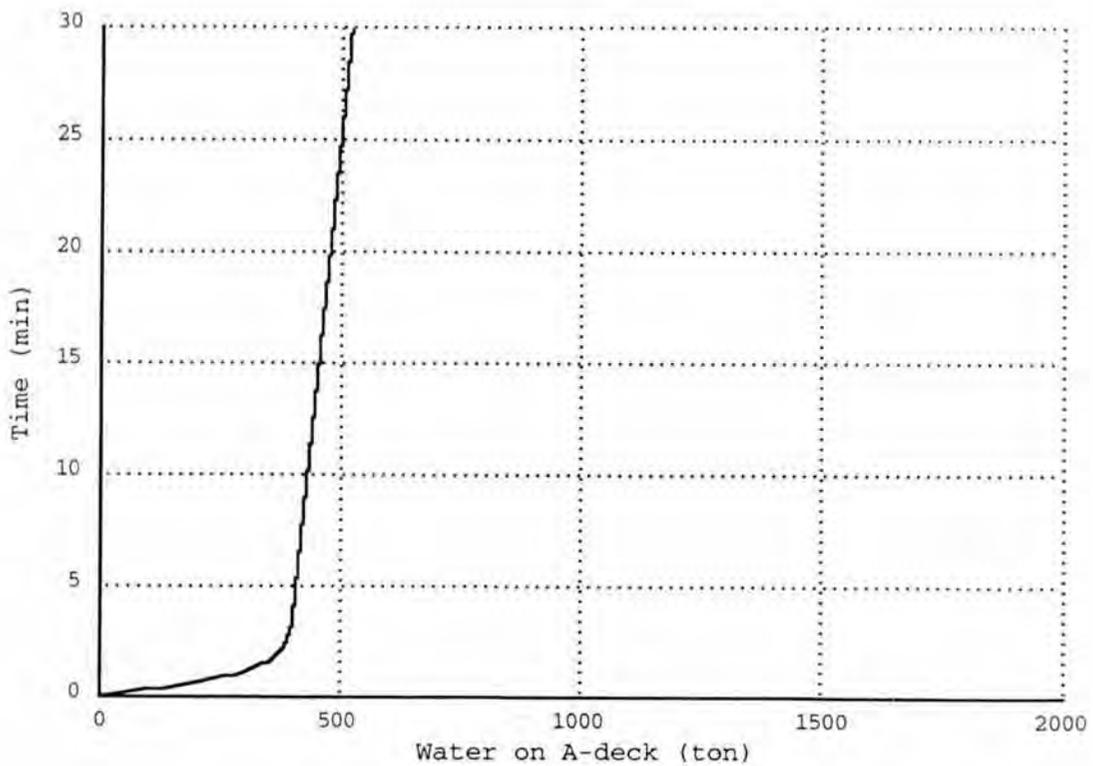
Figure 4.16 Time sequence of water inflow in hypothetical simulation example 3.

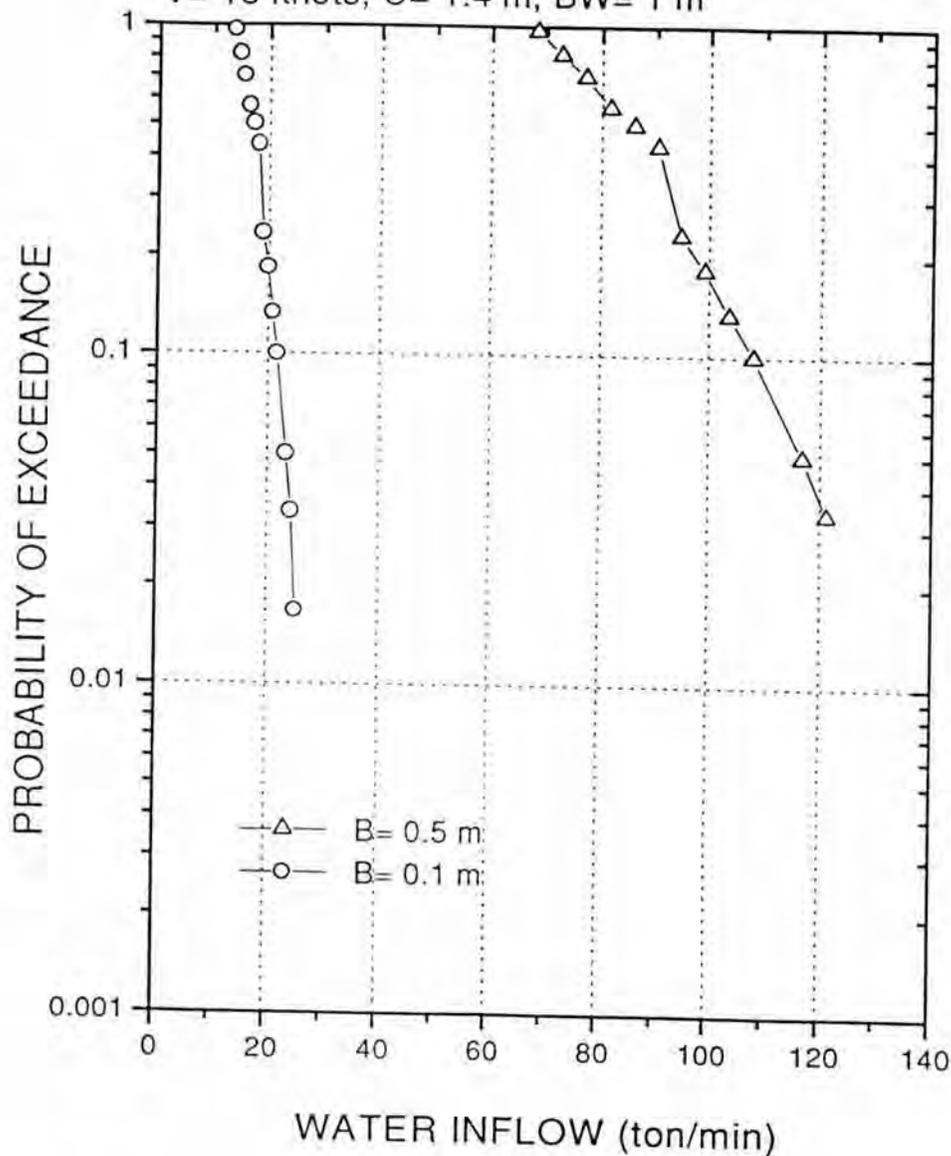
Fig. 2. Water inflow to the car deck in the bow oblique seas with $H_s = 4.0\text{ m}$

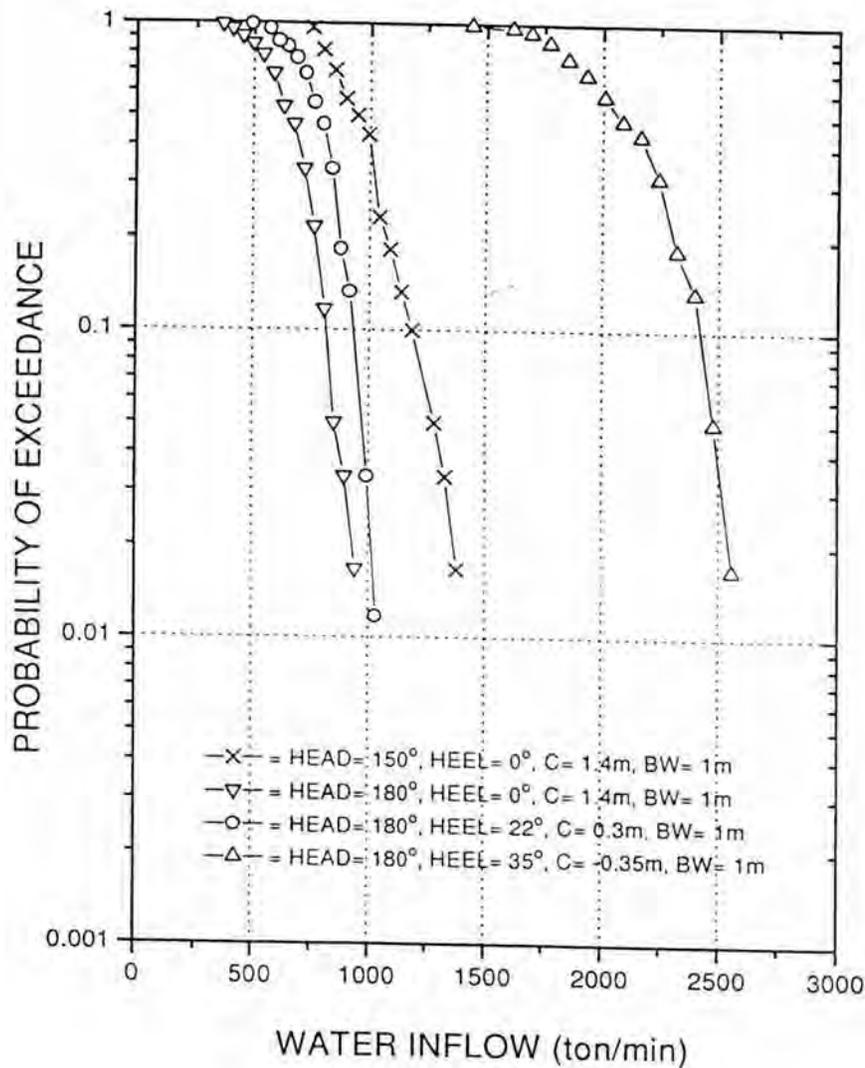
Fig. 3. Water inflow to the car deck in the oblique and head seas

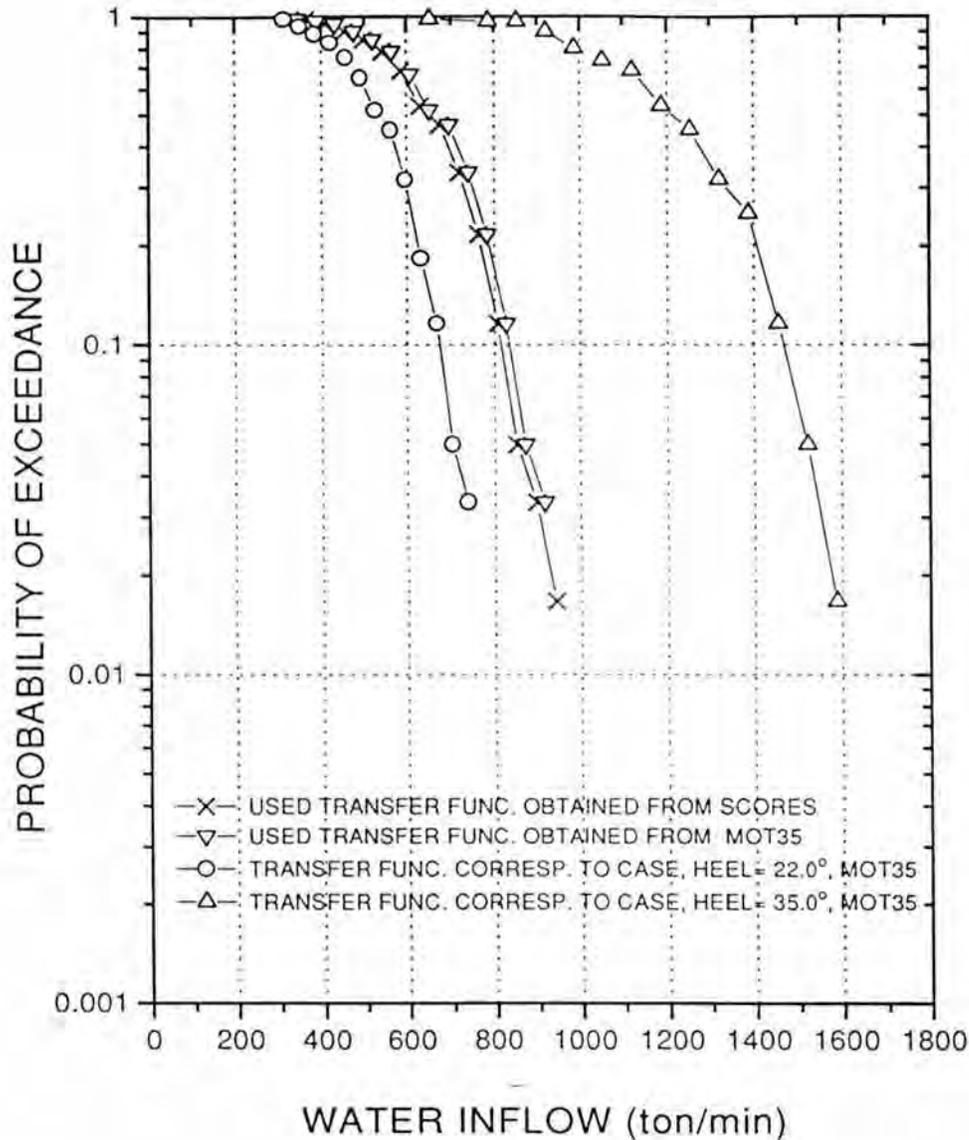
Fig. 4. Water inflow to the car deck calculated with different kinds of the transfer functions.

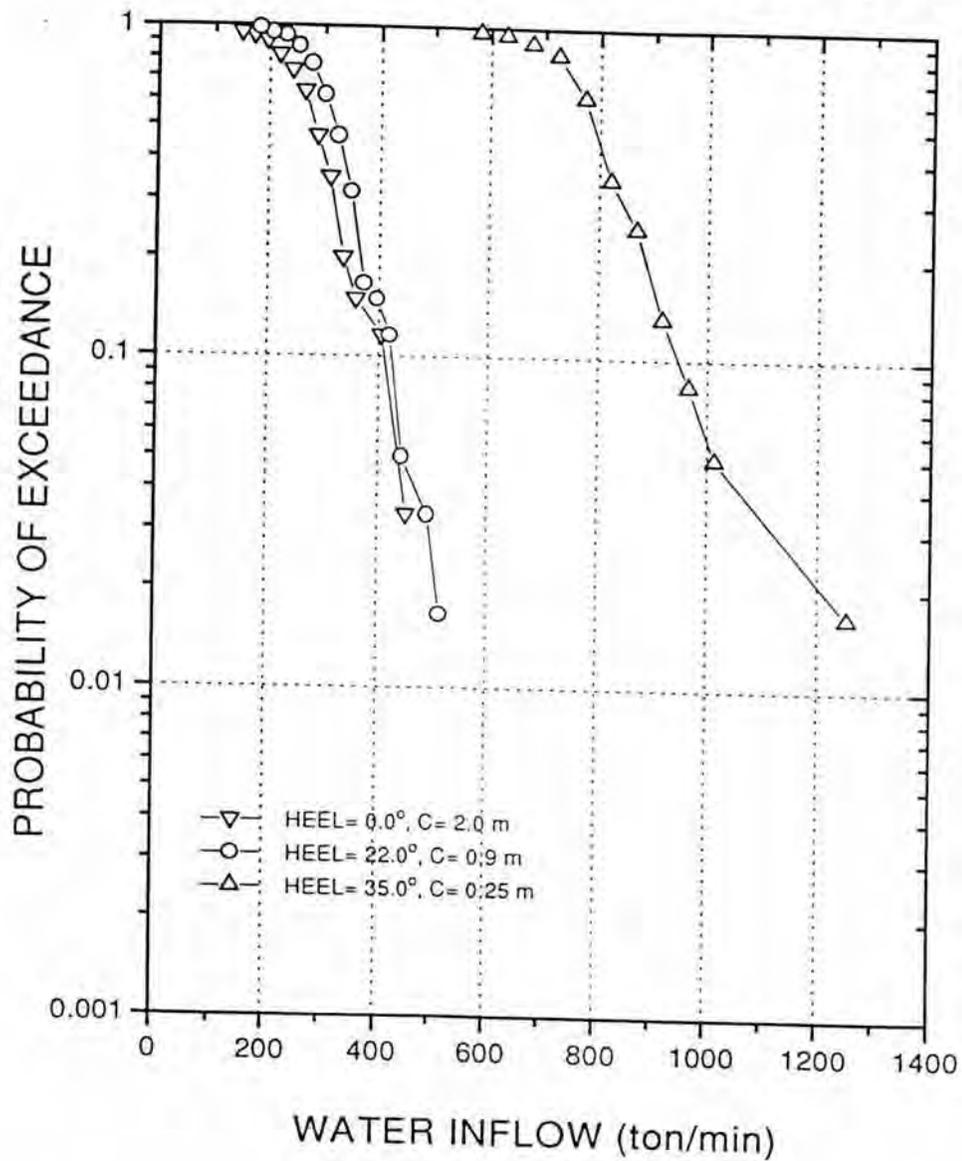
Fig. 5. Water inflow to the car deck in the head seas

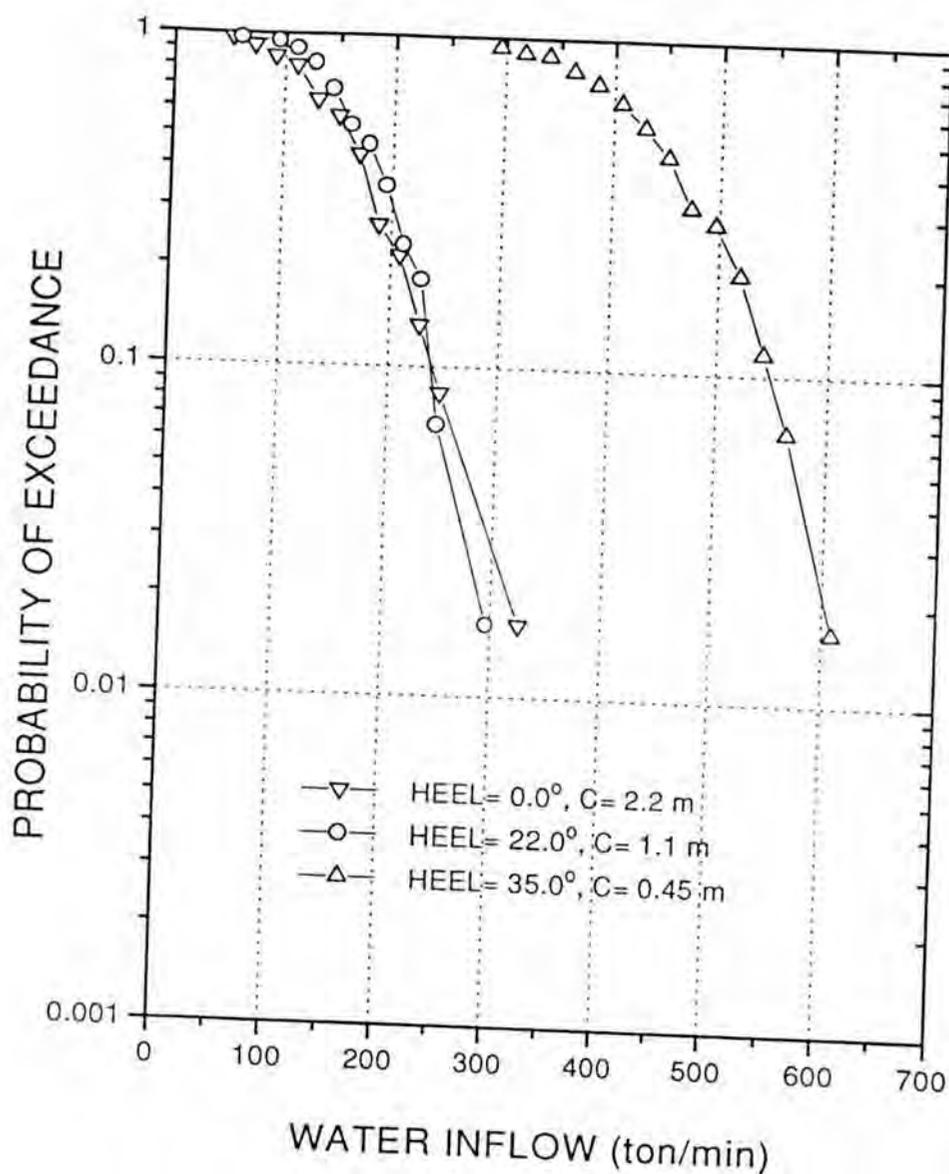
Fig. 6. Water inflow to the car deck in the head seas

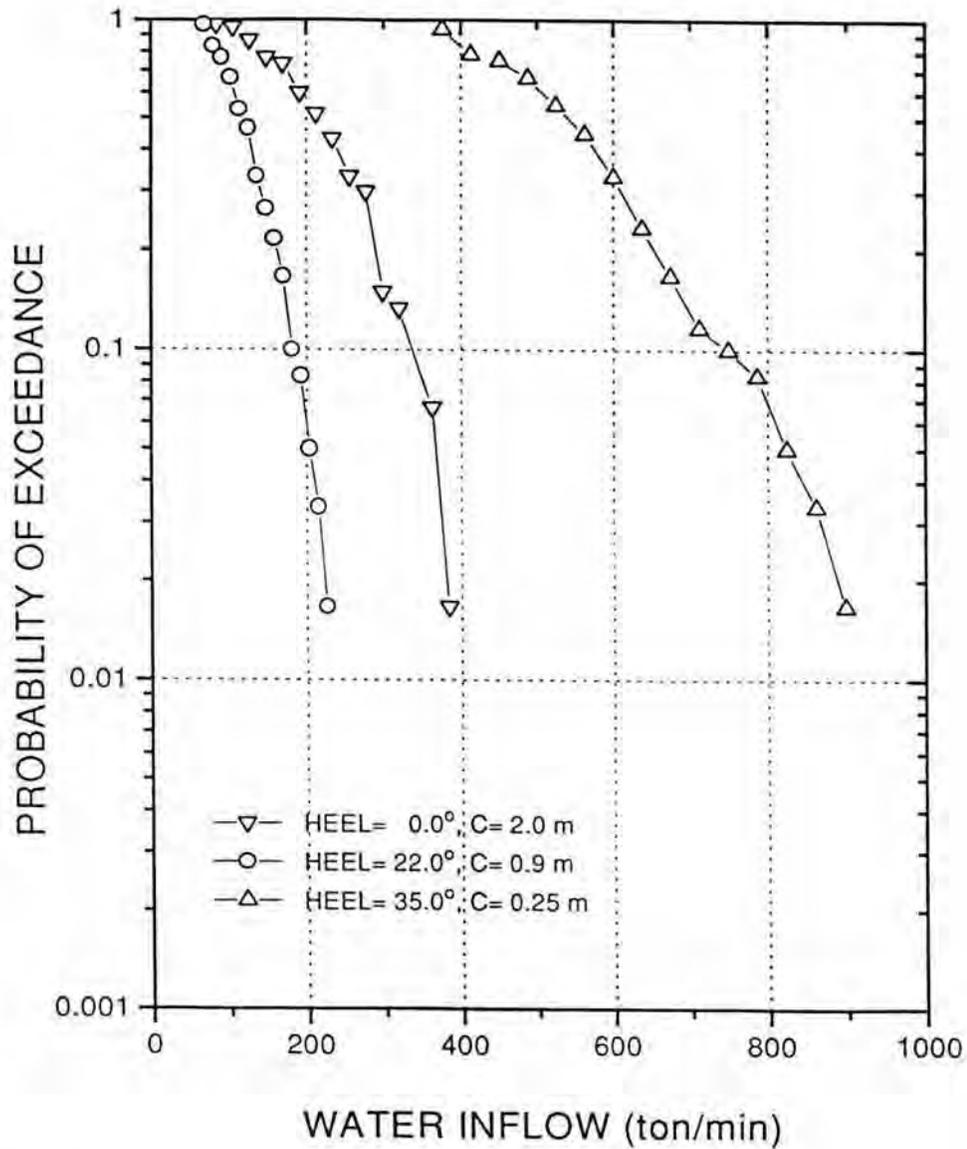
Fig. 7. Water inflow to the car deck in the beam seas

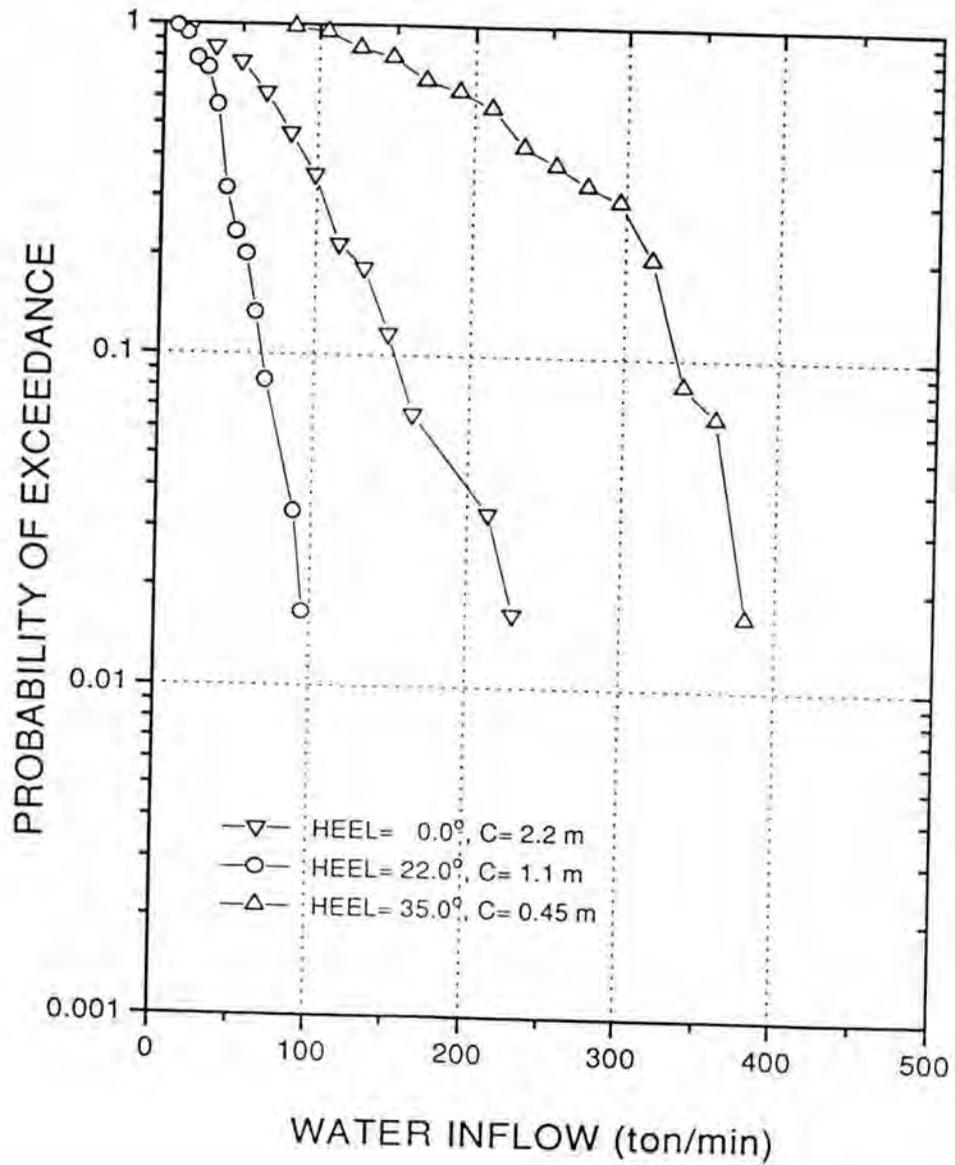
Fig. 8. Water inflow to the car deck in the beam seas

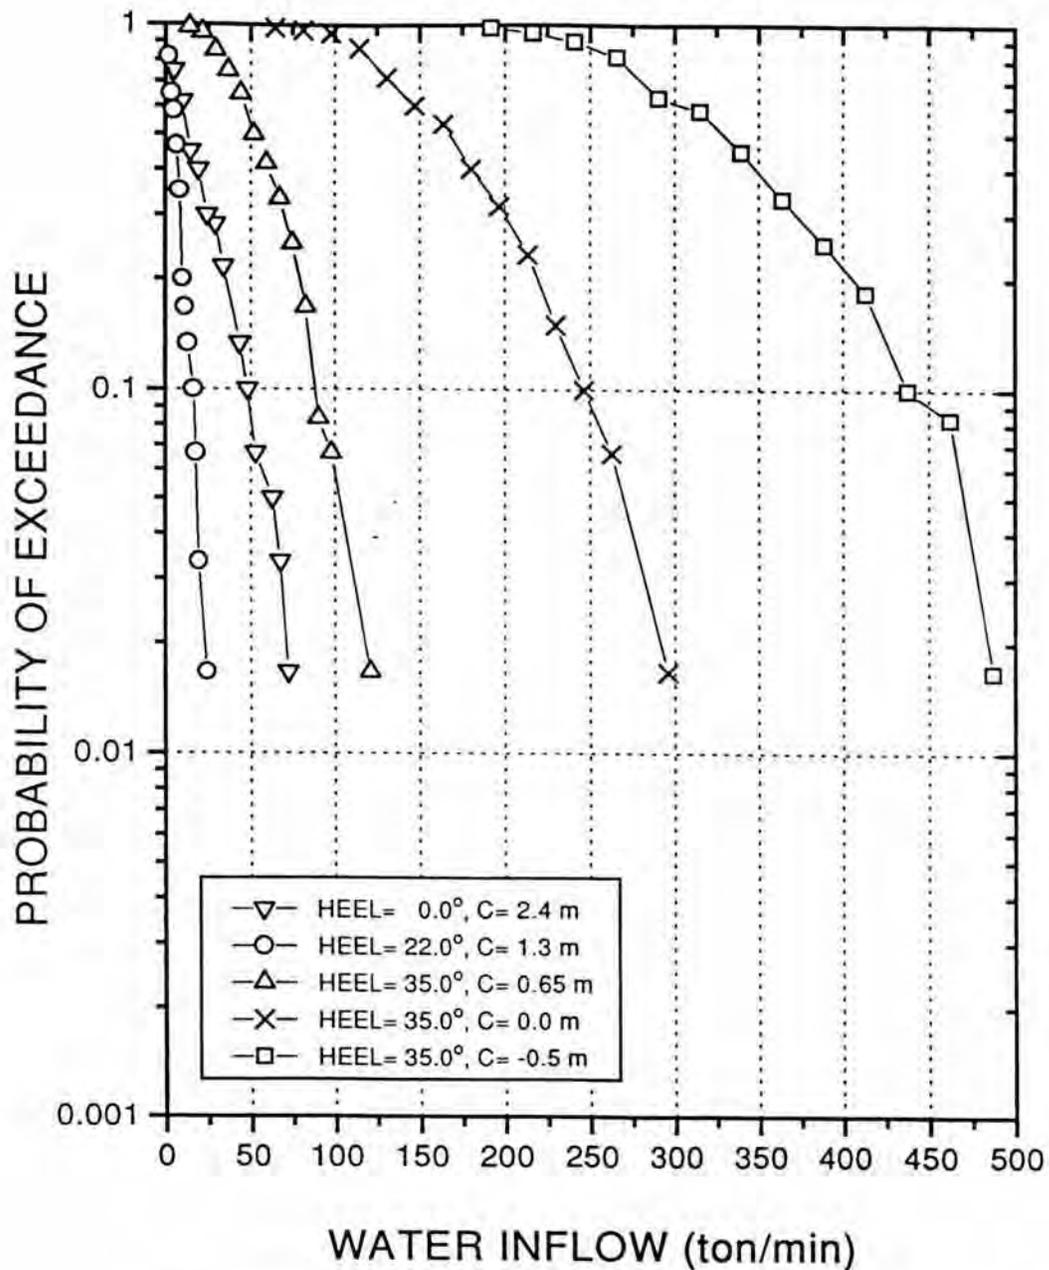
Fig. 9. Water inflow to the car deck in the beam seas

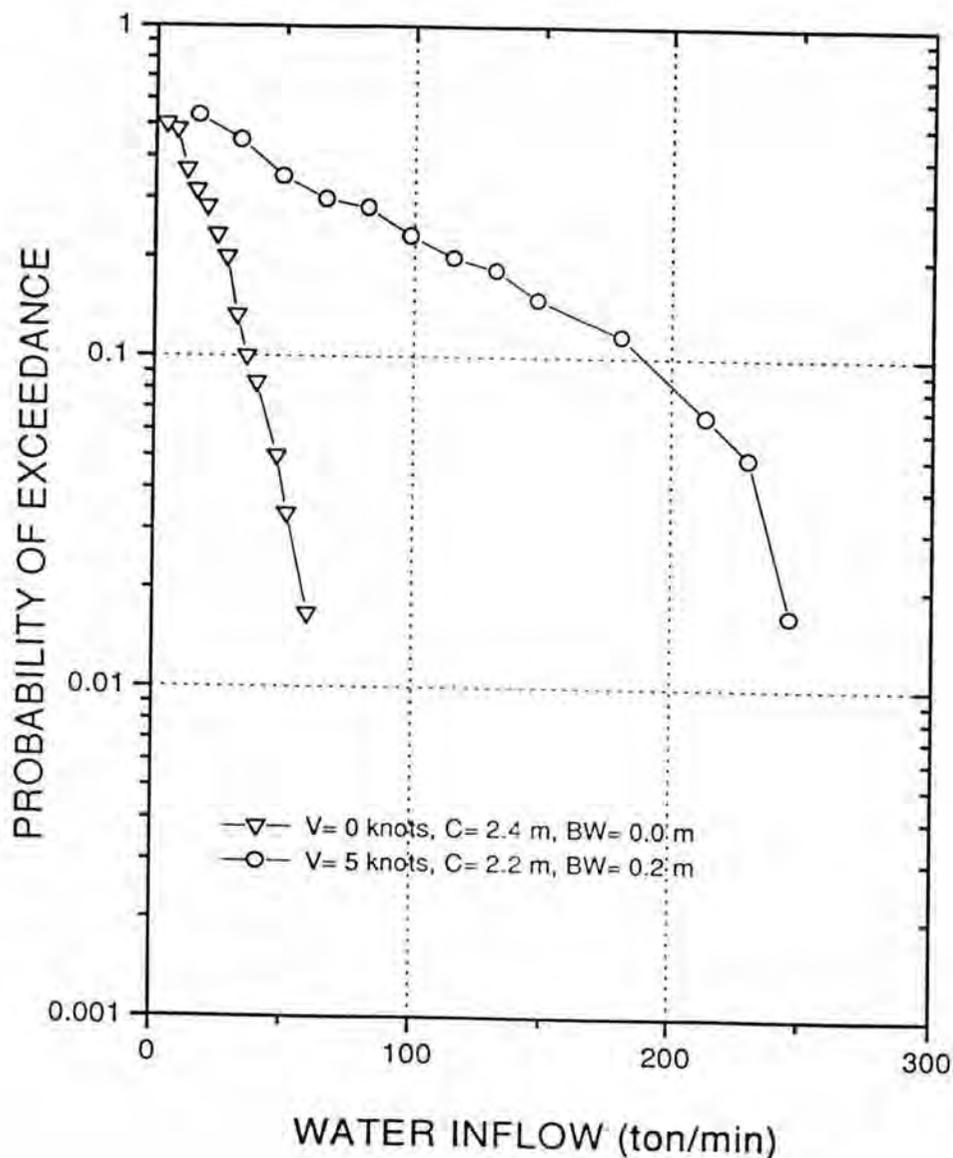
Fig. 10. Water inflow to the car deck in the following seas
