THE FINAL REPORT ON THE CAPSIZING ON 28
SEPTEMBER 1994 IN THE BALTIC SEA OF THE
RO-RO PASSENGER VESSEL MV ESTONIA

The Joint Accident Investigation Commission
of
Estonia, Finland and Sweden

The Joint Accident Investigation Commission publishes in this Supplement the most important documents used in Commission's work. Large appendices of some research reports have been edited, but a list of appendices has been included.

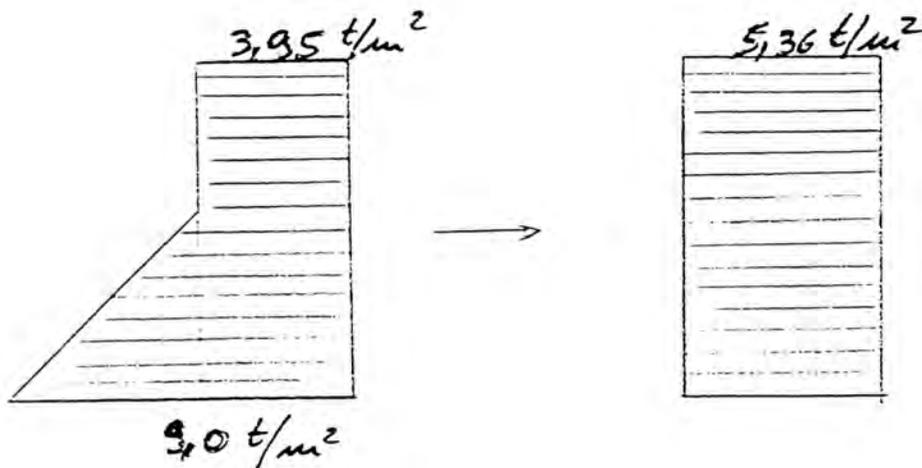
1

Angreifende Kräfte nach BV-Regel 1976

Kraftangriffspunkt im Flächenschwerpunkt
der projizierten Flächen:

$$P_x = 381 \text{ t}$$

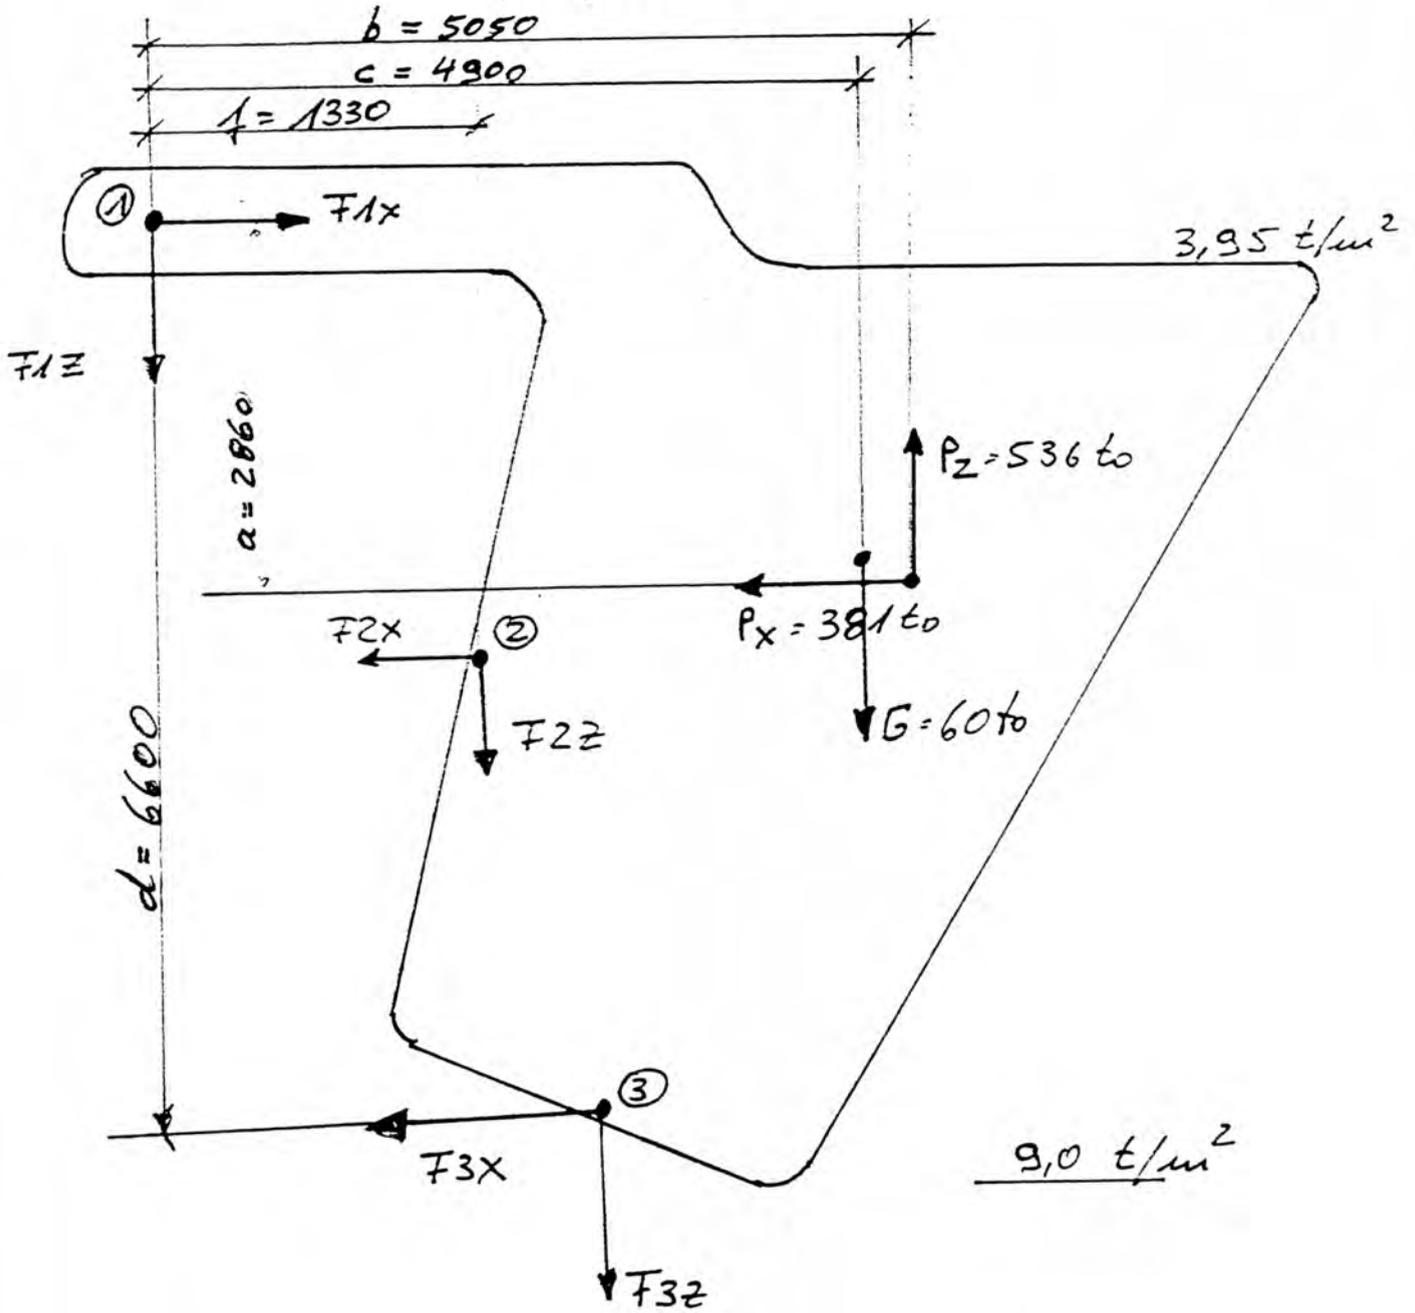
(2)

Kraftesystem

Gesamt horizontal kraft:

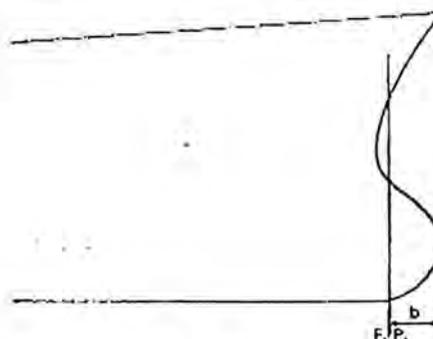
b being the distance, in metres, defined in the following sketch:

Steps or recesses may be permitted provided that the bulkhead shifted parts comply with the preceding limit values.

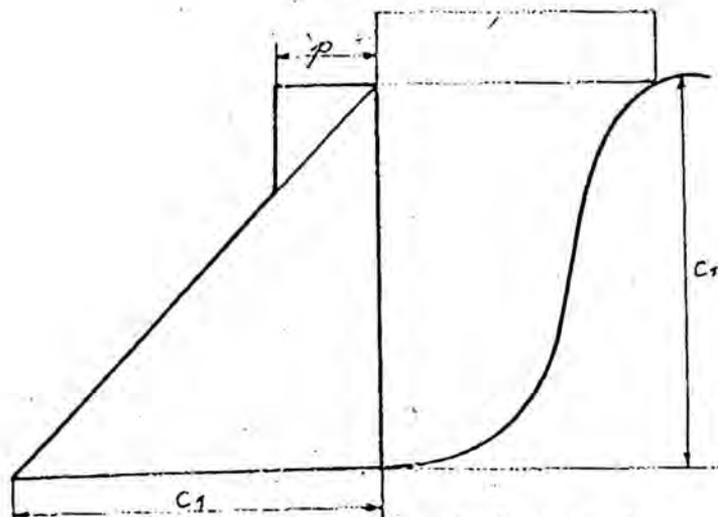
CALCUL DIRECT DES MURAILLES DU PEAK AVANT DES GRANDS NAVIRES :

CHARGES LOCALES

C_1 : creux au pont supérieur au droit du peak

p est la charge en t/m^2 déduite des formules de lisses de pont supérieur de pétroliers.

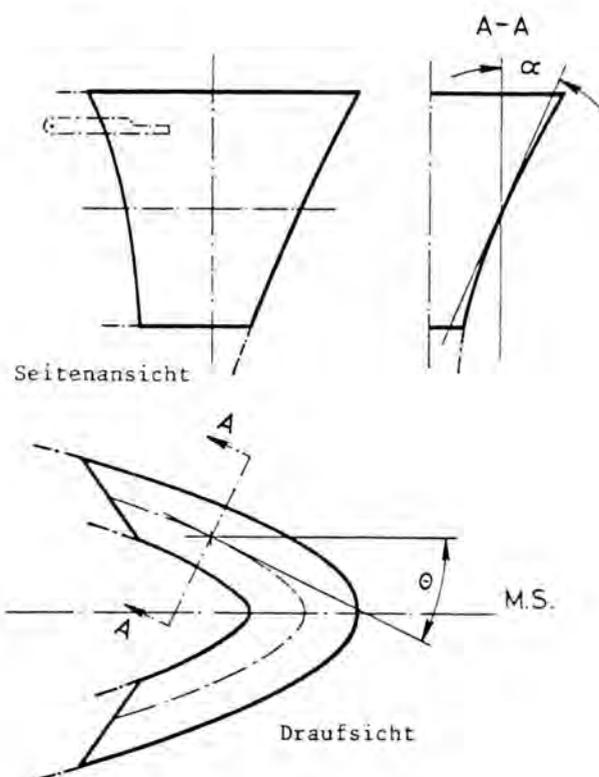
Abb. 6.2

α = Seitlicher Ausfall der Oberfläche der Bugpforte gegenüber der Mittschiffsebene auf Mitte Pforte gemäß Abb. 6.2.

θ = Winkel zwischen der Mittschiffsebene und der horizontalen Tangente an die Oberfläche der Bugpforte auf Mitte Pforte gemäß Abb. 6.2.

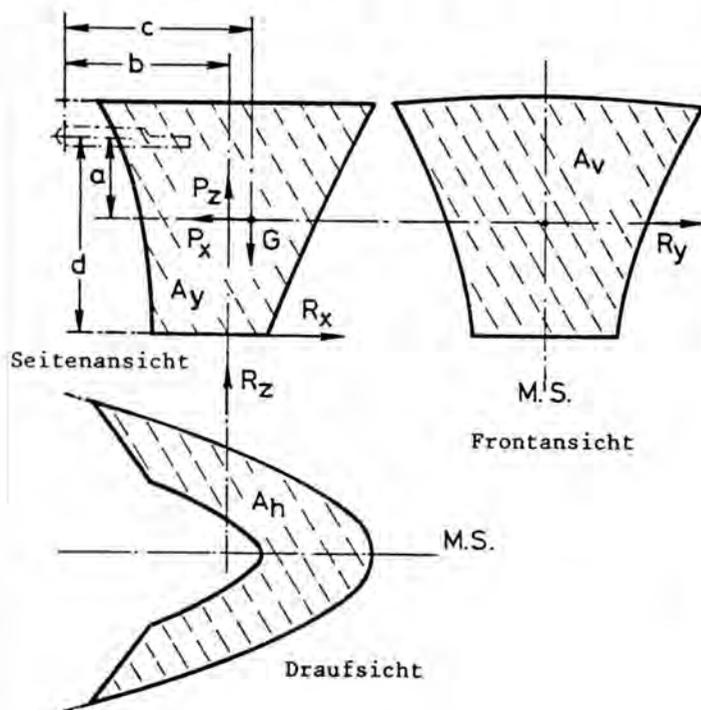
Abb. 6.3

7.3.2 Für Bugpforten vom Visiertyp, die nach oben öffnen, sind die horizontalen und vertikalen Kräfte, die an den Verschuß- und Aufhängevorrichtungen angreifen, nach folgenden Formeln zu bestimmen (siehe hierzu auch Abb. 6.3):

A_v = vertikale (auf die Spantebene) projizierte Fläche der Bugpforte in [m²]

A_h = horizontale projizierte Fläche der Bugpforte in [m²]

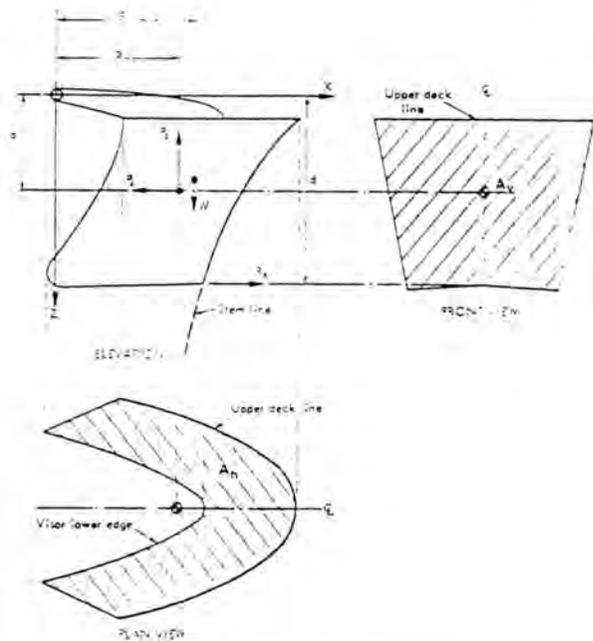
FIG. D 35.1 Bow Visor

3517 In general, the strength of bow and stern doors is to be equivalent to the surrounding structure.

Plating is not to be less than the minimum shell plating end thickness.

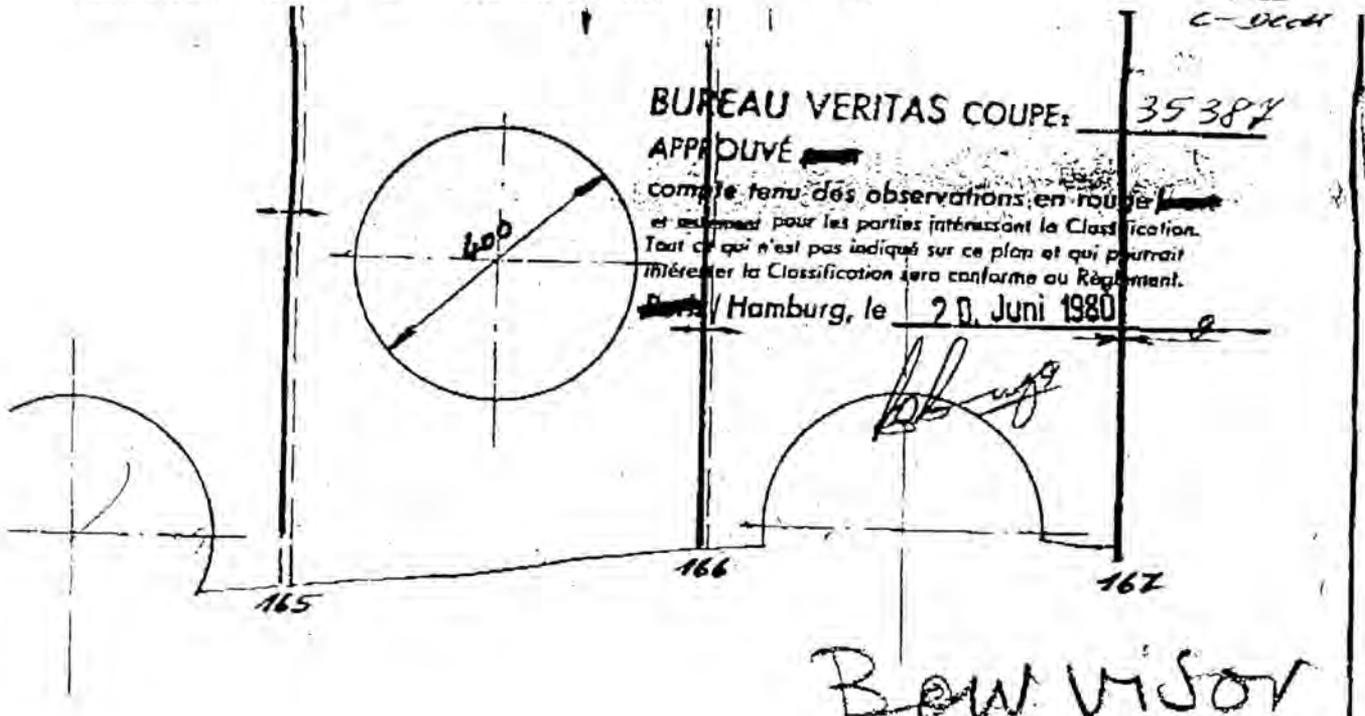
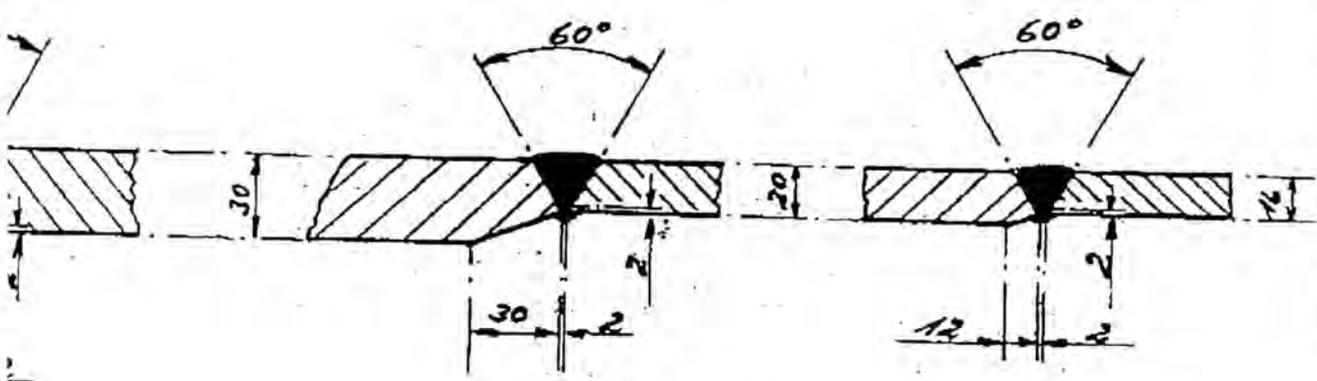
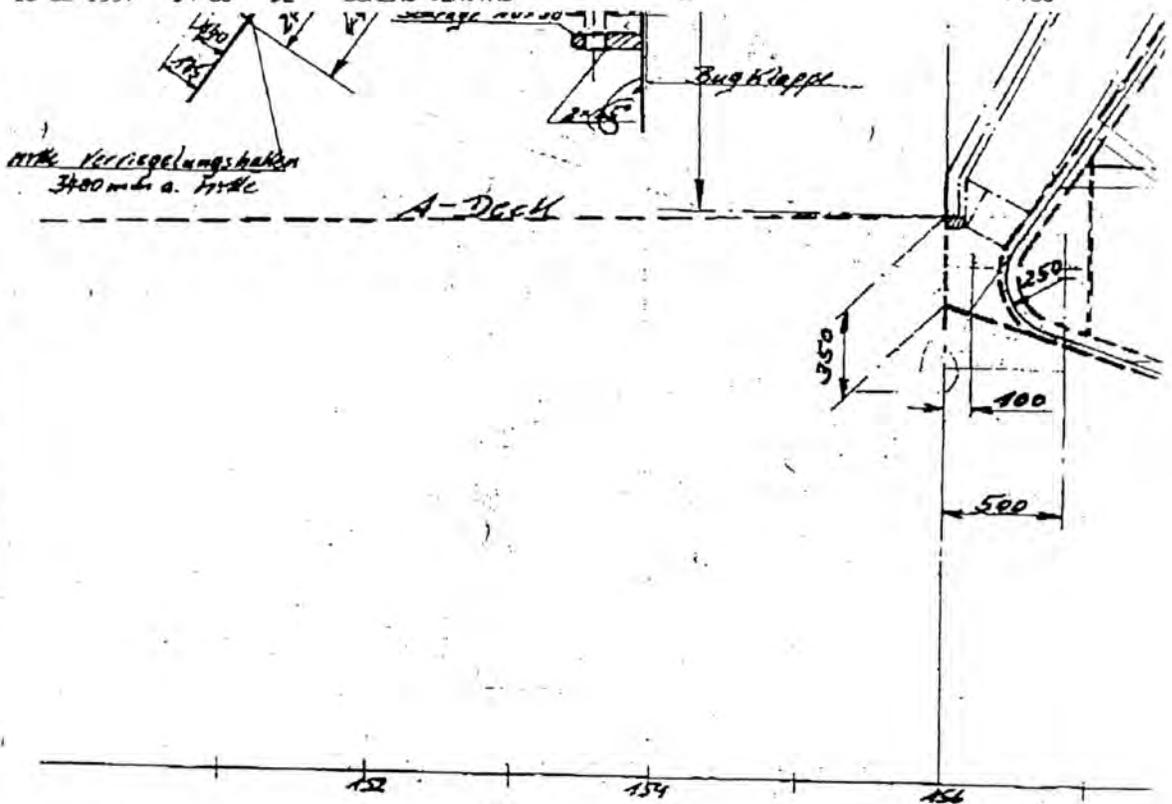
Bow visor

Extracts from notes made by the Bureau Veritas surveyor on the visor
assembly drawing 590/1103 rex 6.

General remarks

- 1) Arrangement of locking devices, subject to the approval of the national Authorities.
- 2) Watertightness of the ramp and local reinforcements of the ship's structure in way of locking devices, cylinders and hinges to Surveyor's satisfaction.

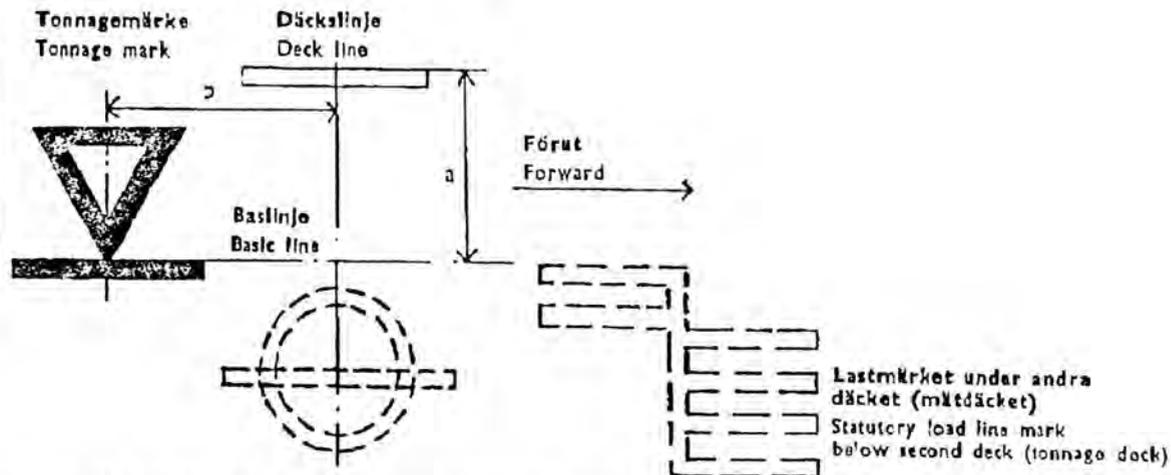
Detta tonnagemärke är märkt på fartygets båda sidor
i höjd med lastmärkets översta linje
On each side of the ship a tonnage mark is marked on level with the
highest load-line grid as follows:

Avstånd (se figur) Distances (see figure)	Tum Inches	Millimeter Millimetres
Vertikalavstånd Vertical distance	a	1445
Horisontalavstånd Horizontal distance	b	1500

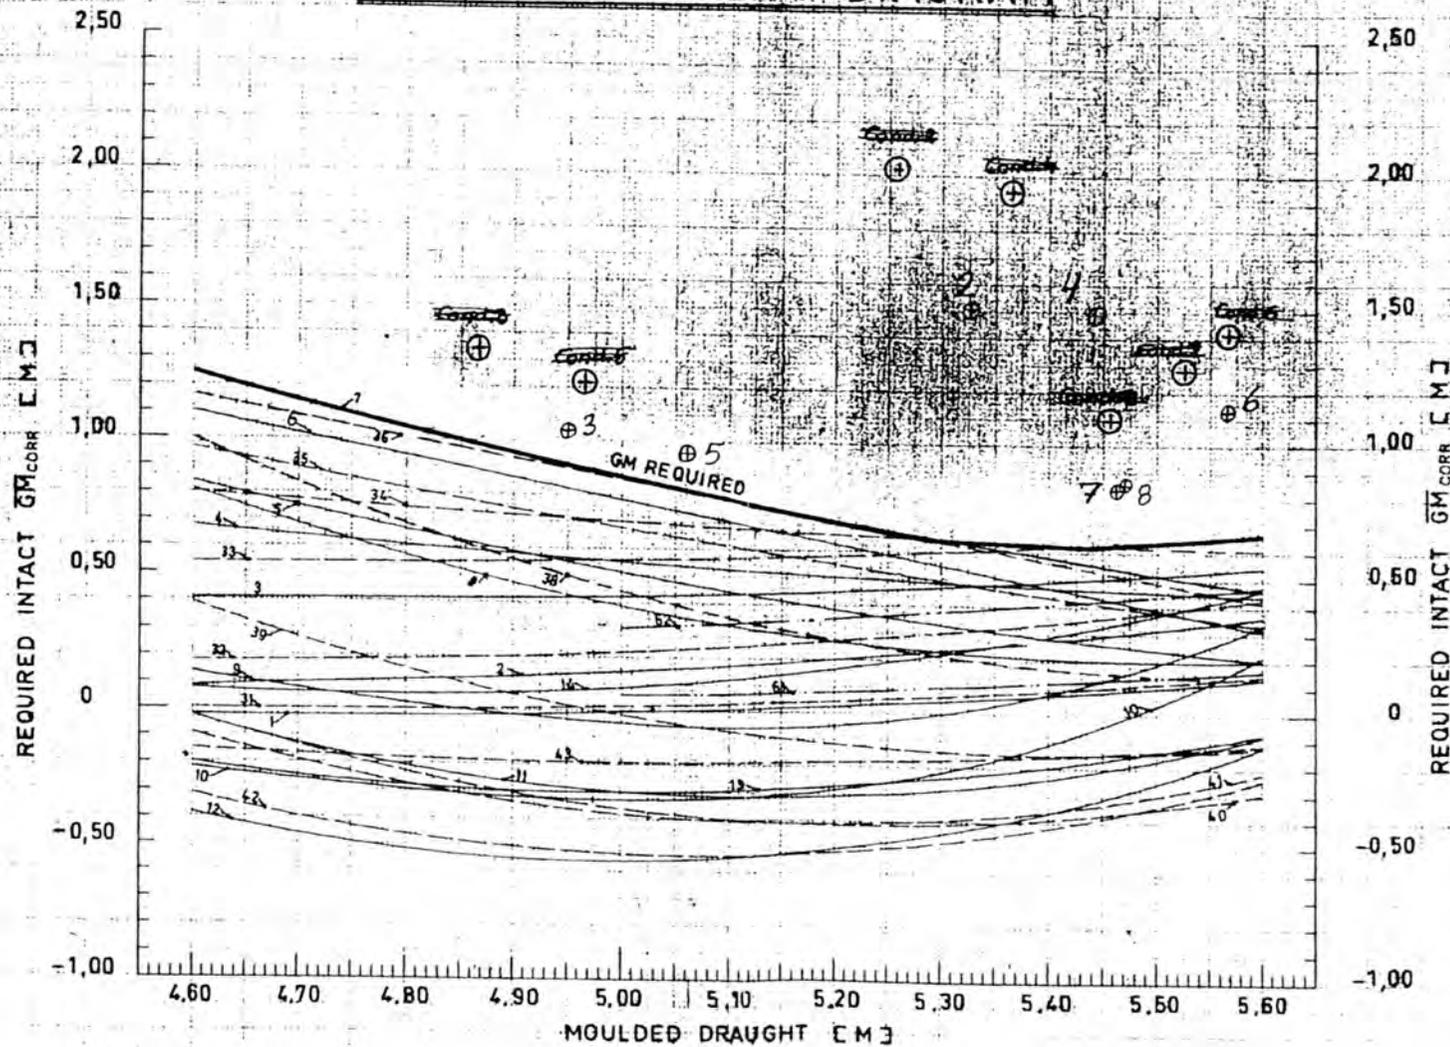
DAMAGE STABILITY DIAGRAM

THE VESSEL'S CALCULATED AVAILABLE GM_{CORR} MUST ALWAYS BE ABOVE OF THE CURVE OF "GM-REQUIRED"

The damage stability diagram has been calculated with the following criterions:

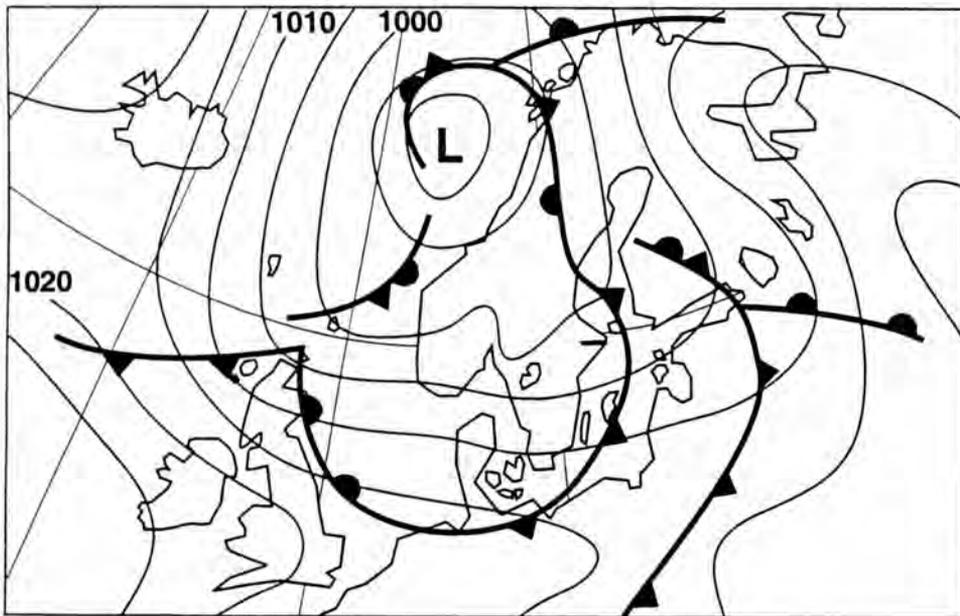
Fig. 1A)
Synoptic weather situation
27.9.94 00 UTC

At 00 UTC on 27.9.1994 (02.00 local time) a wave on the polar front was situated in the vicinity of the British Isles; to the north of the wave, and associated with it, was a trough in the cold air-mass. The trough is denoted on the synoptic charts as an occlusion, as the trough and polar-front wave together constitute a so-called "instant occlusion" (Pearson and Stewart, 1992). The depression had already begun to deepen (Fig. 1A). At 12 UTC the deepening low, with a central pressure of 987 hPa, was situated near Oslo and was moving eastwards. The associated polar front wave and trough also moved east (Fig. 1B). 12 hours later, at 00 UTC on 28.9.1994, the low centre of 982 hPa was to be found

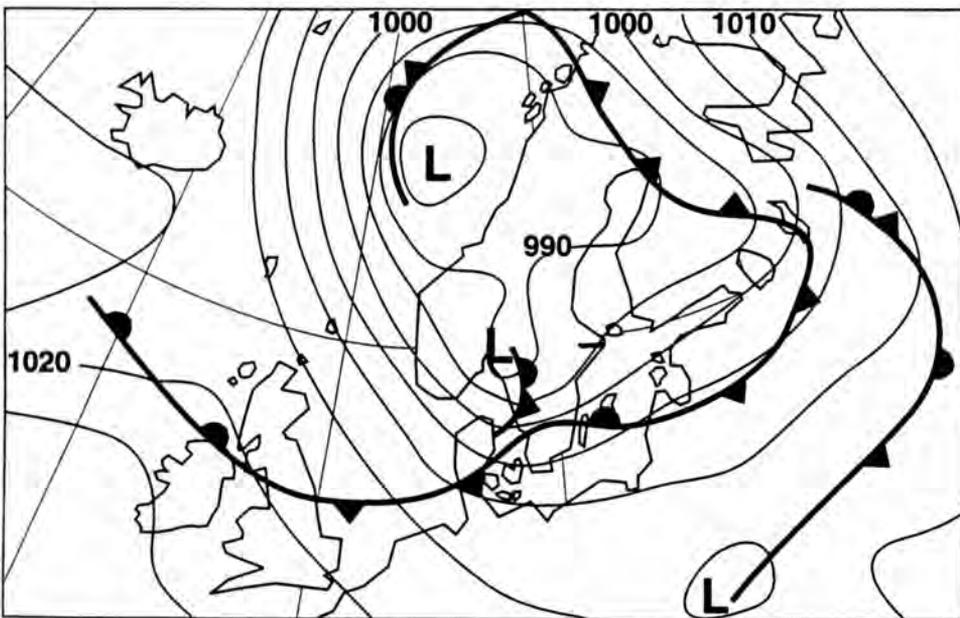
Fig. 1B)
Synoptic weather situation
27.9.94 12 UTC

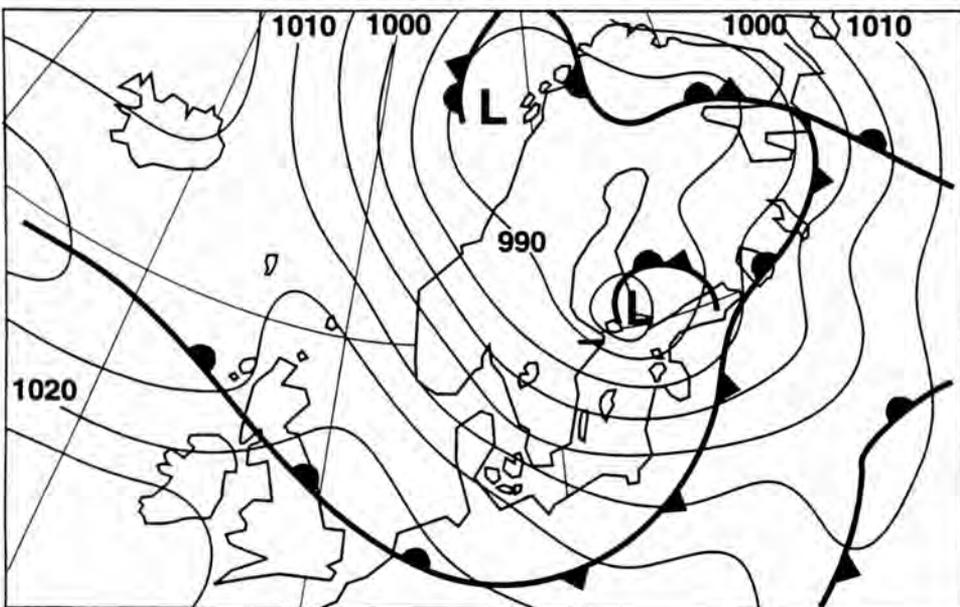
Fig. 1C)
Synoptic weather situation
28.9.94 00 UTC

north of Åland in the southern Gulf of Bothnia. At this time the actual wave on the polar front was already moving away to the east of Finland, but the depression situated in the cold air-mass, together with the trough, moved more slowly. The depression deepened slightly still further (Fig. 1C). The synoptic weather situation at the time of the accident is depicted in Fig. 2. The track of the low centre can best be seen from Fig. 3F. The fronts in the vicinity of the area of the accident are also shown in Figs. 3A - 3F. The position of the centre of the low is marked in the figures with an asterisk. In this particular weather situation the passage of the fronts was not associated with sudden changes in wind speed or direction. Statistically, the tracks of depressions at the end of September and during October run from the south of Iceland over southern Scandinavia and then in a north-easterly direction, so that the track taken by this depression was quite usual. Central pressures below 980 hPa are unusual: depressions this deep cross Finland on average twice in October. Storm-force winds may be associated with them. The central pressure of the low on 28.9 was 981 hPa. The strongest momentary gust measured in connection with this low, 29 m/s, was recorded at the Ristna weather station between 00 and 03 UTC. At that time the ten-minute average wind speeds measured by weather stations in the northern Baltic Sea were in the range 17 - 23 m/s.

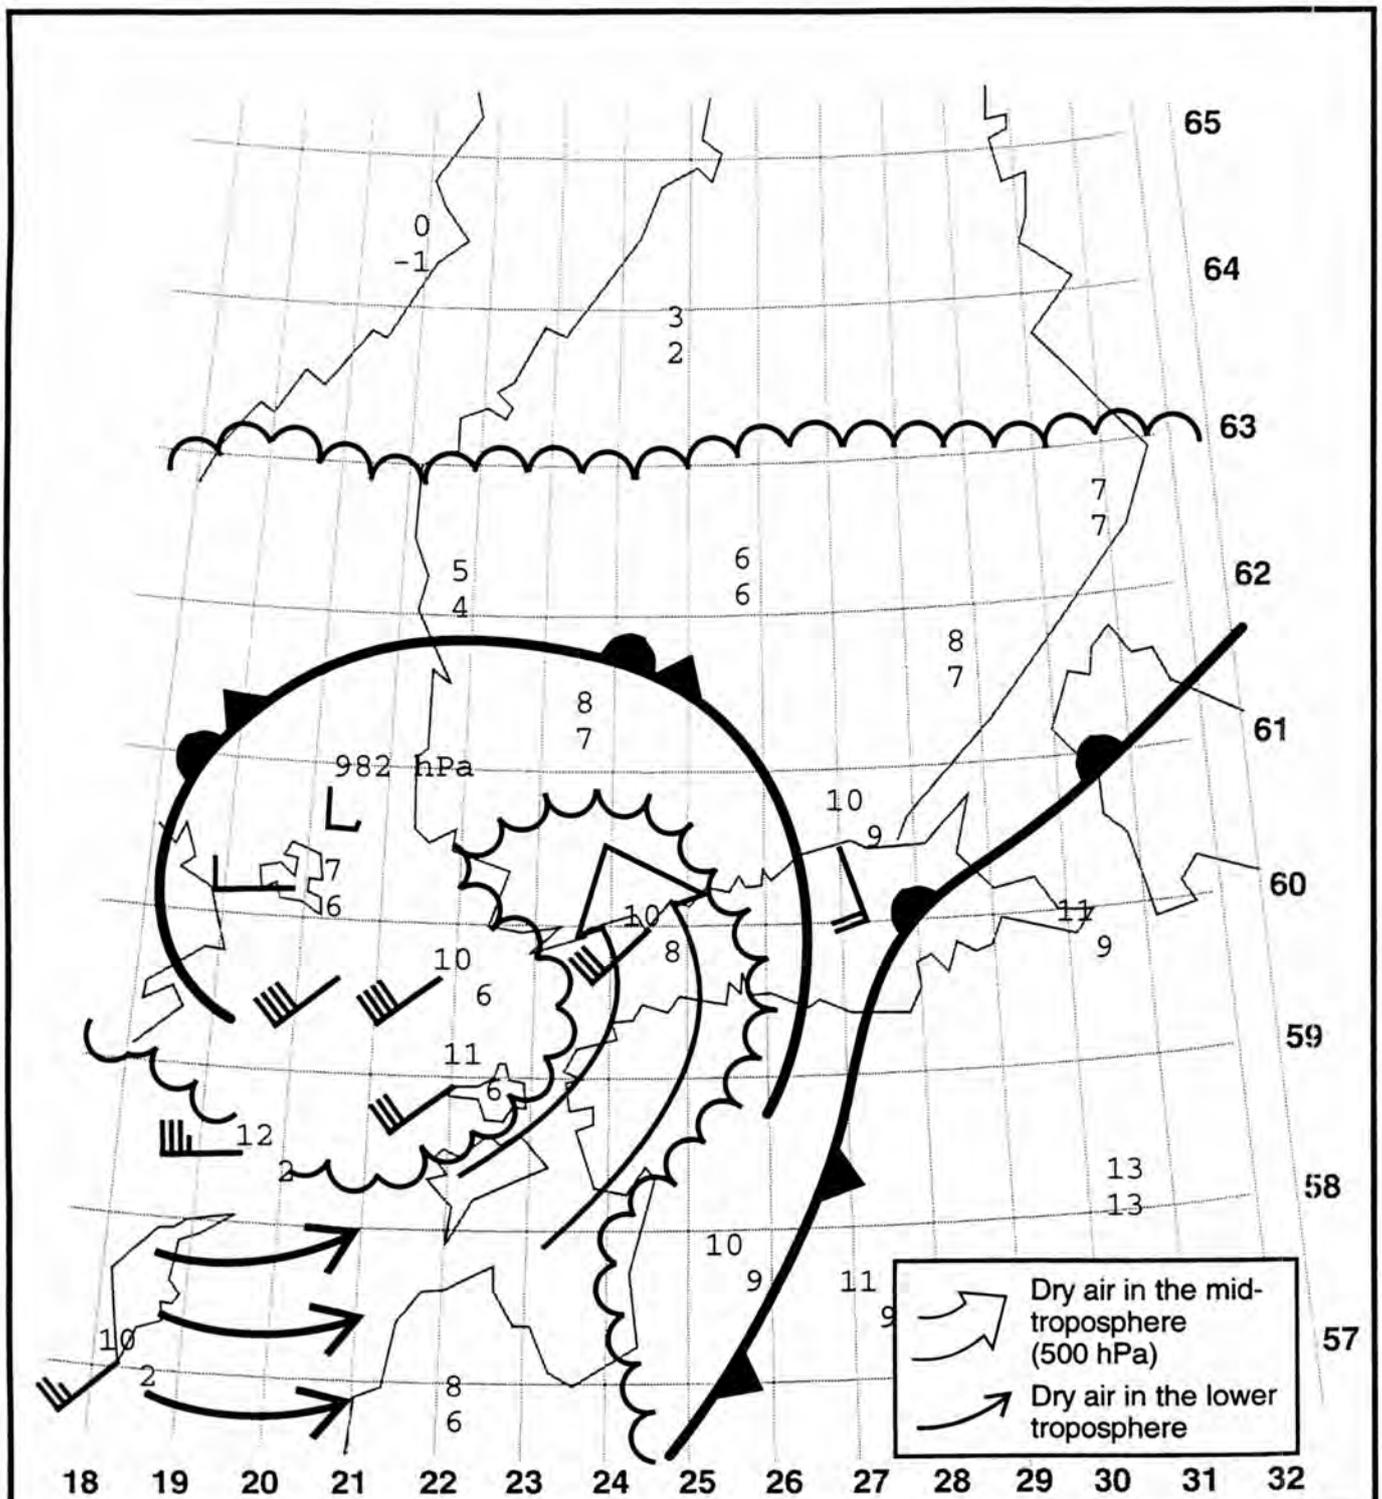
Fig.2. Synoptic weather situation at the time of the accident, 00UTC on 28.9.1994. Values of temperature (upper value), dew-point (lower value) and wind are plotted at selected locations. The wind speed is in knots, with the longer barb representing 10 kt, and the shorter 5 kt.

The synoptic weather situation near the time of the accident is depicted in Fig. 2. The front is shown as an unbroken thick line. To the rear of the front the winds have strengthened and veered (turned clockwise) to the south-west. The arrows mark the position of a dry and gusty airstream which has intruded between the front and the centre of the depression as a narrow tongue of clearer weather. Shower clouds are associated with the cloudy area of the depression, but before 00 UTC on 28.9. no lightning was observed in the sea area; after that time lightning was observed locally inland over south-western Finland. In the series of figures 3A - 3F are shown the locations of the weather observation stations surrounding the accident area. The wind speed and direction, as well as the sea temperature, have been plotted at each station location. The convention shows the wind blowing towards the station. The wind speed is depicted with barbs and black triangular flags. A black flag indicates a wind speed of 25 m/s (50 kt), a long barb a speed of 5 m/s (10 kt) and a short barb a speed of 2 - 3 m/s (5 kt). The wind information from the stations has been shown in the figures at 3-hourly intervals. The frontal zone movement can be seen from Figs. 3A - 3D; the front is estimated to have passed over the accident location at approximately 19 UTC (21.00 local time), after which the wind veered south-west and strengthened. Before the passage of the front the wind backed (turned counter-clockwise), and for a period of about two hours probably blew from the south or south-south-east. As is usual during the passage of a front, the wind veered, in

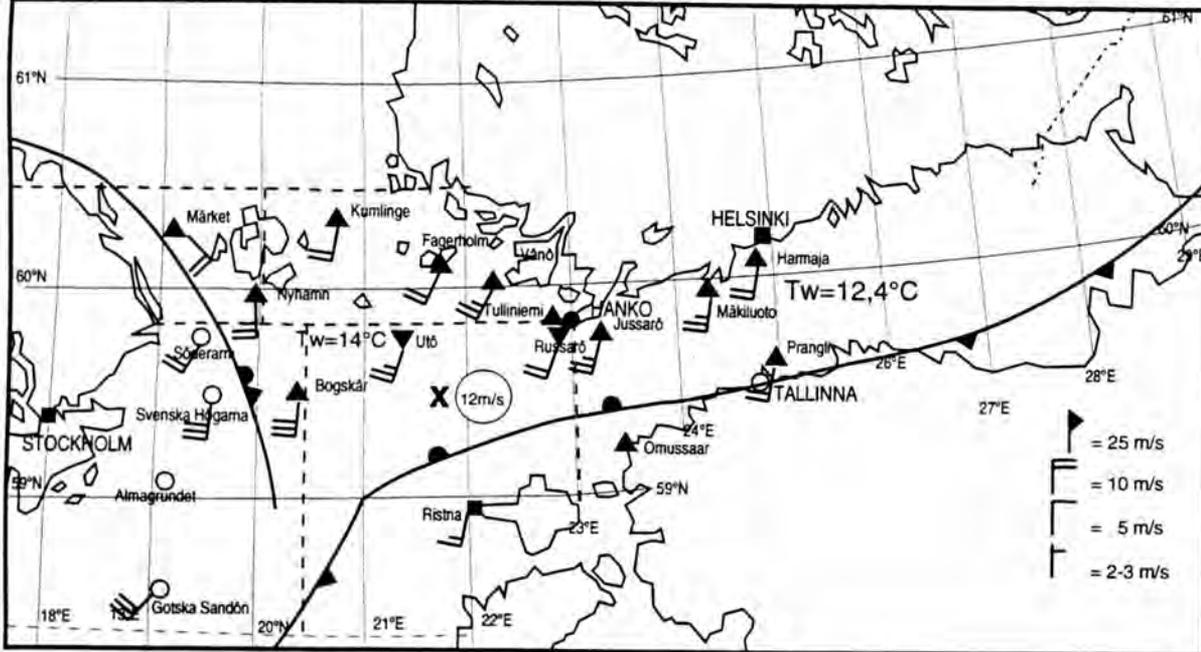
Fig. 3A)
 Synoptic weather
 situation
 27.9.1994 18UTC

The analyses in Figs. 1, 2 and 3 have been prepared on the basis of FMI Central Weather Service chart material.

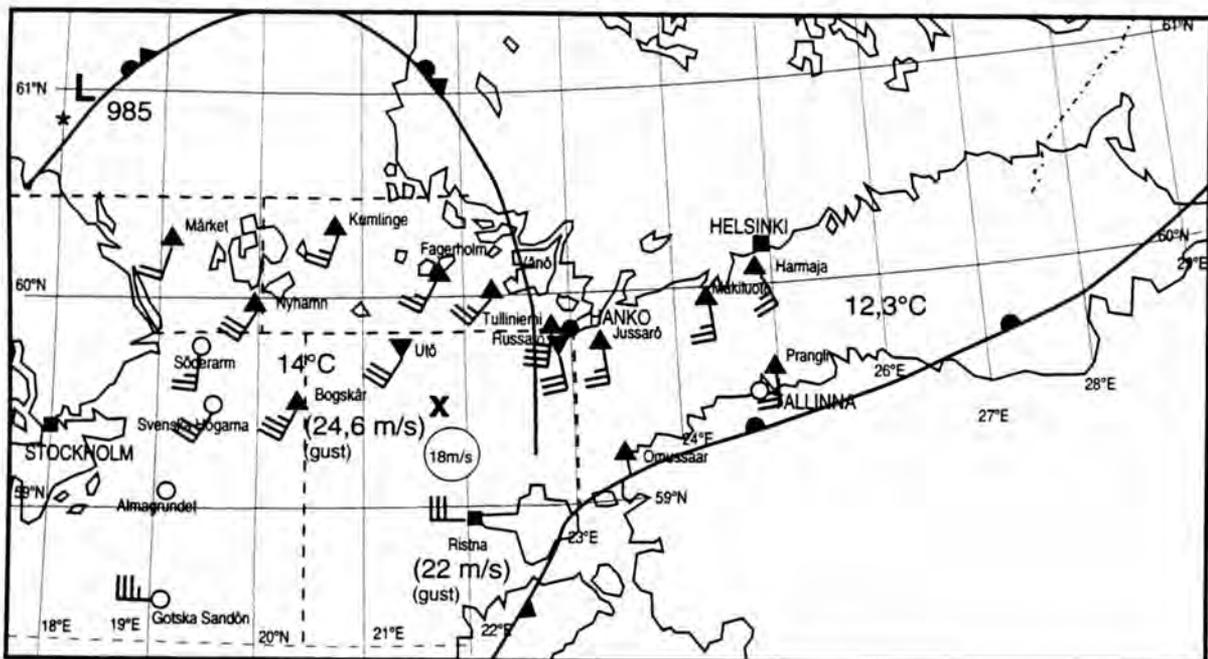
Fig. 3B)
 Synoptic weather
 situation
 27.9.1994 21UTC

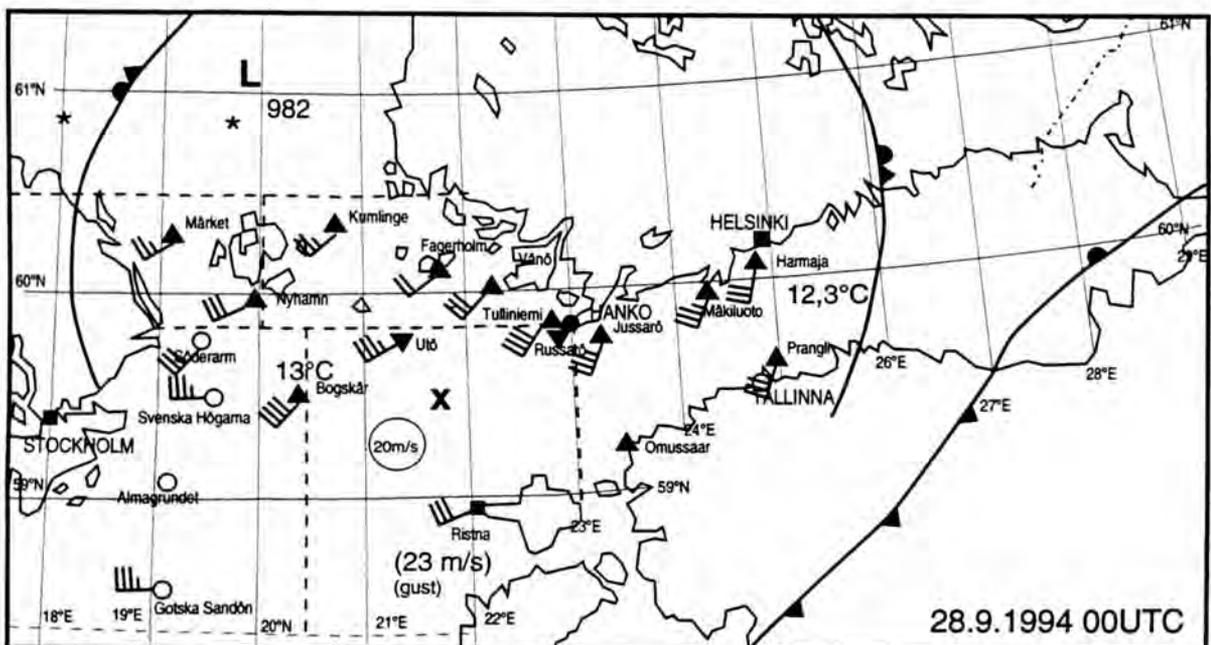
Fig. 3C)
 Synoptic weather
 situation
 28.9.1994 00UTC

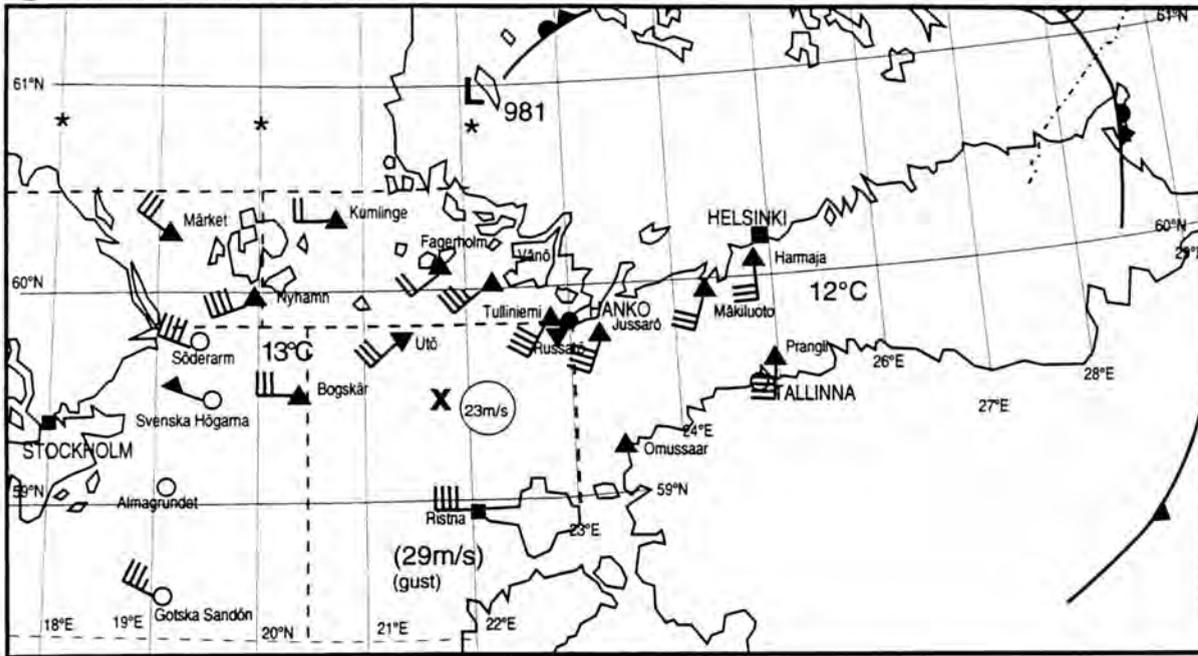
Fig. 3D)
Synoptic weather
situation
28.9.1994 03UTC

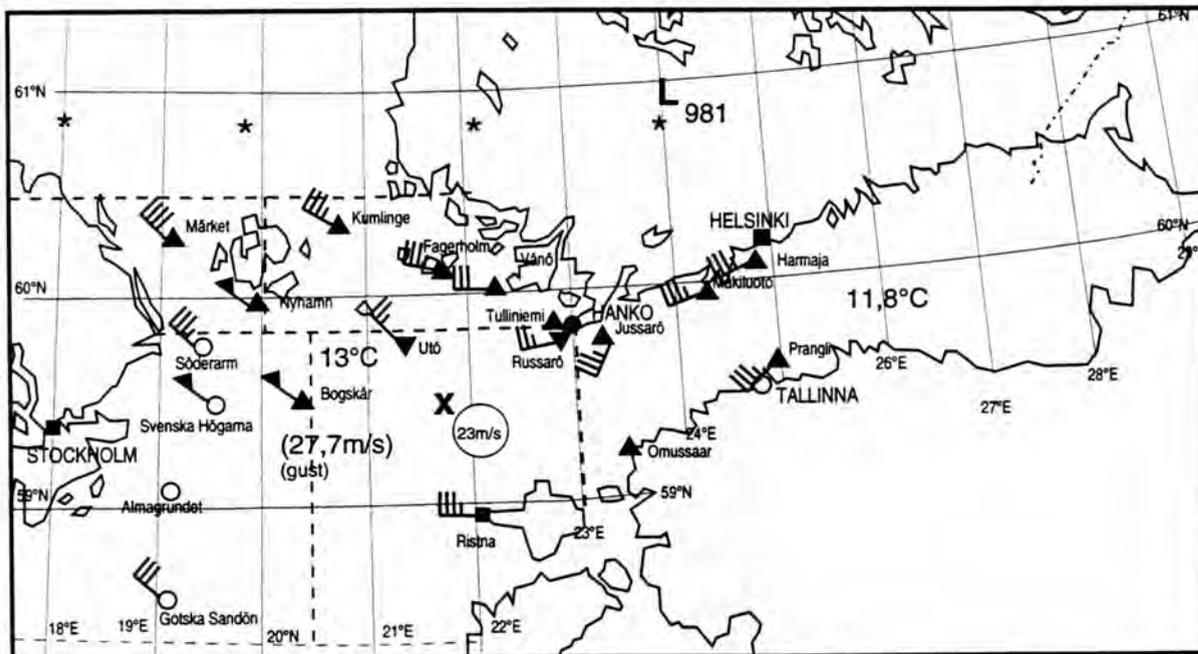
Fig. 3E)
Synoptic weather
situation
28.9.1994 06UTC

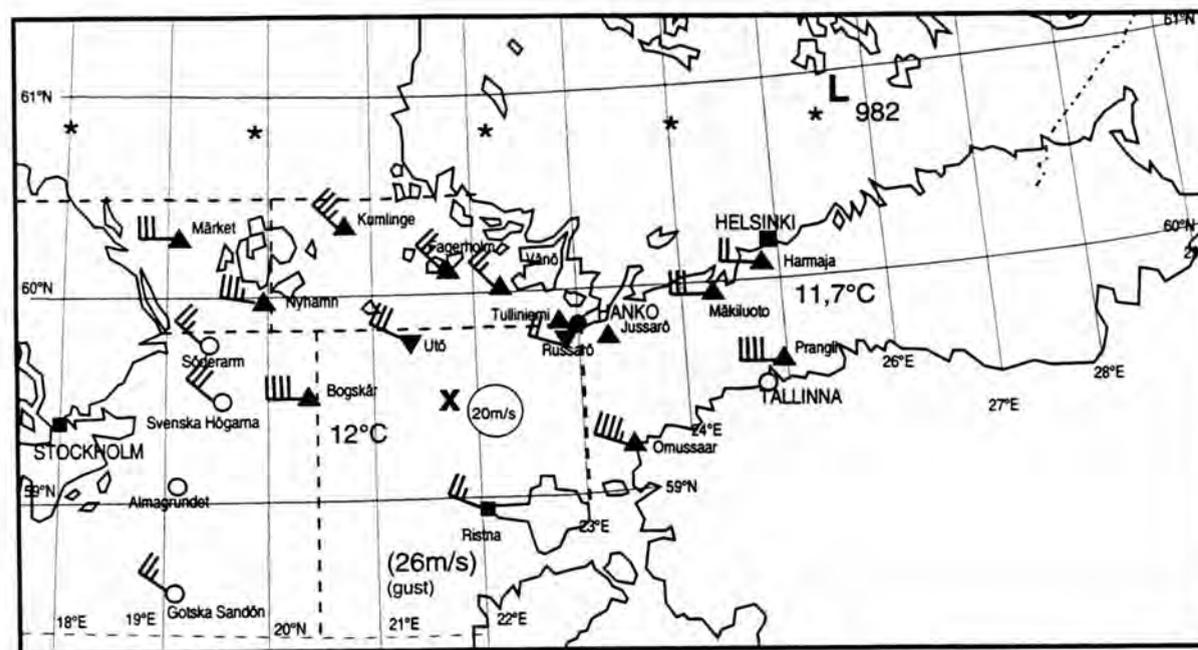
Fig. 3F)
Synoptic weather
situation
28.9.1994 09UTC

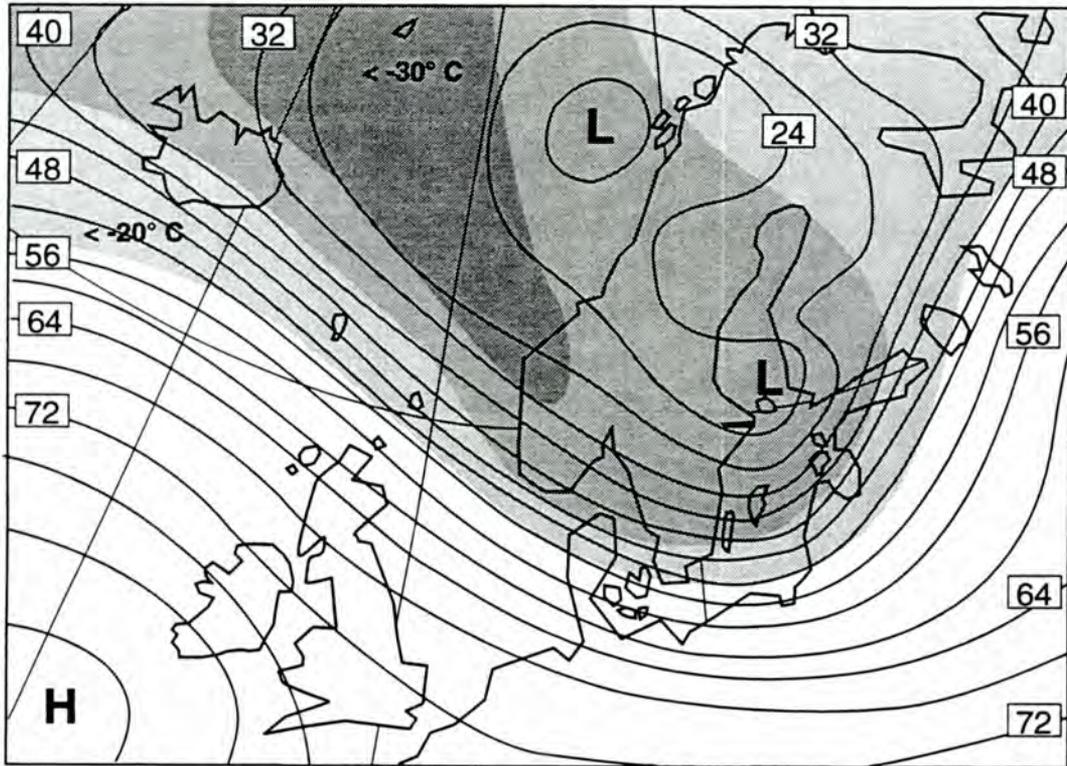
Fig. 4A) 500hPa height isopleths and temperature analysis for 00UTC on 28.9.1994

Fig. 4A shows the 500 hPa height isopleths and temperature analysis for 00 UTC on 28.9., while Fig. 4B depicts the corresponding 850 hPa analysis. These have been prepared on the basis of FMI Central Weather Service upper-air analysis material. In the figures cold air can be seen to flow from the north-west towards southern Scandinavia and the Baltic Sea. A cold air-mass aloft is a prerequisite for gusty winds.

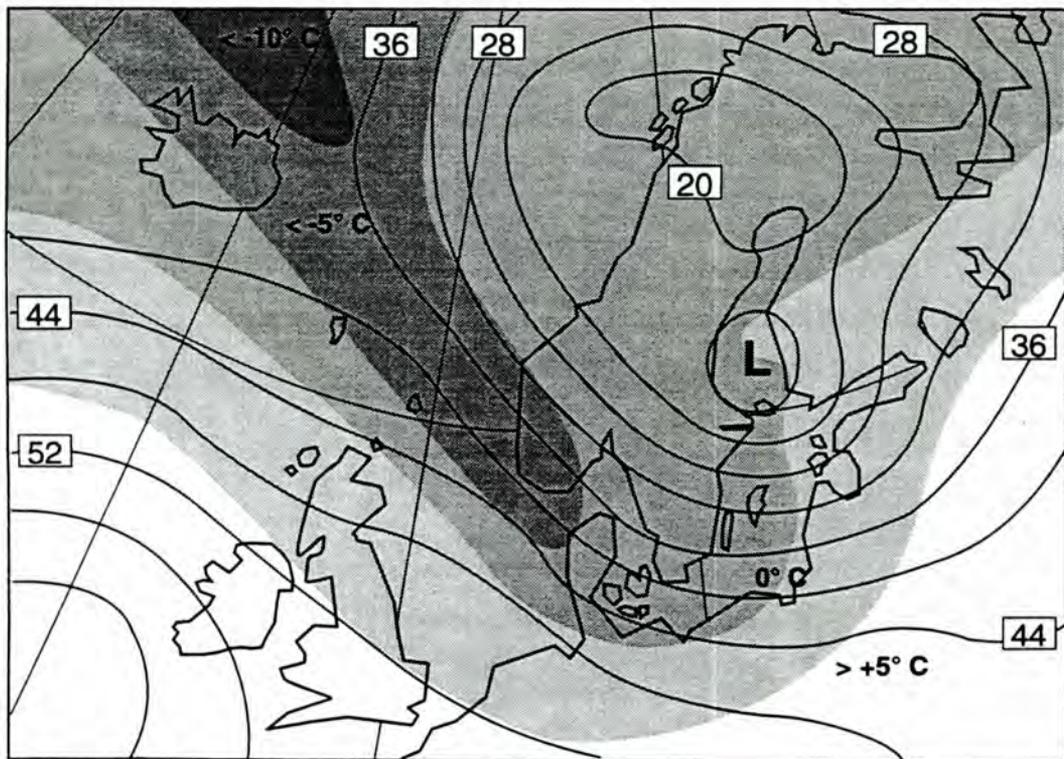
Fig. 4B) 850hPa height isopleths and temperature analysis for 00UTC on 28.9.1994
