THE FINAL REPORT ON THE CAPSIZING ON 28
SEPTEMBER 1994 IN THE BALTIC SEA OF THE
RO-RO PASSENGER VESSEL MV ESTONIA

The Joint Accident Investigation Commission
of
Estonia, Finland and Sweden

The Joint Accident Investigation Commission publishes in this Supplement the most important documents used in Commission's work. Large appendices of some research reports have been edited, but a list of appendices has been included.

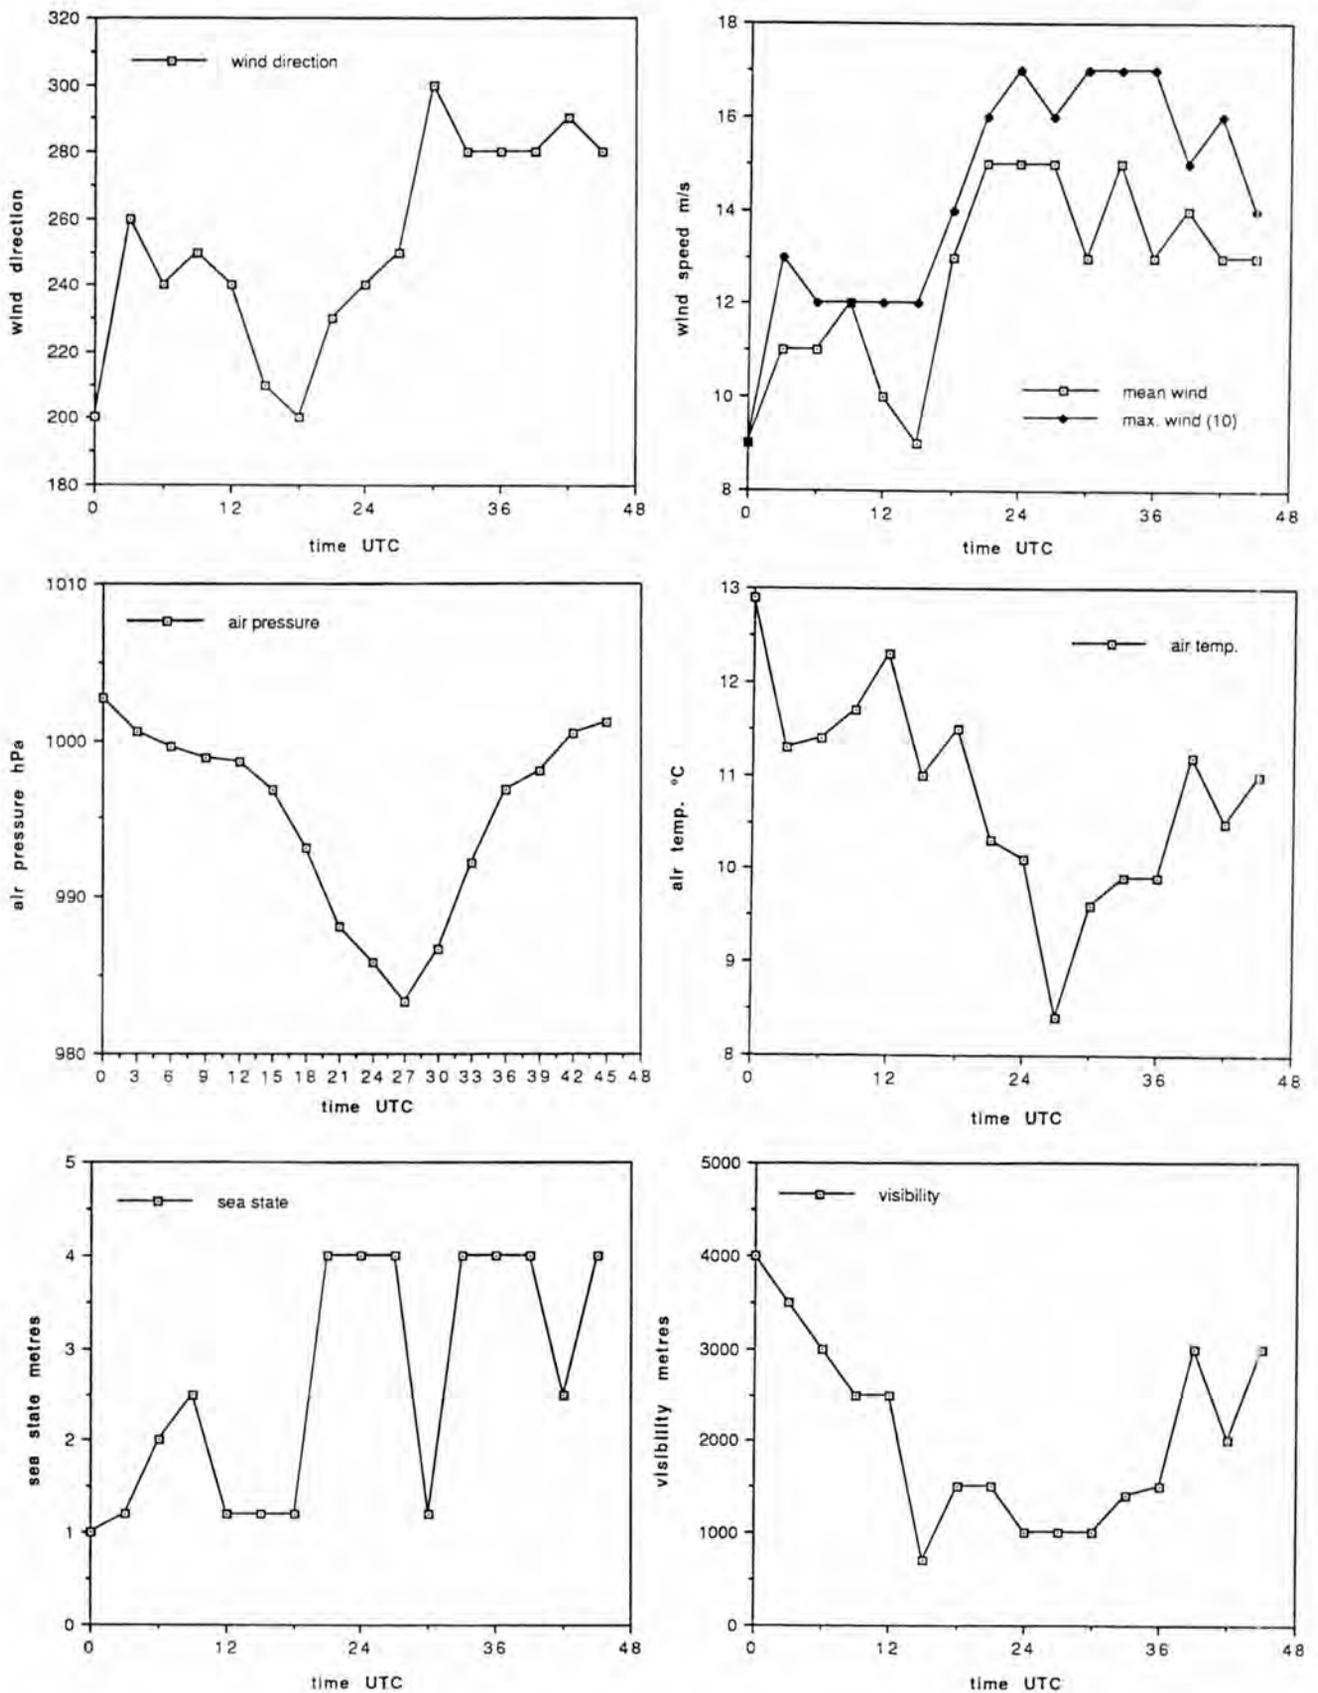
Fig. 5. Utö synoptic station weather observations 27.9-28.9 1994.

Wind speed observations represent 10-minute averages. The max. wind speed is the strongest 10-minute mean value during 3 hours interval. The max. gust speed is the measured strongest 2 seconds gust. Air temperatures and sea water temperatures are given in centigrades. Visibilities and sea states are given in meters.

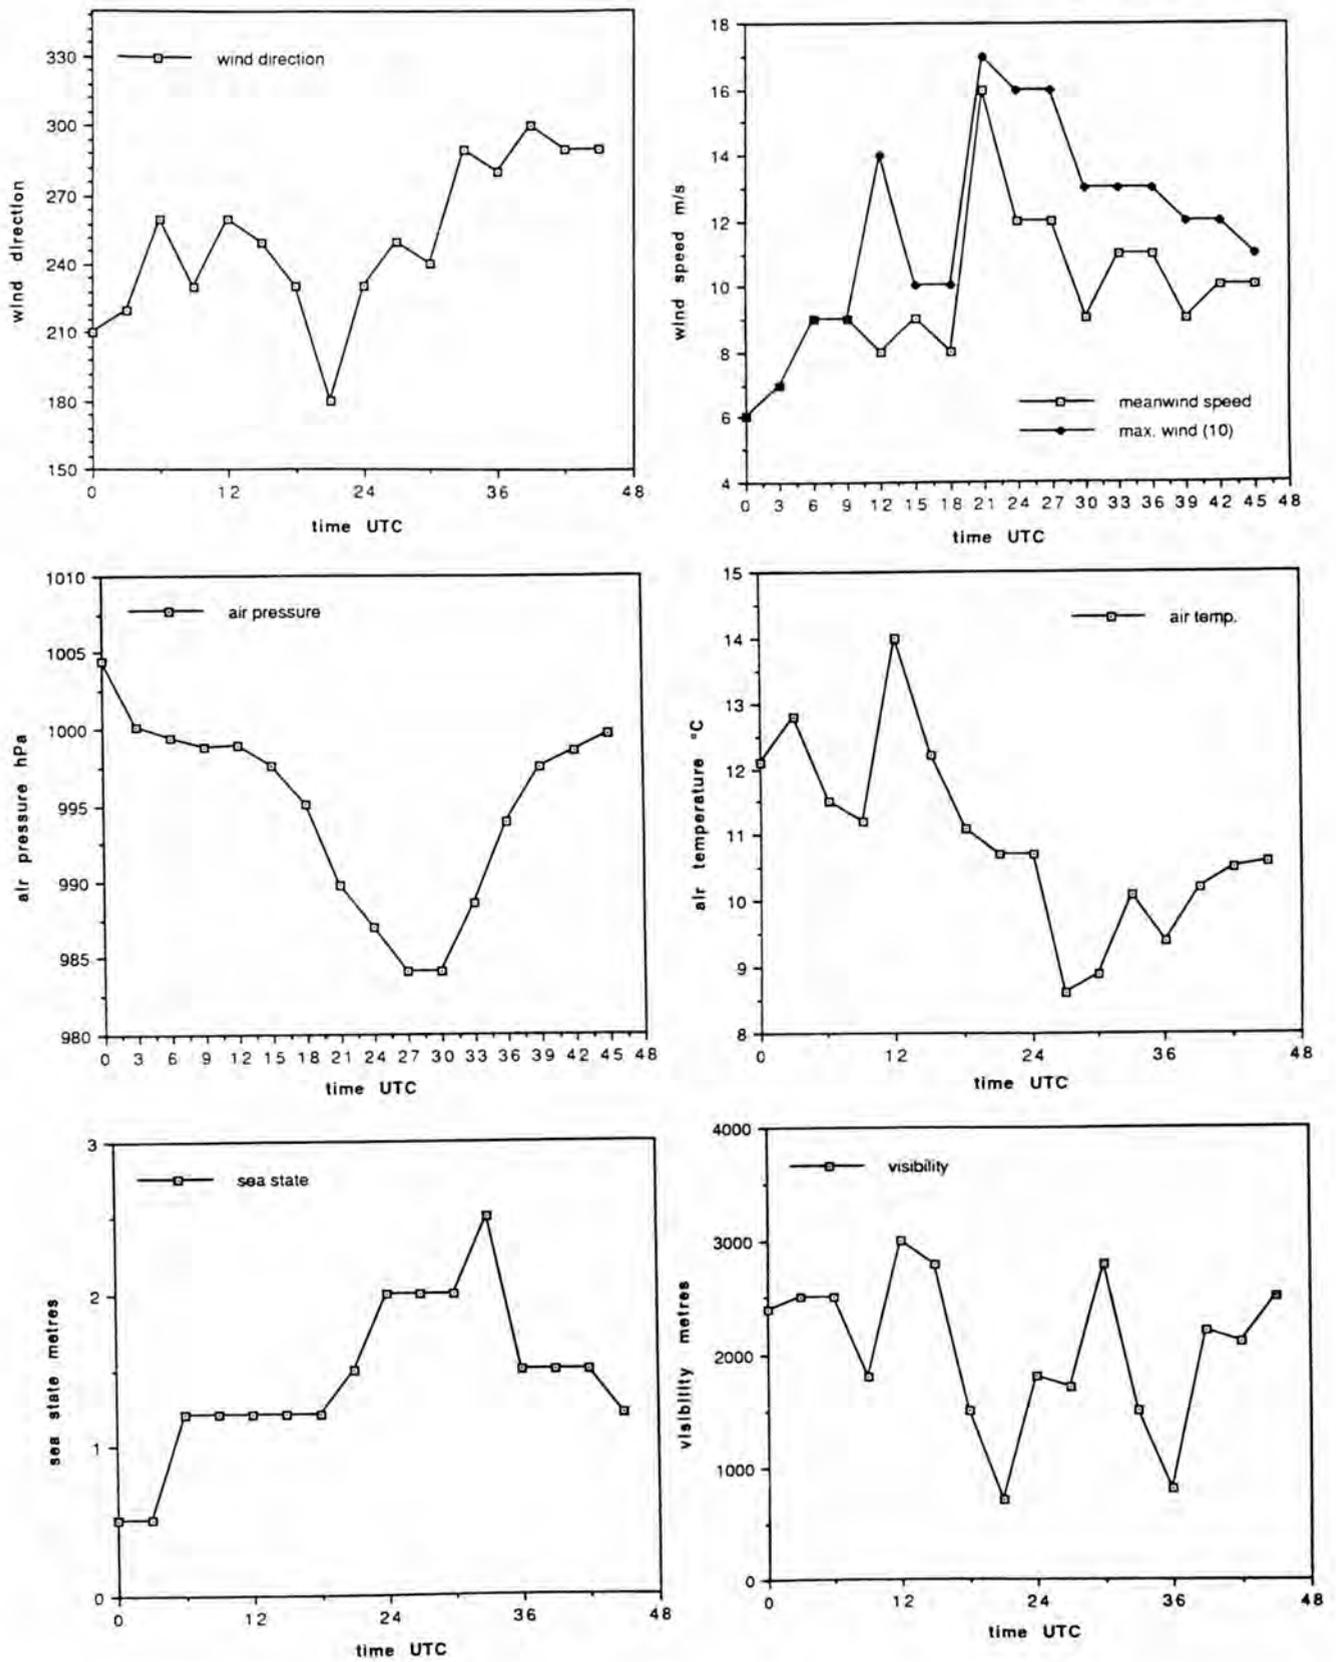
Fig. 6. Russarö synoptic station weather observations 27.9-28.9 1994

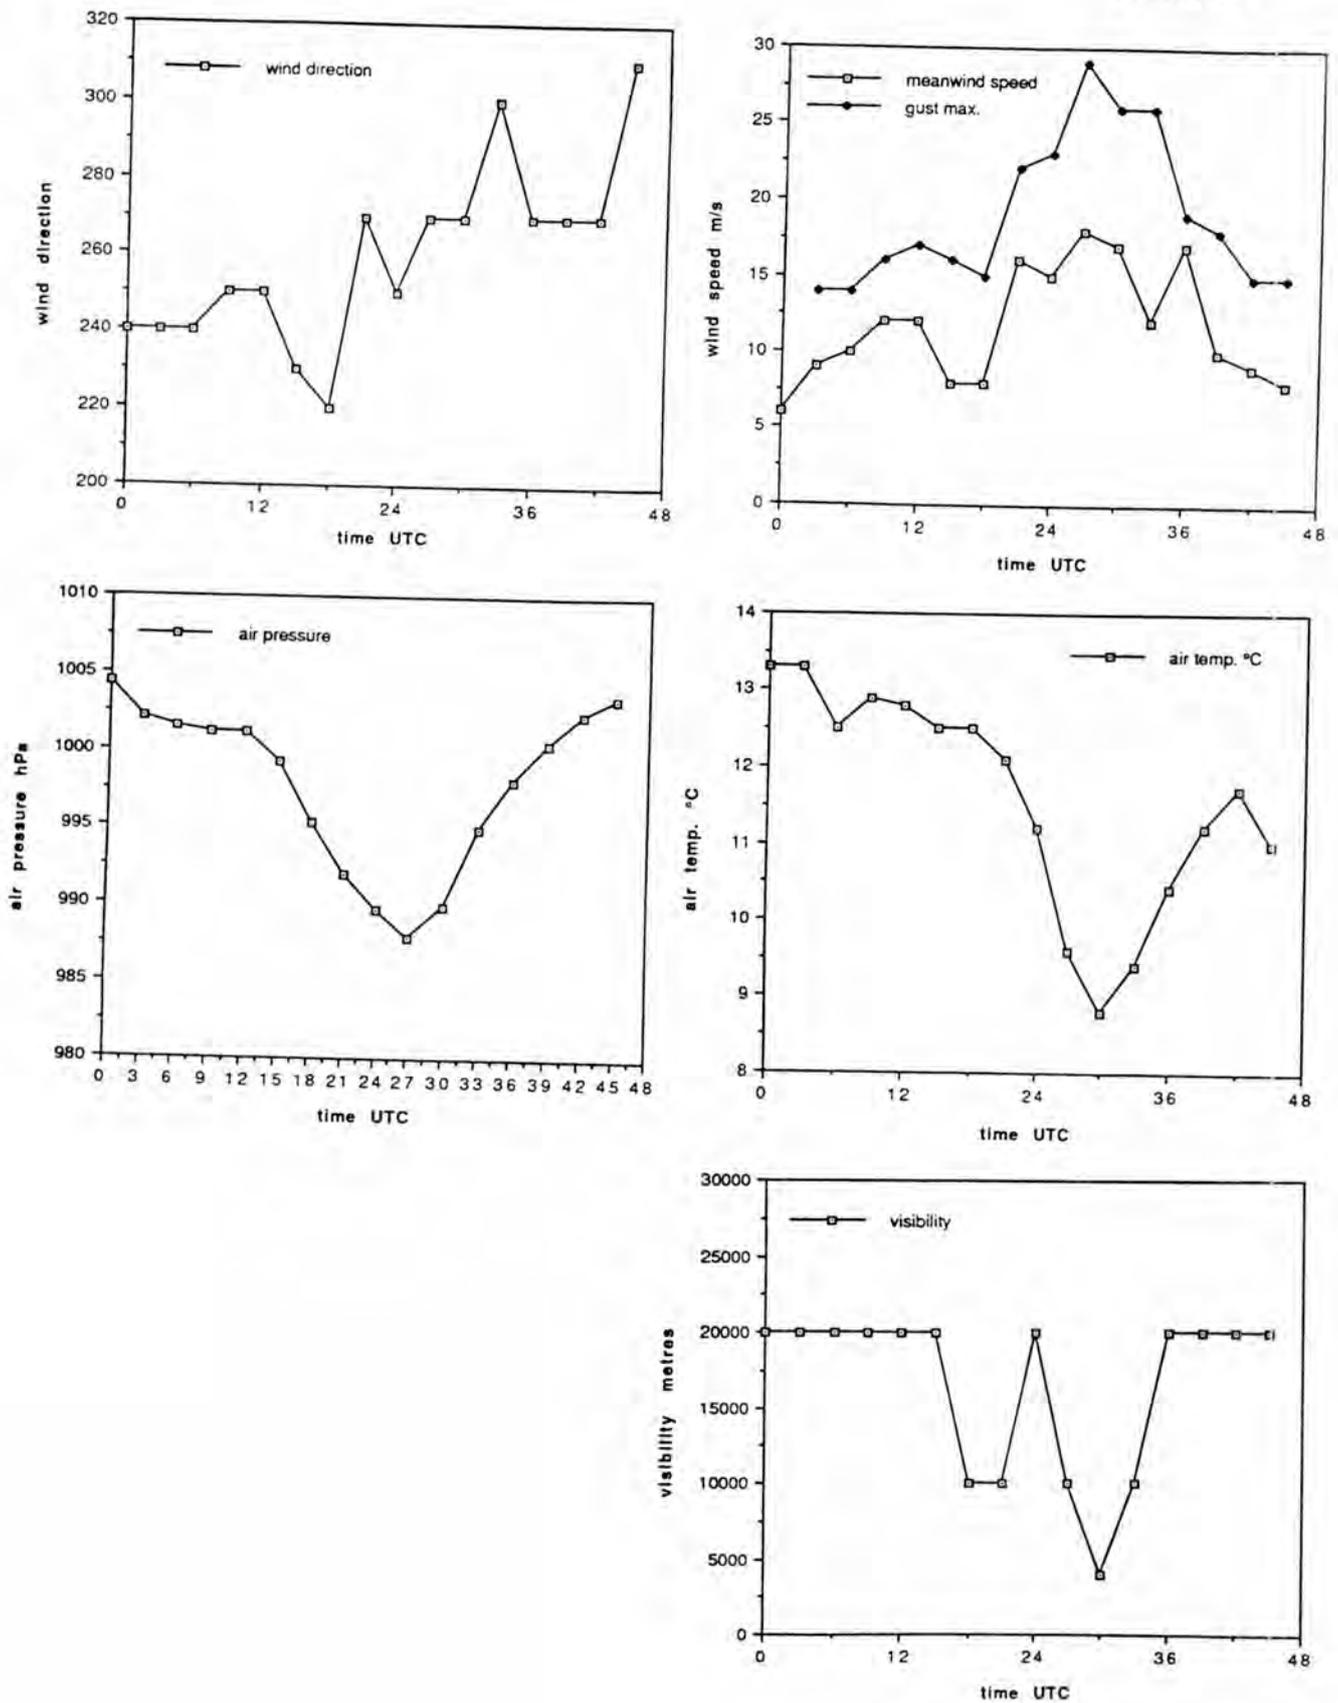
Fig. 7. Ristna synoptic station weather observations 27.9-28.9 1994

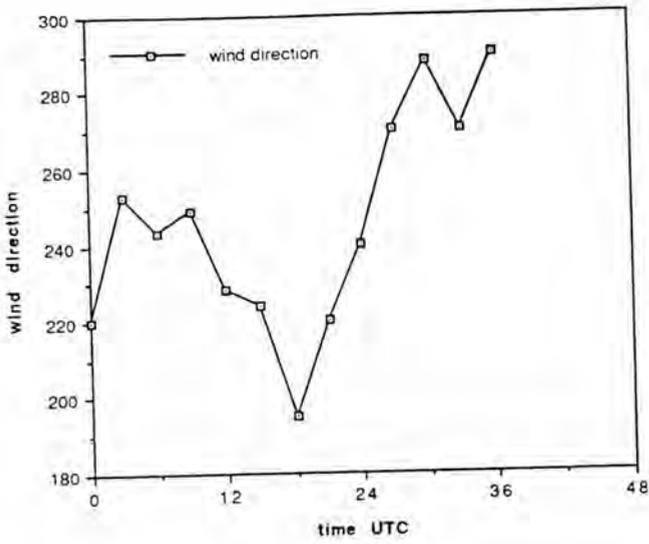
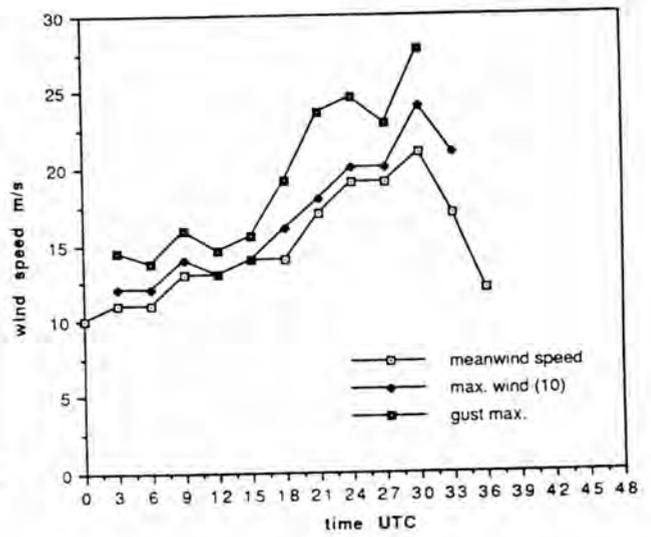
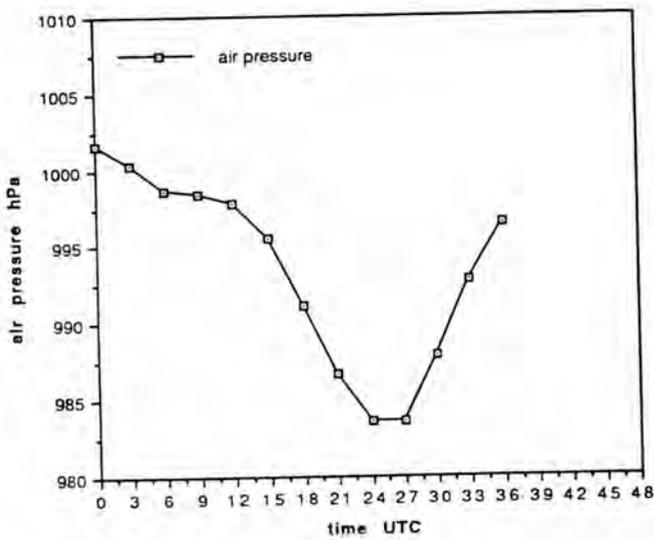
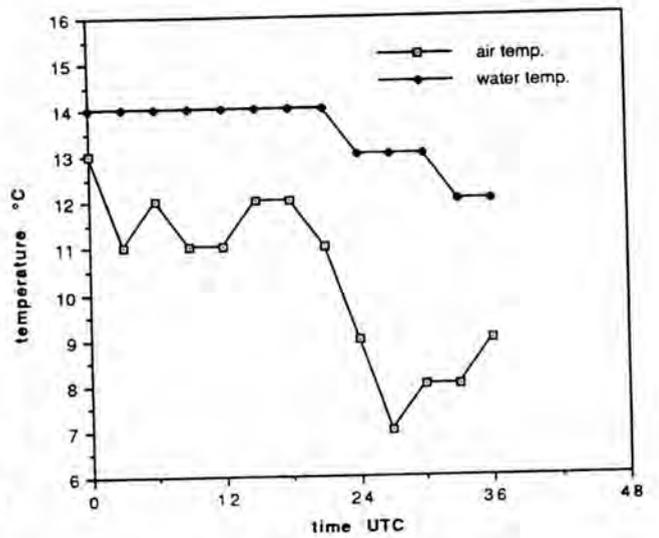
Fig. 8. Bogskär automatic station weather observations 27.9-28.9 1994

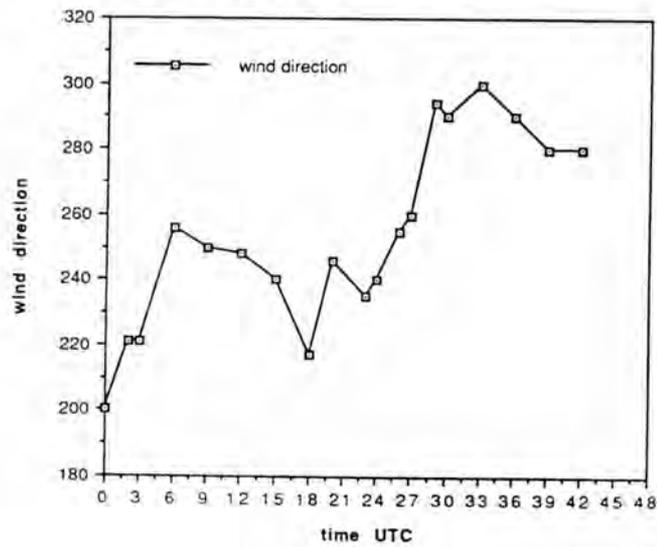
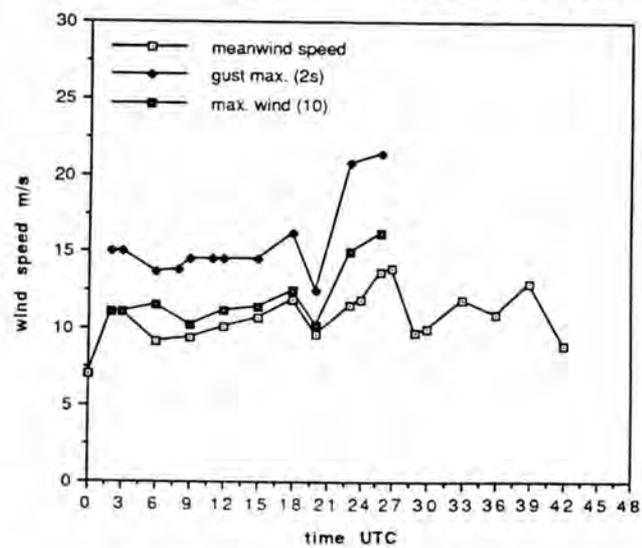
VÄNÖ AUTOMATIC STATION 27.9-28.9 1994
WIND DIRECTION

VÄNÖ AUTOMATIC STATION 27.9-28.9 1994
10 min. MEAN AND MAX. WIND SPEED , 2 sec. GUST

Fig. 9. Vänö automatic station weather observations 27.9-28.9 1994

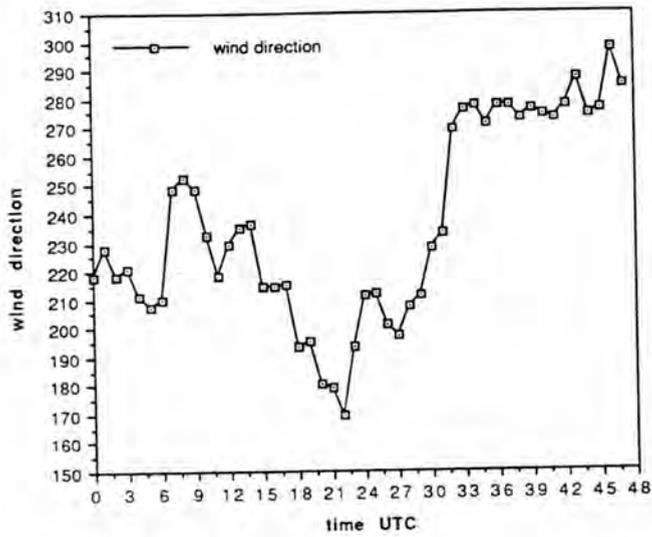
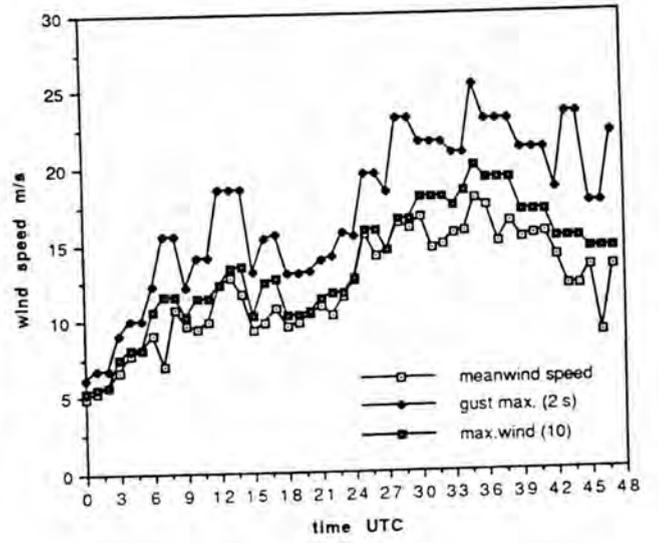
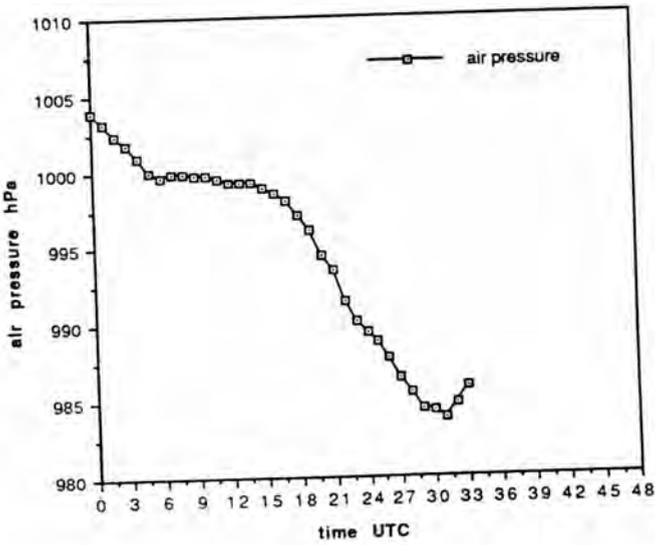
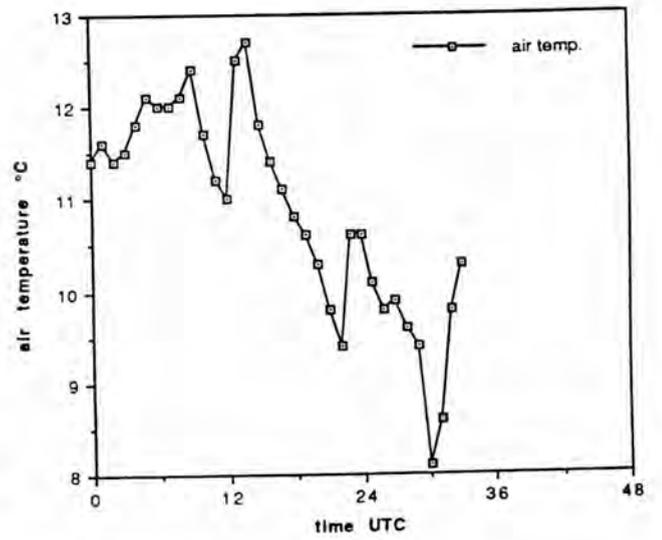
Fig. 10. Prangli automatic station weather observations 27.9-28.9 1994

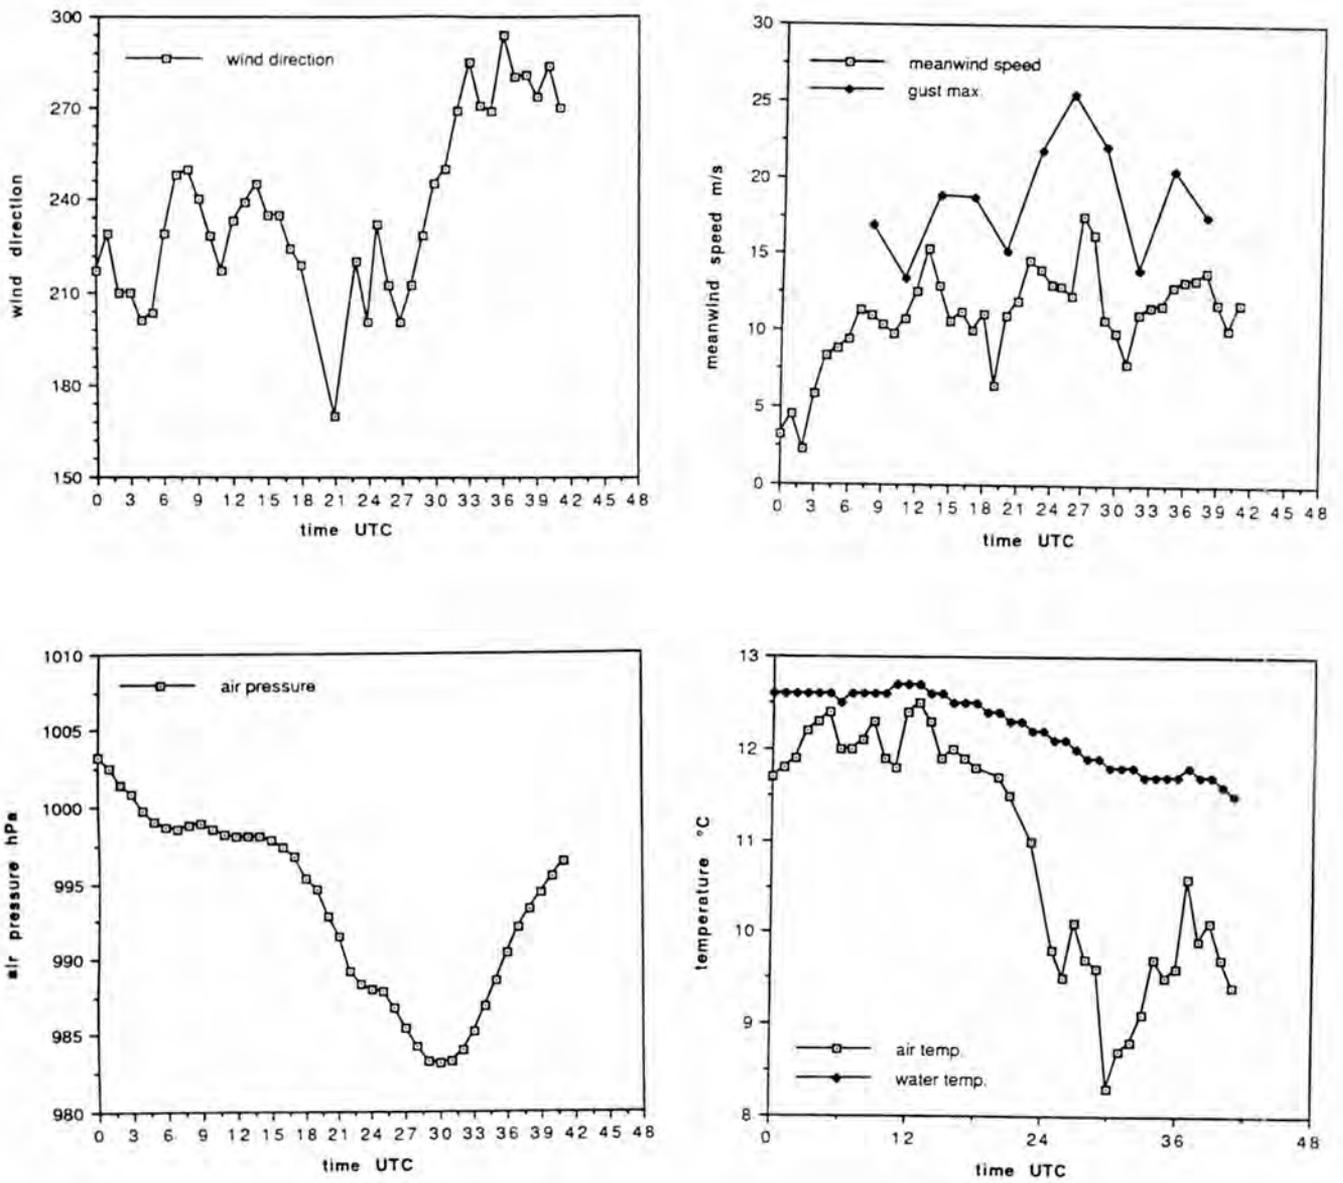
Fig. 11. Harmaja automatic station weather observations 27.9-28.9 1994

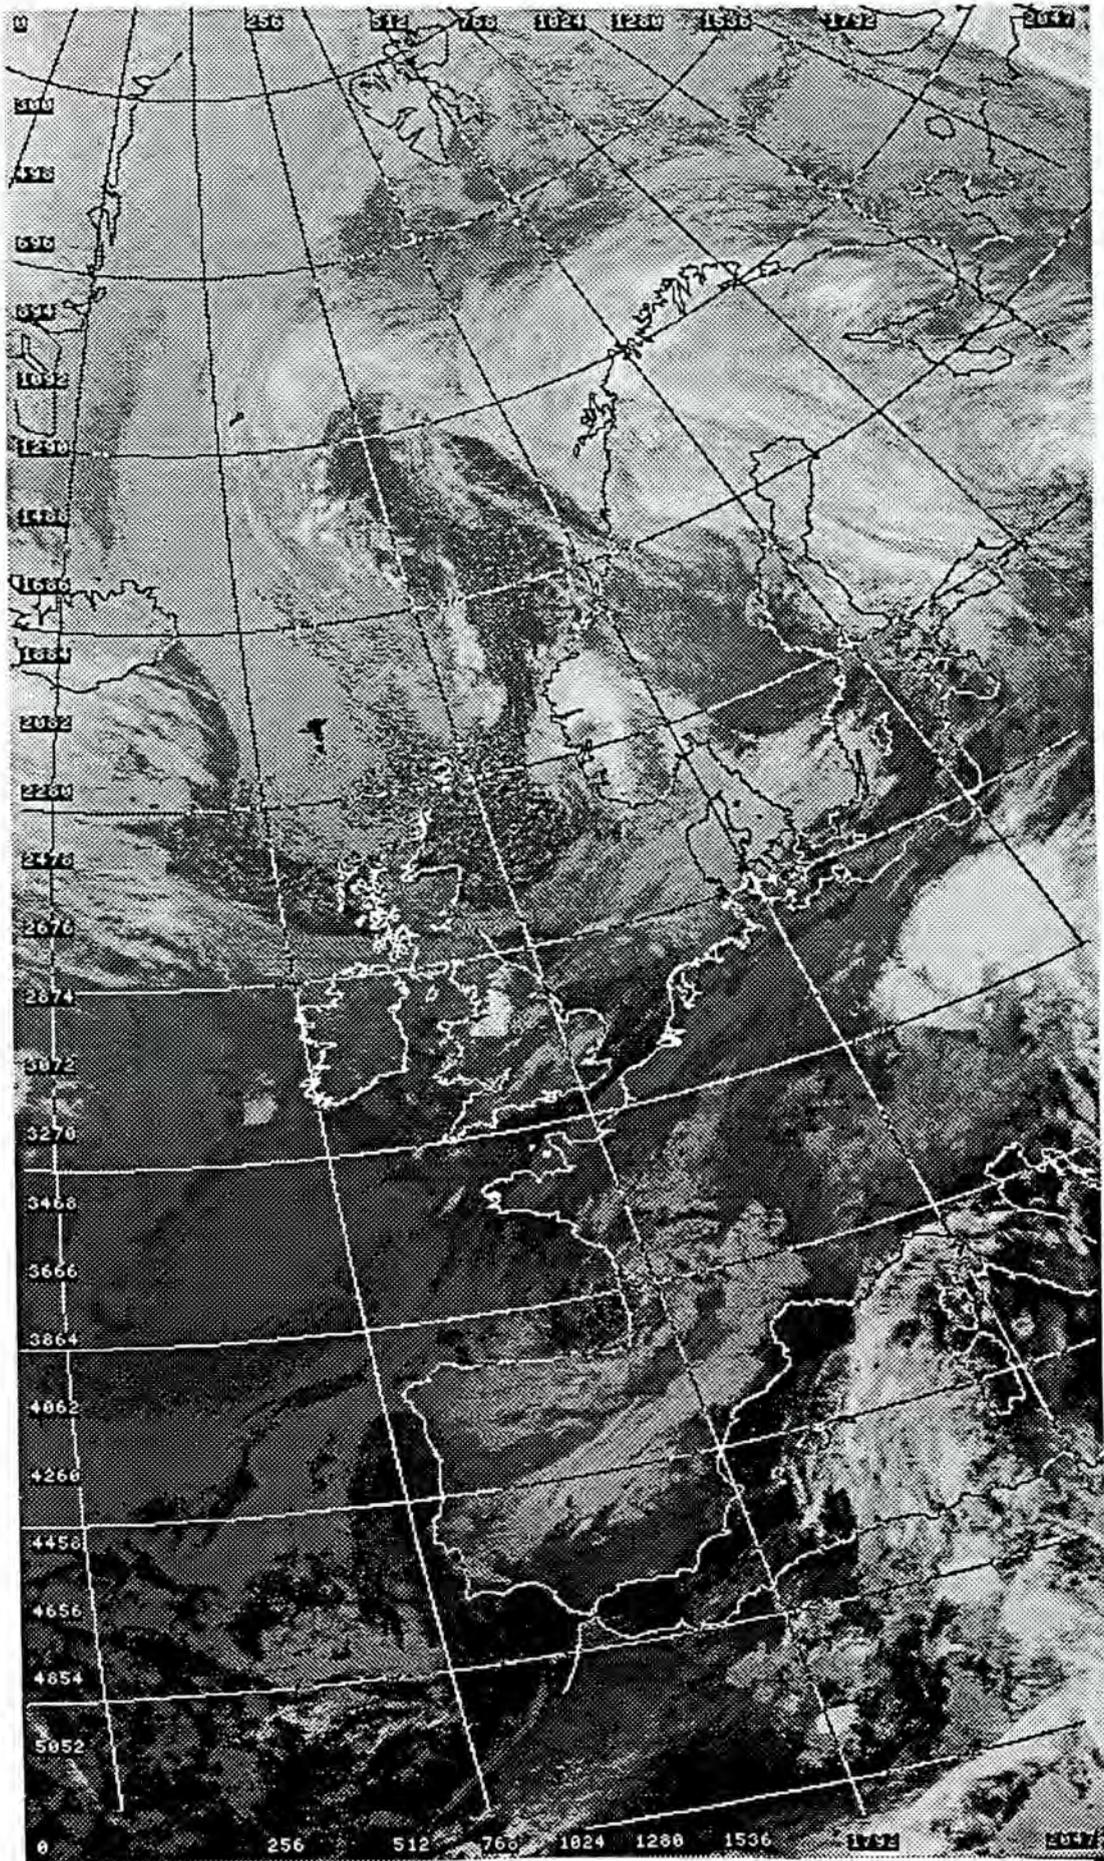
Fig. 12. The satellite image received from NOAA (at 06.46 UTC on 27.9.1994)

Satellite images received from NOAA are for the times of 06.46 UTC on 27.9.1994 and 06 UTC on 28.9.1994. The developing cloud and frontal area over southern Scandinavia can be seen from the images to move over the period of a day to Finland. The satellite images can be found in Annex 2.

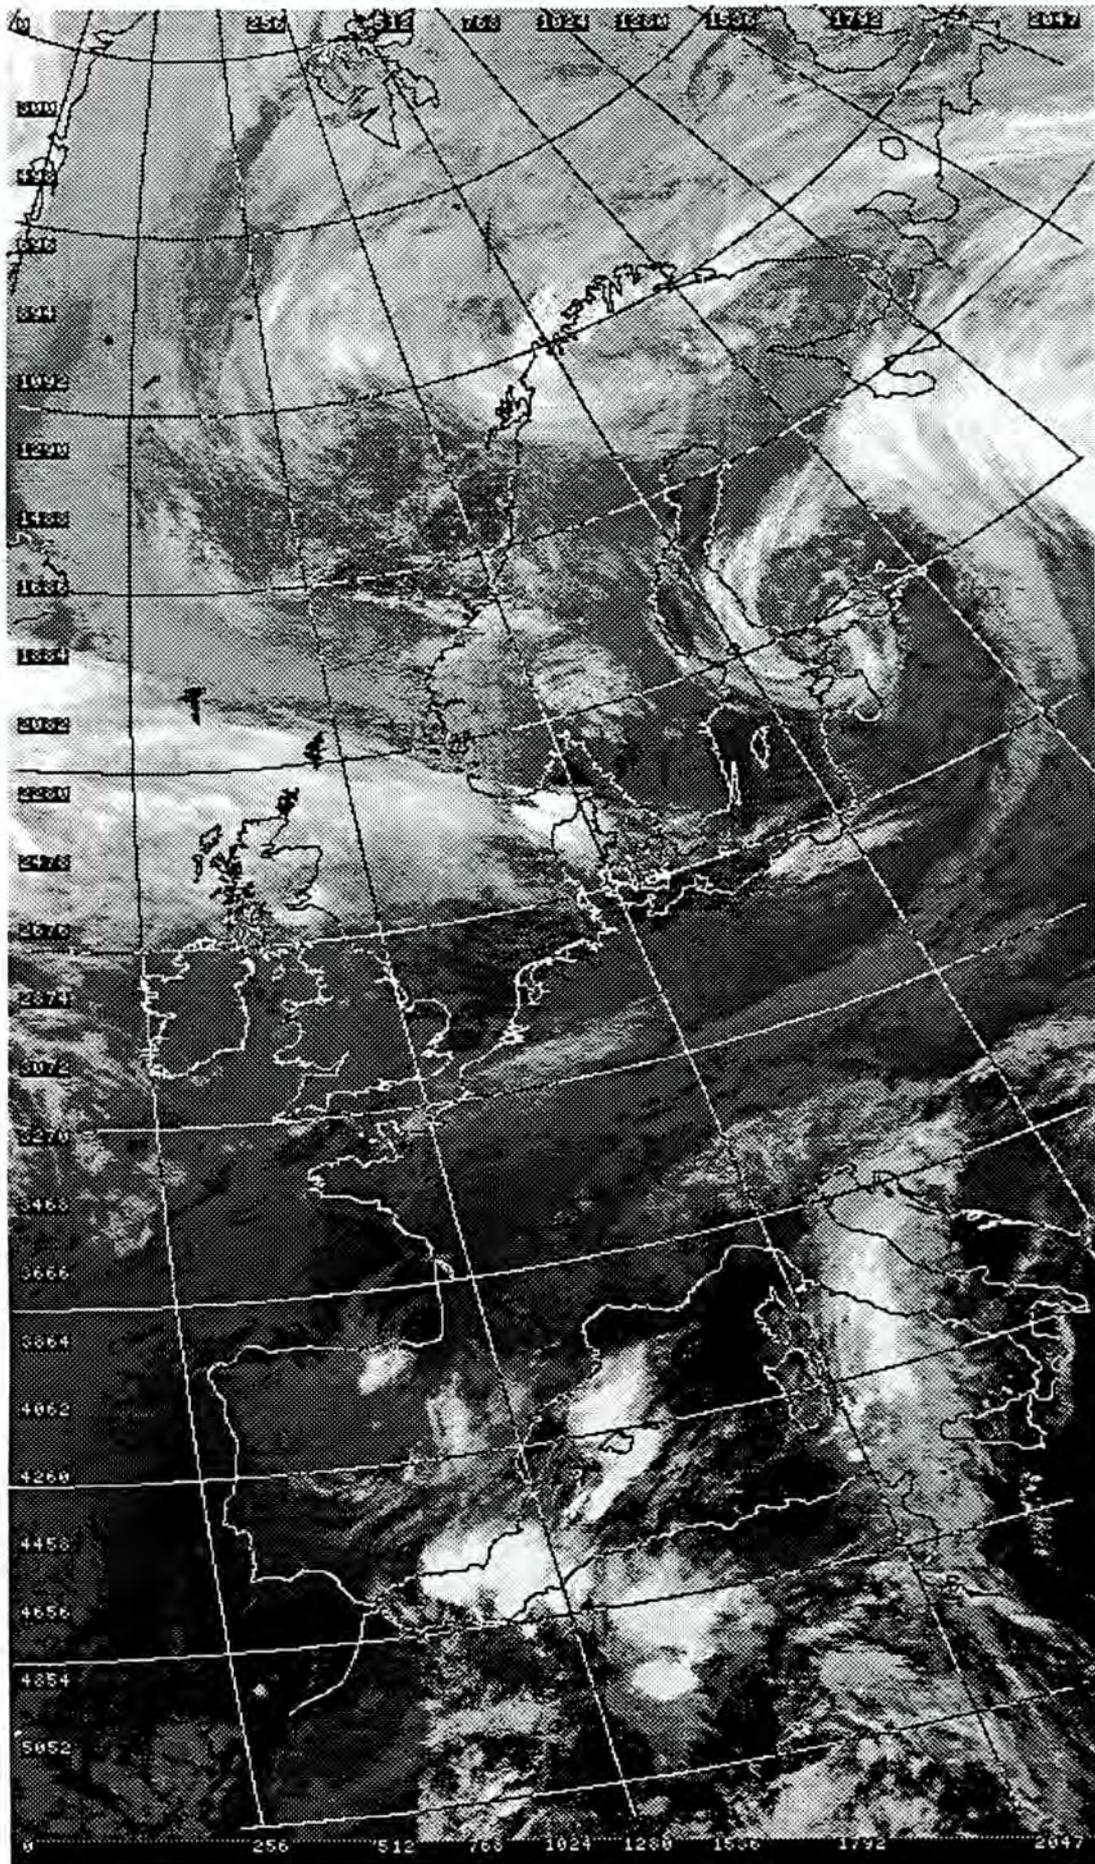
Fig. 13. The satellite image received from NOAA (at 06.00 UTC on 28.9.1994)

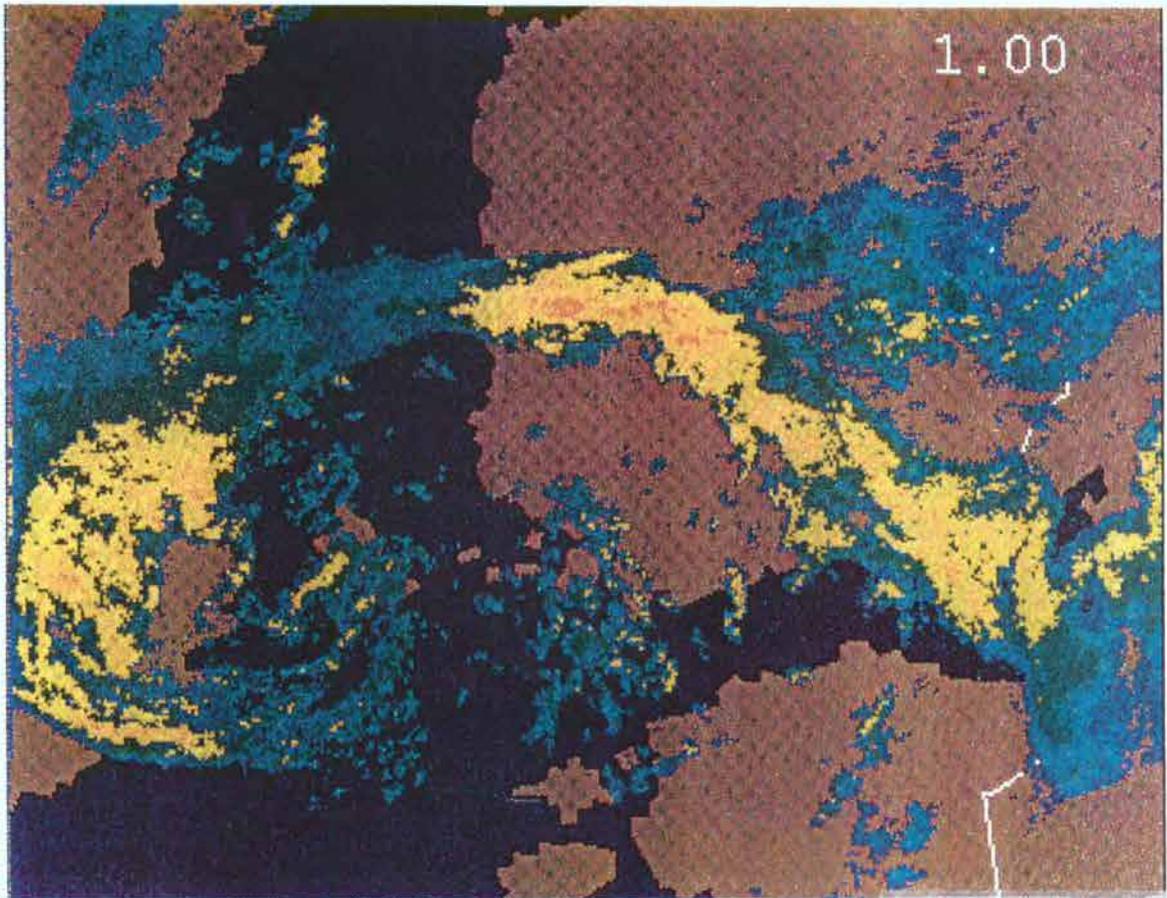
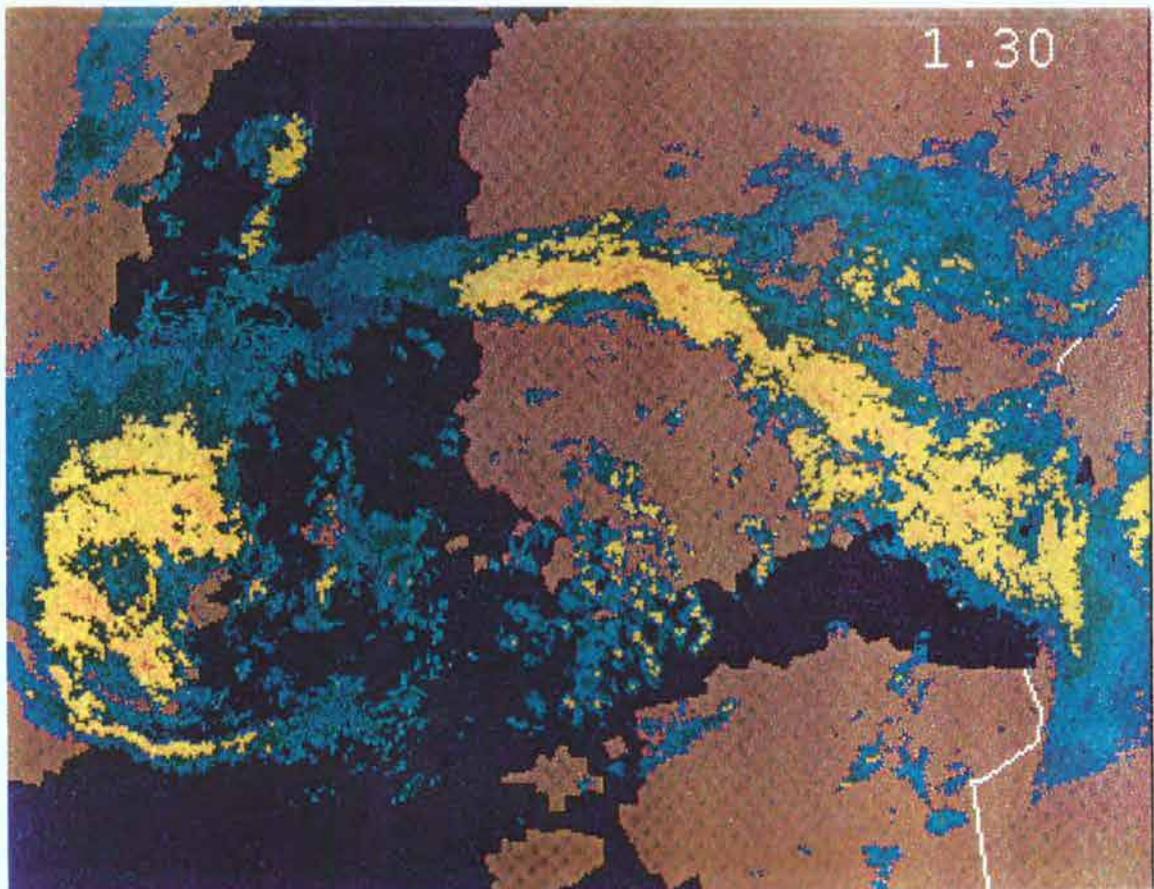
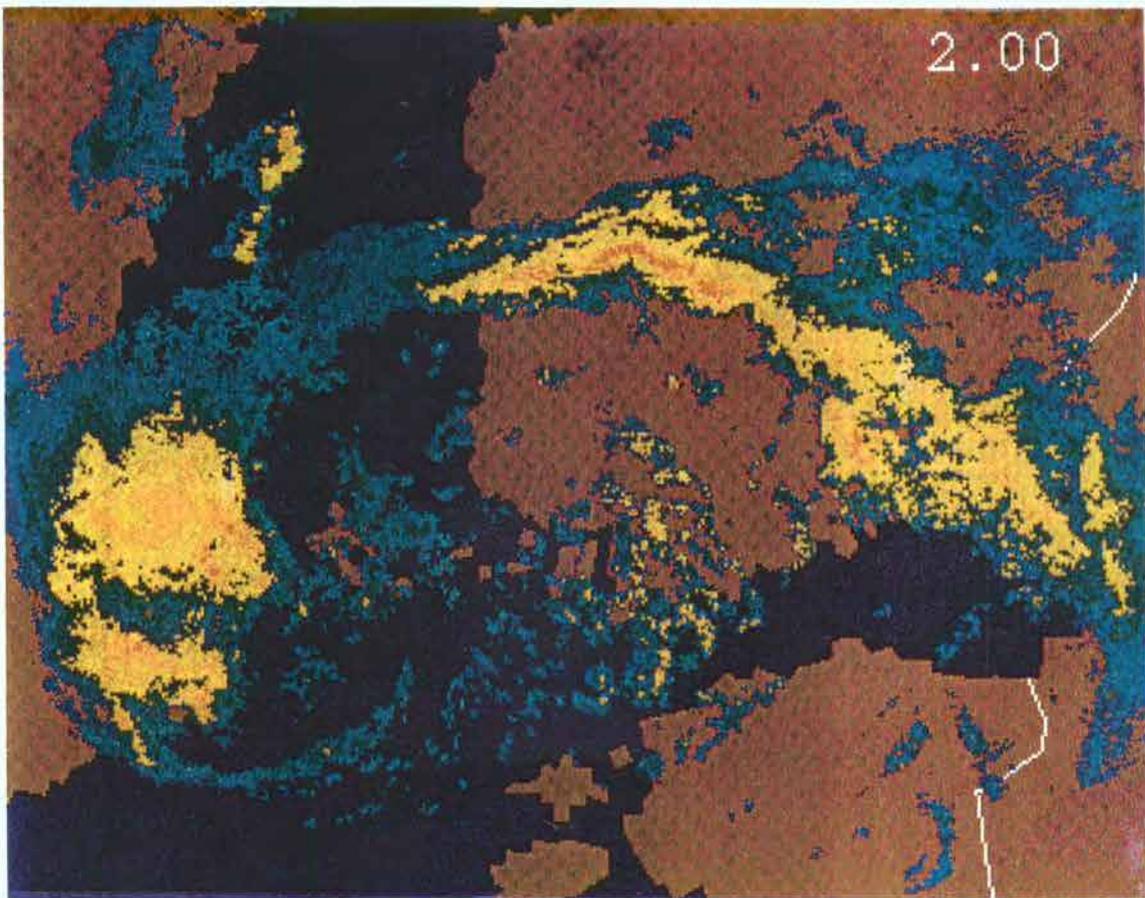
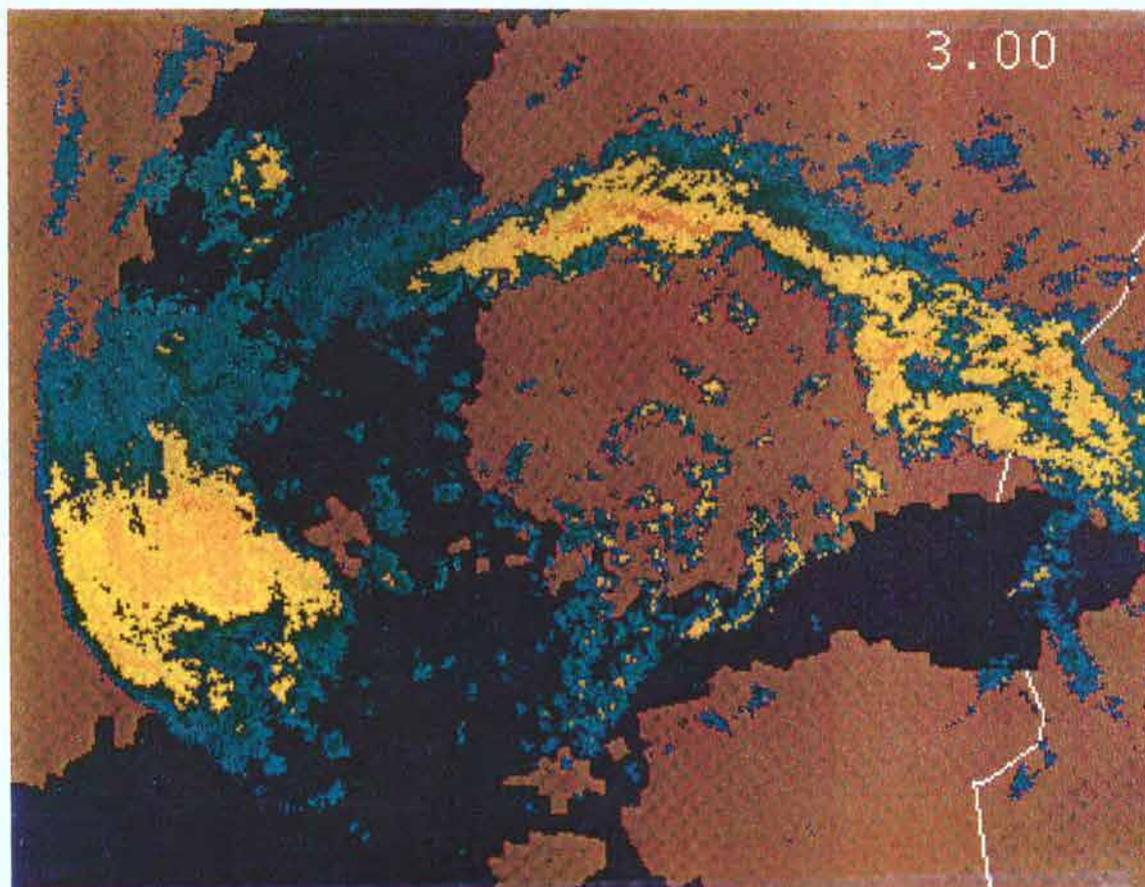
Fig. 14 A). The composite image on 27.9.1994 at 23.00 UTC (28.9.1994 01.00 local time).

Fig. 14 B). The composite image on 27.9.1994 at 23.30 UTC (28.9.1994 01.30 local time).

Fig. 14 C). The composite image on 28.9.1994 at 00.00 UTC (02.00 local time).

Fig. 14 D). The composite image on 28.9.1994 at 01.00 UTC (03.00 local time).

Fig. 14 A), B), C), D). The composite image contains data from the three Finnish radars at Anjalankoski, Ikaalinen and Vantaa, as well as from the Swedish radars at Arlanda, Hudiksvall, Örnköldsvik and Gotland. The series contains images from data on 27.9.1994 at 23.00 and 23.30 UTC, on 28.9.1994 at 00 and 01 UTC (local time 28.9.1994 01.00, 01.30, 02.00 and 03.00).

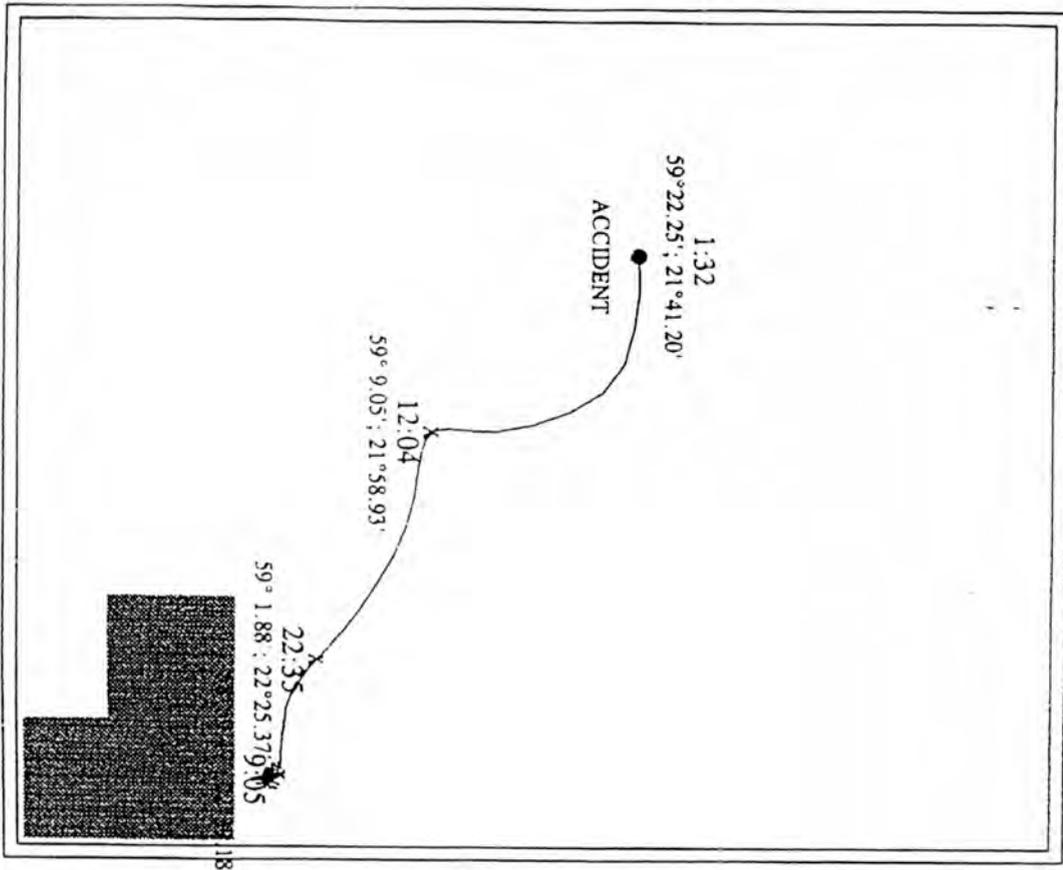
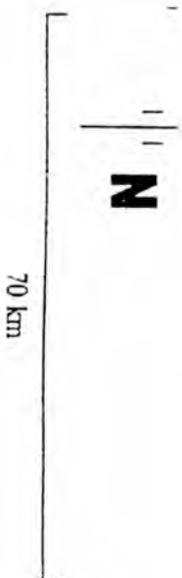
Estonia, effect of flow and wind Estonia, virtaus + tuulivaikutus

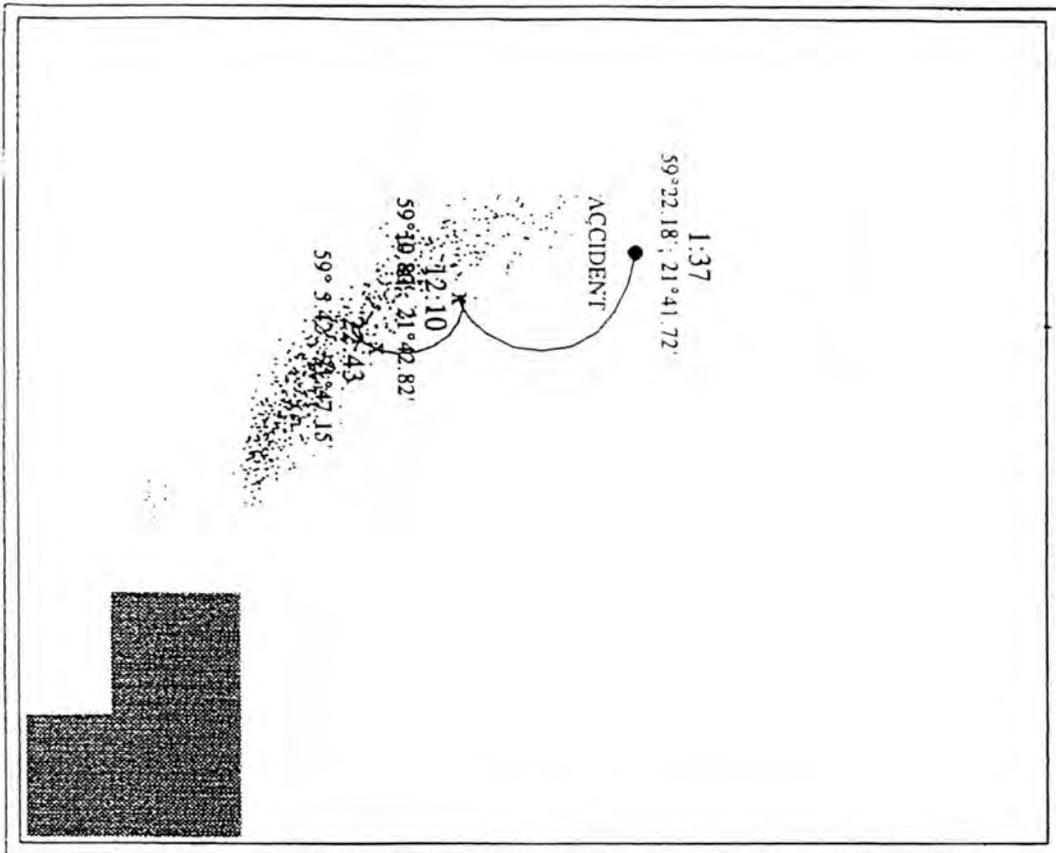
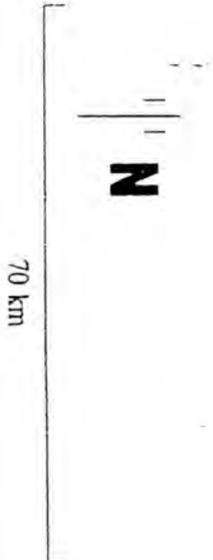
Estonia, spreading of the oil

Estonia, öljyn leviäminen
