THE FINAL REPORT ON THE CAPSIZING ON 28
SEPTEMBER 1994 IN THE BALTIC SEA OF THE
RO-RO PASSENGER VESSEL MV ESTONIA

The Joint Accident Investigation Commission
of
Estonia, Finland and Sweden

The Joint Accident Investigation Commission publishes in this Supplement the most important documents used in Commission's work. Large appendices of some research reports have been edited, but a list of appendices has been included.

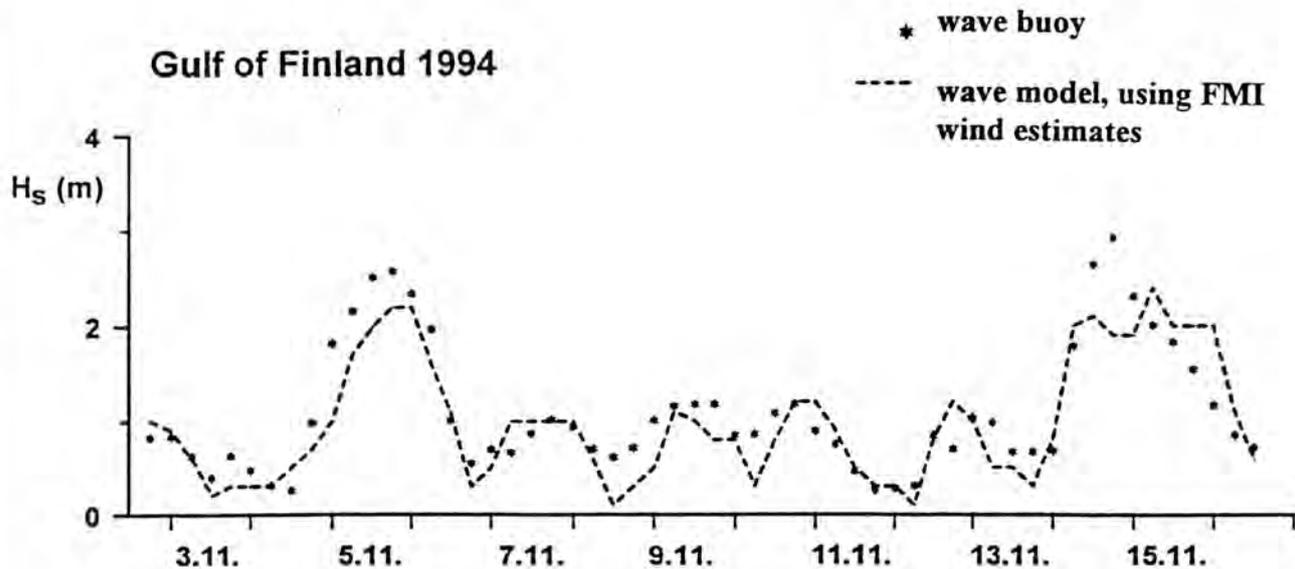
Figure 1. Model verification measurements made in the Gulf of Finland.

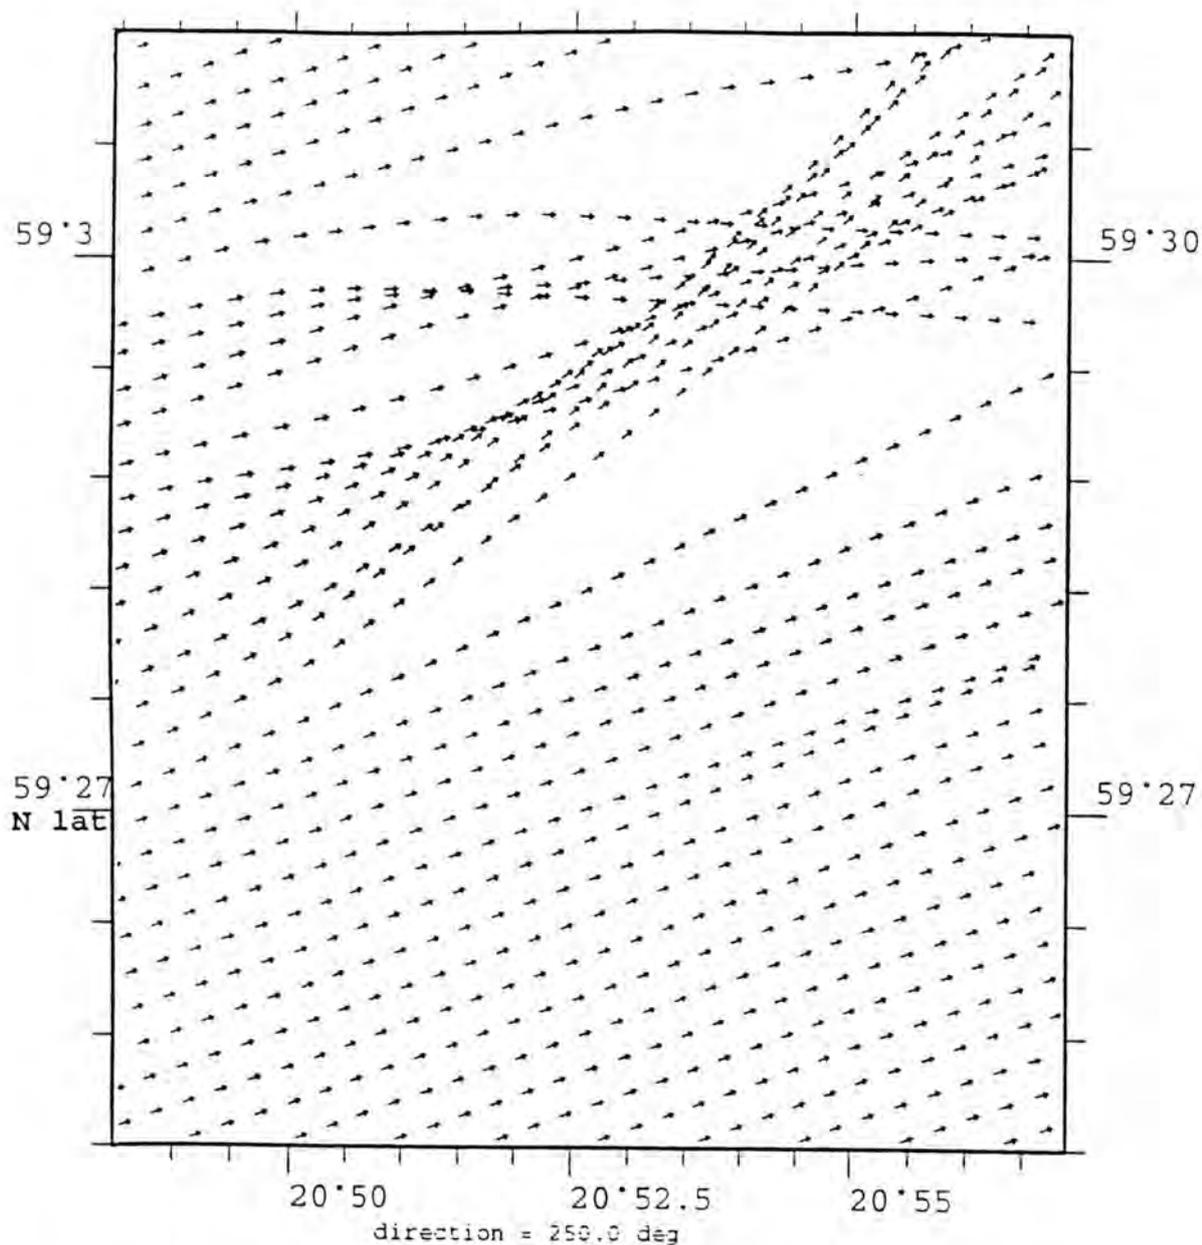
Figure 2a. Refraction of unidirectional waves (log crested swell) over a shoal, wave rays.

The refraction rays describe the behaviour of unidirectional waves. In practice this occurs only when swell is coming into the area from a great distance. When the sea is actively growing under the influence of wind, the direction of the incoming waves is distributed over a broad angle. When the significant wave height is estimated, all these different wave rays have to be taken into account. In our model the Monte-Carlo method proposed by Bouws and Battjes (1982) is used .

Calculations indicate that in the Northern Baltic Proper there are focal points where wave refraction in certain conditions can increase the wave height significantly above the surroundings. As an example of phenomenon we show the results at Suomen Leijona, about 25 nm from the place of accident (Fig. 2).

Figure 3 shows significant wave height of short crested storm waves behind the same shoal. While the wave height enhancement by refraction is up to double in the case of unidirectional swell (Fig.2.), actively growing wind generated waves are enhanced by factor 1.4 in this case. If the spreading is wider the maximum height is less.

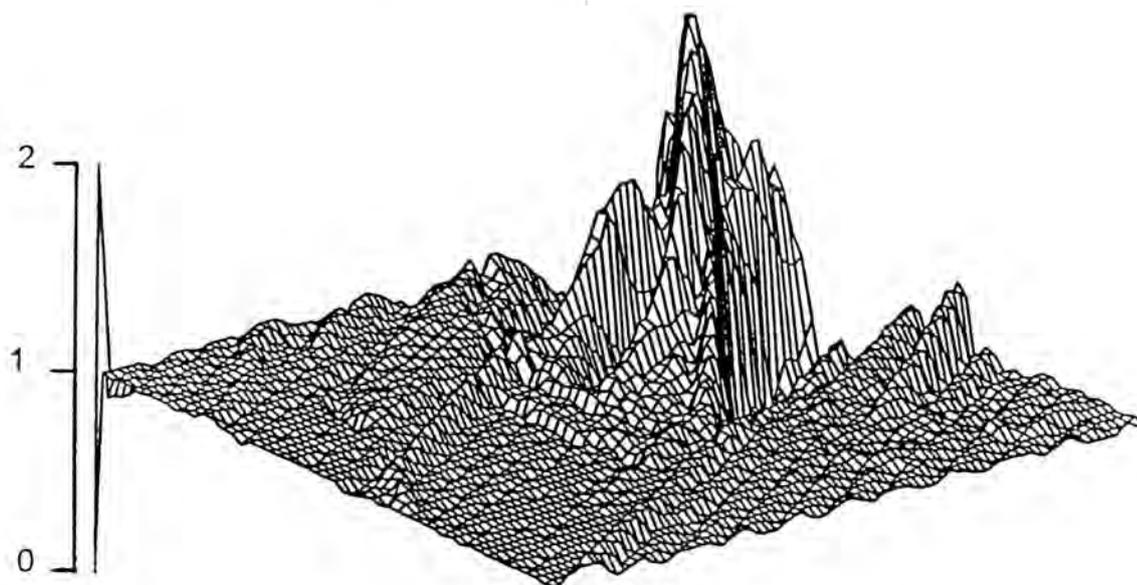
Suomen Leijona, period 8 s, Wind dir 250

Figure 2b. Refraction of unidirectional waves (log crested swell) over a shoal, the change in wave height.

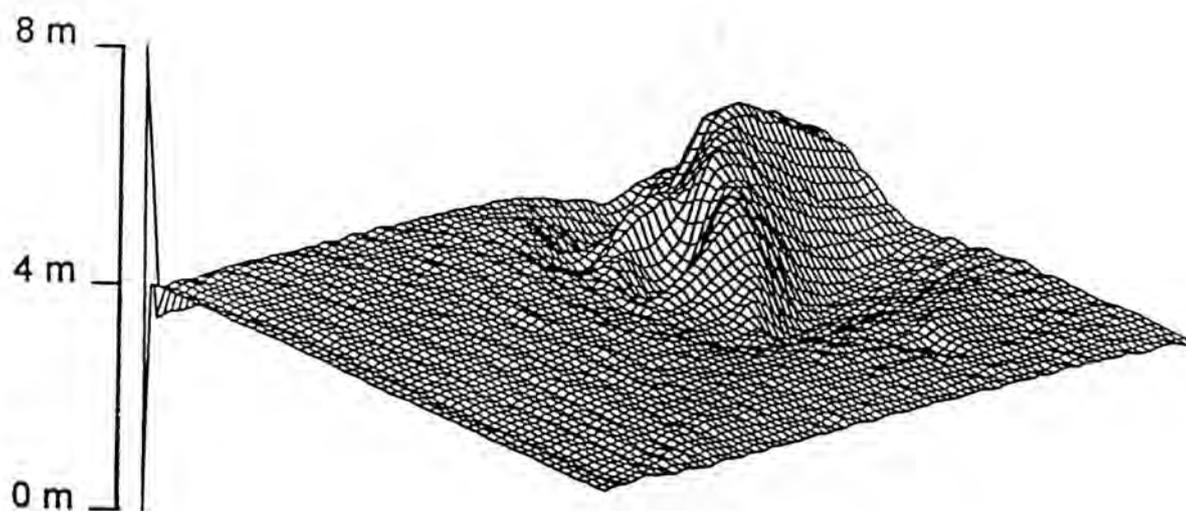
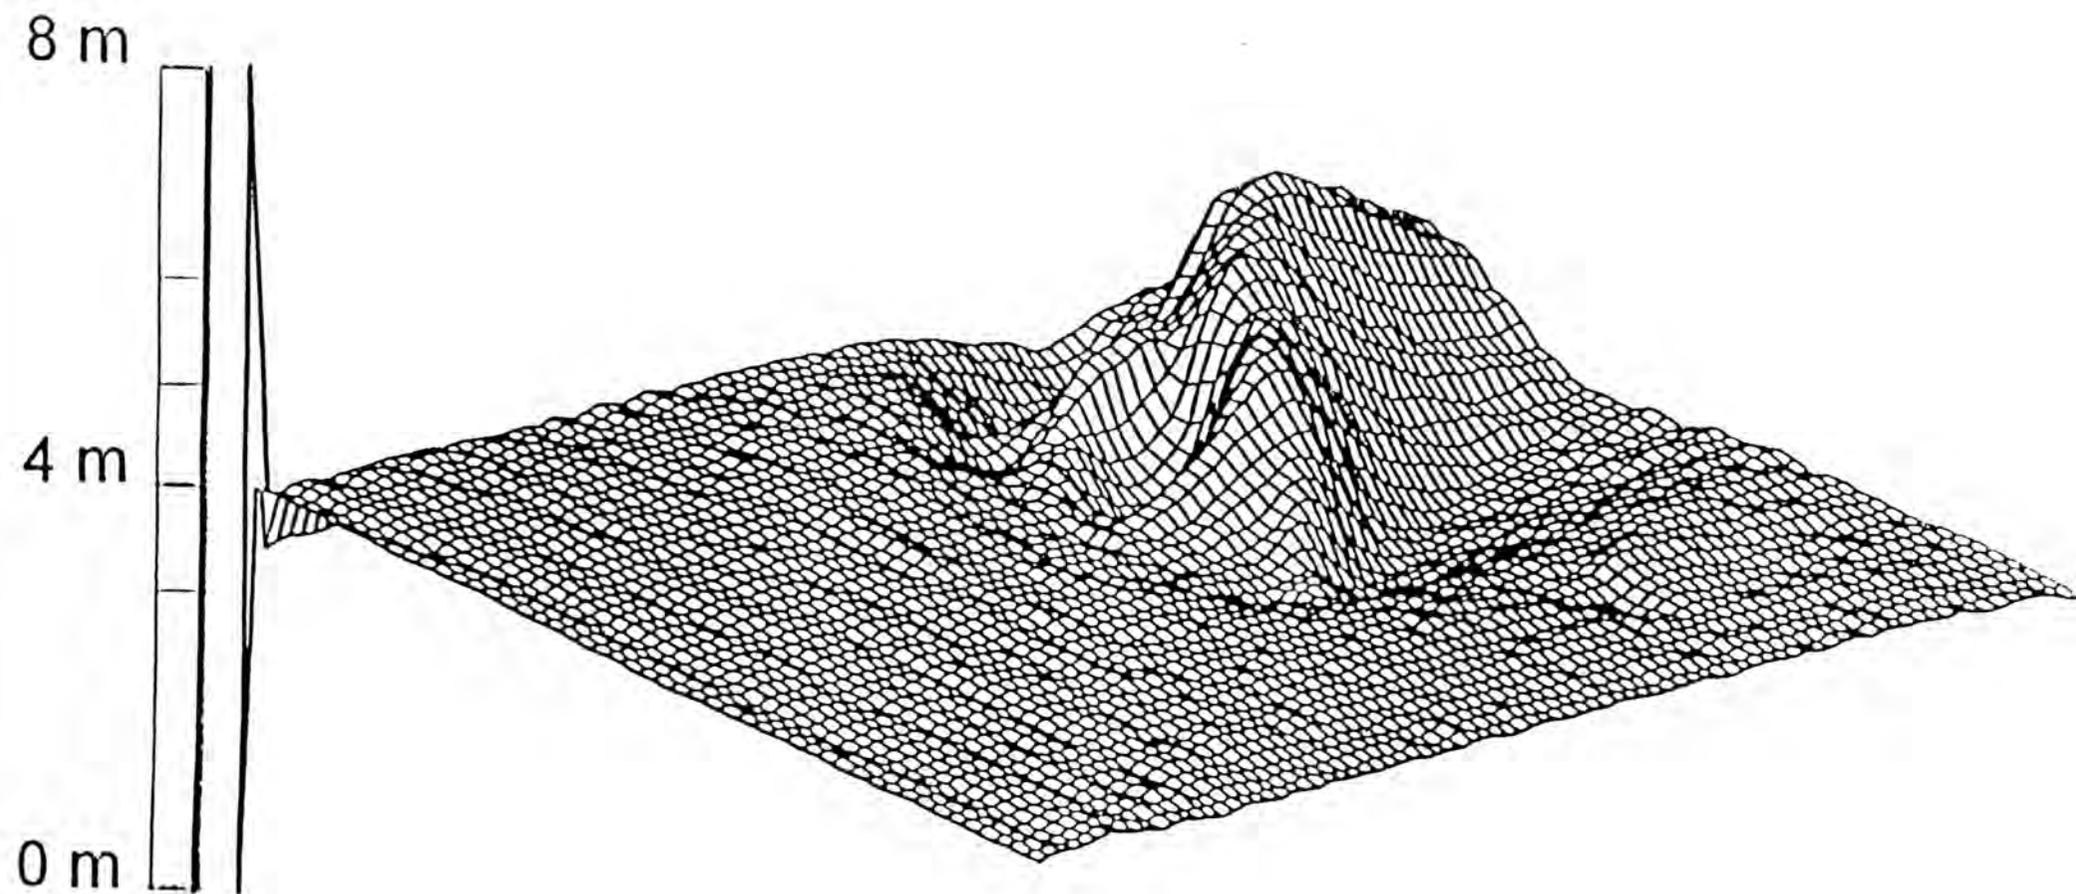
Suomen Leijona, period 8 s, Wind dir 250, beta=3.7

Figure 3. Refraction of wind generated waves (short crested storm waves) over the same shoal. Period 8 s, significant wave height 4 m before the shoal. Wave spreading 14 degrees.

We want to emphasize that the estimates how much the wave height will increase are very sensitive to the details of the topography and the directional properties of the wave spectrum, as well as the assumptions of the physics of the growth of wind generated waves. Estimates of the enhancement of the wave height by refraction are inaccurate when the waves are actively growing by the wind.

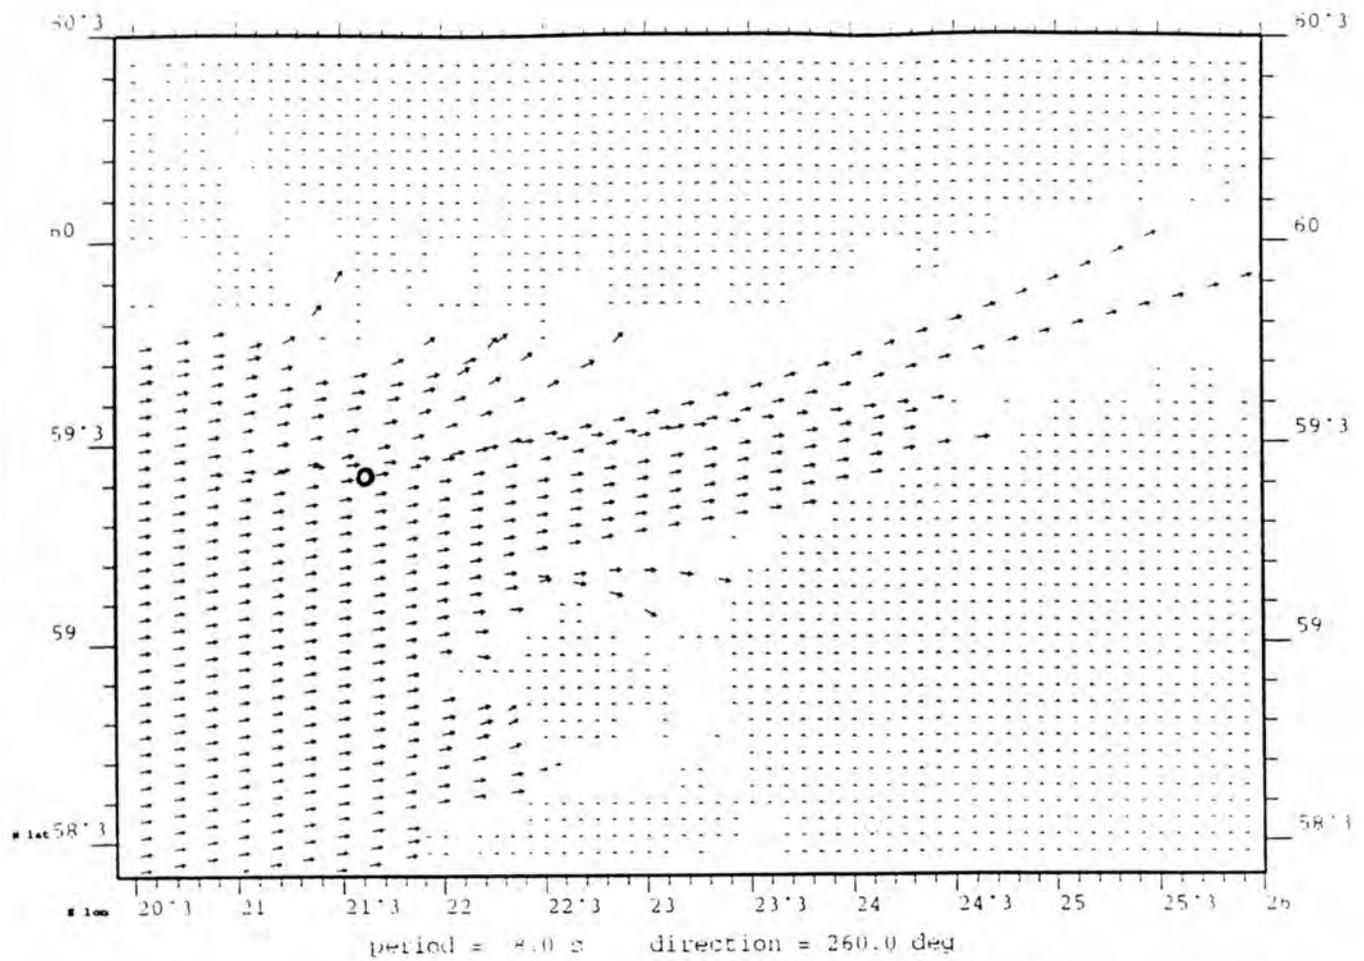
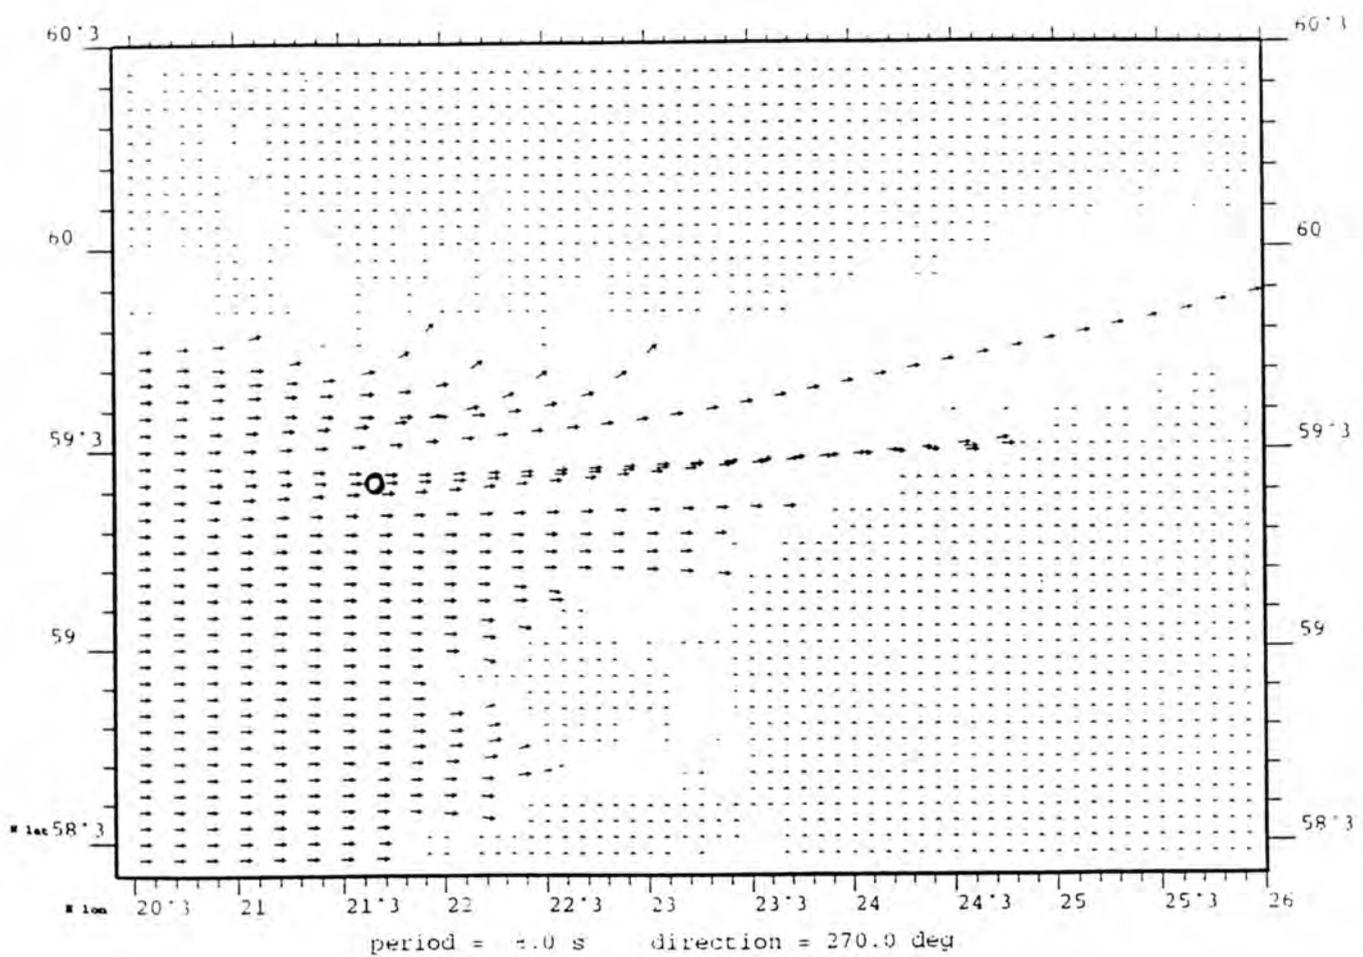
Figure 4. Wave rays, waves coming initially from 260° and 270°, period 8 s.

The series of maps in Appendix B shows the wave rays calculated separately for waves coming in from different directions at intervals of 5° , and having different periods in the range 7 s to 9 s. An example is shown as Fig.4. In the refraction map the length of the arrow is directly proportional to the group velocity of the waves.

Figure 4 shows that refraction occurs at 8 second period waves on the northern Baltic Proper. The wave height of unidirectional swell would increase at places where the rays converge. The point of accident is shown by a circle. The waves coming from 270 degrees are enhanced there.

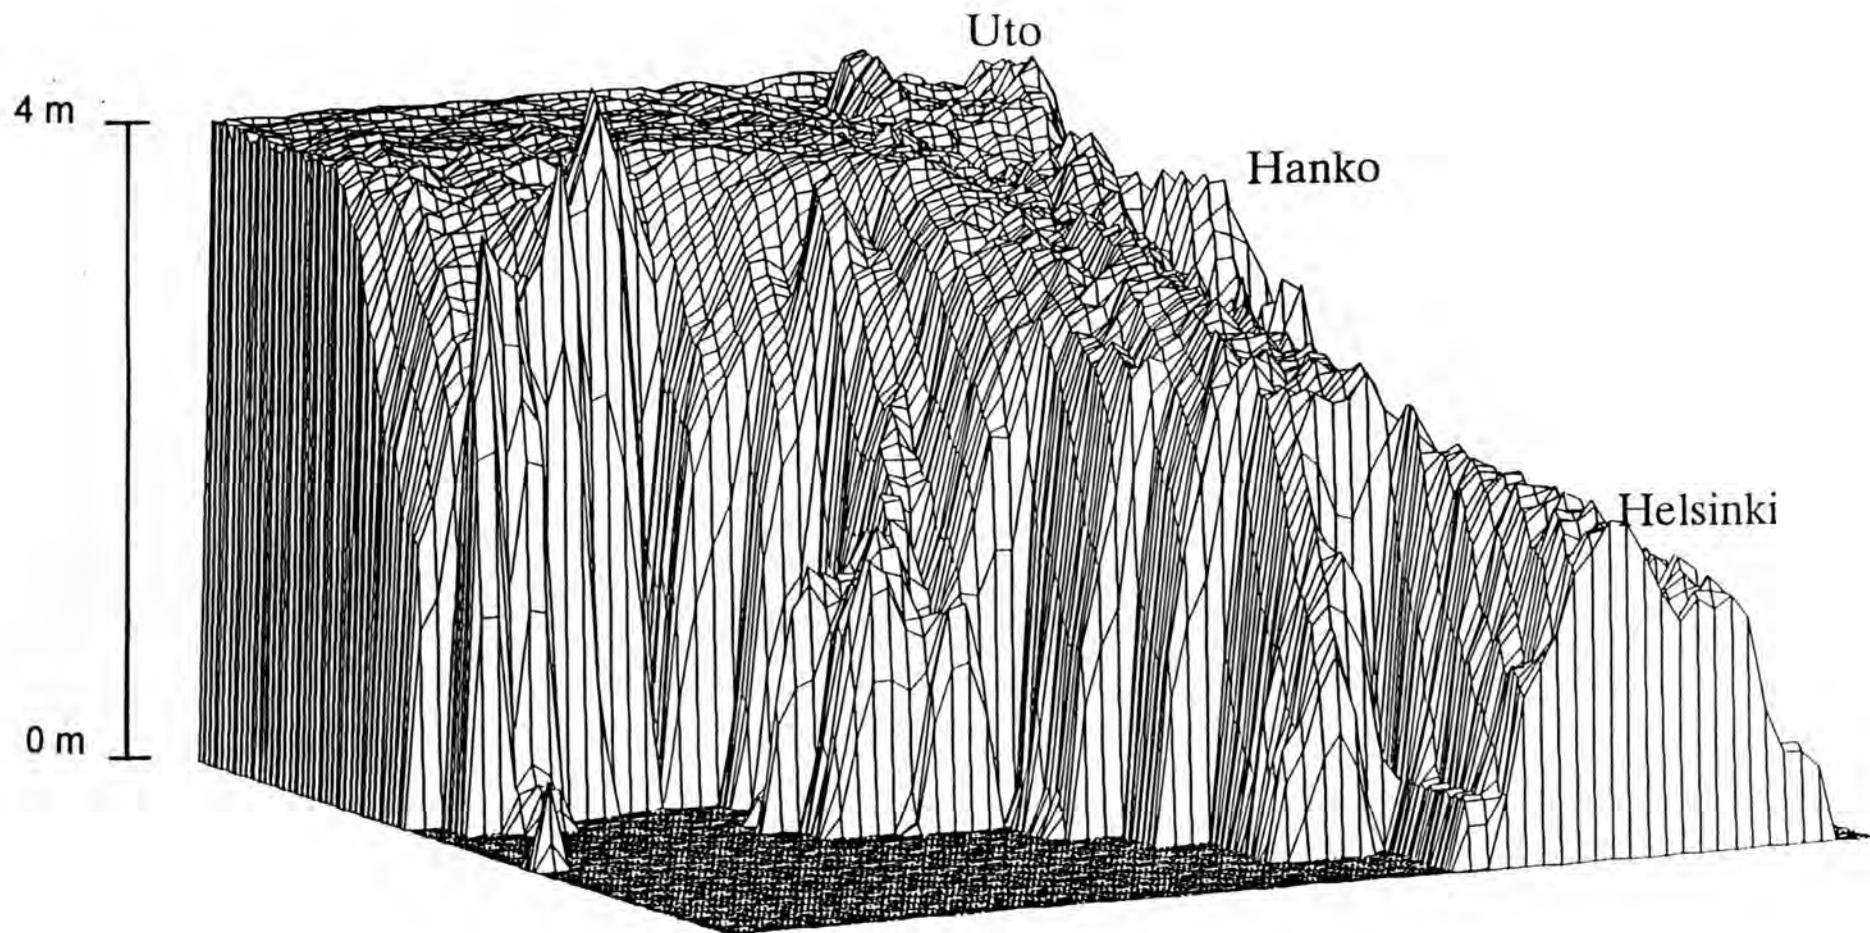
dir 260 deg, $T_p=8$ s

Figure 5. Significant wave height, predicted by the large scale refraction model.

When the angular spreading of growing waves is taken into account the refraction from this large scale bottom topography does not increase the wave height of a growing sea along the assumed route of M/S Estonia (Fig.5). This means that the wave forecasts in section 3 that ignore the refraction can be used to estimate the general wave height along the route. On the other hand the directional properties are changed. This could enhance the refraction if there is a shoal along the route.

Fig.5 also shows how waves arriving from the Baltic Proper would decay as they propagate along the Gulf of Finland. This decay is somewhat overestimated, if the wind is still blowing in the Gulf of Finland.

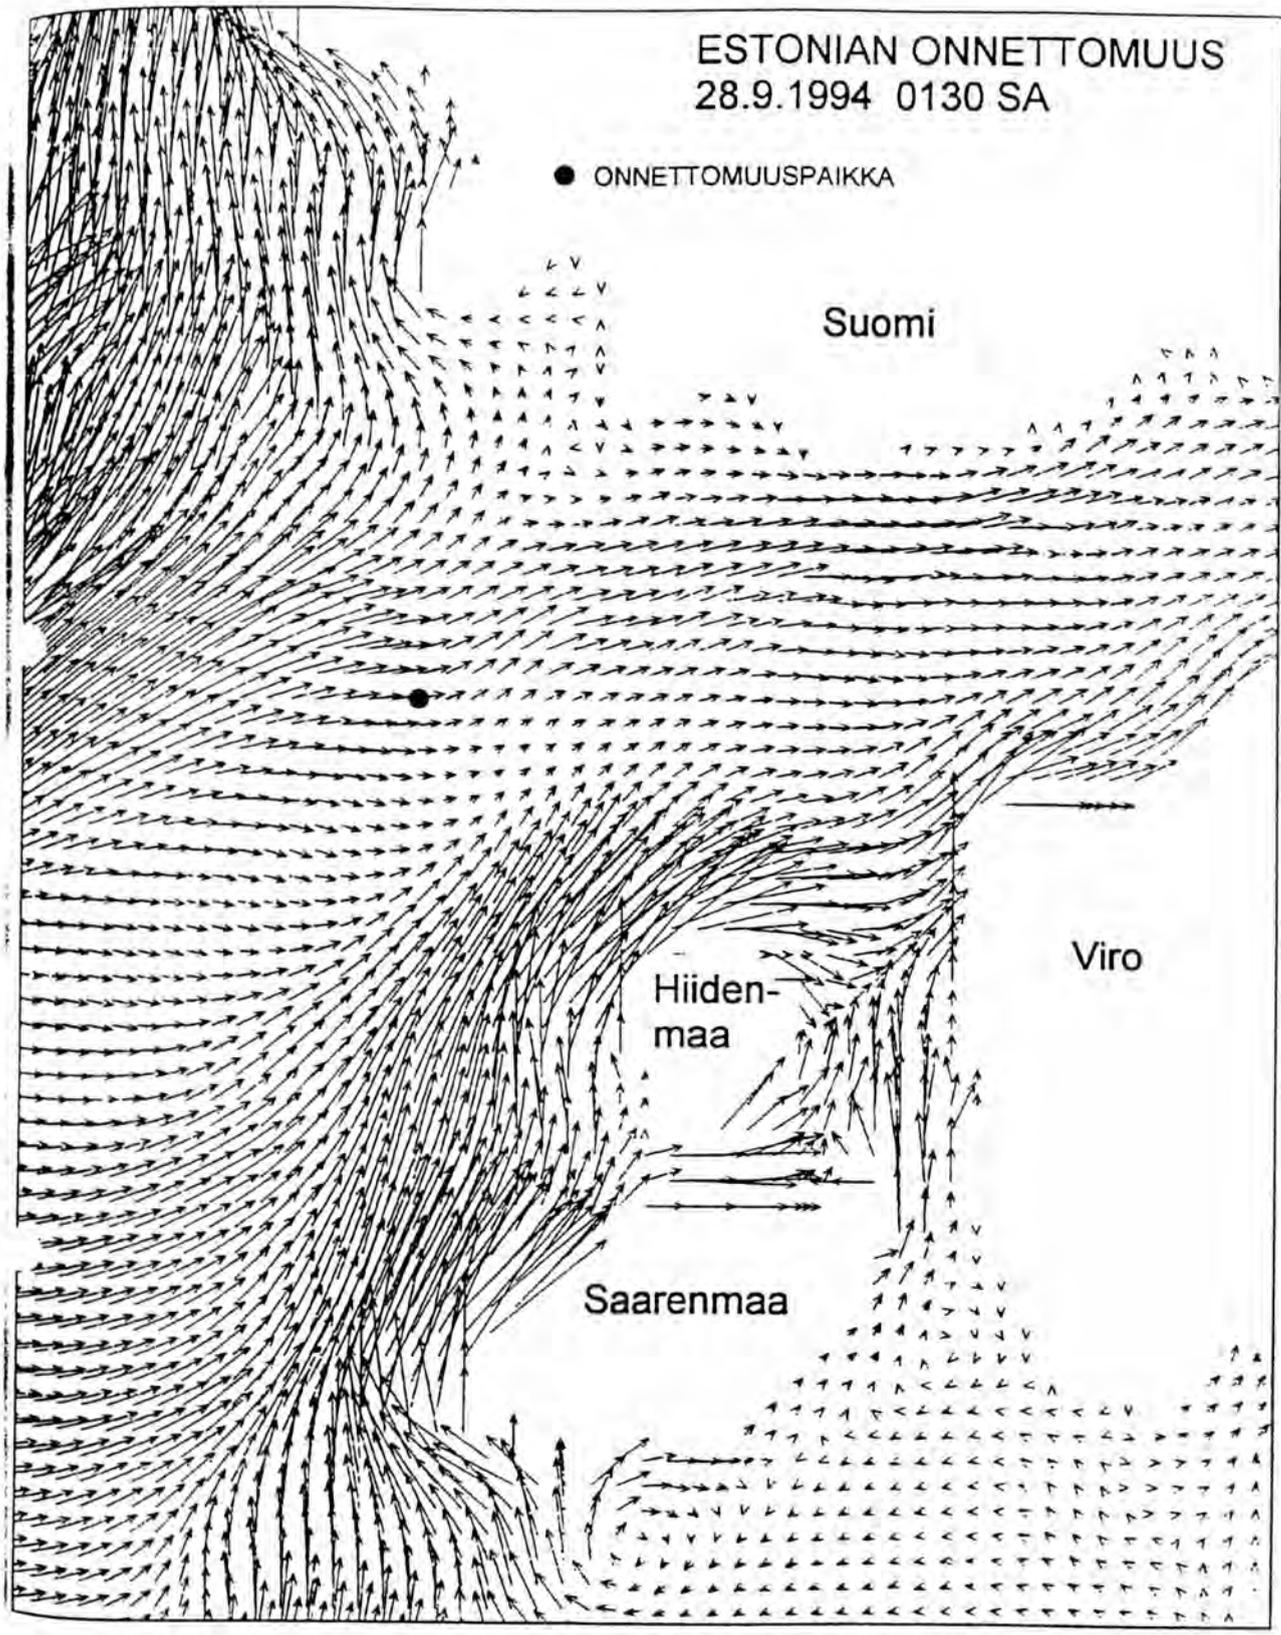
Figure 6. Surface currents at depth 0...5 m at September 28 1994 01:30 EST.

The current at depth 0...5 m at the time of the shipwreck is estimated to have been ca. 10 cm/s in direction 90° ... 100° , Figure 6. The dominate direction surface currents was between 45° and 90° . The speed varied between 10 cm/s and 30 cm/s. At site of the accident the surface current was smaller than nearby.

Surface currents were smaller than one could expect from the maximum wind speed. The reason is variation in the wind direction that also reduced the wave height.

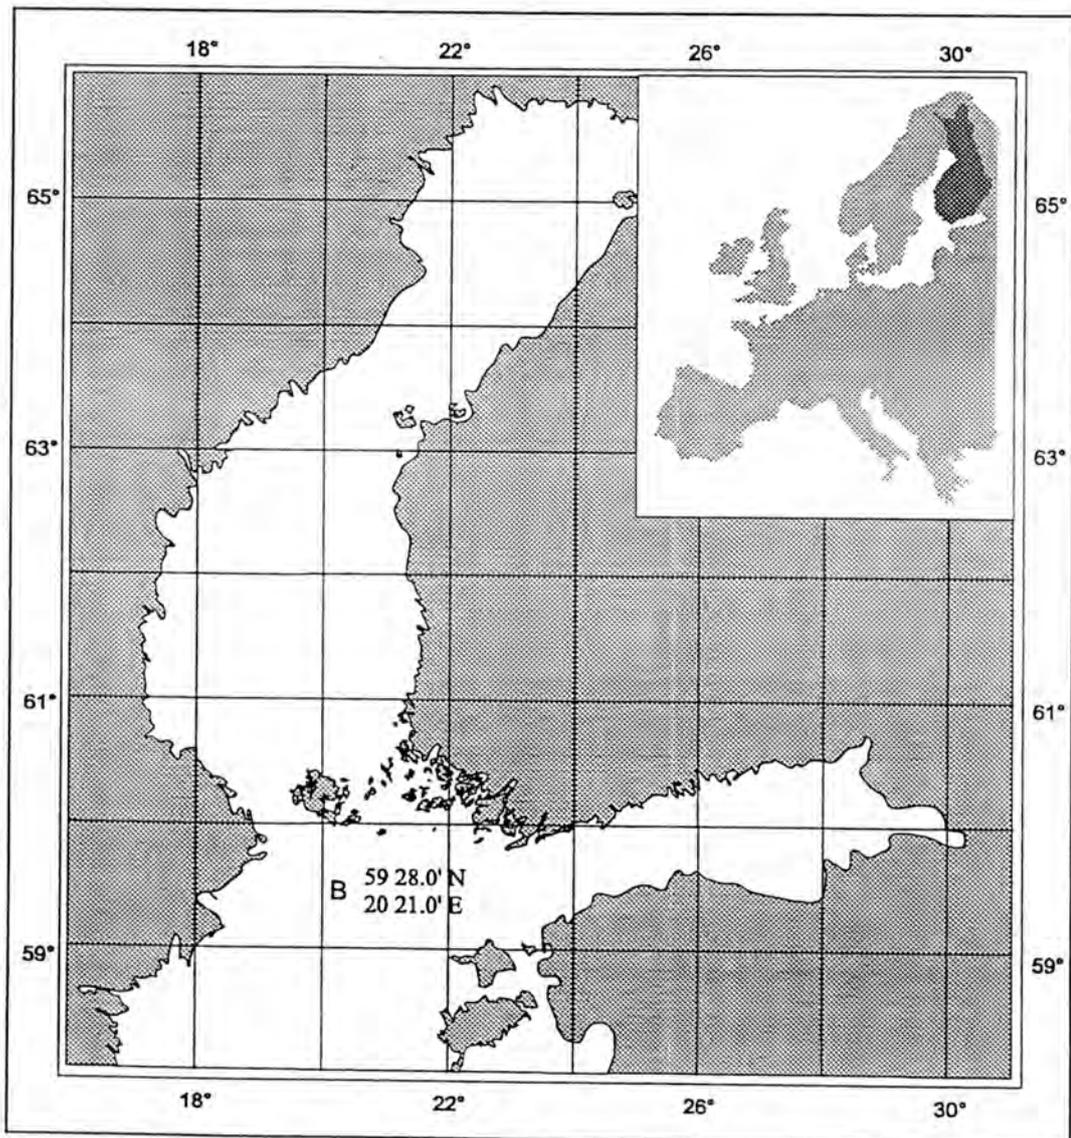
Figure 1. The wave measuring place (B), about 2.5 nautical miles south of the lighthouse of Bogskär.

The measuring point, denoted as B on the map, is about 2.5 nautical miles south of the lighthouse at Bogskär. The place represents well the conditions in the open sea in the Northern part of Baltic proper. The wave climate at Bogskär is not representative for the conditions to the north of latitude 59°45' N, where shallow water effects and islands create a wave climate that varies rapidly from place to place. This also applies to a smaller area behind the lighthouse Suomen Leijona.

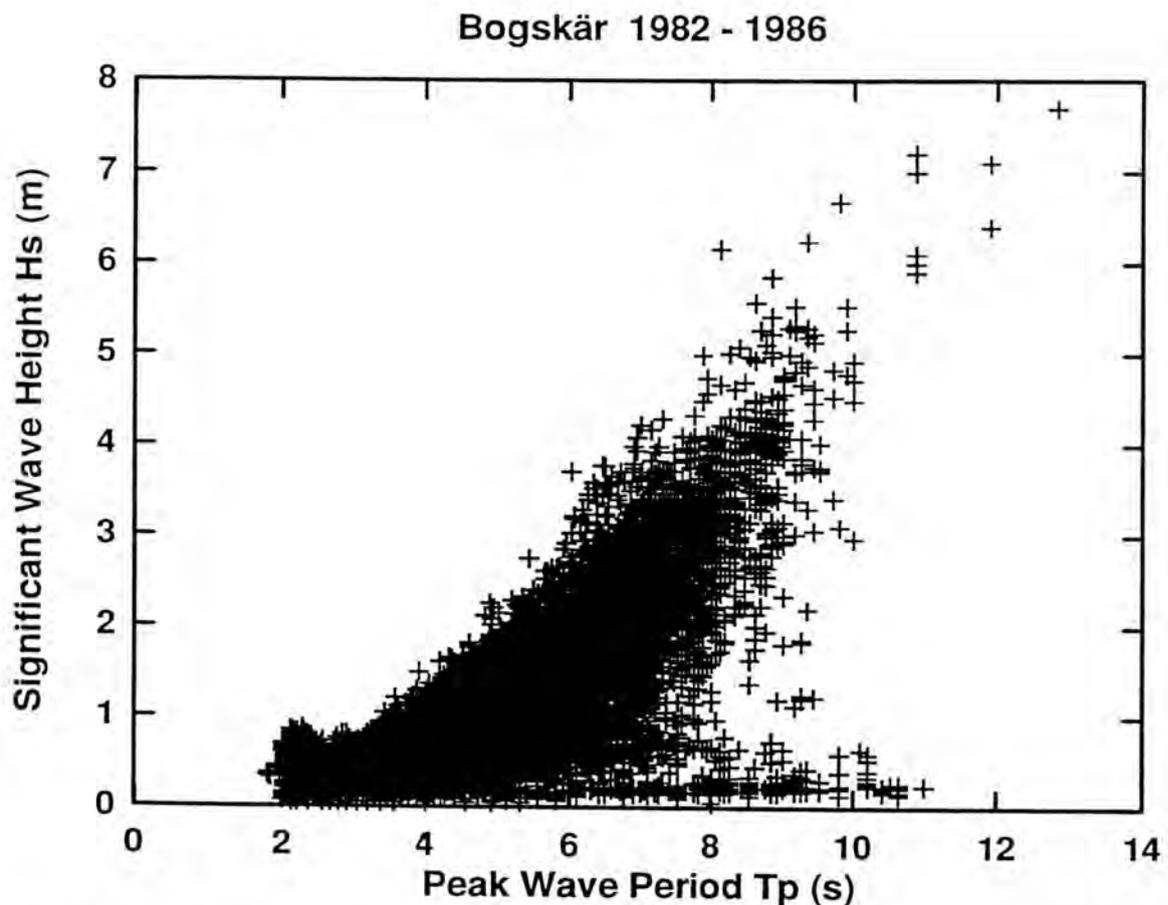
Figure 2. Scattering diagram of peak wave period and significant wave height from wave data collected at Bogskär in 1982...1986.

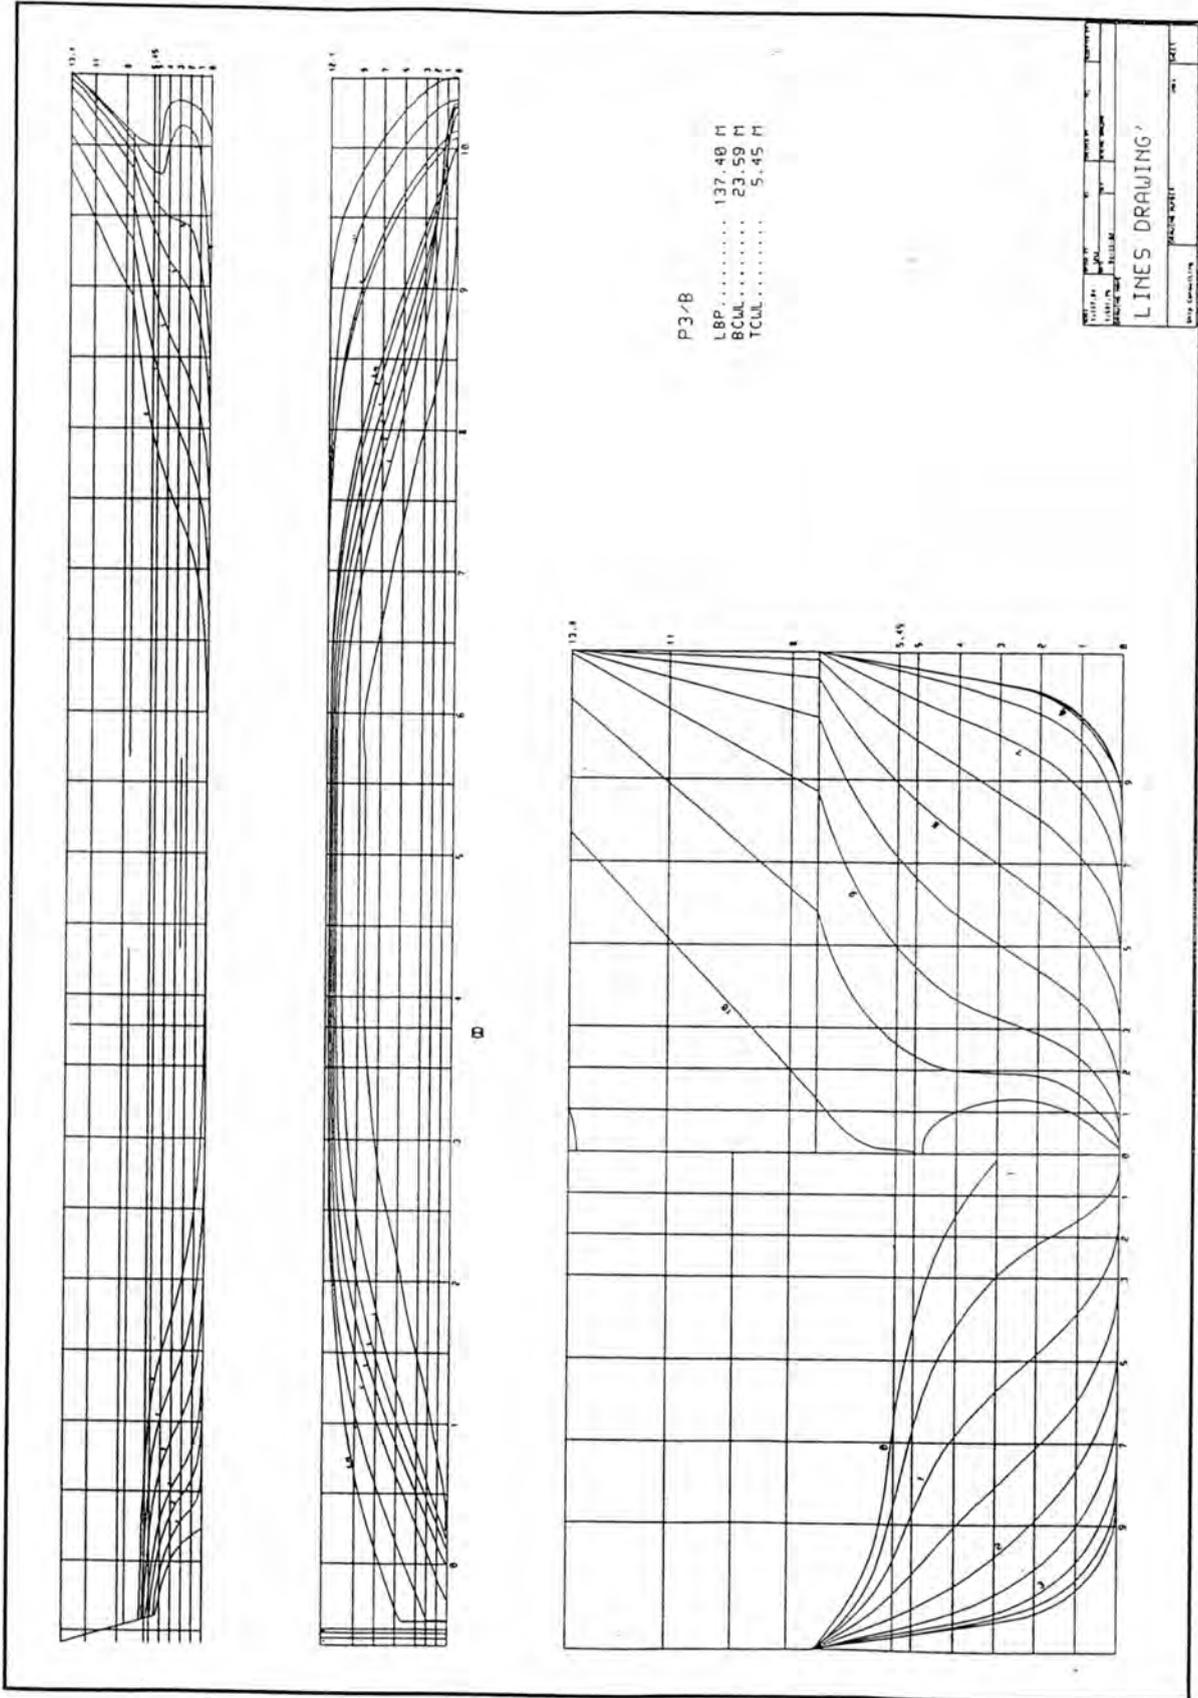
Fig. 2.1 Body and lines plan of MV Estonia.

Figure 2.1 shows the body plan and lines of MV Estonia. In the predictions of the heave and pitch Response Amplitude Operators by the SCORES-program (Raff, 1972) based on the strip method, the vessel hull form was defined by 11 and 21 sections. The number of sections had an insignificant effect on the wave-induced motions. Lewis-forms were used in defining the section shapes. Table 2.4 presents a summary of the main particulars of MV Estonia.

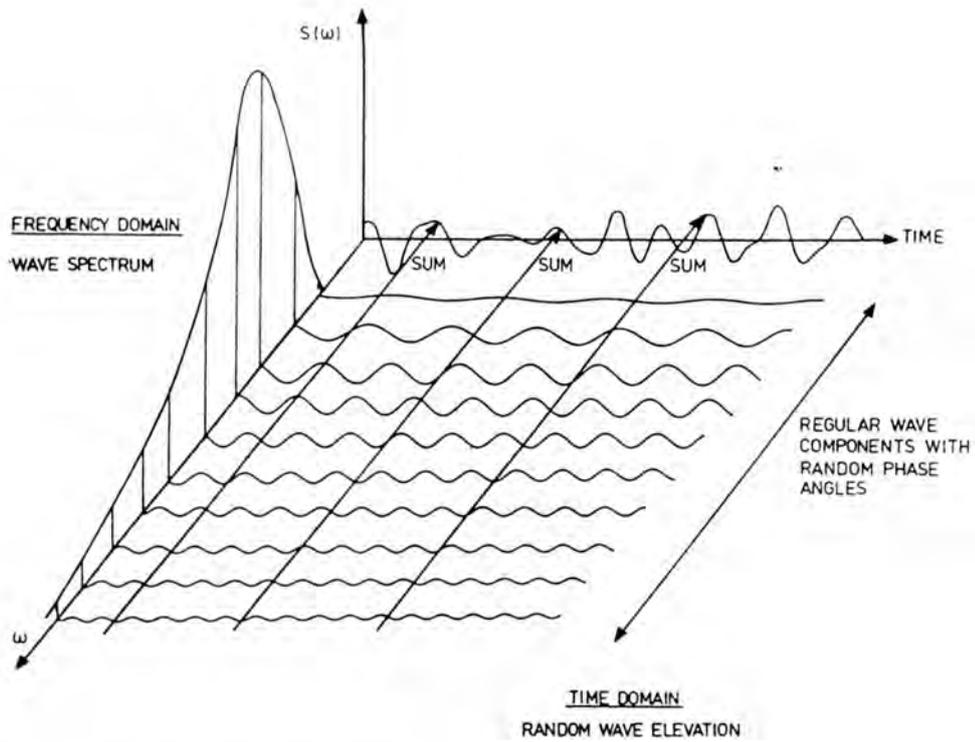
Fig. 3.1 The superposition principle (Faltinsen, 1990).

In the simulations, time histories of irregular waves, surface velocities and accelerations are generated by applying the linear superposition principle, i.e. a large number of regular sinusoidal wave components are summed (Fig.3.1). The amplitude of a regular wave component at frequency ω is determined on the basis of the ordinate of the simulated wave spectrum at ω . In order to get non-repeating random time histories of arbitrary length, each harmonic wave component has a random phase angle and its frequency ω is chosen at random in each narrow frequency band.

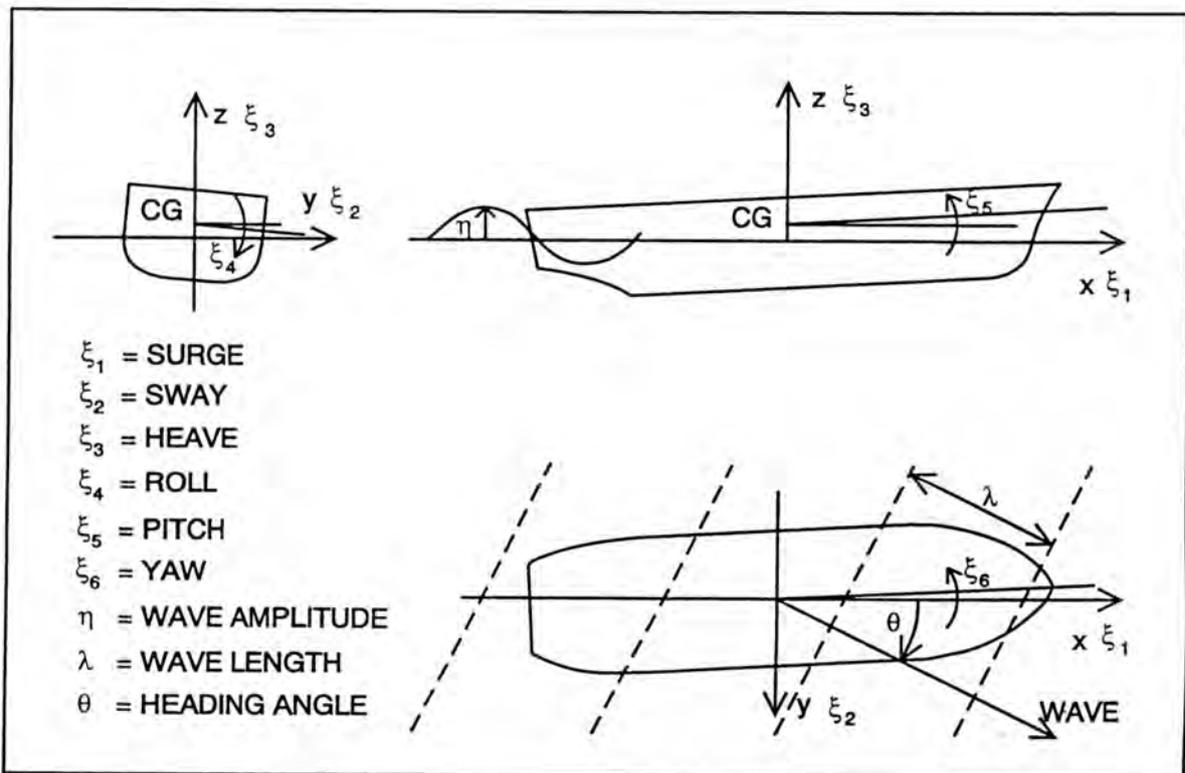
Fig. 3.2 Axis system and definitions.

The wave surface elevation (1) is defined in a Cartesian coordinate system (X,Y,Z) where the origin is fixed to the undisturbed free water surface defined by $Z = 0$. The positive direction of Z points upwards. The equation (1) may be transformed to a reference frame moving with the steady forward motion of the ship just by replacing the circular frequency of the i th harmonic wave component by the frequency of encounter:

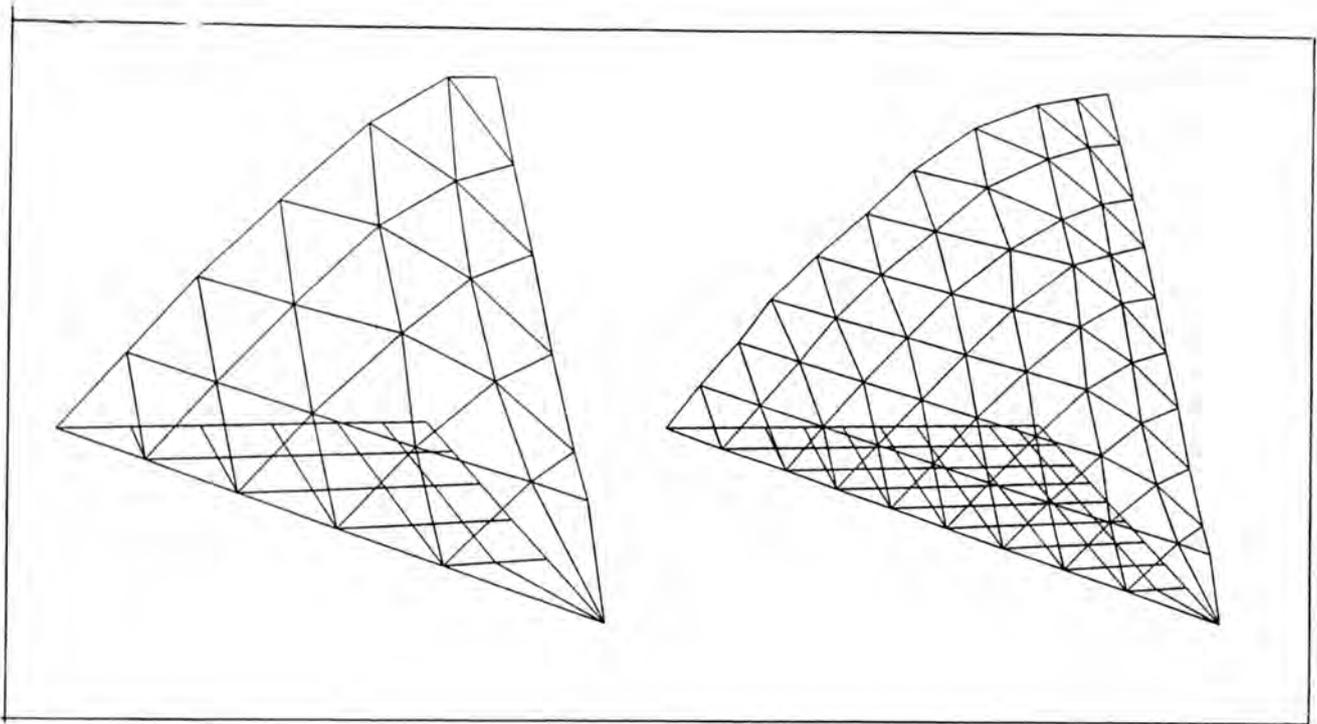
Fig. 3.3 Element mesh of the visor at 11 m and 15.4 m (right) draughts.

The heave added mass and damping coefficients of the visor at different waterlines have been computed by a three-dimensional sink-source method (Kalske et al., 1985) which is based on the numerical algorithm developed by Garrison (1974). In these numerical predictions, the surface of the visor has been described by triangular elements (Fig. 3.3). Different numbers of elements have been used at different draughts according to Table 3.1. The shape of the visor has been simplified so that the back bulkhead is vertical and the lower end is sharp (Fig. 3.4). Thus, the original visor has more volume at the lower end than the model used in the simulations. Higher up the difference in volume equalizes.

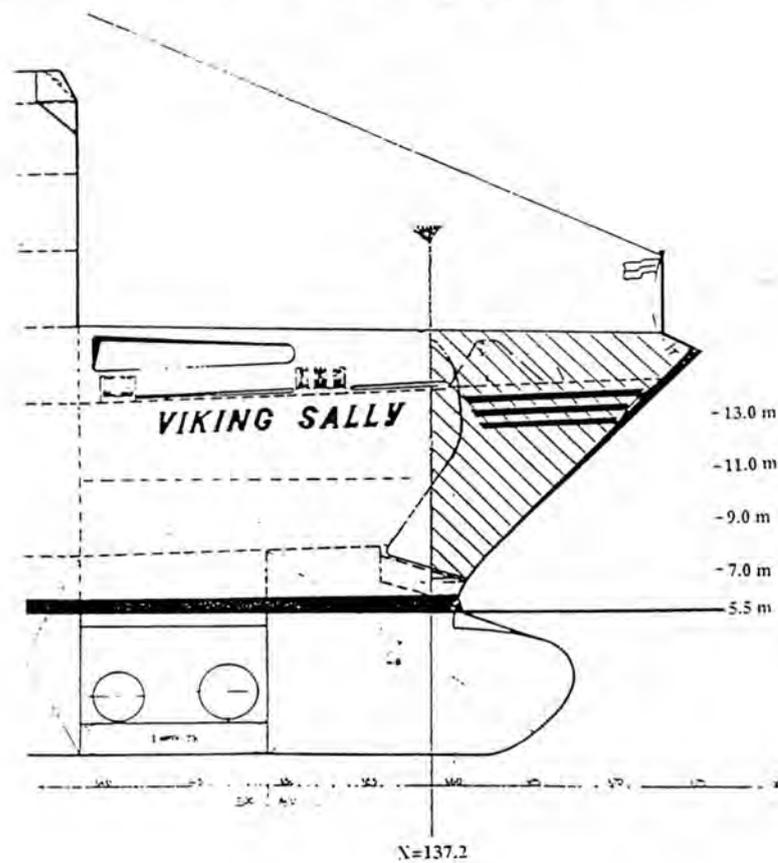
Fig. 3.4 The simplified shape of the visor used in the numerical predictions.

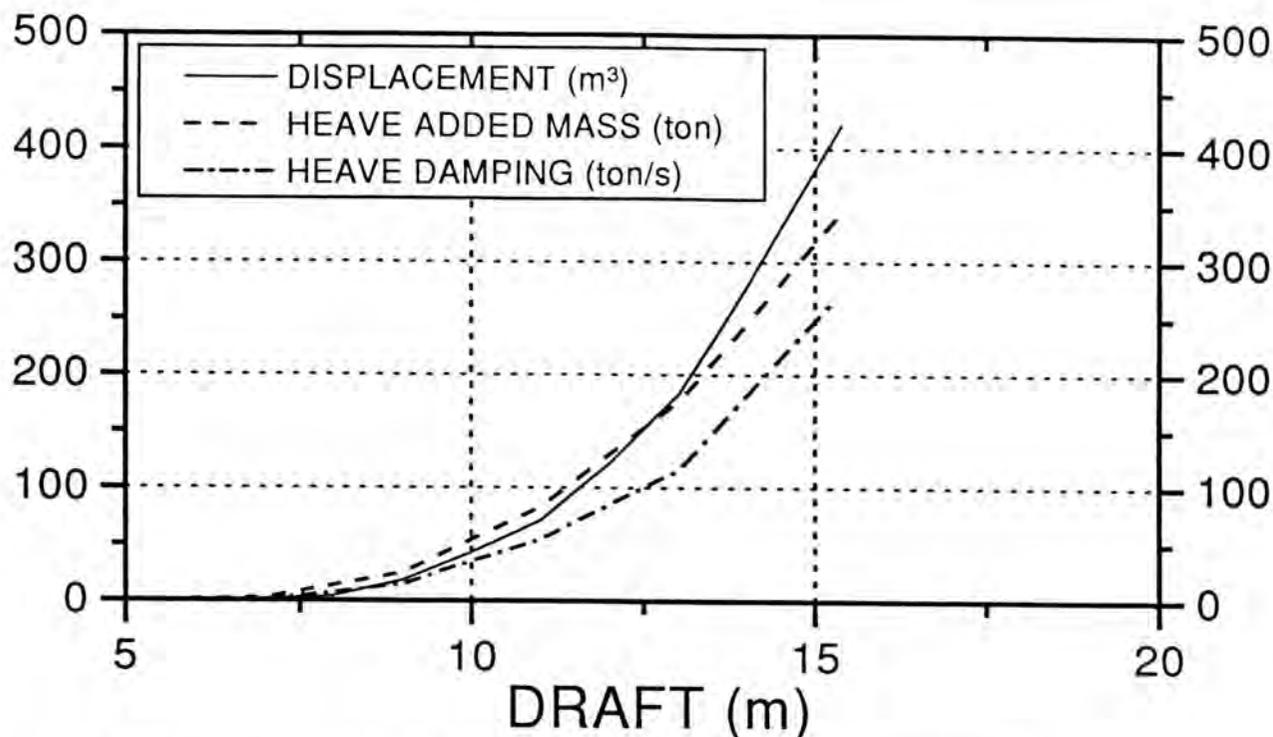
Fig. 3.5 Displacement, heave added mass and damping of the visor versus draught.

The predictions were made for three frequencies, $f = 0.172, 0.208$ and 0.263 Hz covering the range of wave encounter frequencies with the major wave components. The oscillation frequency had a small effect on the results. The largest values of the coefficients have been used in the simulations. Figure 3.5 shows that the added mass versus draught follows closely the displaced volume of the visor. The added mass and damping coefficients were given as input in tabular form to the simulation program and curve fitted by a third degree polynomial. At each time step, the added mass and damping coefficients have been determined for the instantaneous draught by using the curve fitted values.

The bow wave has also the important effect of decreasing the freeboard, or helping lower waves to reach the visor. Since the displacement and the waterplane area of the visor increase dramatically higher up (Fig. 3.5), the bow wave height may have a significant effect on the wave loads of the visor. In the simulations, the bow wave has been considered as a constant offset increasing the submergence of the visor. Thus, the height of the bow wave has been added to the relative motion. In reality, there must be interaction between the bow wave, incoming wave and the waves generated by ship motion so that the simple superposition does not strictly hold. A proper numerical method would give the behaviour of the bow wave as part of the solution.
