THE FINAL REPORT ON THE CAPSIZING ON 28
SEPTEMBER 1994 IN THE BALTIC SEA OF THE
RO-RO PASSENGER VESSEL MV ESTONIA

The Joint Accident Investigation Commission
of
Estonia, Finland and Sweden

The Joint Accident Investigation Commission publishes in this Supplement the most important documents used in Commission's work. Large appendices of some research reports have been edited, but a list of appendices has been included.

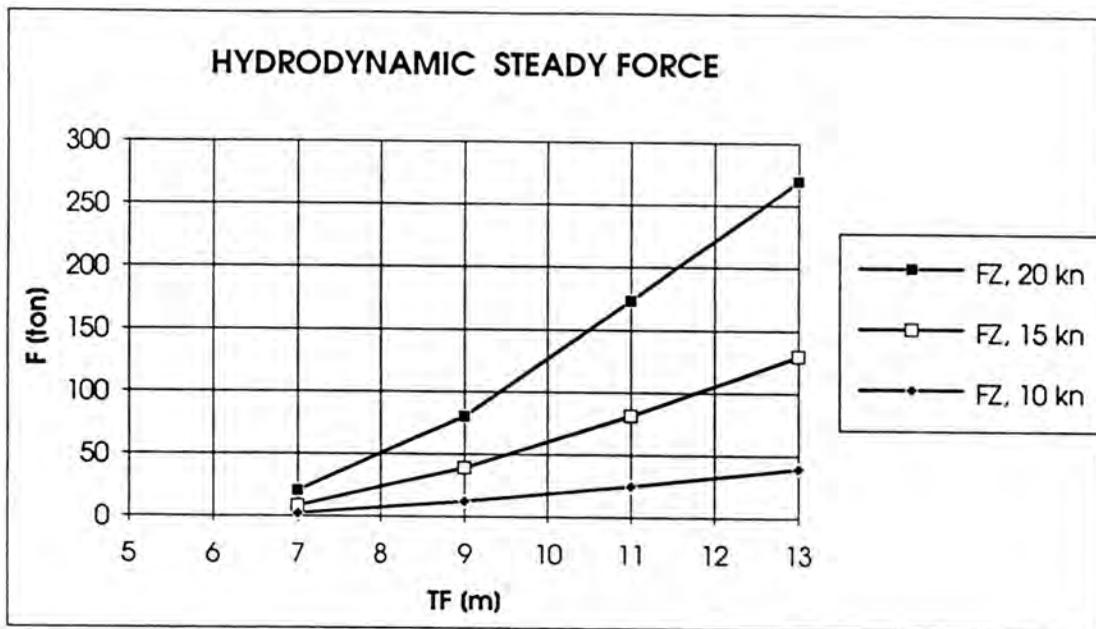
Fig. 3.6 The effect of ship speed and bow submergence on the steady, vertical, hydrodynamic force.

resistance. The vertical force component on the visor has been programmed to the simulation method as a simple function giving the force versus the draught at FP (Fig. 3.6).

Figure 3.6 shows that the vertical force due to the stationary flow increases quickly with increasing speed and forward draught. At a large bow submergence, the force is about 100 tons at 15 kn speed and over 200 tons at 20 kn speed. The large force at 20 kn speed is due to the bow wave height rising to over 3 m high. The numerical method does not model wave breaking which would probably take place before the wave grows so high. At 15 kn speed, the bow wave height is 1 to 1.5 m. The predictions are for a steady situation while in waves the bow is pitching up and down at the quite short wave encounter period. It is questionable whether the bow wave rises to the same height during this pitch period as in calm water in a steady flow. However, the predictions by the SHIPFLOW-program have not been tried to correct for these effects. On the other hand, the effect of the horizontal water particle velocity in the incoming wave has been disregarded and only the stationary flow due to the vessel forward speed has been considered in the predictions. The neglected effect of the horizontal water particle velocity, in particular if waves are breaking, probably more than compensates for the effect of a too high bow wave.

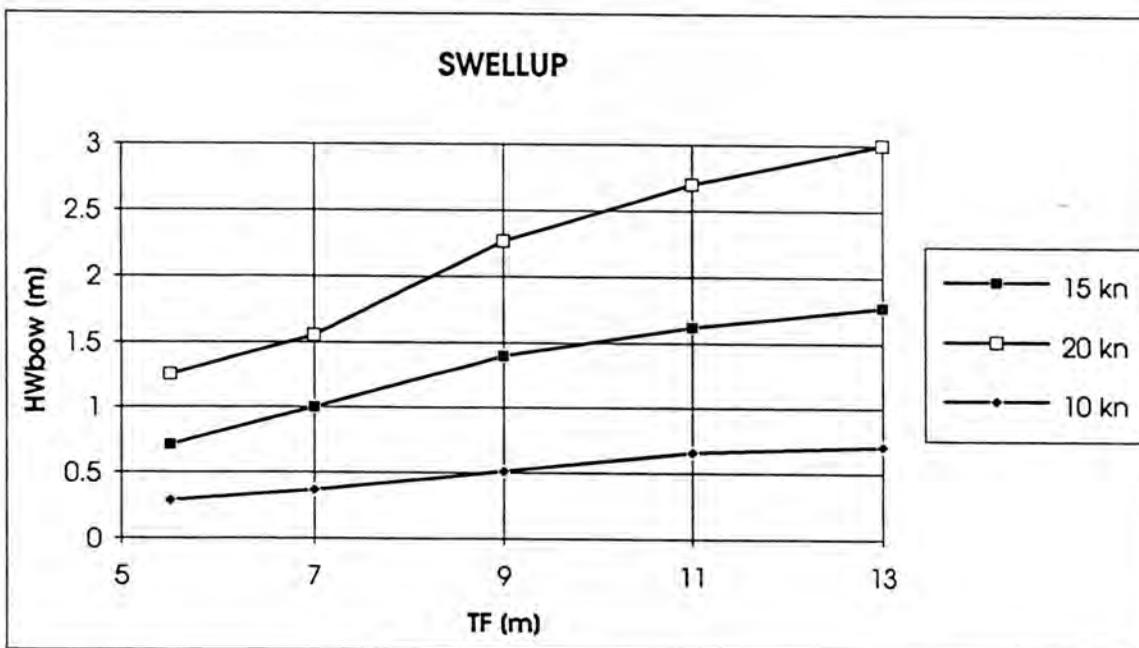
Fig. 3.7 The bow wave height as a function of draught at FP and ship speed.

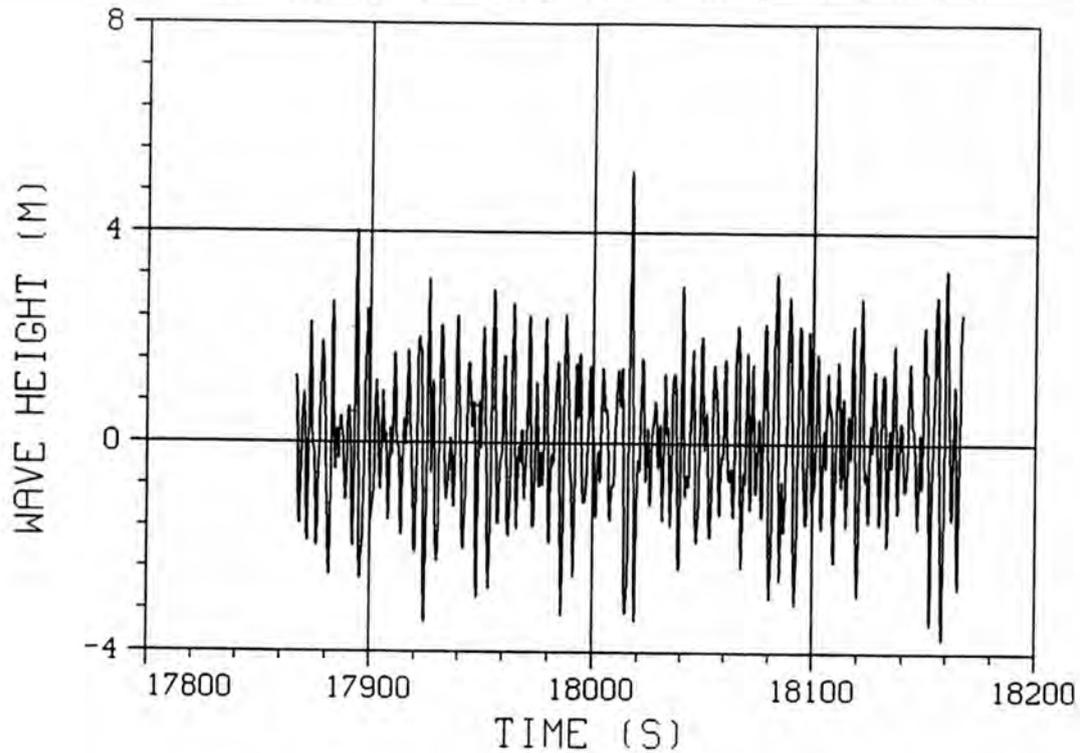
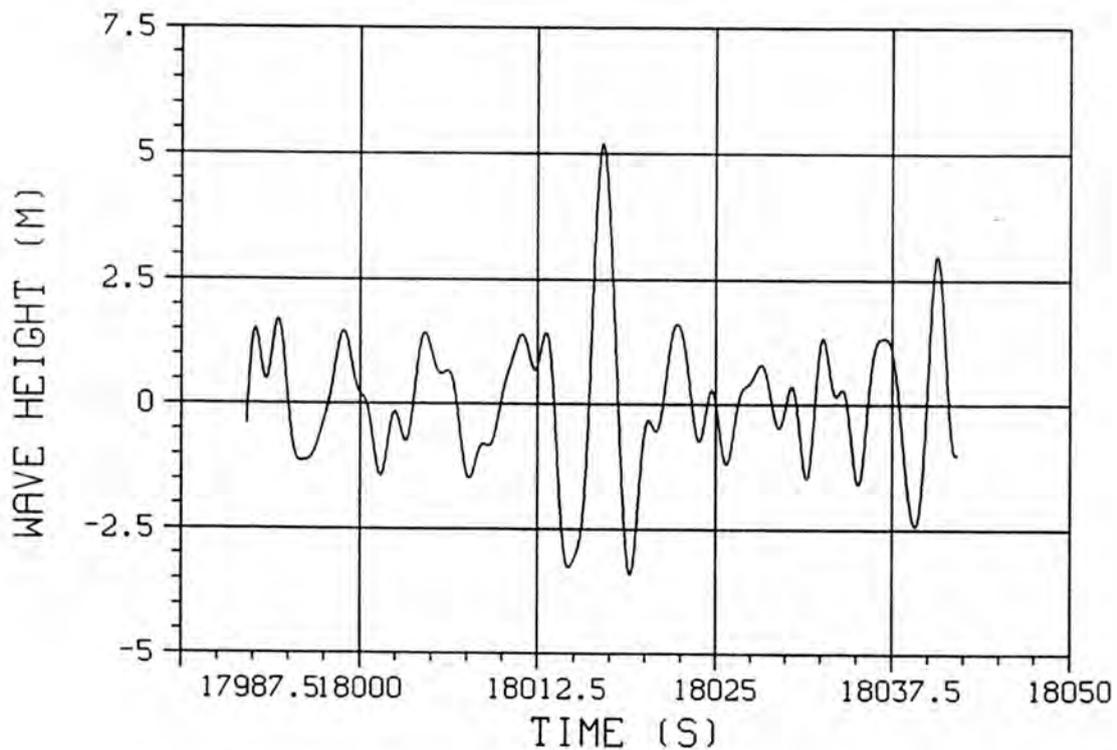
SIGNIFICANT WAVE HEIGHT $H_s = 5.5$ M
TIME HISTORY OF WAVE HEIGHT

Fig. 5.1 Two short sequences of simulated irregular waves.

Figures 5.1 and 5.2 show short sequences of simulated irregular waves and wave loads on the bow visor, respectively. The wave time history includes a wave crest of about 5 m high but otherwise the record seems to be approximately symmetric about the still water level, i.e. the heights of crests and troughs follow the same distribution. The wave load record is highly asymmetric showing only high positive peaks due to the bow submergence. Low waves don't even reach the visor and the vertical force on the visor remains close to its weight of 600 kN. Both the wave and the load record have time scales as the vessel encounters head waves at 15 knots speed.

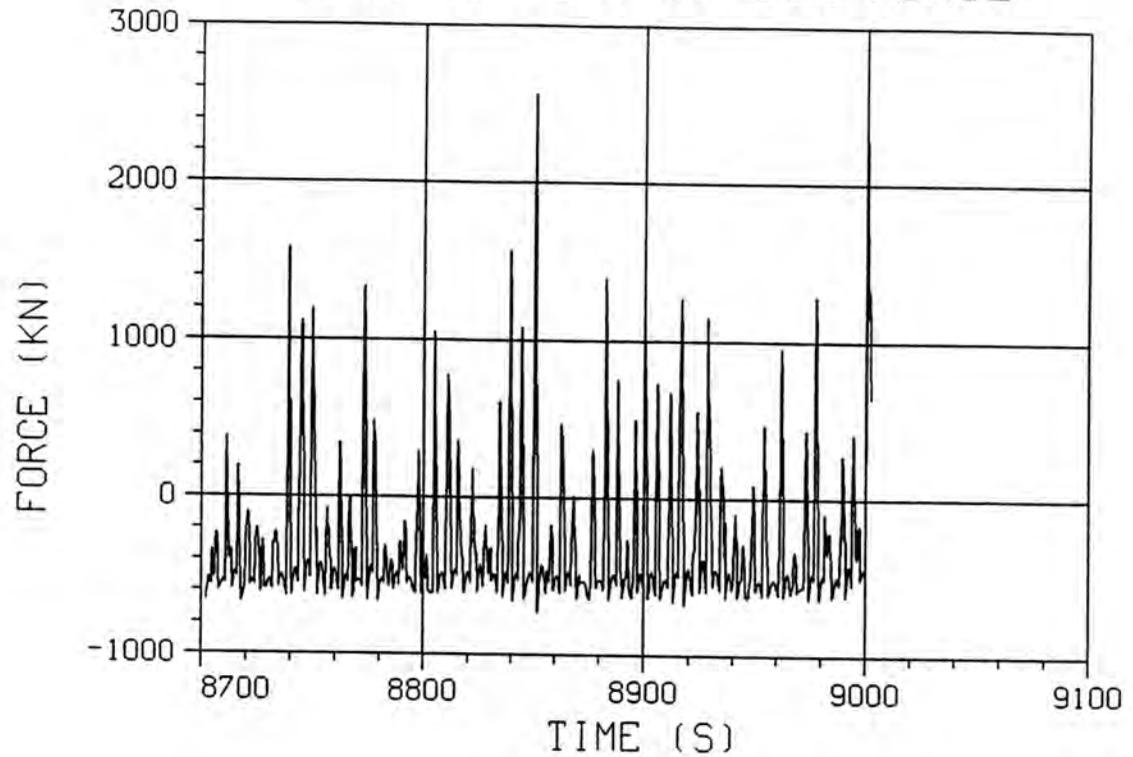
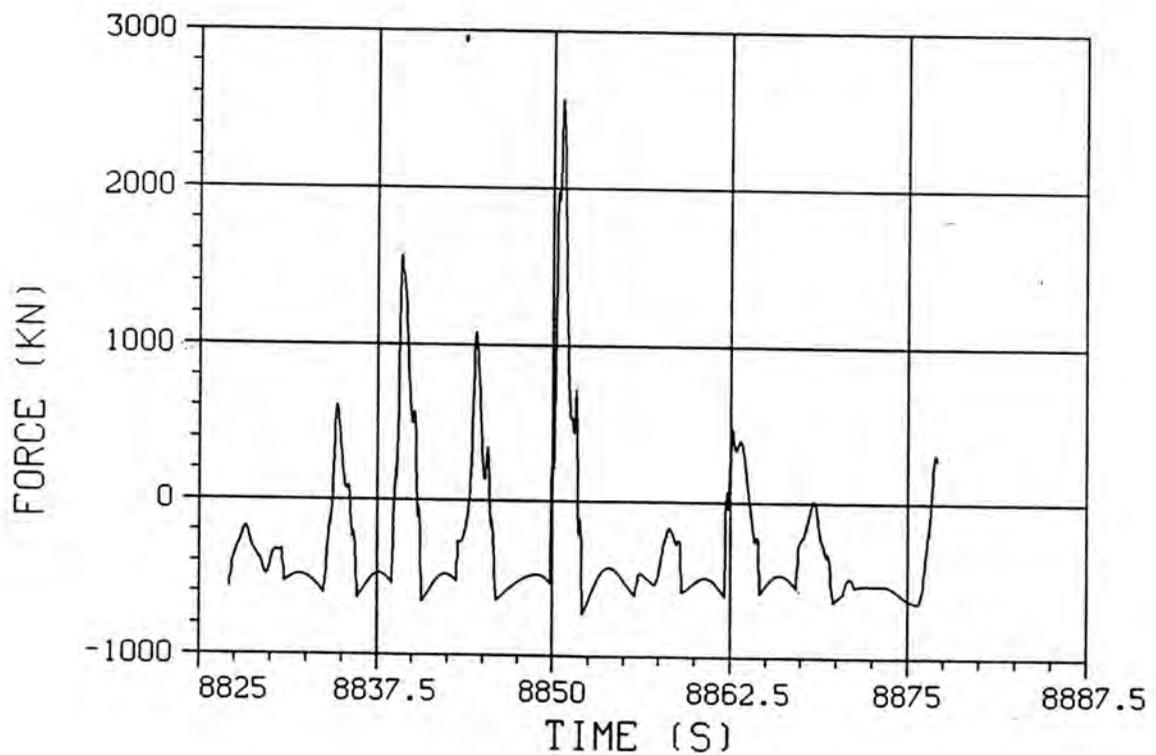
SIGNIFICANT WAVE HEIGHT $H_s = 5.5$ M
TIME HISTORY OF BOW FORCE

Fig. 5.2 Simulated short sequences of vertical wave load on the visor.

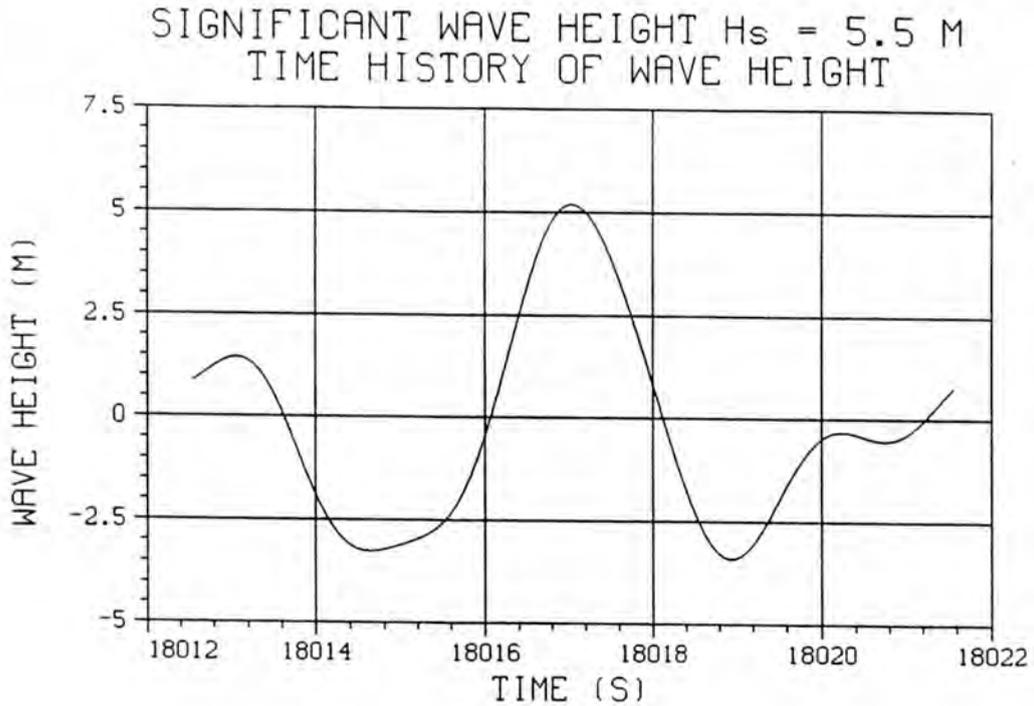
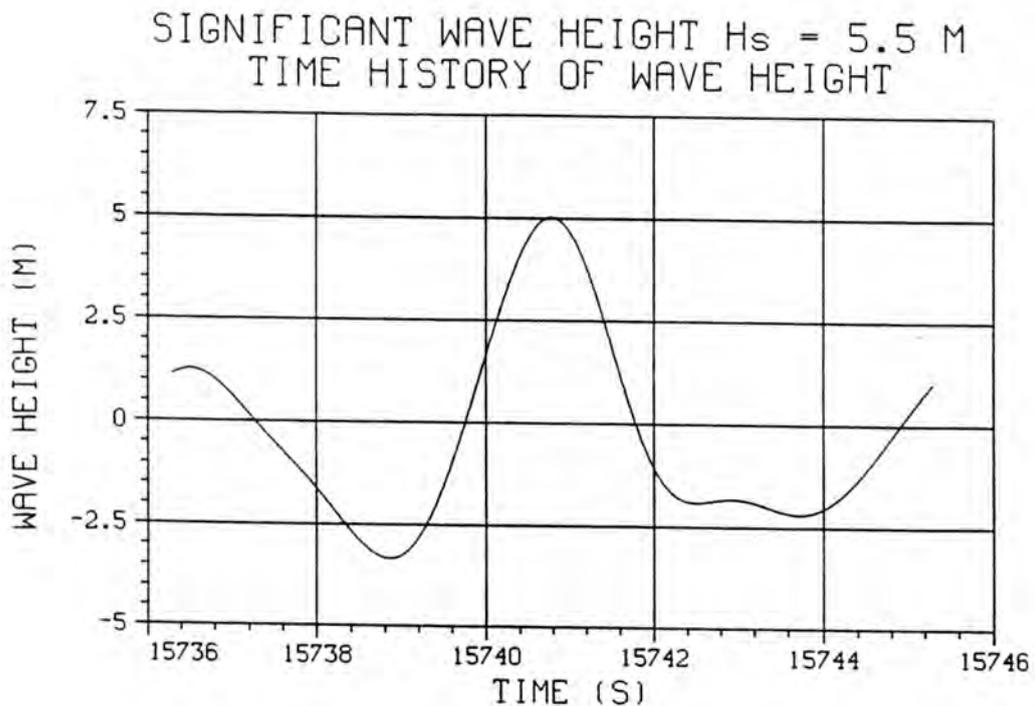
Fig. 5.3 Two high individual waves which excited significantly different loads on the visor in head seas at 15 kn speed. The wave in the upper plot excited a vertical force of 9 800 kN while the lower wave excited a force below 5 200 kN.

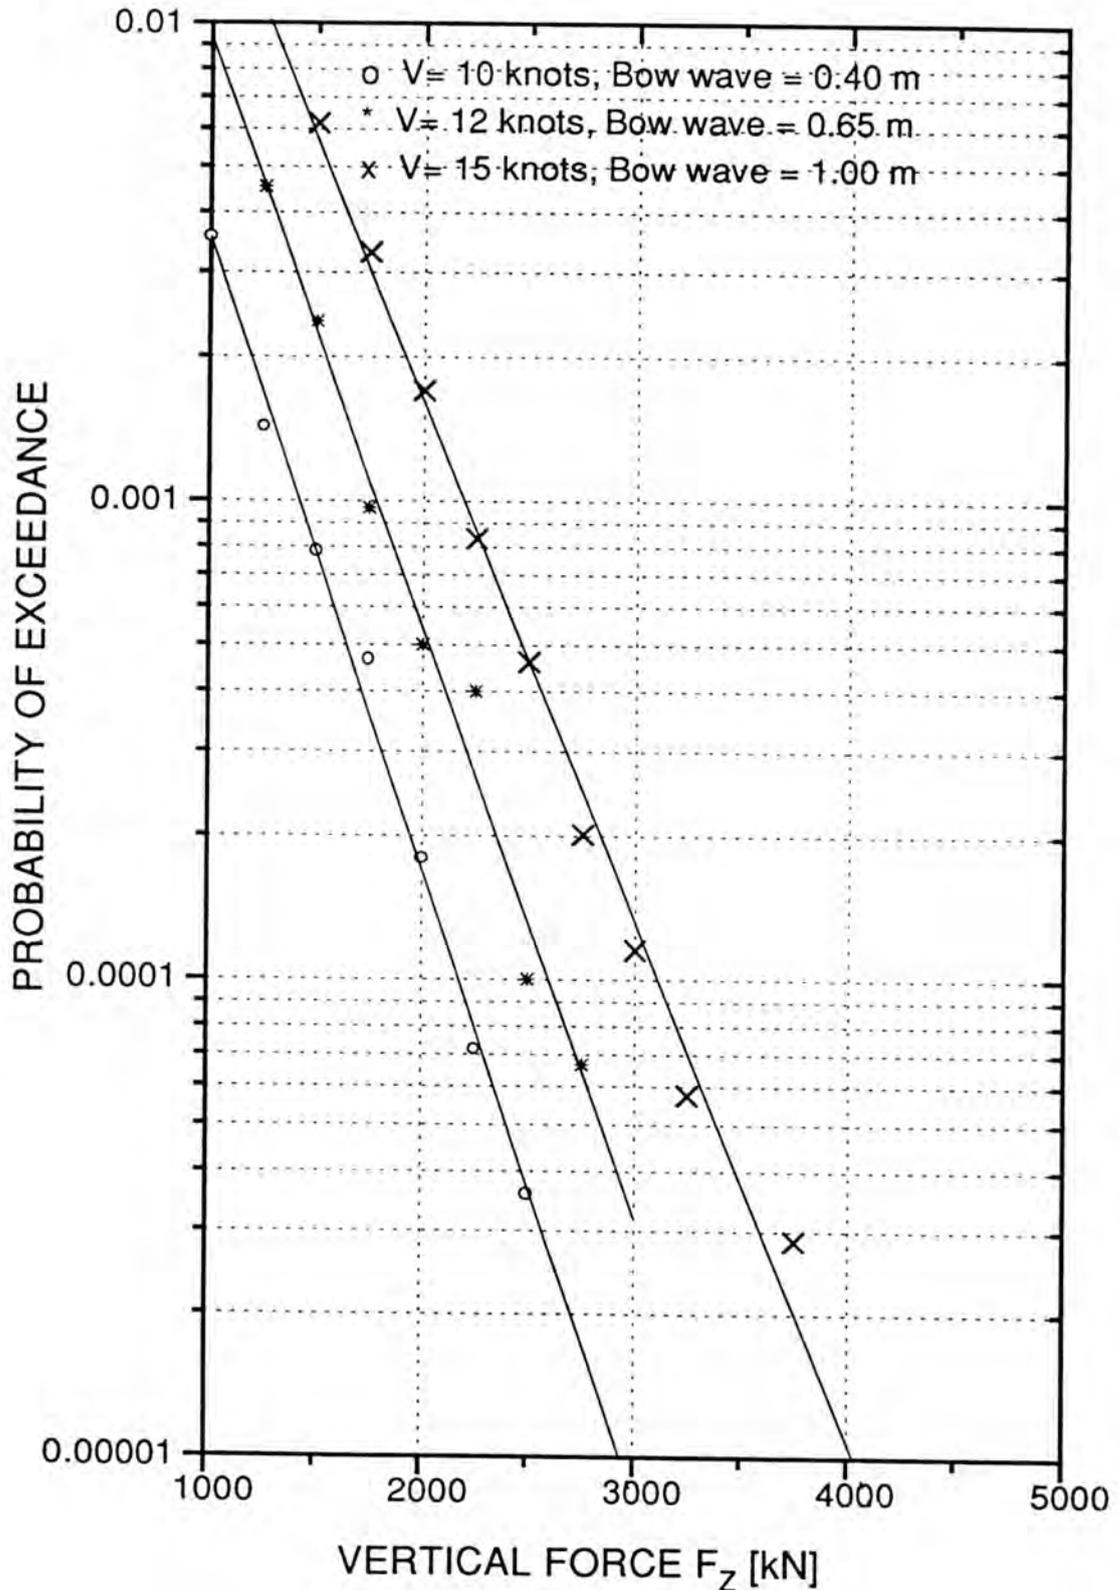
PROBABILITY OF VERTICAL FORCE
36 h HOURS SIMULATION
HEAD SEAS, $T_0 = 8$ s, $H_s = 4.0$ m

Fig. 5.4 Vertical wave loads on the visor in head seas with $H_s = 4$ m and $T_0 = 8.0$ s.

Due to the larger wave-induced motions in bow seas than in direct head seas the loads on the visor are higher at 150° heading than in head waves (Figs. 5.4 and 5.8). The difference is about 20 % at the level of an 1 to 10 000 exceedance probability in 4 m high seas. An increase of the modal wave period from 8 to 8.5 s slightly increases the loads in head seas at 15 knots speed (Figs. 5.4 and 5.5).

The simulated forces F_z sim. have been estimated from the probability of exceedance curves in Figures 5.4, 5.6 and 5.8. The forces correspond to the exceedance probabilities of 1/(number of wave encounters), for instance, in bow seas at 14.5 kn speed the exceedance probability has been 1/2 557 = 0.00039. If the maximum force measured during the experiments differs considerably from the general trend of the lower peak force values expressed in the form of a Weibull-diagram, the general trend has been extrapolated and an estimate F_z est. has been read from the extrapolation line. This has been made in three cases of which examples are in Figure 5.19.

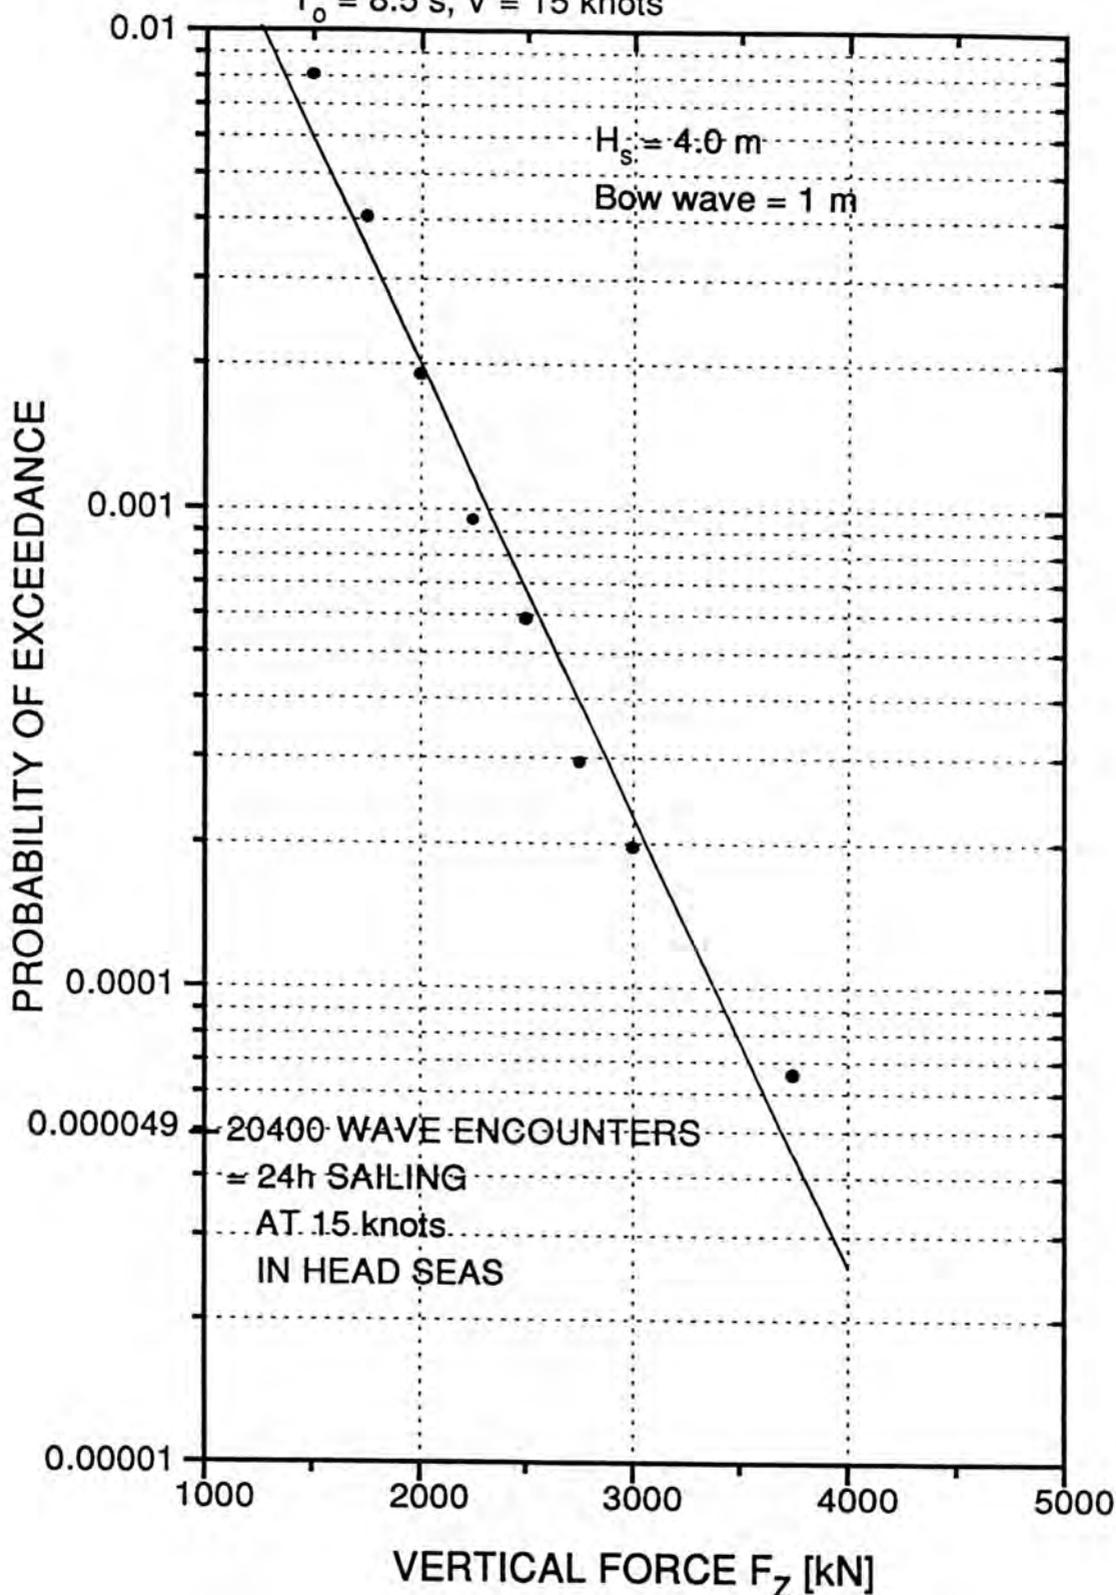
PROBABILITY OF VERTICAL FORCE
36 h HOURS SIMULATION
HEAD SEAS

$T_0 = 8.5 \text{ s}, V = 15 \text{ knots}$

Fig. 5.5 Vertical wave loads on the visor in head seas with $H_s = 4 \text{ m}$ and $T_0 = 8.5 \text{ s}$.

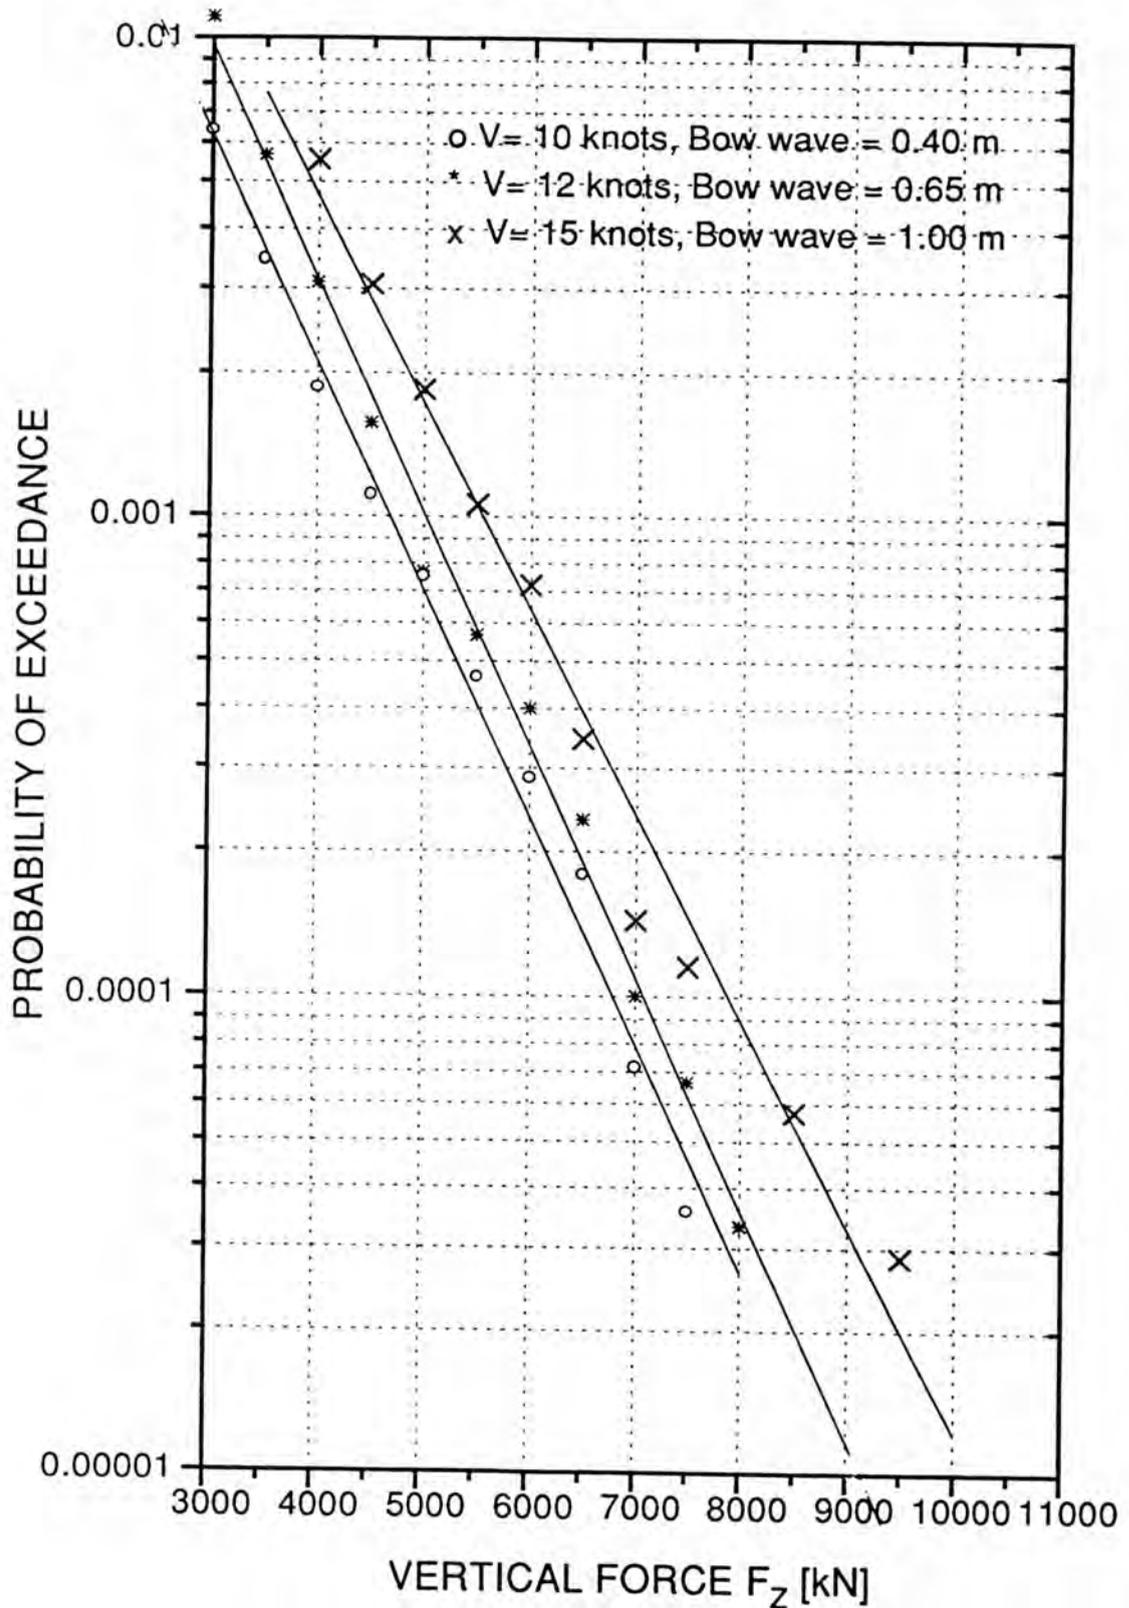
PROBABILITY OF VERTICAL FORCE
36 h HOURS SIMULATION
HEAD SEAS, $T_0 = 8$ s, $H_s = 5.5$ m

Fig. 5.6 Vertical wave loads on the visor in head seas with $H_s = 5.5$ m and $T_0 = 8.0$ s.

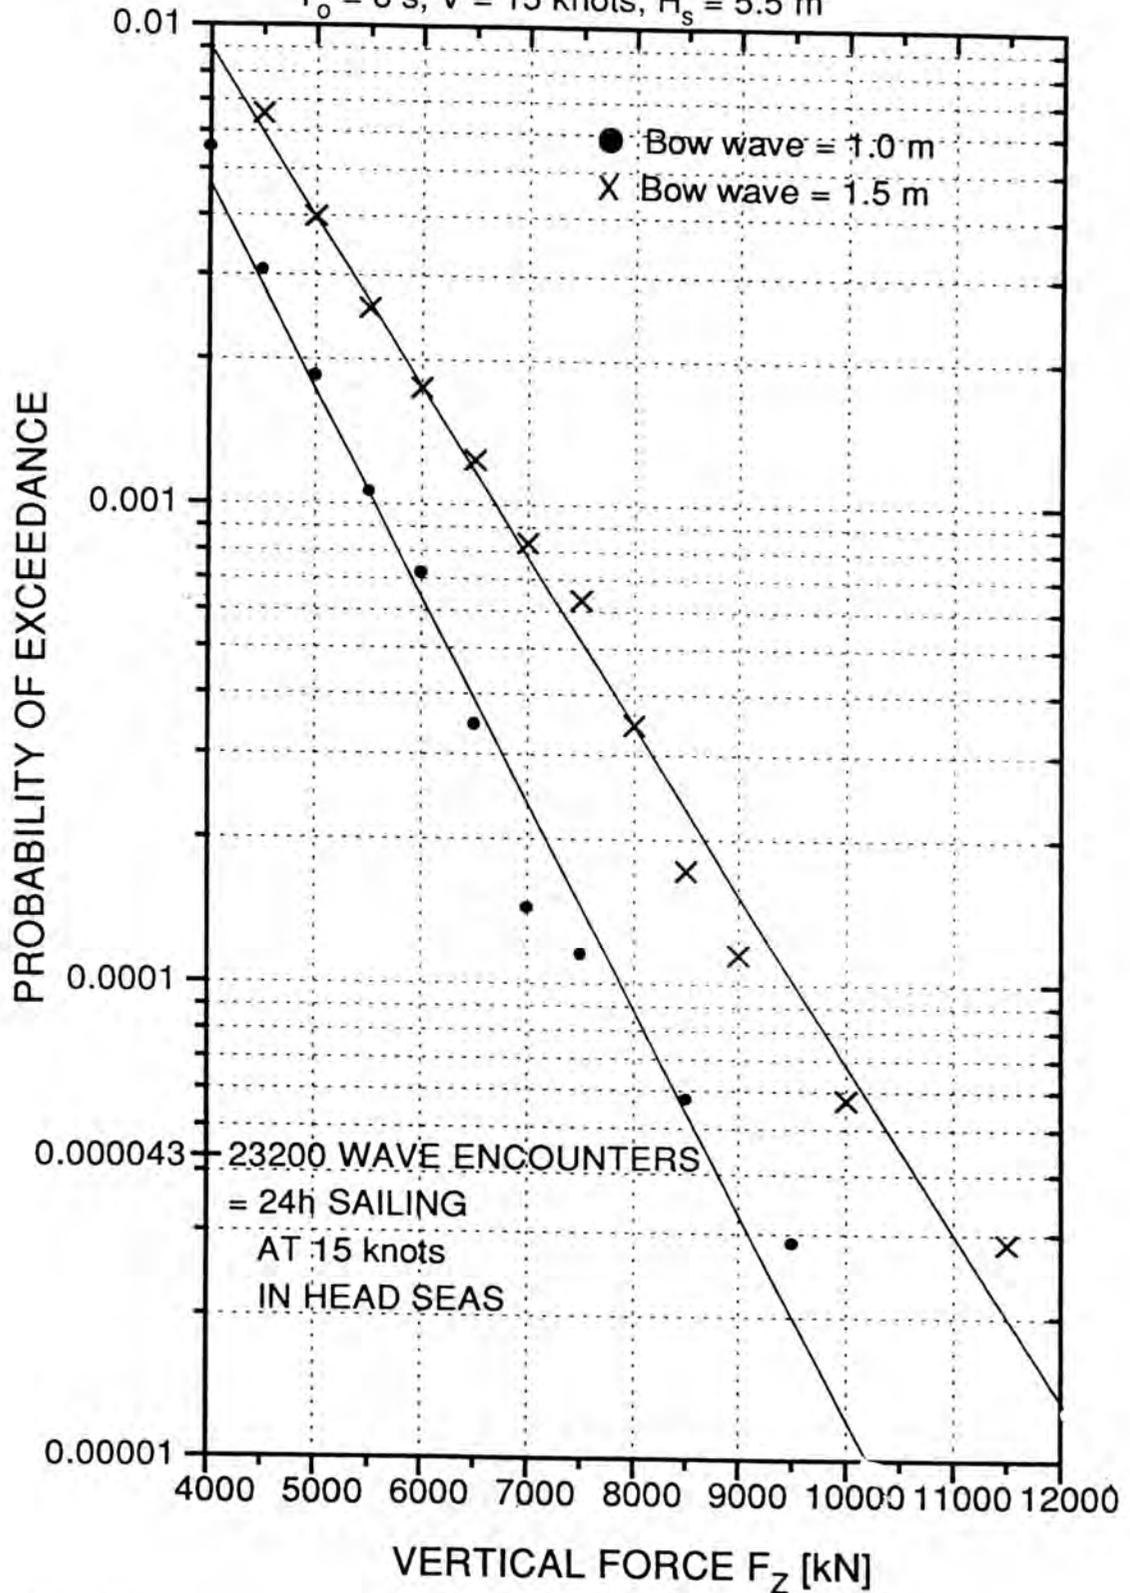
PROBABILITY OF VERTICAL FORCE
36 h HOURS SIMULATION
HEAD SEAS

$T_o = 8$ s, $V = 15$ knots, $H_s = 5.5$ m

Fig. 5.7 The effect of bow wave height on the visor loads in head seas with $H_s = 5.5$ m at $V = 15$ kn.

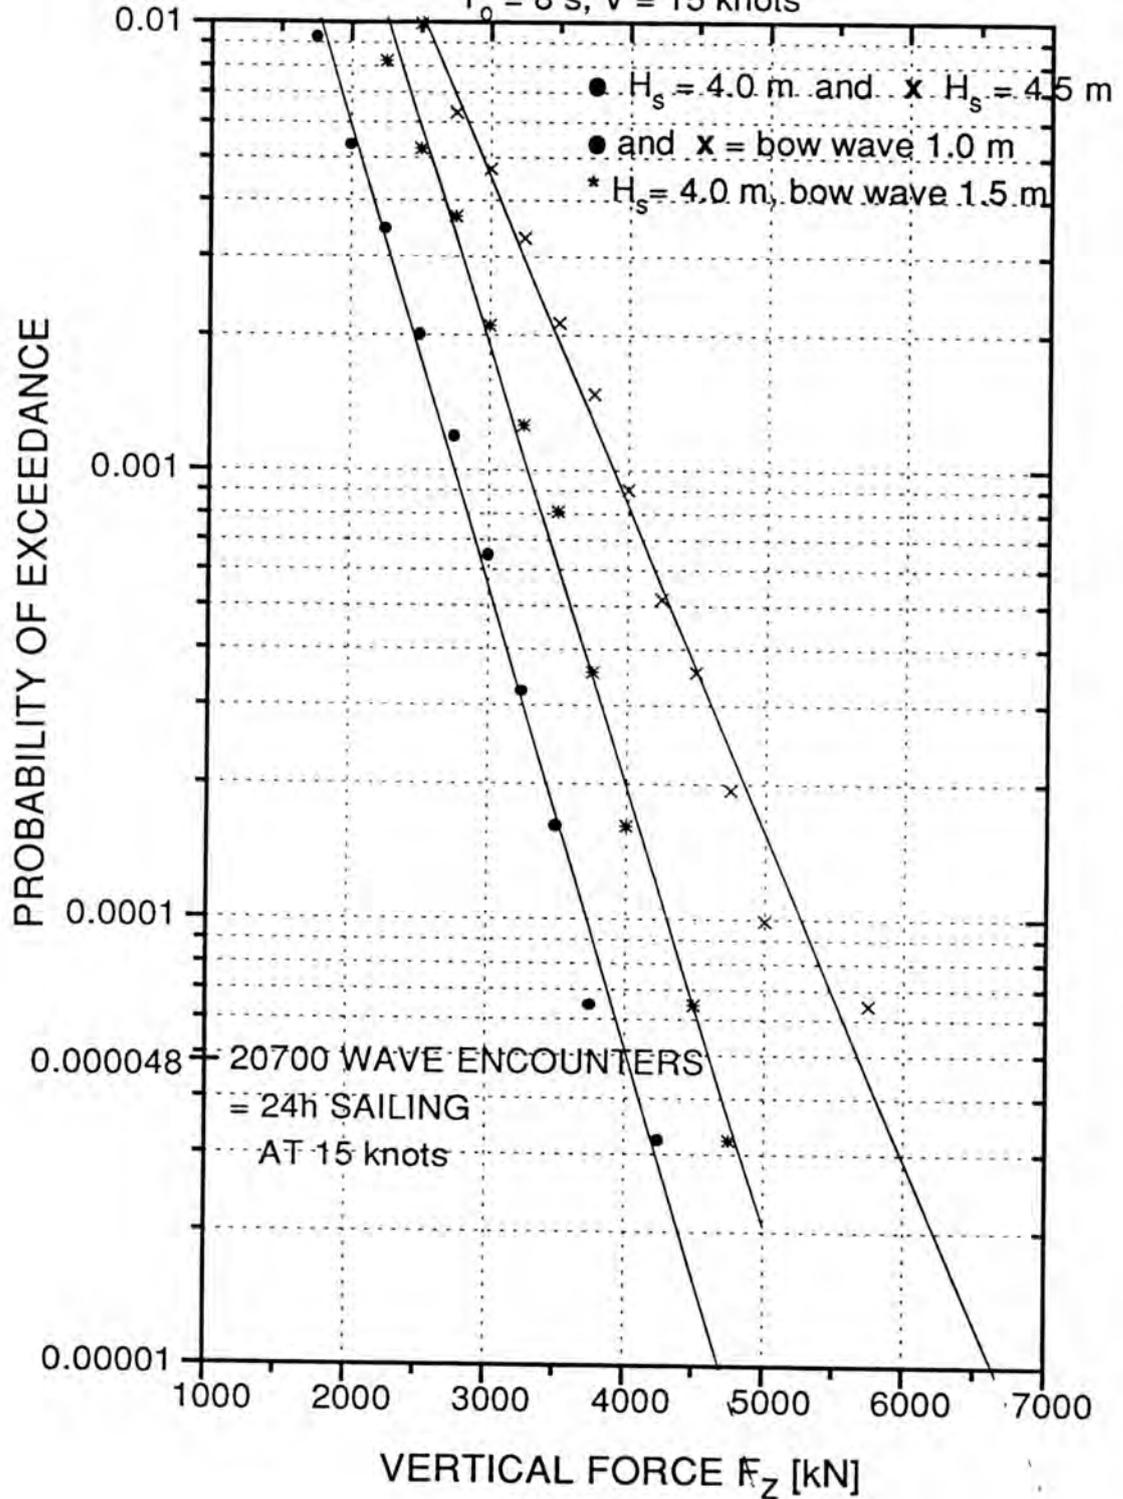
PROBABILITY OF VERTICAL FORCE
36 HOURS SIMULATIONS

HEADING = 150°

$T_0 = 8$ s, $V = 15$ knots

Fig. 5.8 Vertical wave loads on the visor in bow oblique seas with $H_s = 4$ m and 4.5 m.

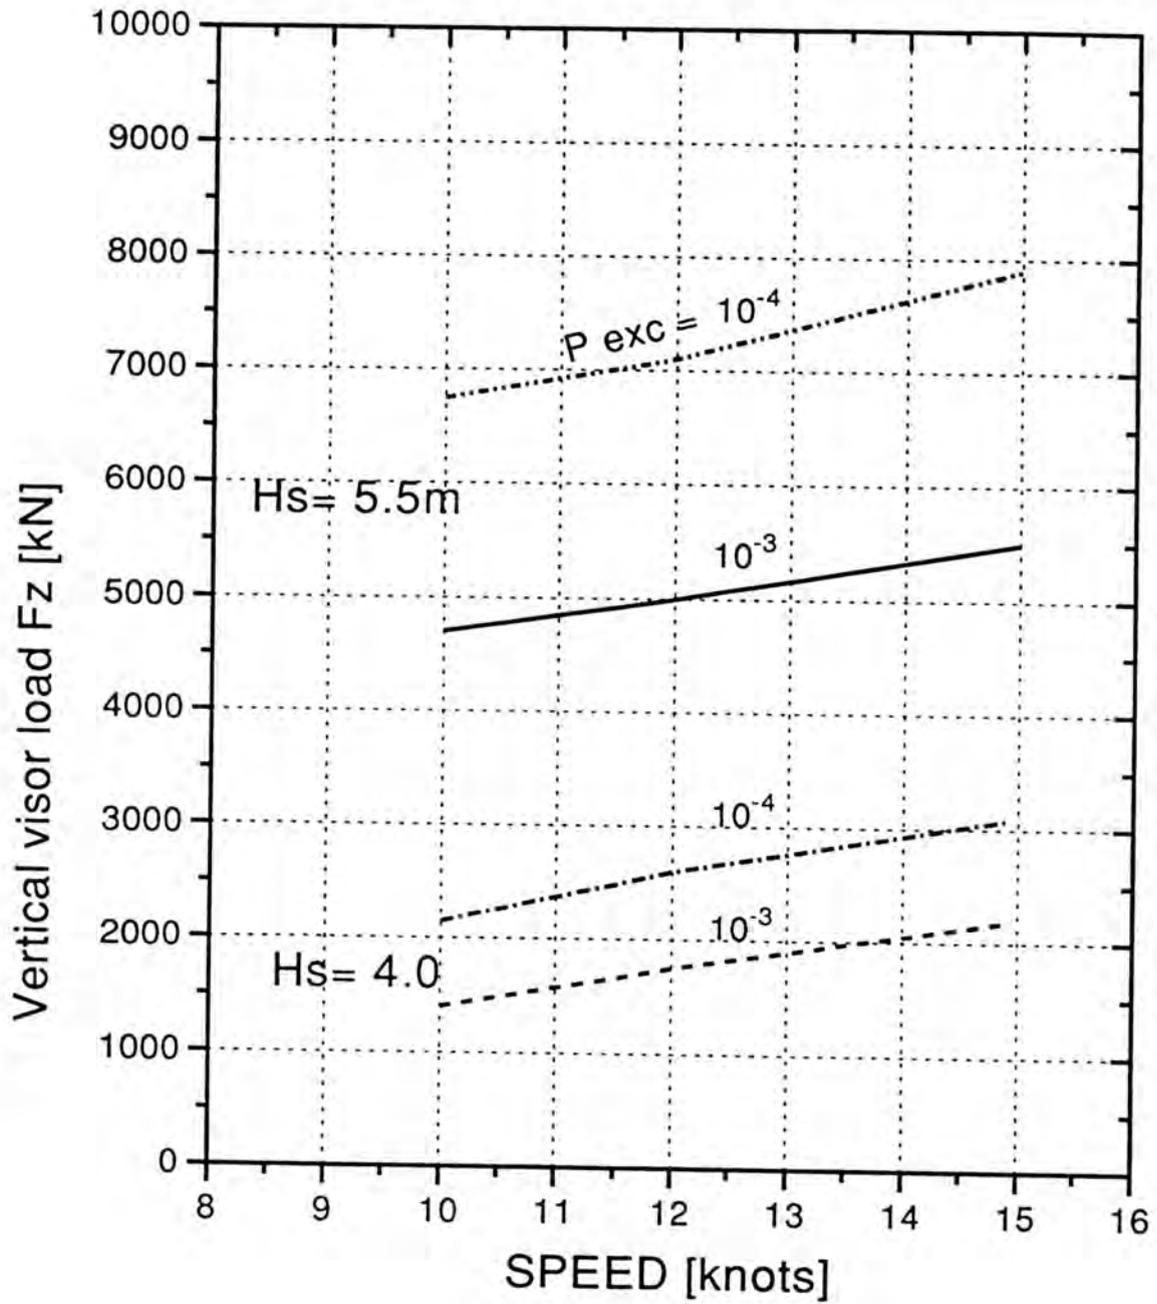
Fig. 5.9 The effect of wave height and speed on the loads of MV Estonia's visor in head seas.

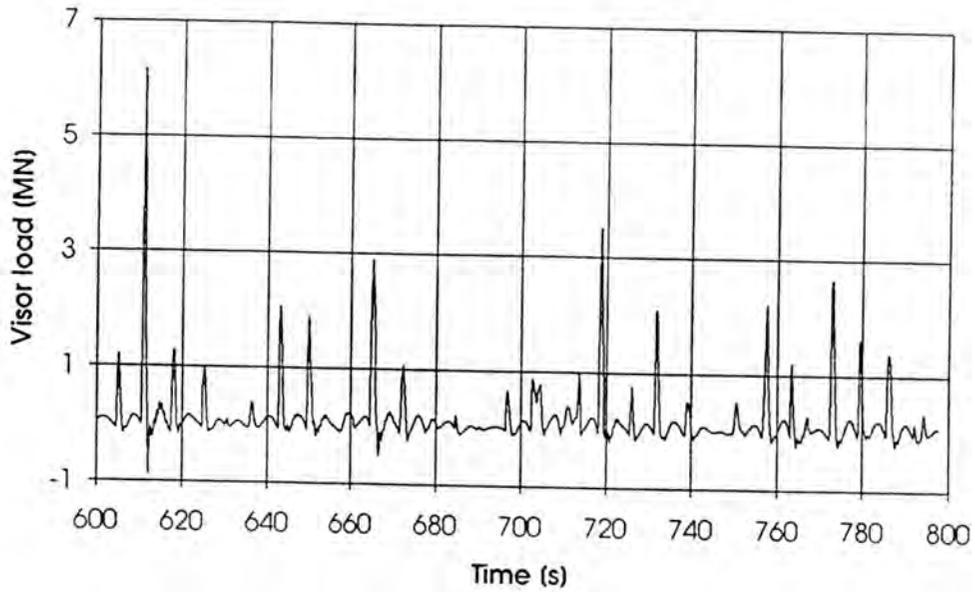
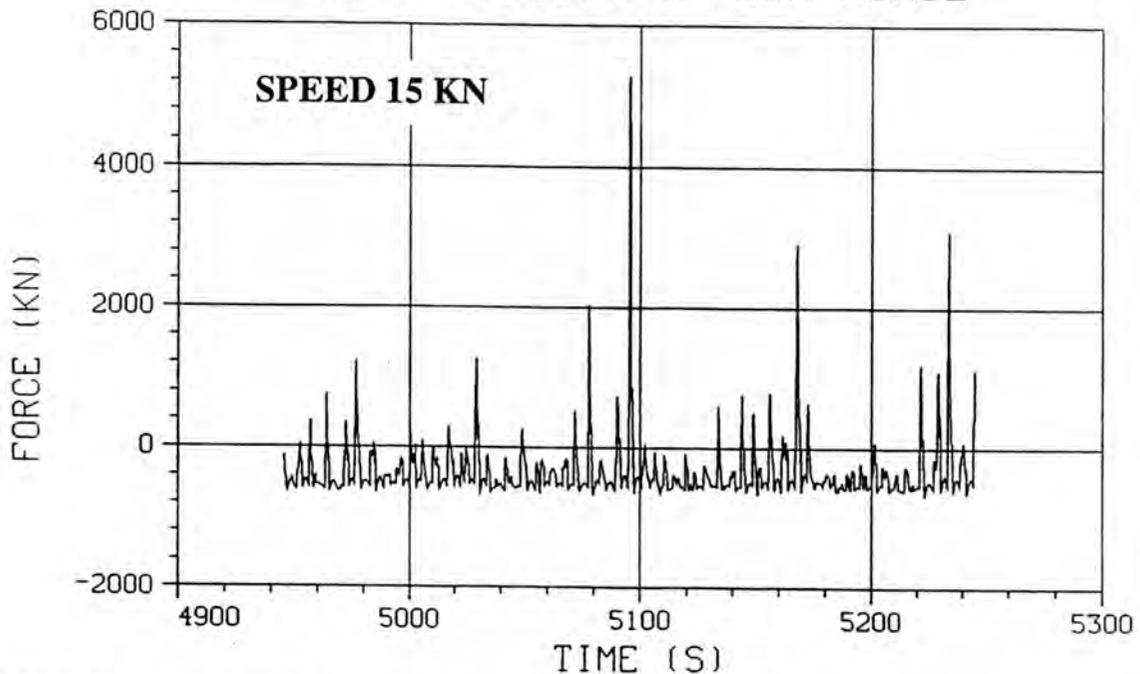
SSPA MODEL EXPERIMENTS

Vertical visor load F_z

VTT SIMULATIONS

SIGNIFICANT WAVE HEIGHT $H_s = 5.5$ M
TIME HISTORY OF BOW FORCE

Fig. 5.10 Experimental (SSPA) and simulated records of visor loads in head seas, $H_s = 5.5$.

In irregular head seas the simulated wave-induced motions of MV Estonia were not so violent as in high regular waves. This may have contributed to the surprising result that in irregular seas the numerical results are significantly below the model tests of SSPA. Figure 5.12 compares the results of MV Estonia to the maximum vertical visor force of Model No. 1 during 3 hours. The model test results have been extrapolated from an about one hour (full scale) long measurement to a time span of 3 hours. The results for MV Estonia correspond to the exceedance probability of 1/2 500 in Figures 5.4 and 5.6. MV Estonia encountered from 2 300 to 2 900 waves in head seas in three hours depending on the forward speed according to Table 4.2. The weight of the visor, 60 tons, has been added to the simulated results since the static situation was considered as zero level in the model tests (see Fig. 5.10).

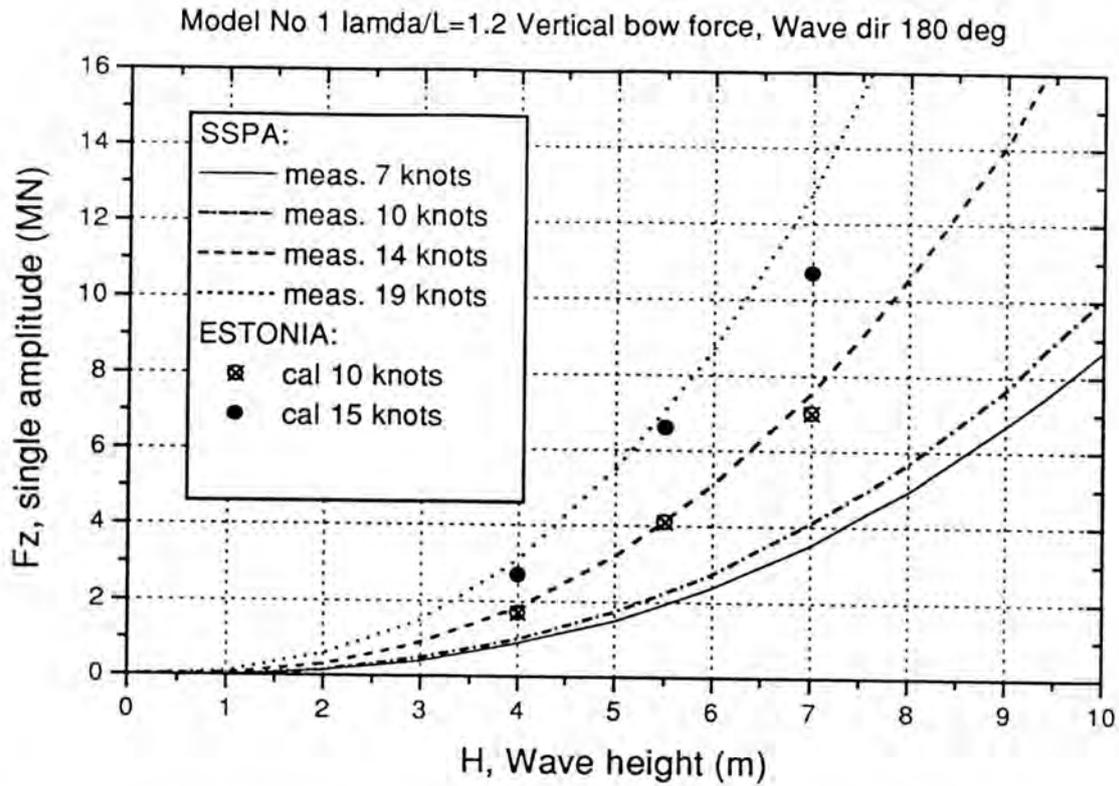
Fig. 5.11 Simulated and experimental (SSPA) vertical visor loads in regular head waves.

Figure 5.11 compares the vertical wave load on the bow visor of MV Estonia with experimental results of SSPA for the Model No. 1 in regular head waves. The wave length has been $1.2L$. The predictions are for 10 and 15 knots speeds while the model tests have been carried out at speeds corresponding to 7, 10, 14 and 19 knots in full scale. The results for MV Estonia follow quite well the same trend with increasing wave height as the experimental results, but the numerical results are larger than the experimental at the same speed. At 10 knots speed, the predicted loads on the bow

visor of MV Estonia are close to the test results at 14 knots speed. A partial explanation may be that high up MV Estonia had a wider bow flare than Model No. 1 and in regular waves, close to heave and pitch resonance, the simulated motions were violent.

If only the largest values measured during one hour of testing time are compared to the largest simulated values, regardless of statistics, the correlation is much better than in Fig. 5.12. This together with the comparison in regular waves (Fig. 5.11) and the strong dependence of the visor loads on the wave height suggest that the irregular wave trains in the simulations and in the model experiments may have different statistics although they have the same significant wave height. A comparison of short wave time histories representing seas with $H_s = 5.5$ m in the simulations and in the model experiments (Fig. 5.13) indicates that the crest heights of the experimental waves may be larger than the heights to wave troughs measured from the still water, zero level. In the experiments, minus sign indicates wave surface level above the still water surface while the opposite sign convention has been used in the simulations.

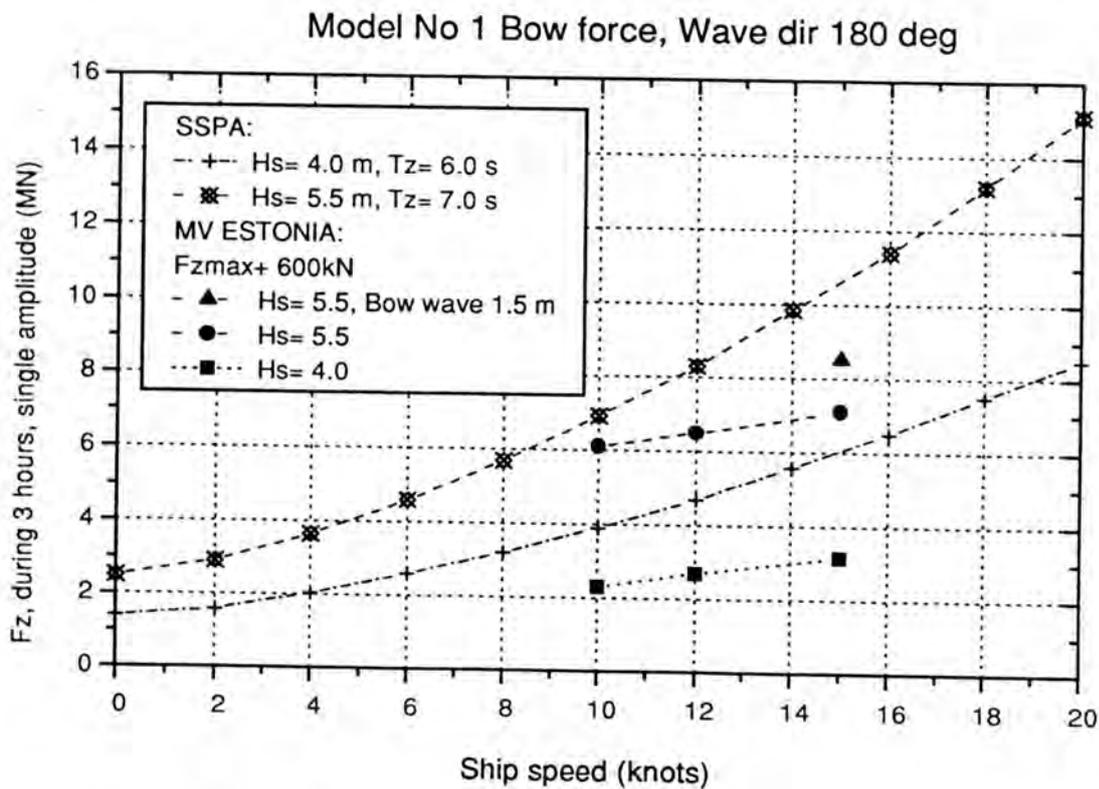
Fig. 5.12 Simulated and experimental (SSPA) vertical visor loads in irregular head seas.
