THE FINAL REPORT ON THE CAPSIZING ON 28
SEPTEMBER 1994 IN THE BALTIC SEA OF THE
RO-RO PASSENGER VESSEL MV ESTONIA

The Joint Accident Investigation Commission
of
Estonia, Finland and Sweden

The Joint Accident Investigation Commission publishes in this Supplement the most important documents used in Commission's work. Large appendices of some research reports have been edited, but a list of appendices has been included.

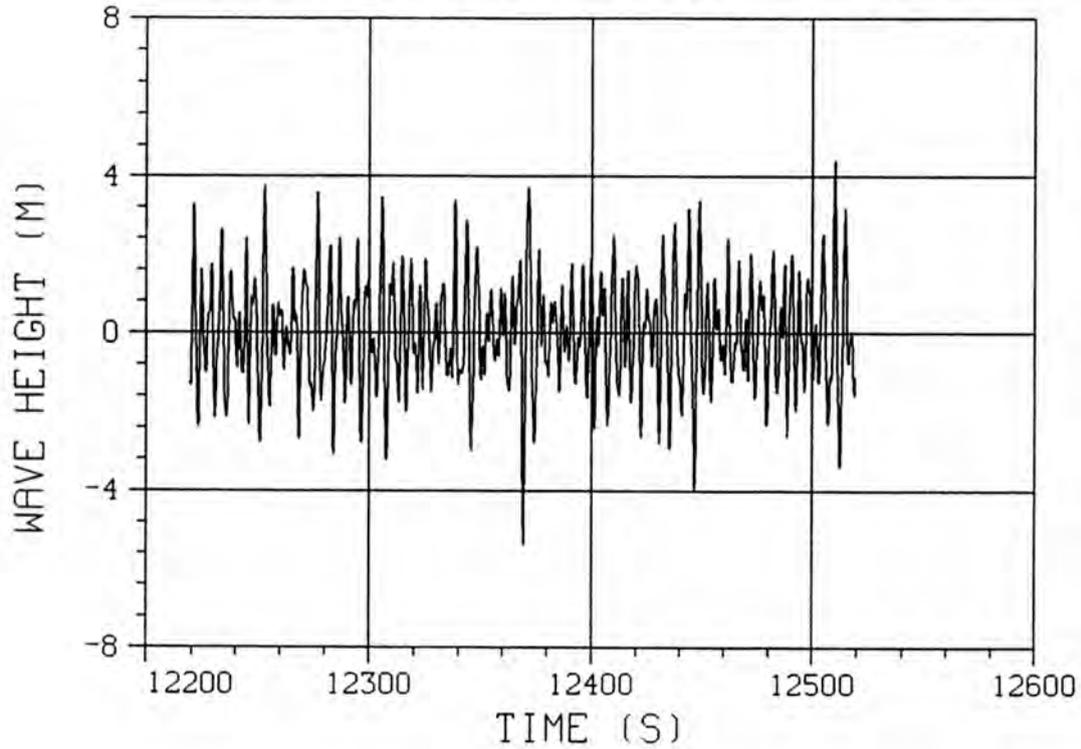
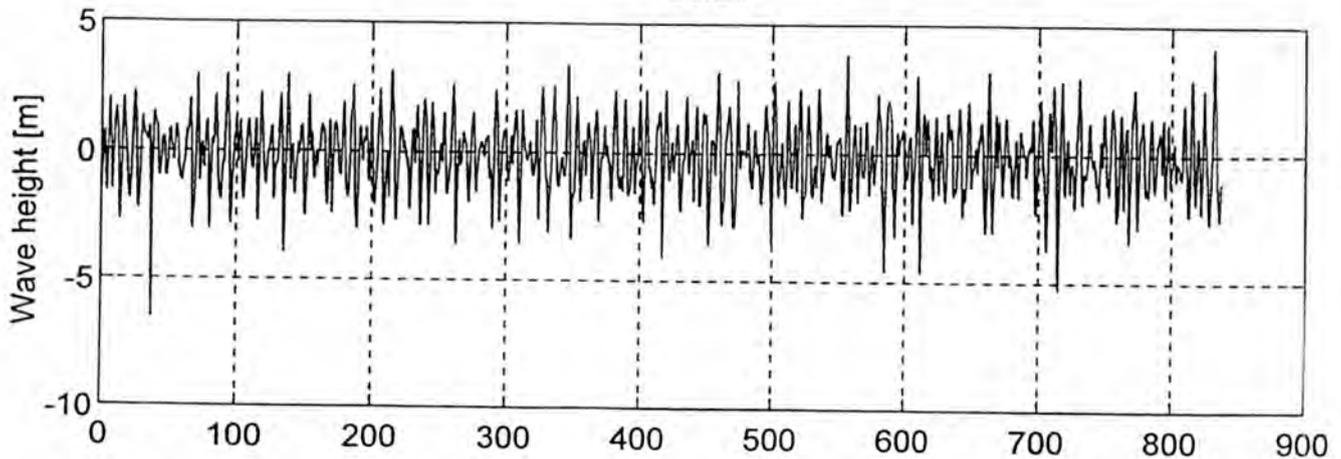
VTT SIMULATIONS

SIGNIFICANT WAVE HEIGHT $H_s = 5.5$ M
TIME HISTORY OF WAVE HEIGHT

SSPA MODEL EXPERIMENTS

Fig. 5.13 Wave time histories from simulations and model experiments (SSPA) with $H_s = 5.5$ s.

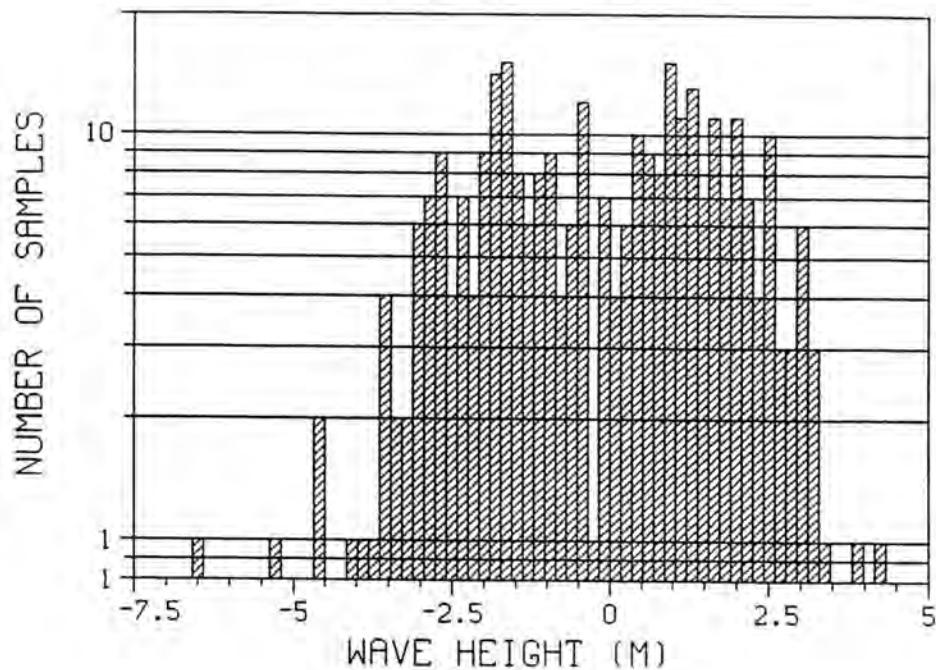
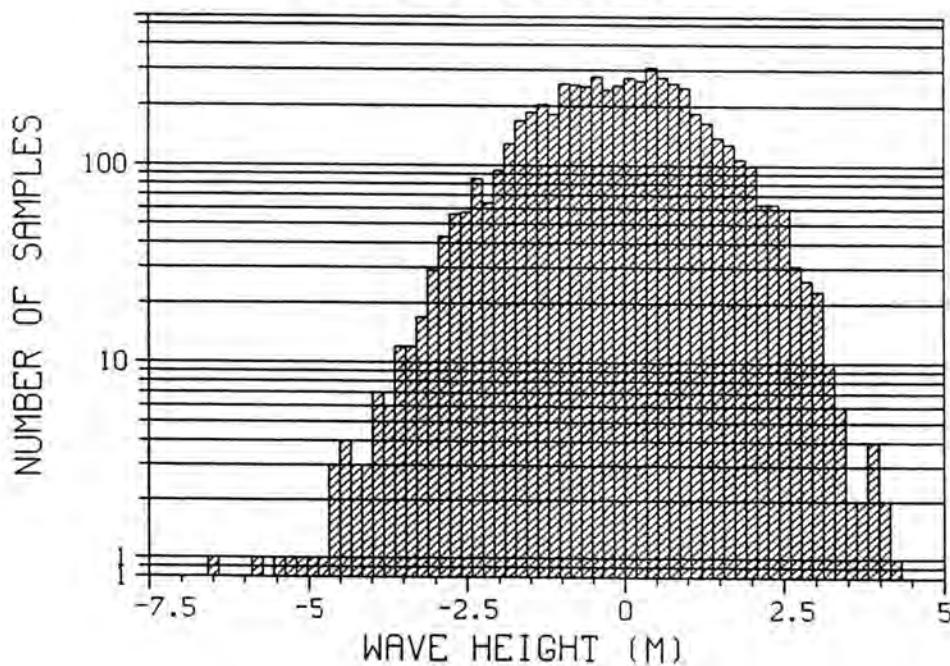
TEST WAVE HEIGHT $H_s = 5.5$ M
PEAK DISTRIBUTION

TEST WAVE HEIGHT $H_s = 5.5$ M
LEVEL DISTRIBUTION

Fig. 5.14 Peak and level distributions of a wave record from the model tests by SSPA.

One wave record from the experiments containing about 150 waves was analysed more in detail. The peak distribution of wave single amplitudes and the level distribution are presented in Fig. 5.14. Both distributions show that the wave record includes more high crests than deep troughs. Figure 5.15 confirms that the probability of wave crest amplitude exceeding certain high level is significantly higher than the trough amplitude exceeding the same level. The exceedance probability curve of crest amplitudes differs considerably from the Rayleigh distribution which the low wave troughs follow. The simulated waves follow the Rayleigh distribution (Fig. 5.16).

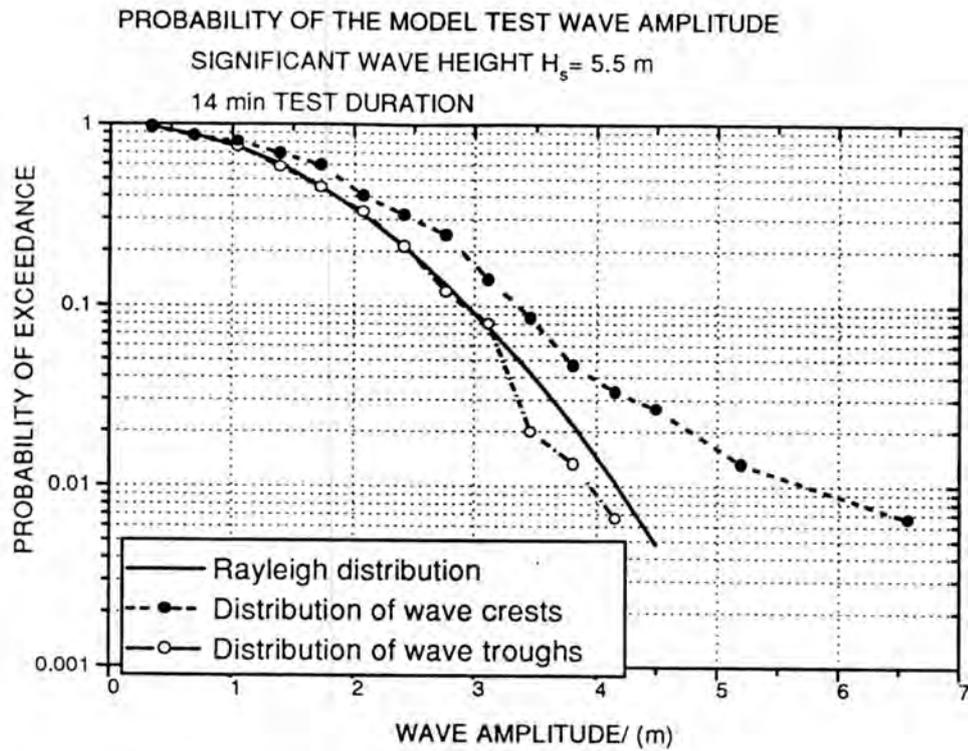
Fig. 5.15 Exceedance probabilities of wave crest and trough amplitudes from model tests by SSPA compared to the Rayleigh distribution.

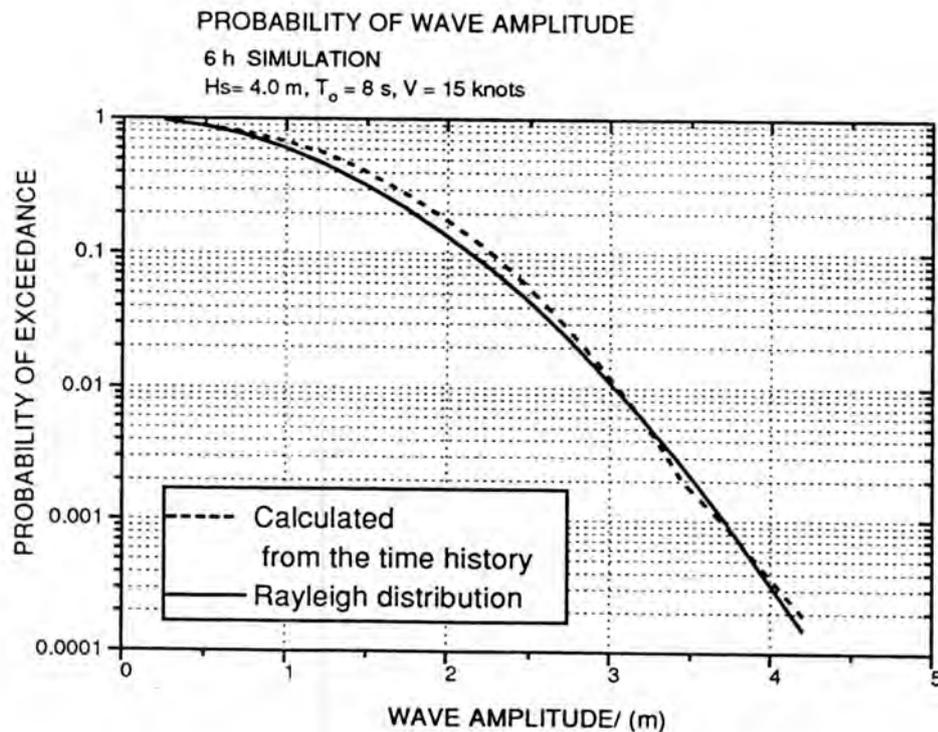
Fig. 5.16 Exceedance probabilities of wave amplitudes of a simulated wave record compared to the Rayleigh distribution.

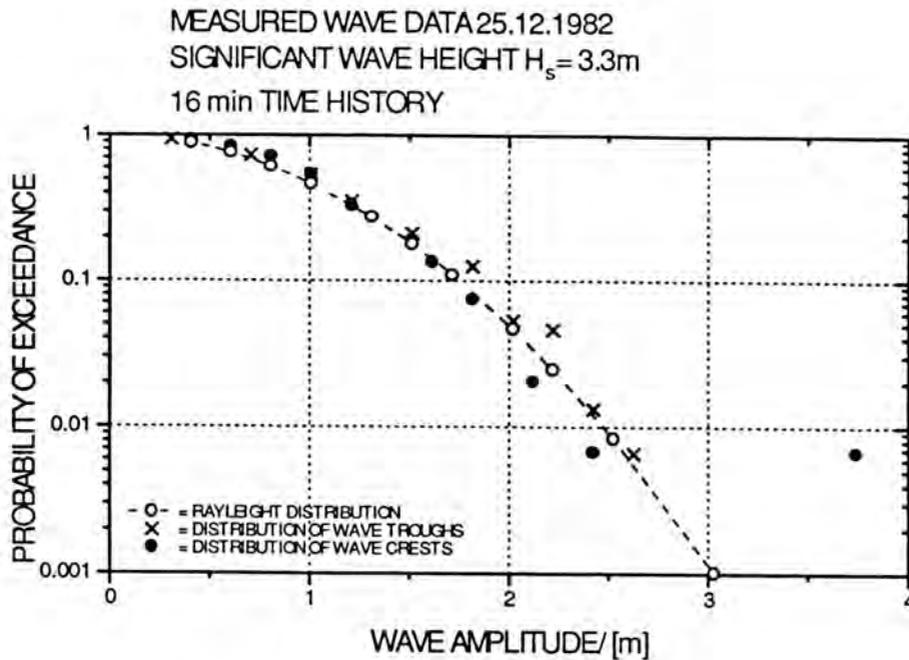
Fig. 5.17 Distribution of wave crest and trough amplitudes measured in December 1982 south of Bogskär compared to the Rayleigh distribution.

Two 16 minutes long wave time histories measured by MTL with a waverider buoy south of Bogskär in December 1982 and in January 1983 have been analysed after the MV Estonia accident to compare the wave crest and trough height distributions with the Rayleigh distribution. Figures 5.17 and 5.18 show that both the crest and trough distributions correlate well with the Rayleigh distribution. However, the wave time history measured in December 1982 contains one exceptionally high wave crest. This crest which is about 3.7 m high while the significant height is 3.3 m differs significantly from the Rayleigh distribution. In certain storm conditions, so called episodic waves which have a height of about $2.4H_s$ have been observed (Buckley, 1983), but it is not known whether this kind of waves appear in the Baltic. Andrew & Lloyd (1980) measured wave-induced motions of two British frigates in severe head seas on a full scale trial south-west of Ireland and found that the wave-induced motions follow quite well the Rayleigh distribution.

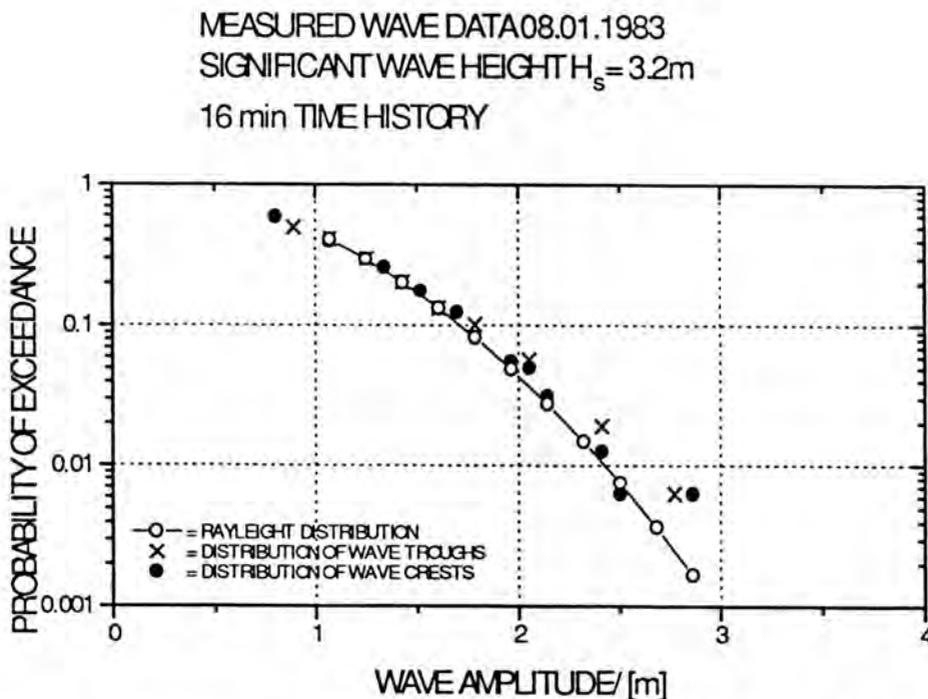
Fig. 5.18 Distribution of wave crest and trough amplitudes measured south of Bogskär in January 1983 compared to the Rayleigh distribution.

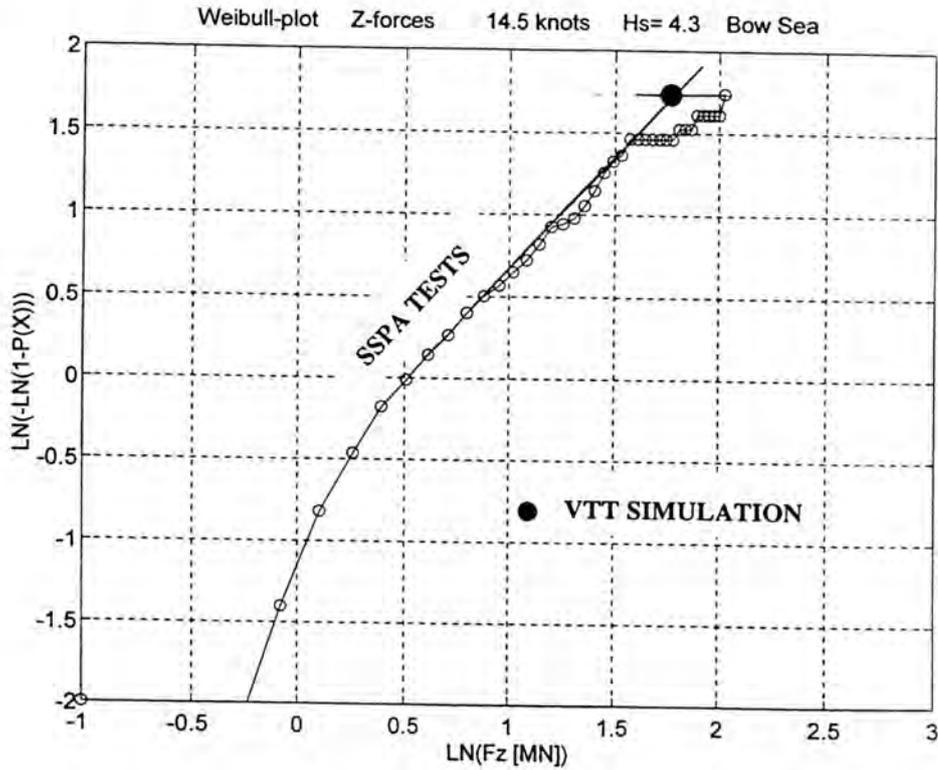
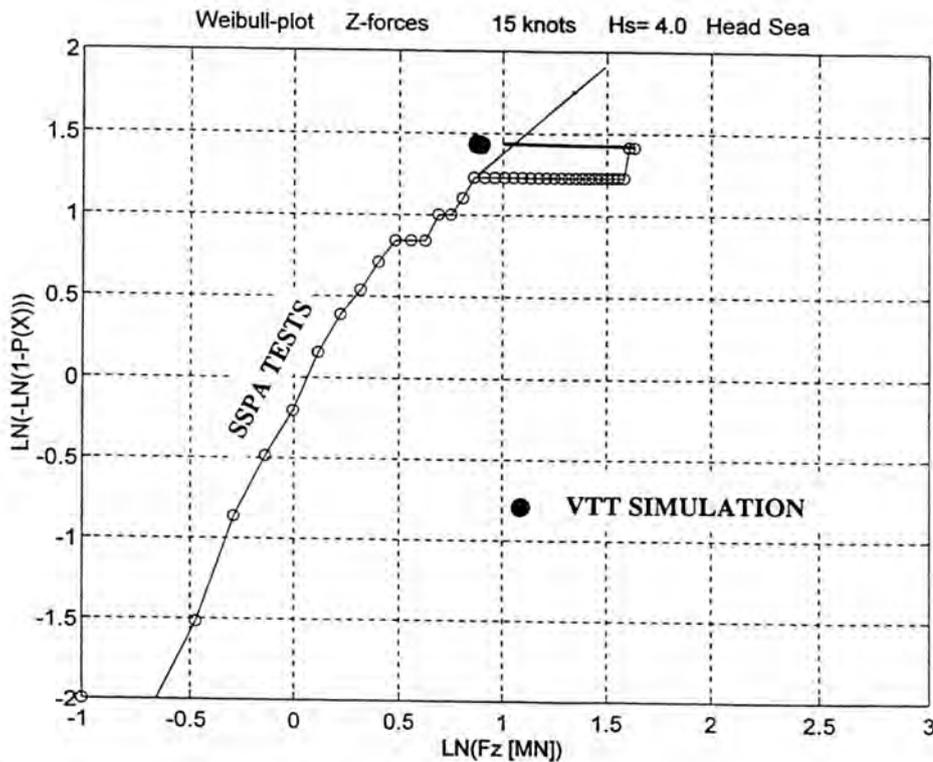
Figure 5.19 Extrapolation of measured data and a comparison with simulated results.

The simulated forces F_z sim. have been estimated from the probability of exceedance curves in Figures 5.4, 5.6 and 5.8. The forces correspond to the exceedance probabilities of 1/(number of wave encounters), for instance, in bow seas at 14.5 kn speed the exceedance probability has been 1/2 557 = 0.00039. If the maximum force measured during the experiments differs considerably from the general trend of the lower peak force values expressed in the form of a Weibull-diagram, the general trend has been extrapolated and an estimate F_z est. has been read from the extrapolation line. This has been made in three cases of which examples are in Figure 5.19.

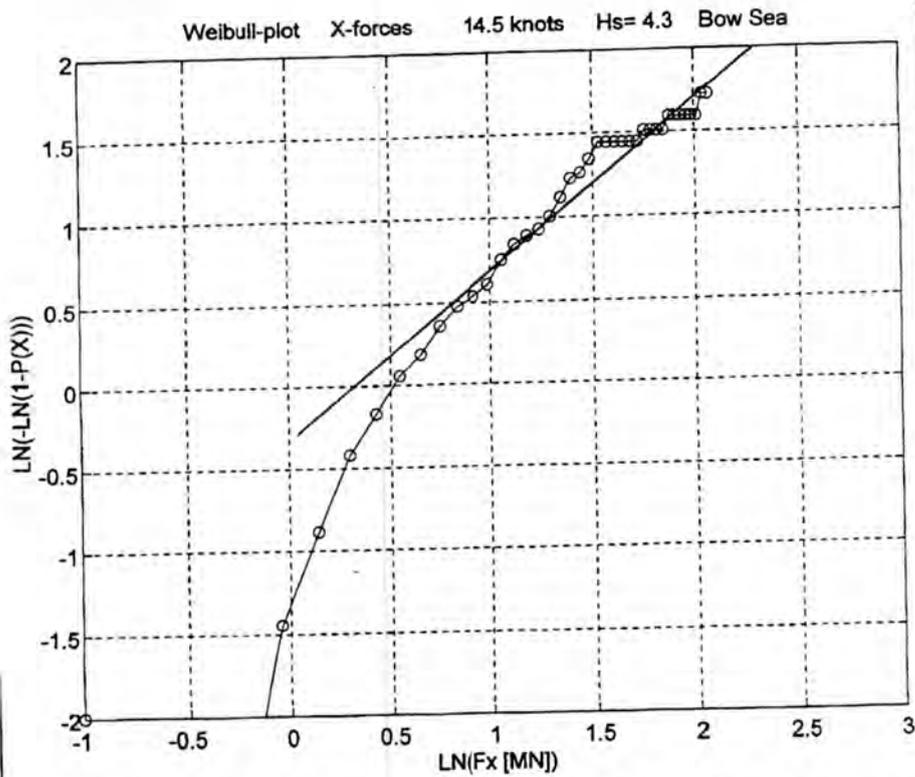
Figure 1.1 X-forces as measured and with Weibull-distribution curve fit

The SSPA plots with the corresponding linear curve fit are shown in Figures 1.1-1.5. The Z-moment distribution was not possible to evaluate directly from this test series.

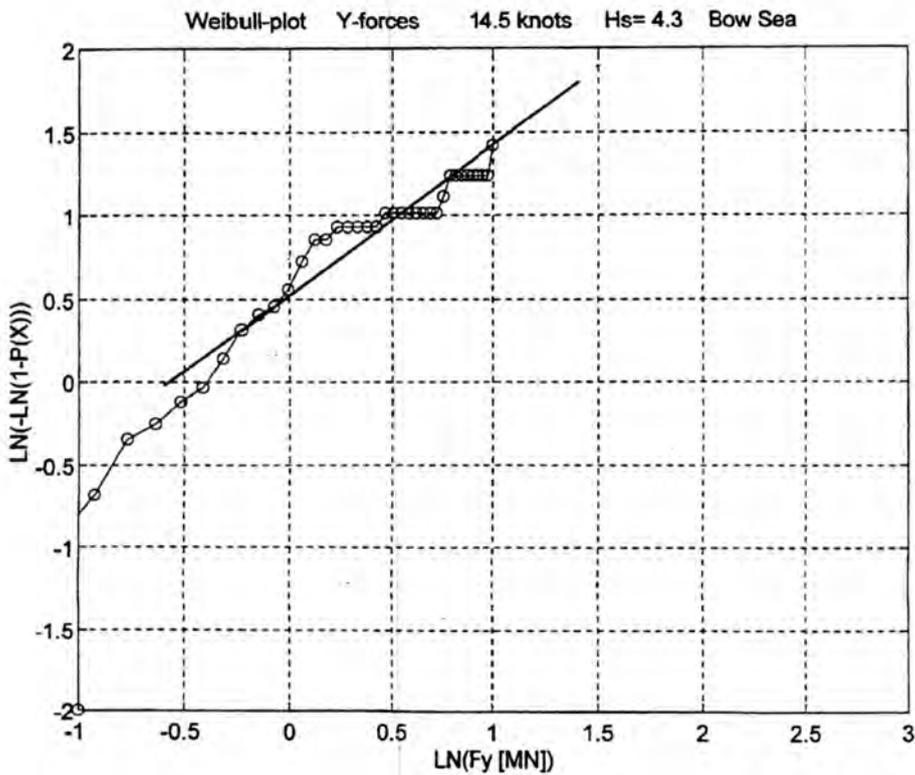
Figure 1.2 Y-forces as measured and with Weibull-distribution curve fit

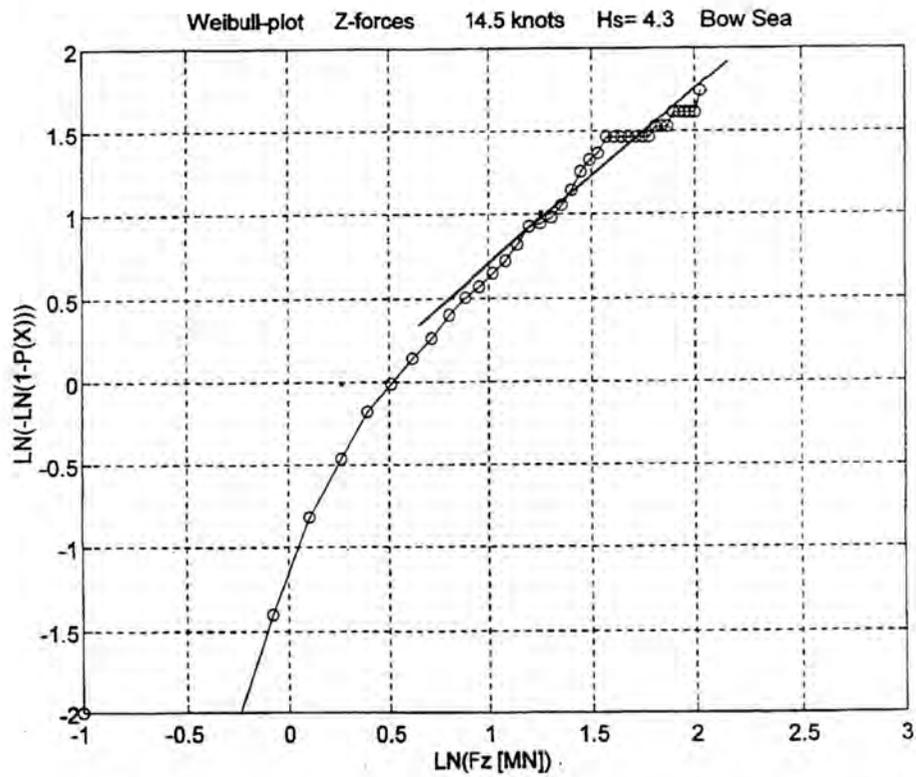
Figure 1.3 Z-forces as measured and with Weibull-distribution curve fit

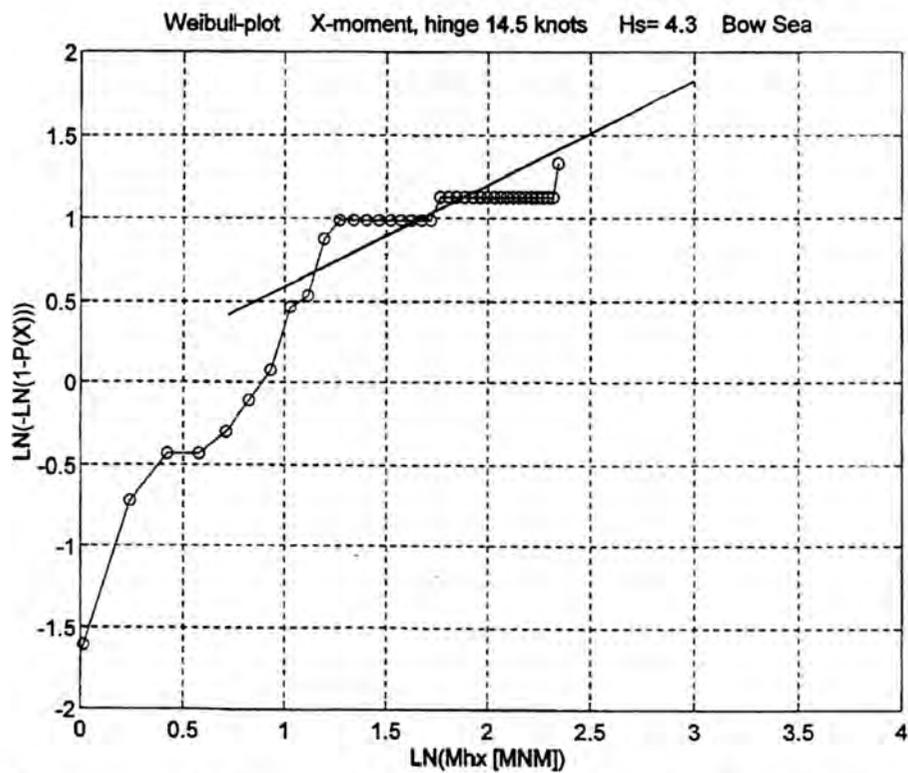
Figure 1.4 X-moments as measured and with Weibull-distribution curve fit

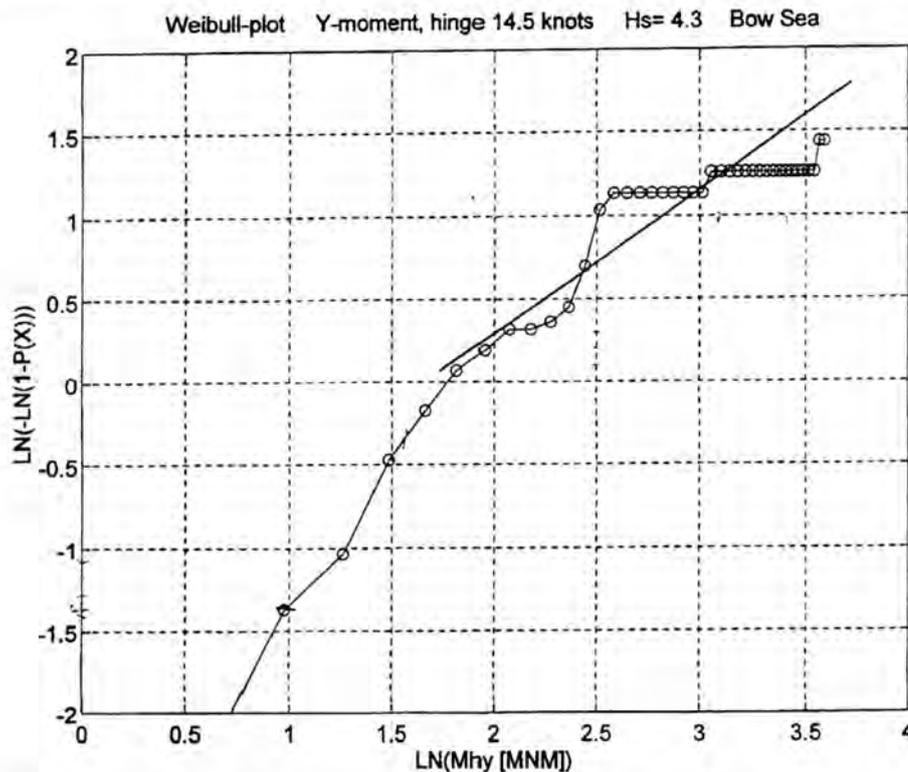
Figure 1.5 Y-moments as measured and with Weibull-distribution curve fit

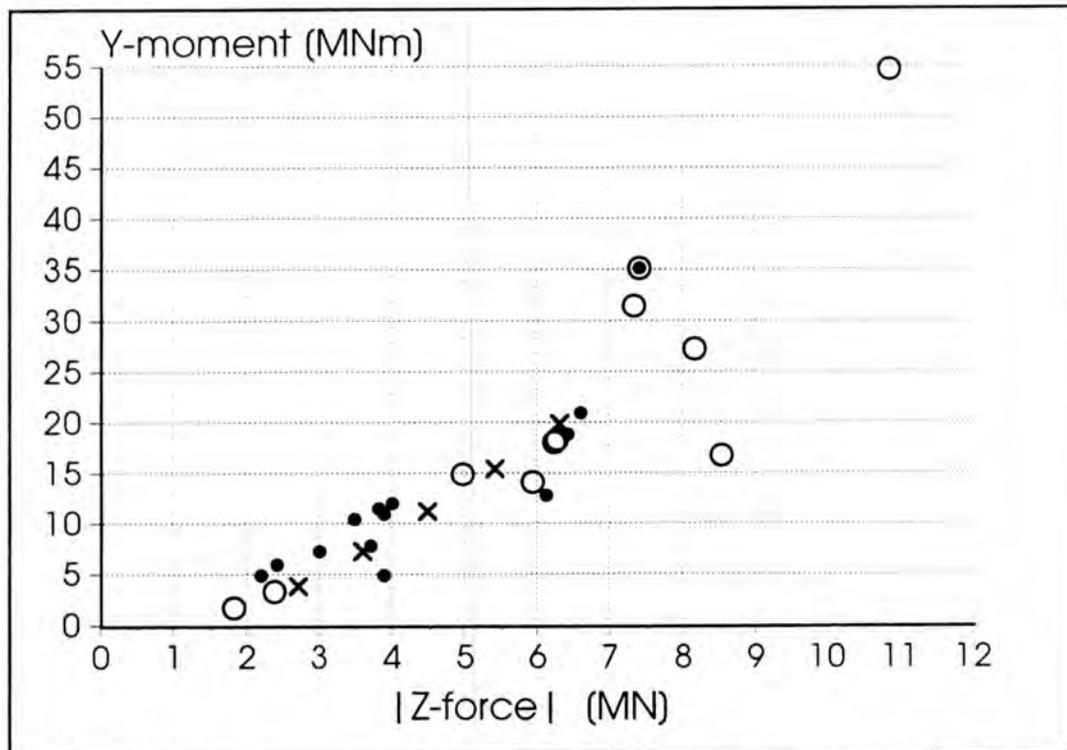
Figure 1.7 Correlation between Z-force and Y-moment, as measured at model tests
Filled spots show the 13 highest wave loads in $H_s = 4.5\text{m}/V = 14.5\text{kn}$
Rings shows the single highest value from all different test series.
The 5 cross show the example load levels A-E as defined on page 9

The reduction on moments have been estimated from the correlation between Z-forces and Y-moments according to Figure 1.7. The diagram includes the 13 highest forces and moments measured during the 3 h long model test series. For the Z-force levels in the range of 4-10 MN, a reduction with 30% will give an approximate reduction of about 50% on the moments. This reduction has here been used for all moments.

The range of maximum wave force components considered has been covered by the following five typical cases A-E (also shown in Figure 1.7):

Figure 2.6 shows the influence of force centre of action. The moments M_y and M_z are varied by 20% with regard to the resultant force level. This variation is about the same as have been found from the model tests as shown in the previous Figure 1.7.

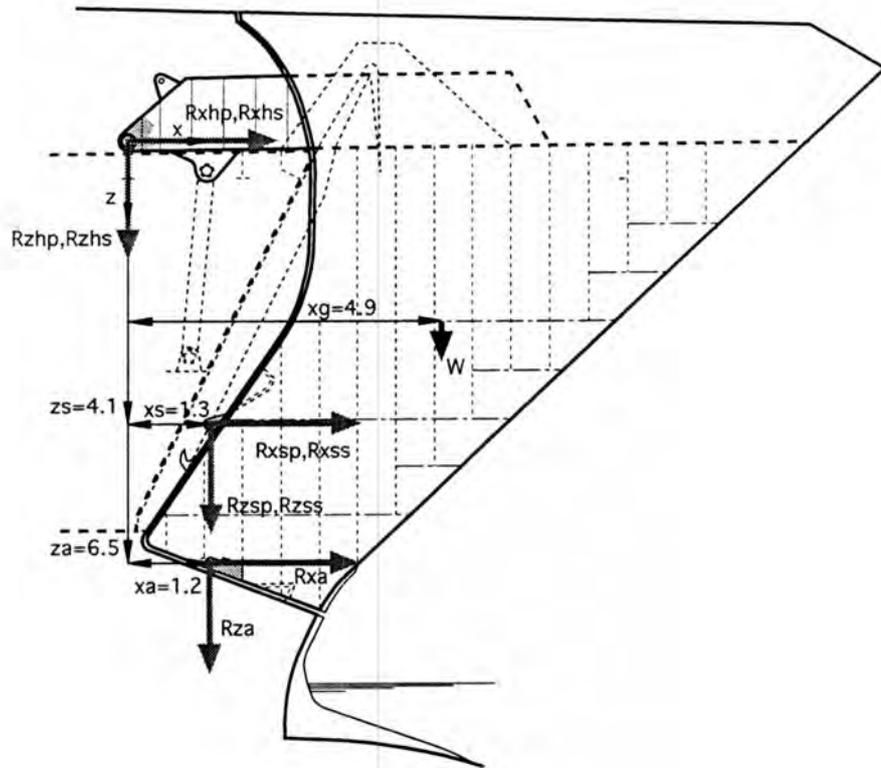
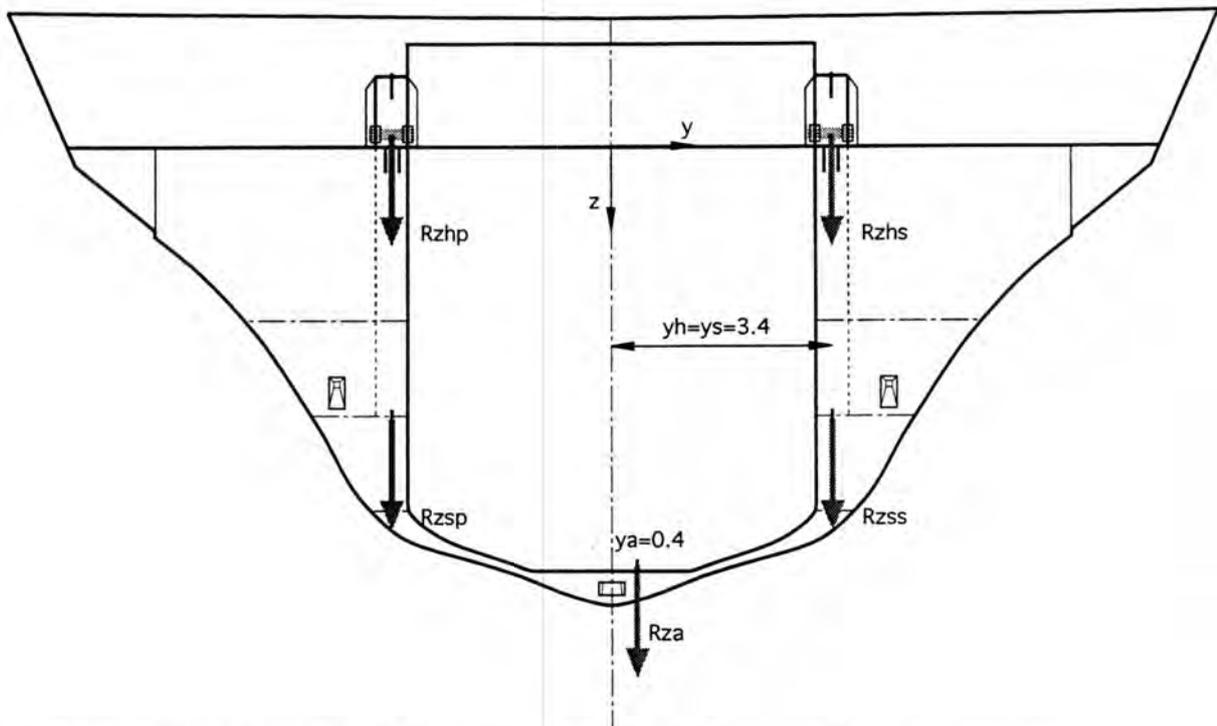
Figure 2.1 Coordinates and notation of reaction forces at attachments

The same direction of coordinates as used by SSPA is used here, i.e. x-forward, y-starboard and z-downwards. The origin of the system is placed at the deck hinge axis and CL-plane. Coordinates and notation of reaction forces are given in Figure 2.1 on the next page. In total 10 reaction forces at 5 different positions are considered.

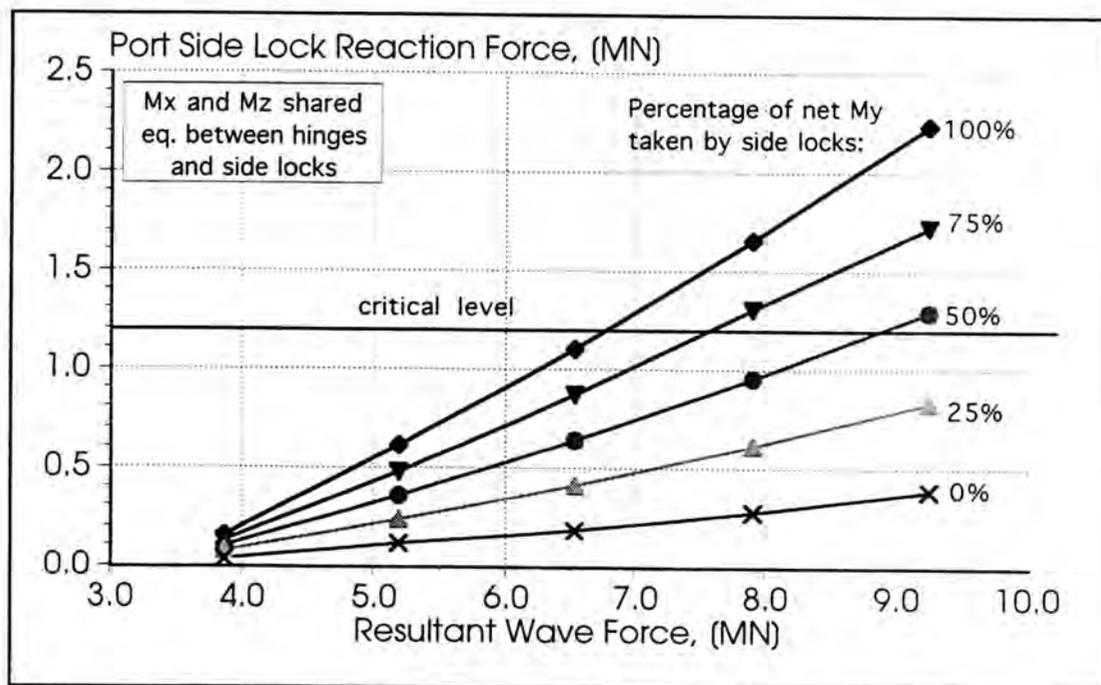
Figure 2.2 Port side lock reaction as function of wave force and My distribution between locks. All attachments intact

The most critical of the complementary conditions is the percentage of opening moment M_y carried by side locks and Atlantic lock respectively. Figures 2.2-2.3 show the resultant reaction force in port side lock and Atlantic lock as function of the load level and the load distribution. When more than 40% of the opening moment is assumed taken by the side locks, the port side lock will be the first to fail. Due to the relative stiffer upper part of the visor and the high position of the wave forces centre of action, it is reasonable to assume that most of the opening moment will be taken by the side locks. Figure 2.4 shows an example of a critical load distribution assuming 67% of M_y carried by the two side locks, and M_x, M_z shared equally between hinges and side locks.

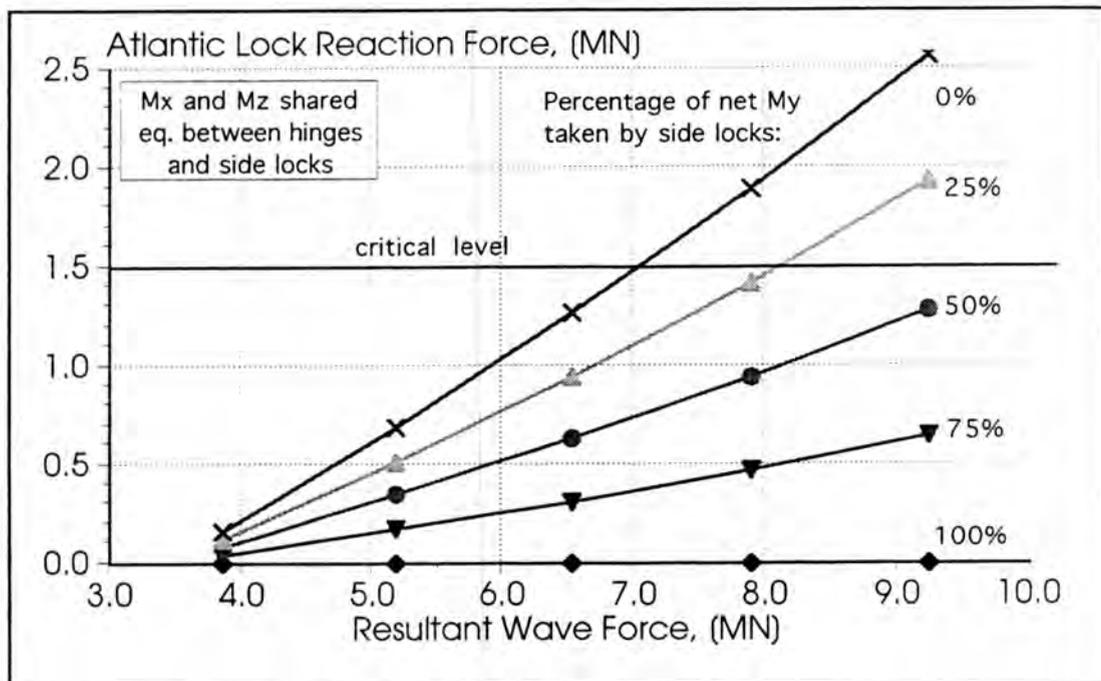
Figure 2.3 Atlantic lock reaction as function of wave force and My distribution between locks. All attachments intact

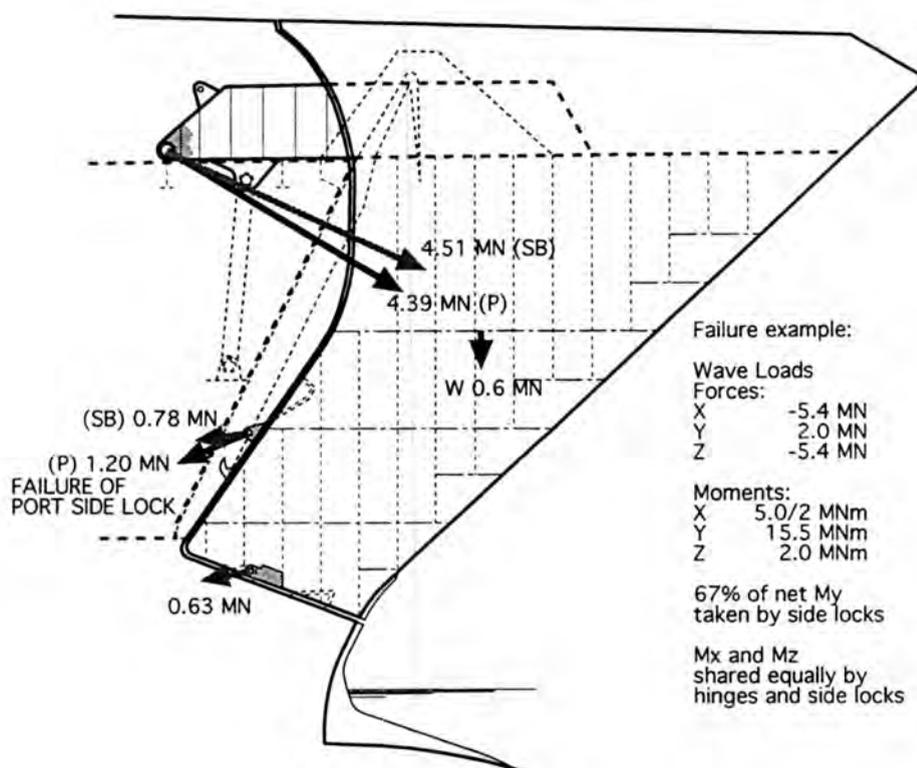
Figure 2.4 Example of reaction force distribution resulting in port side lock failure

Figures 2.7-2.8 show the reaction forces at starboard side lock and Atlantic lock when the port side lock has failed. It is not possible to ascertain which of the remaining locks that will be the second to fail. The capacity of the the starboard side lock has been estimated by different calculations to be at most 1.6 MN. It is also a possibility that the port side deck hinge will fail second due to the more downwards directed reaction force. In general the necessary wave load is about equal or slightly larger for any subsequent failure as for the initial failure. Figure 2.9 gives two examples of possible subsequent failure conditions after the port side lock has failed. The wave load level is here chosen as the same as in Figure 2.4.

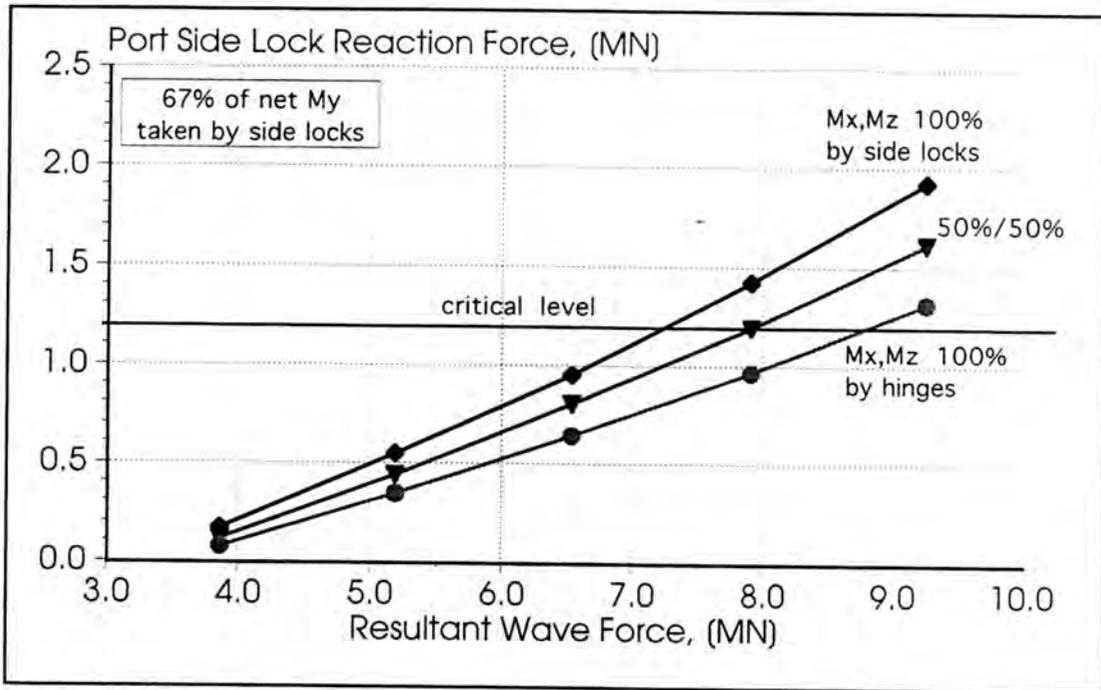
Figure 2.5 Example of influence from Mx, Mz distribution between hinges and side locks

Figure 2.5 shows the influence of M_x, M_z distribution between hinges and side locks.

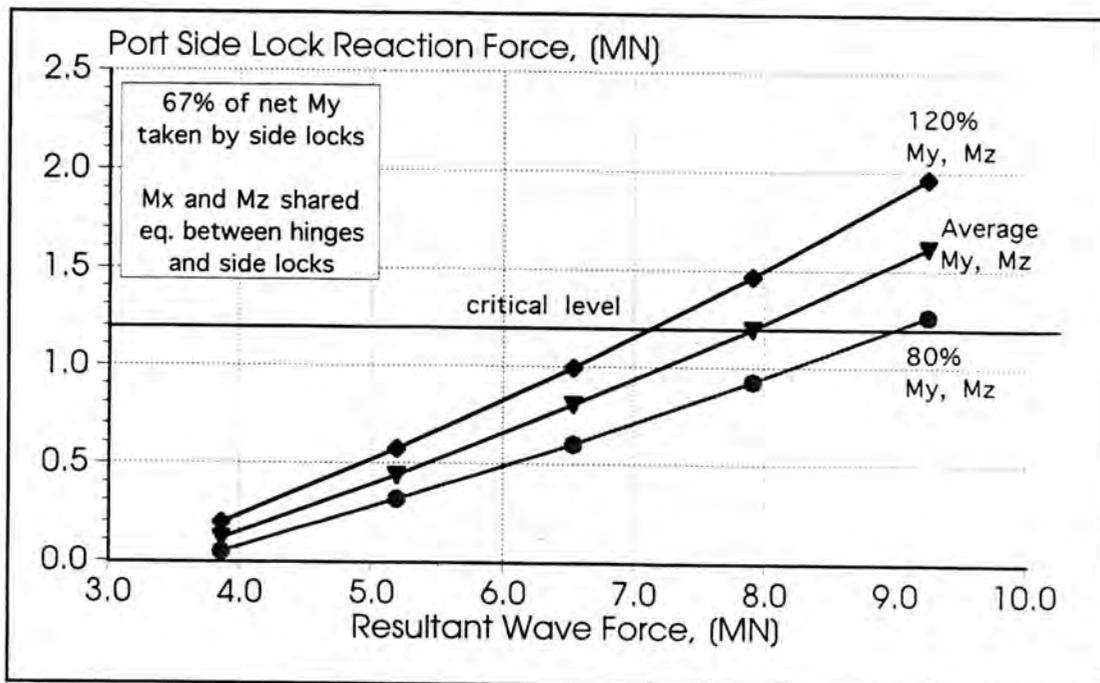
Figure 2.6 Example of influence from variation in My, Mz level

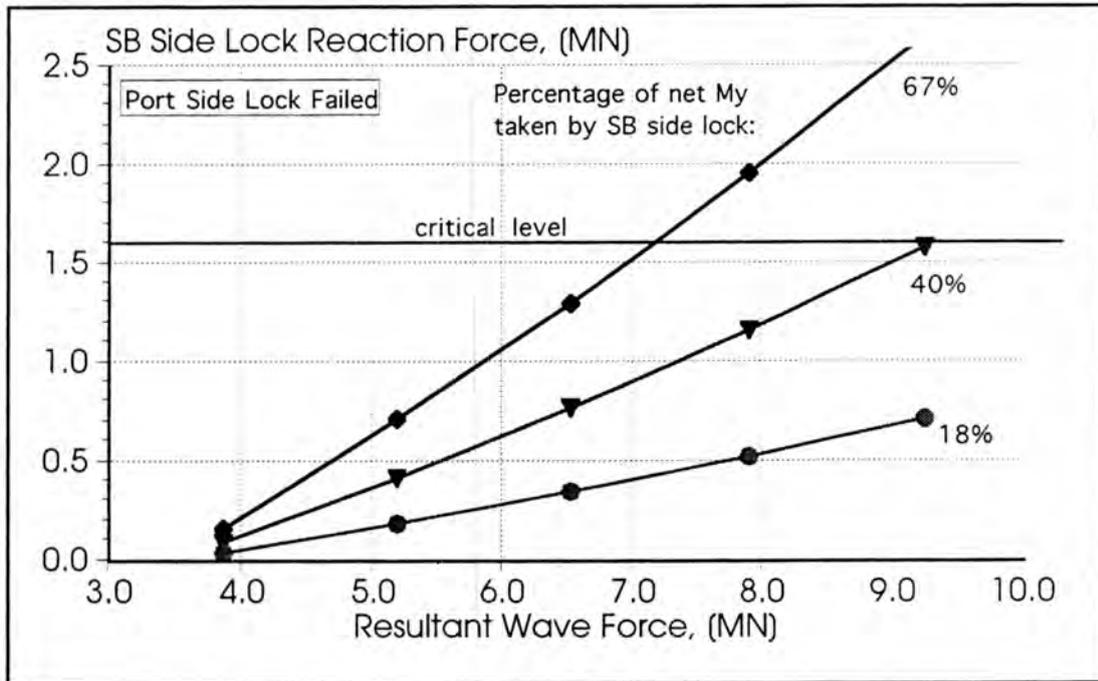
Figure 2.7 Reaction in starboard side lock after port side lock has failed

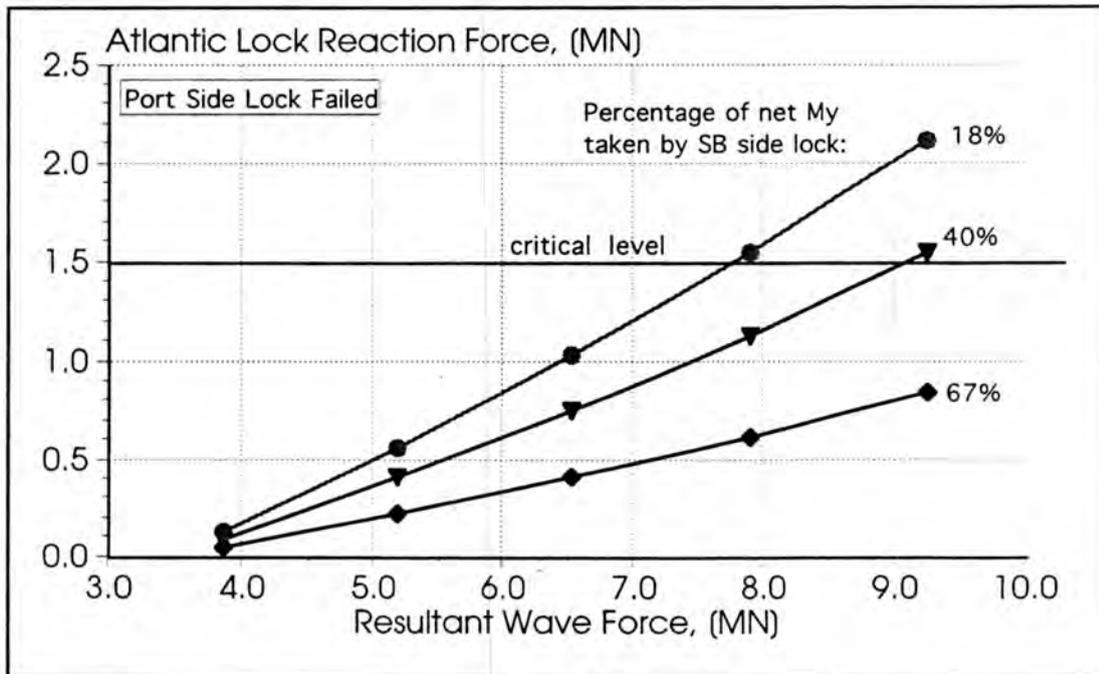
Figure 2.8 Reaction in Atlantic lock after port side lock has failed

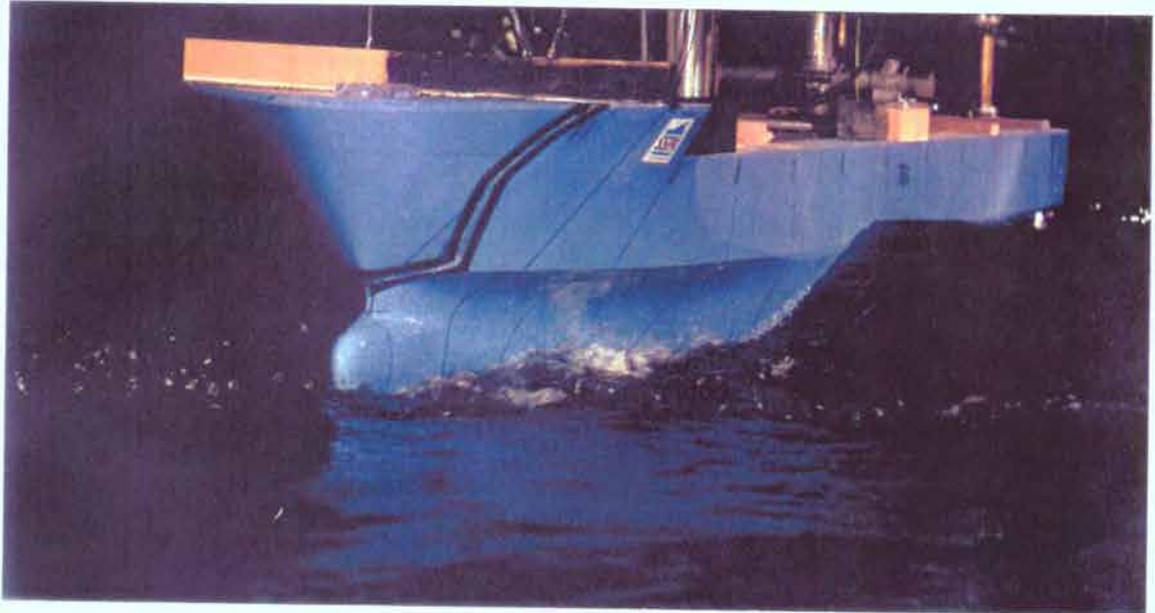
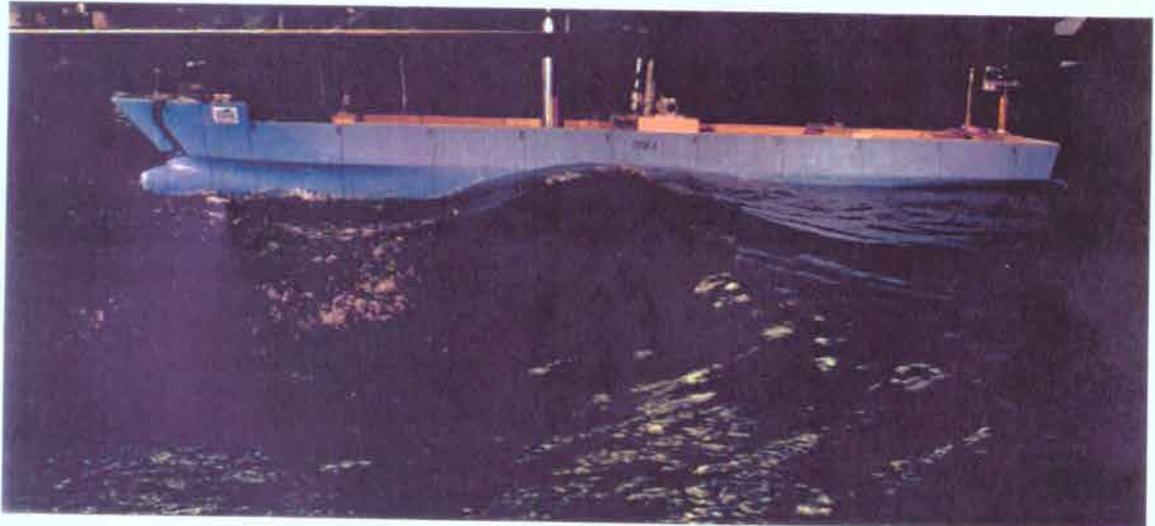
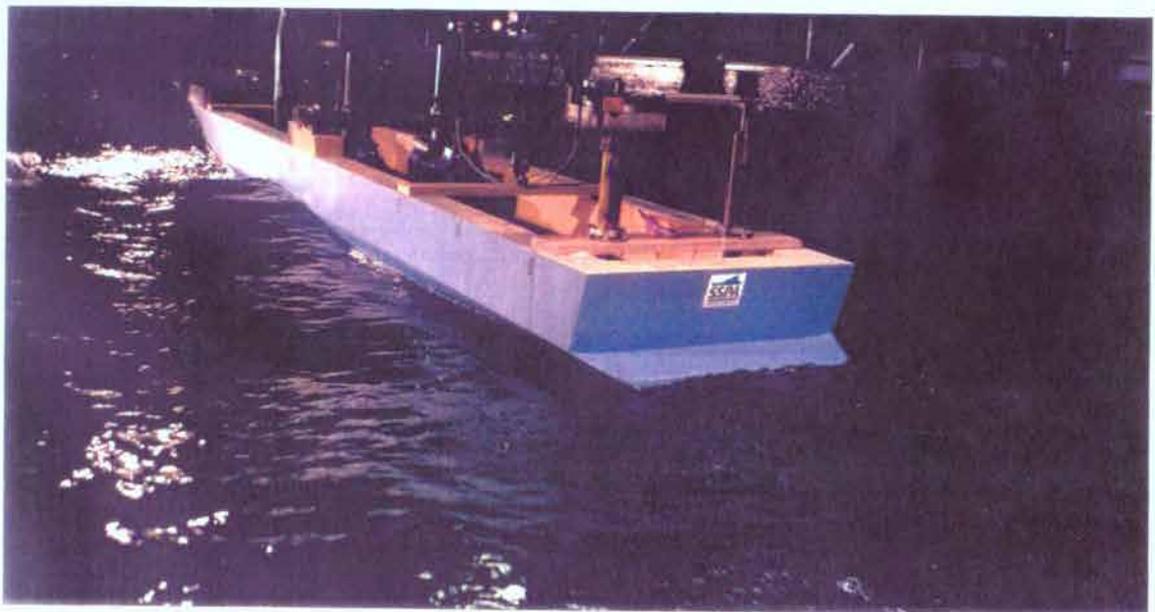
Test in towing tank
Speed 15.0 knots in head sea $H_s = 4.0$ m
