THE FINAL REPORT ON THE CAPSIZING ON 28
SEPTEMBER 1994 IN THE BALTIC SEA OF THE
RO-RO PASSENGER VESSEL MV ESTONIA

The Joint Accident Investigation Commission
of
Estonia, Finland and Sweden

The Joint Accident Investigation Commission publishes in this Supplement the most important documents used in Commission's work. Large appendices of some research reports have been edited, but a list of appendices has been included.

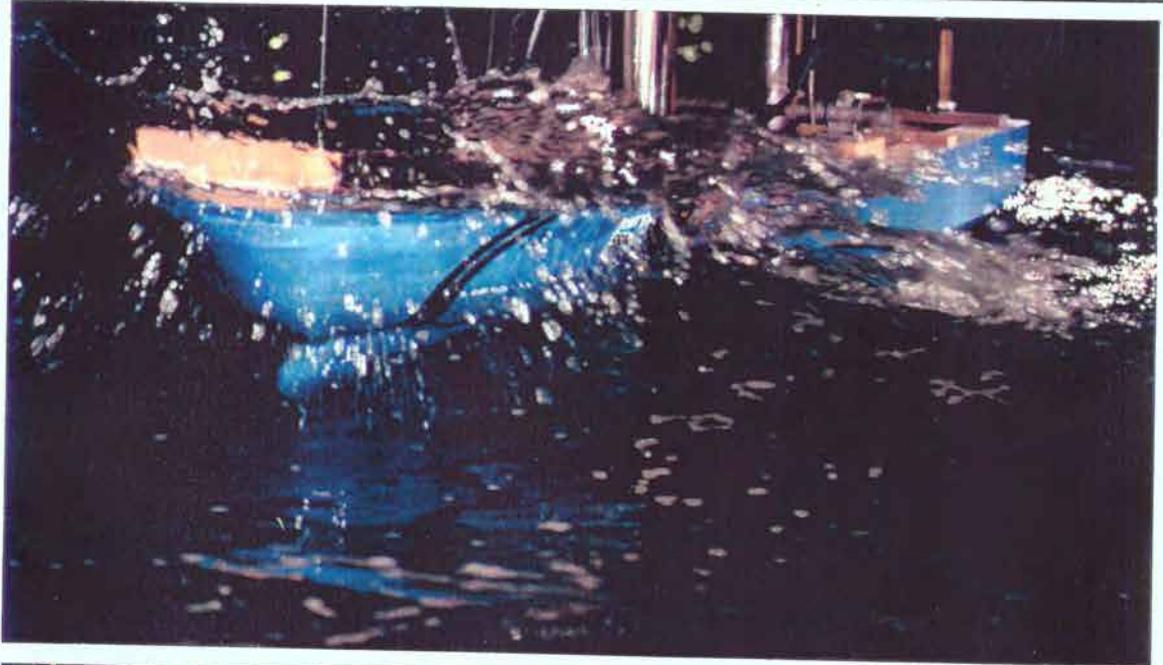
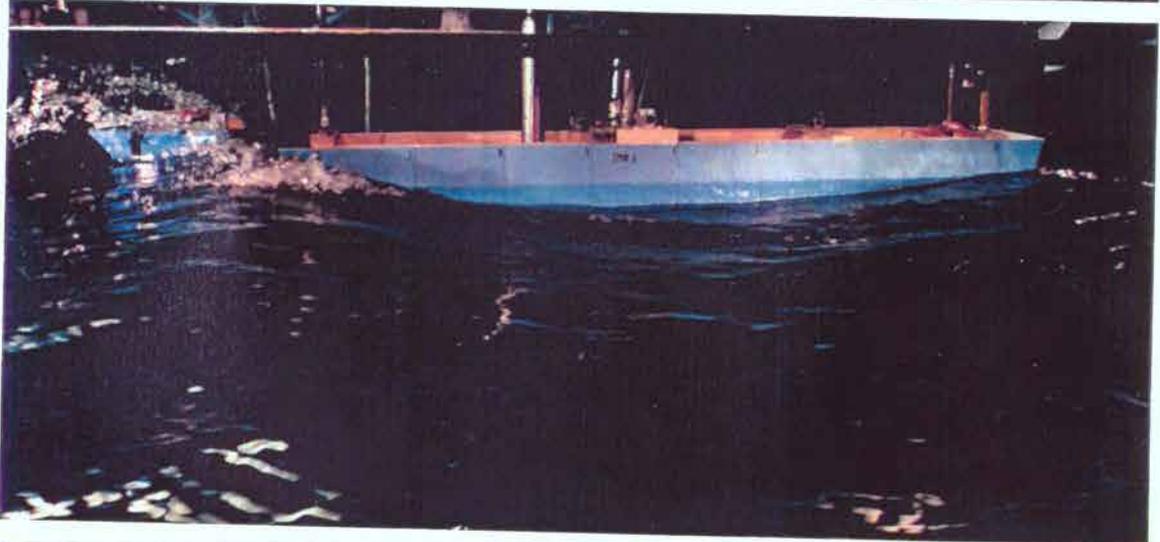
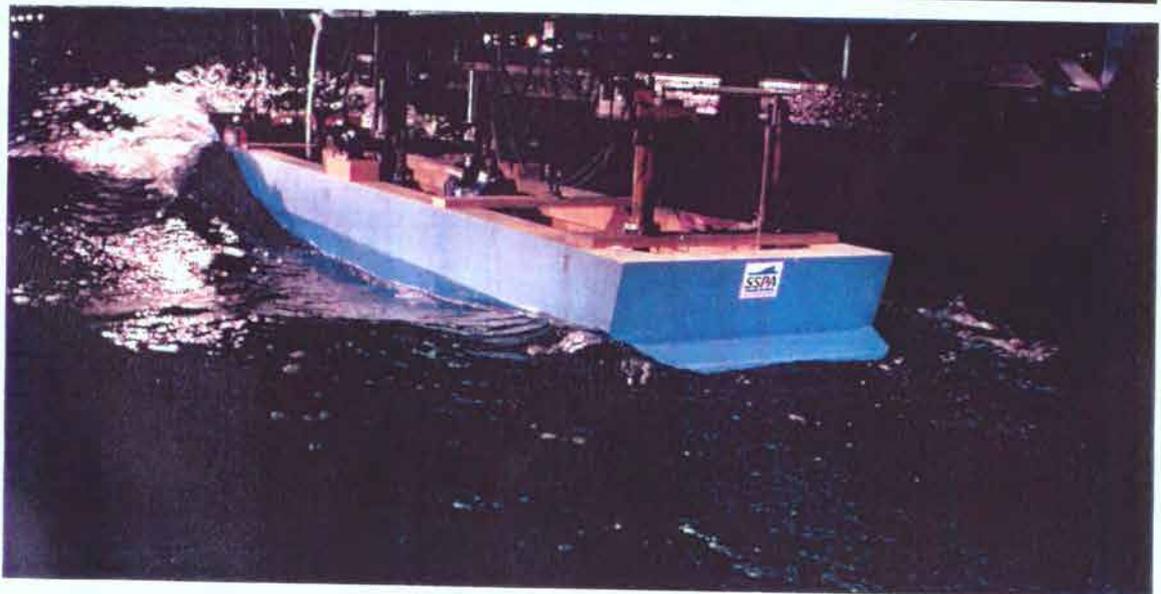
Test in towing tank
Speed 15.0 knots in head sea $H_s = 4.0$ m

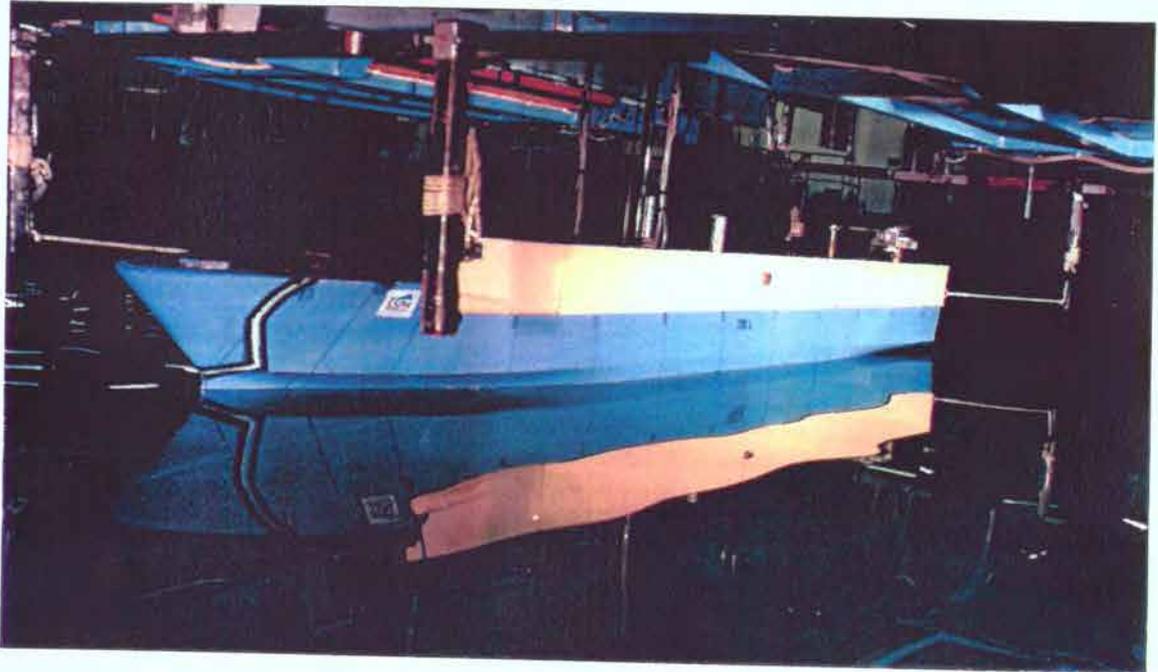
Model at rest

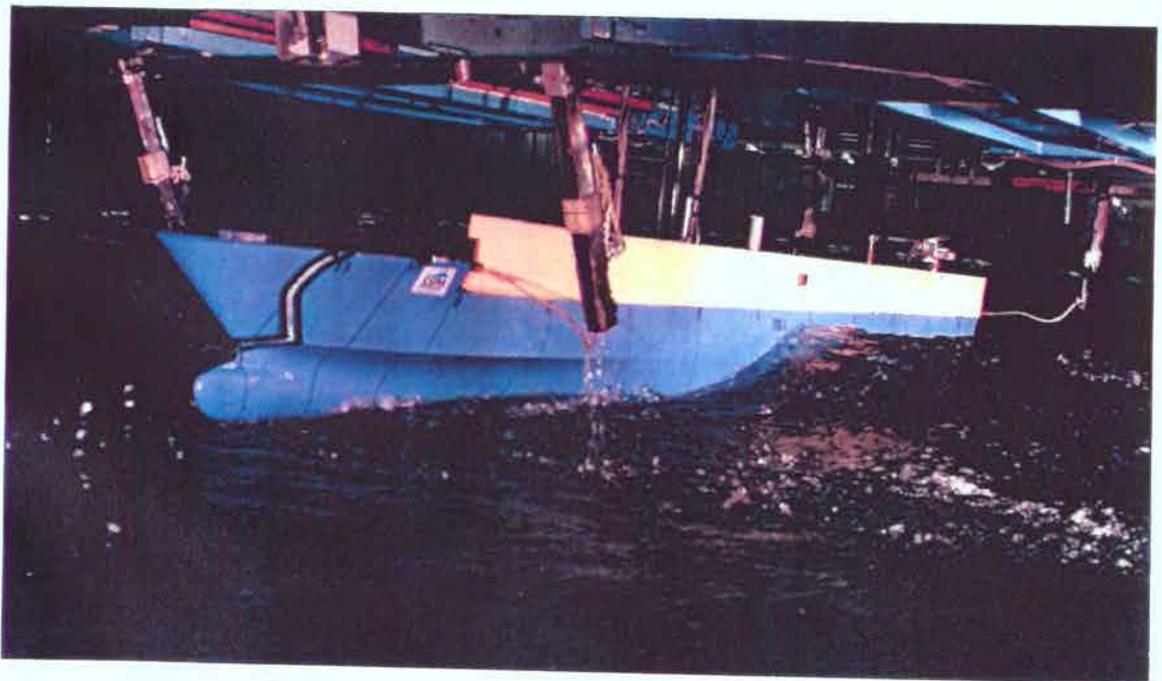
Speed 10.0 knots in bow sea $H_s = 5.5$ m

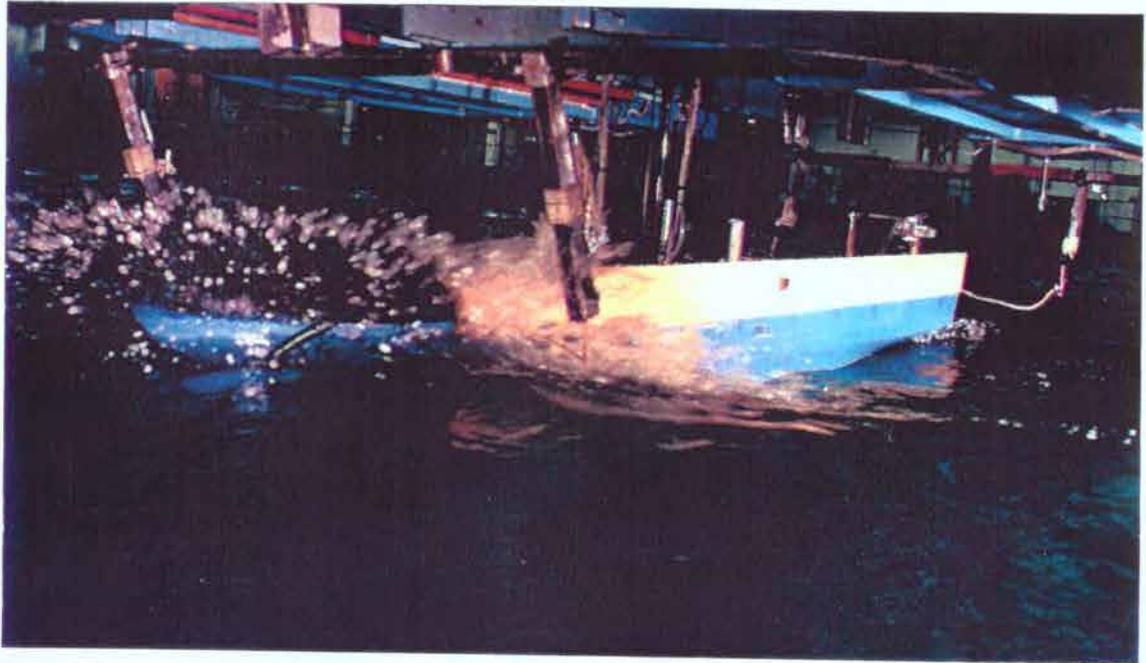
Speed 15.0 knots in bow sea $H_s = 5.5$ m

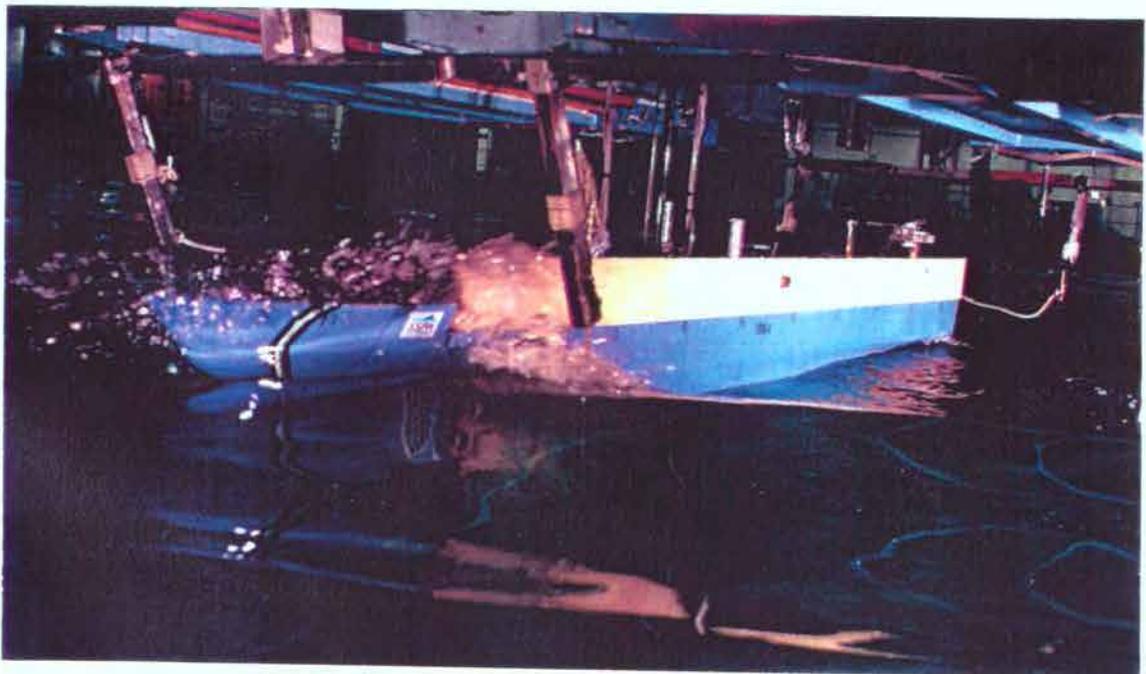
Speed 14.3 knots in bow sea $H_s = 4.3$ m

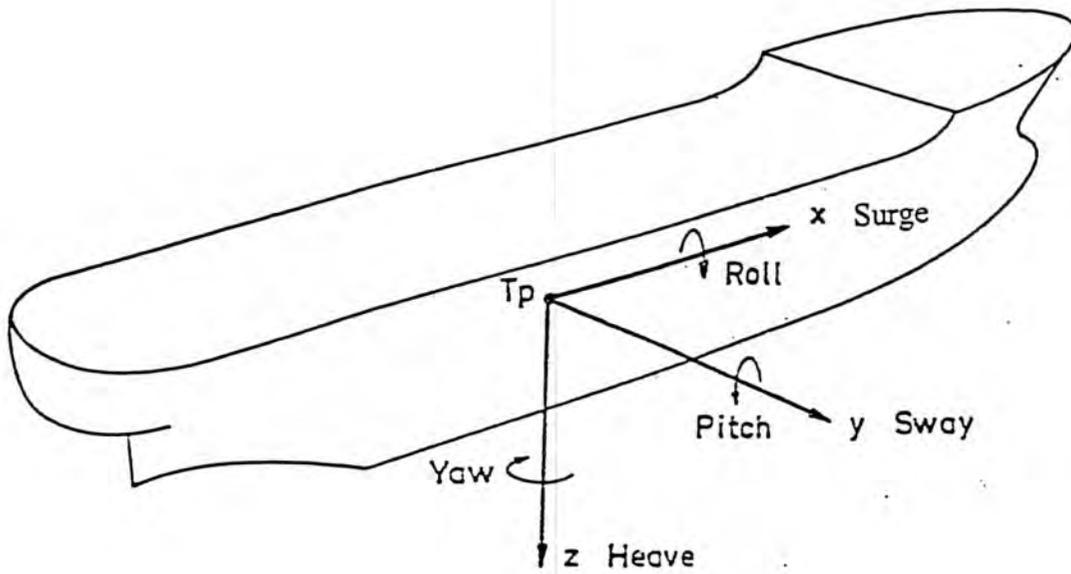
Definitions of motions and wave direction

Definition of motions

Definitions of co-ordinate system, motions and wave direction are given in fig 11. Note that the height of the wave crest is negative and that negative relative motion means decreasing free-board. Standard statistics of relevant parameters from all tests are given in the appendix to this report [1]. Note that the period T_z is the zero-crossing period of encounter and that amplitudes marked with * means single amplitudes and ** double amplitudes. Time series and Weibull diagrams of relevant parameters and tests are also given in [1] but some examples are included here (fig 12-16).

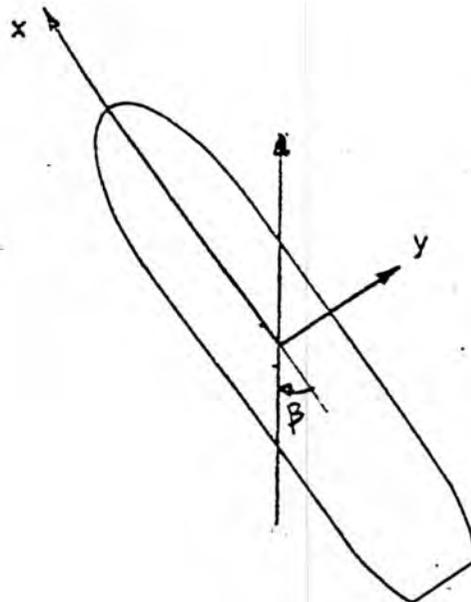
Definition of wave direction

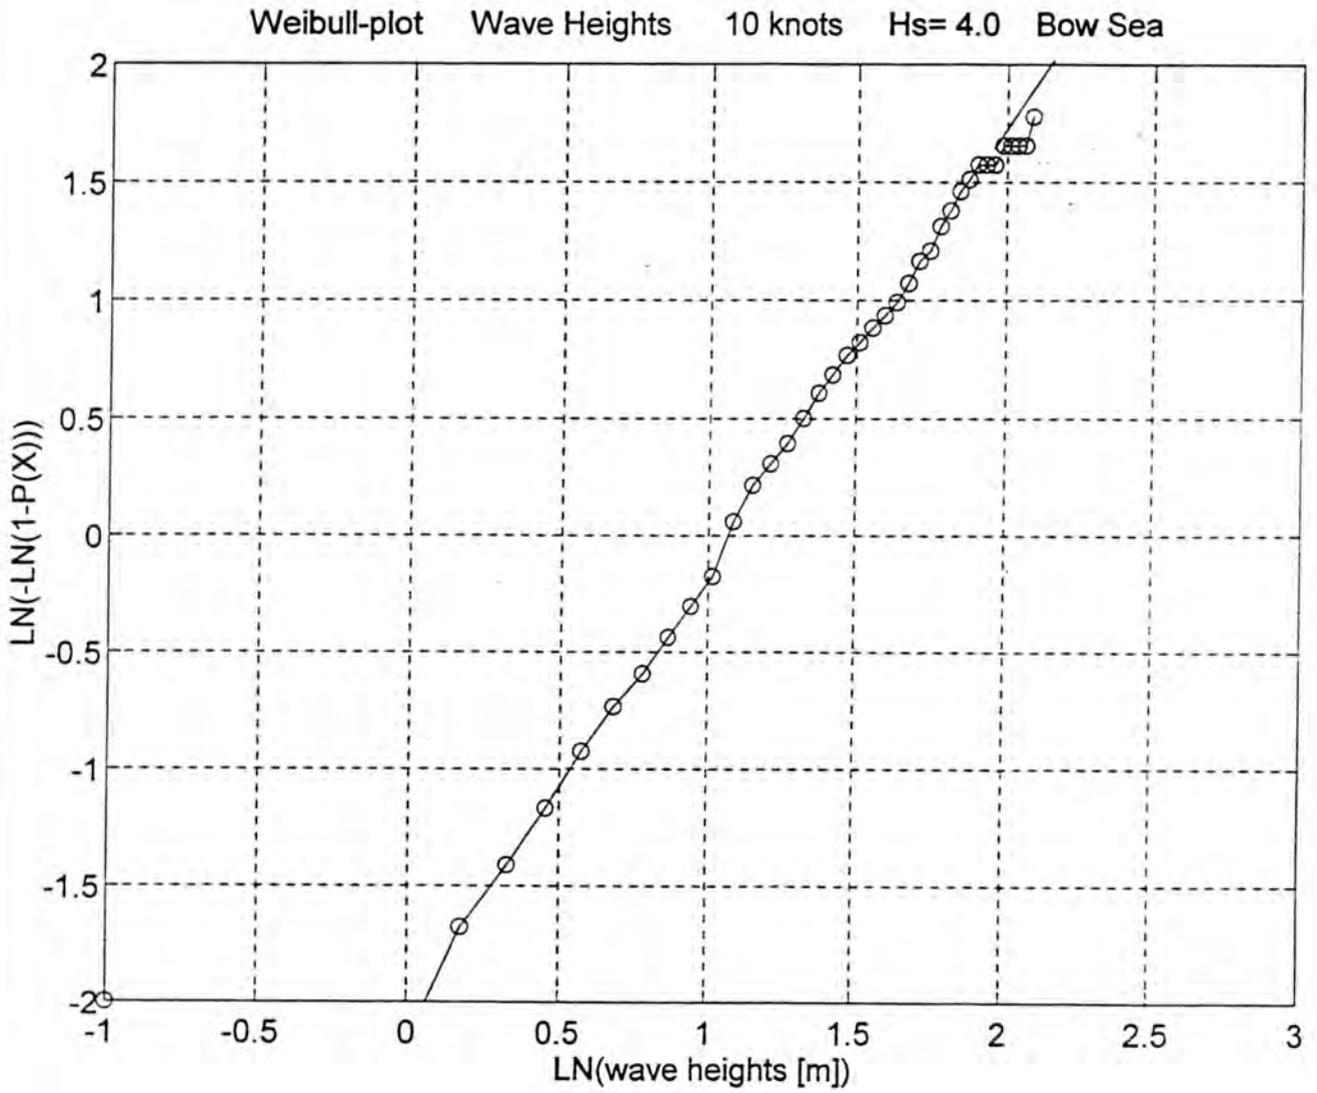
Fig 15a
Report 7524

M/S Estonia
MDL tests in irregular sea
Weibull diagram from run 34-46:
Wave height
Speed 10 knots in bow sea $H_s = 4.0$ m

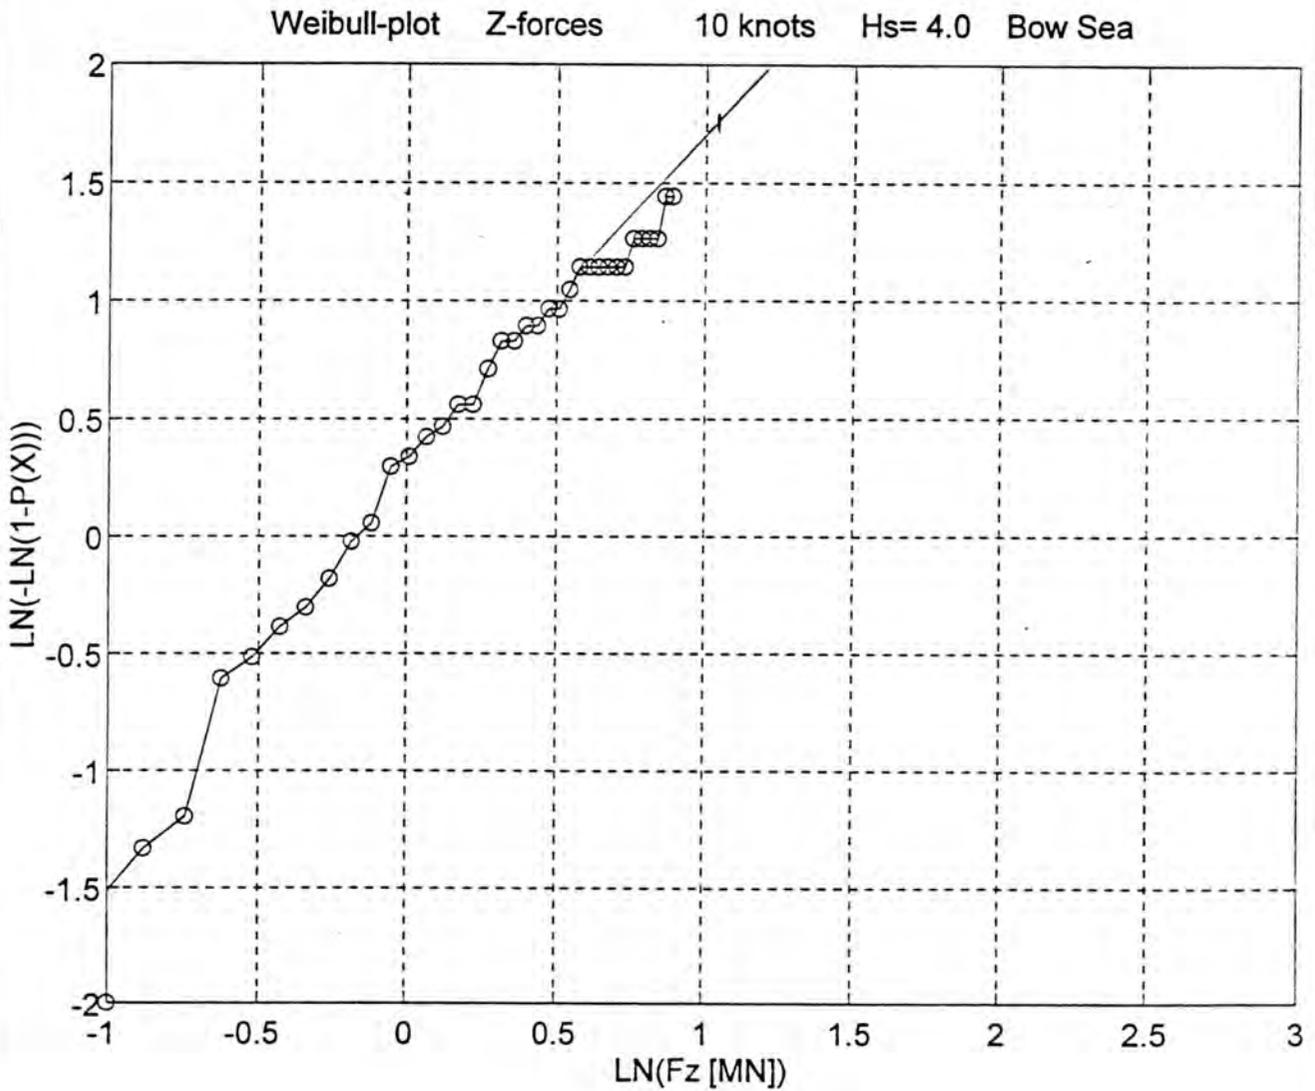
Fig 15b

M/S Estonia
MDL tests in irregular sea
Weibull diagram from run 34-46:
Vertical (Z) force on visor
Speed 10 knots in bow sea Hs= 4.0 m

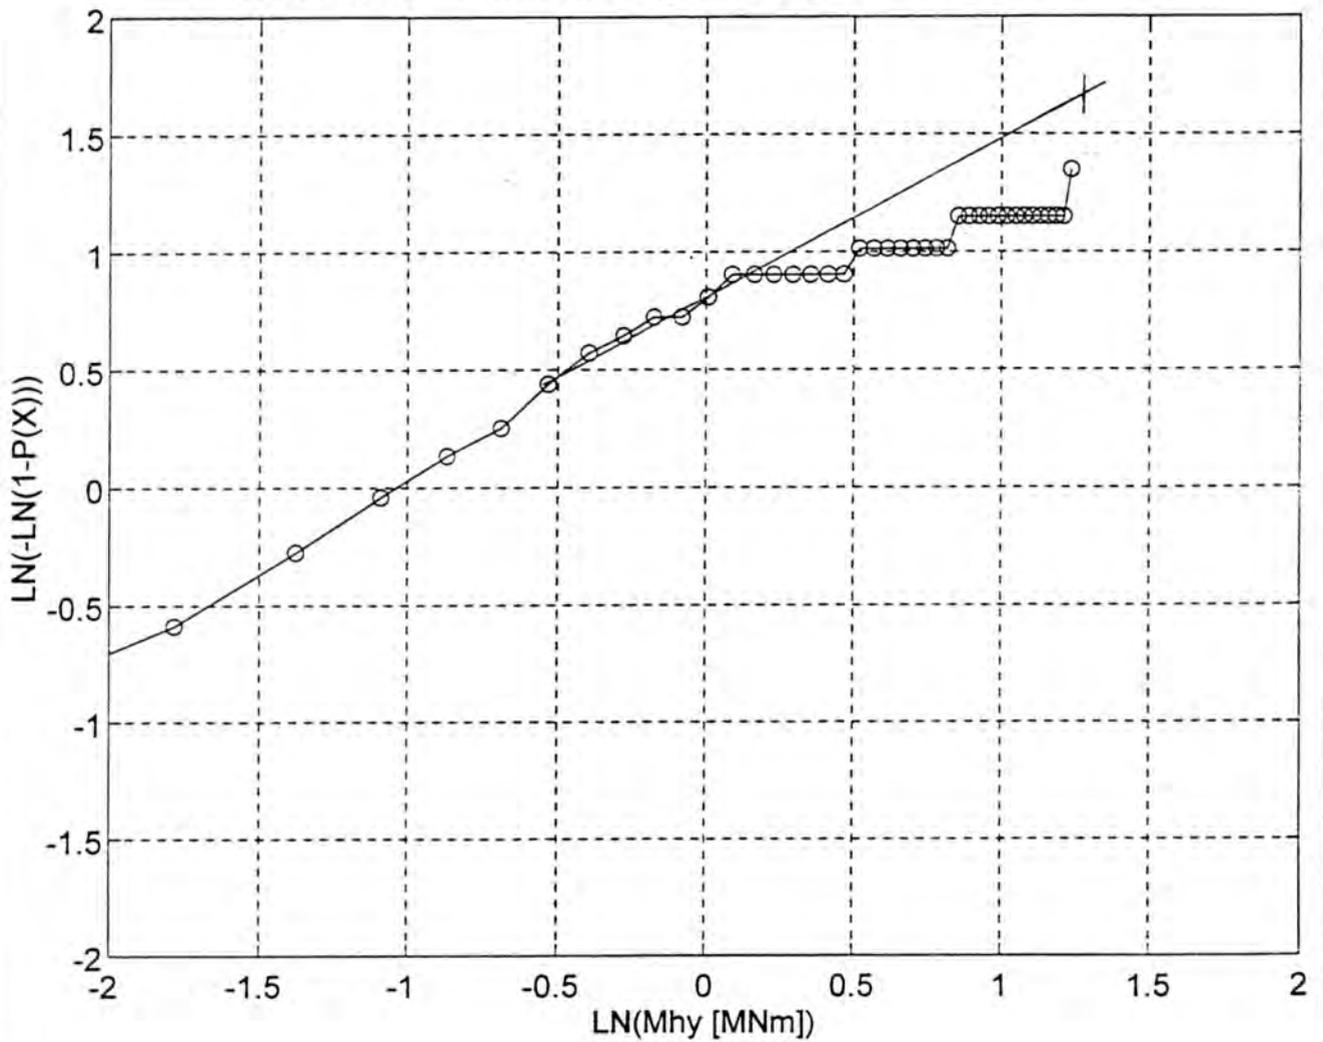
Fig 15c

M/S Estonia
MDL tests in irregular sea
Weibull diagram from run 34-46:
Deck hinge (Yh) moment
Speed 10 knots in bow sea Hs= 4.0 m

Weibull-plot Y-moment, hinge 10 knots Hs= 4.0 Bow Sea

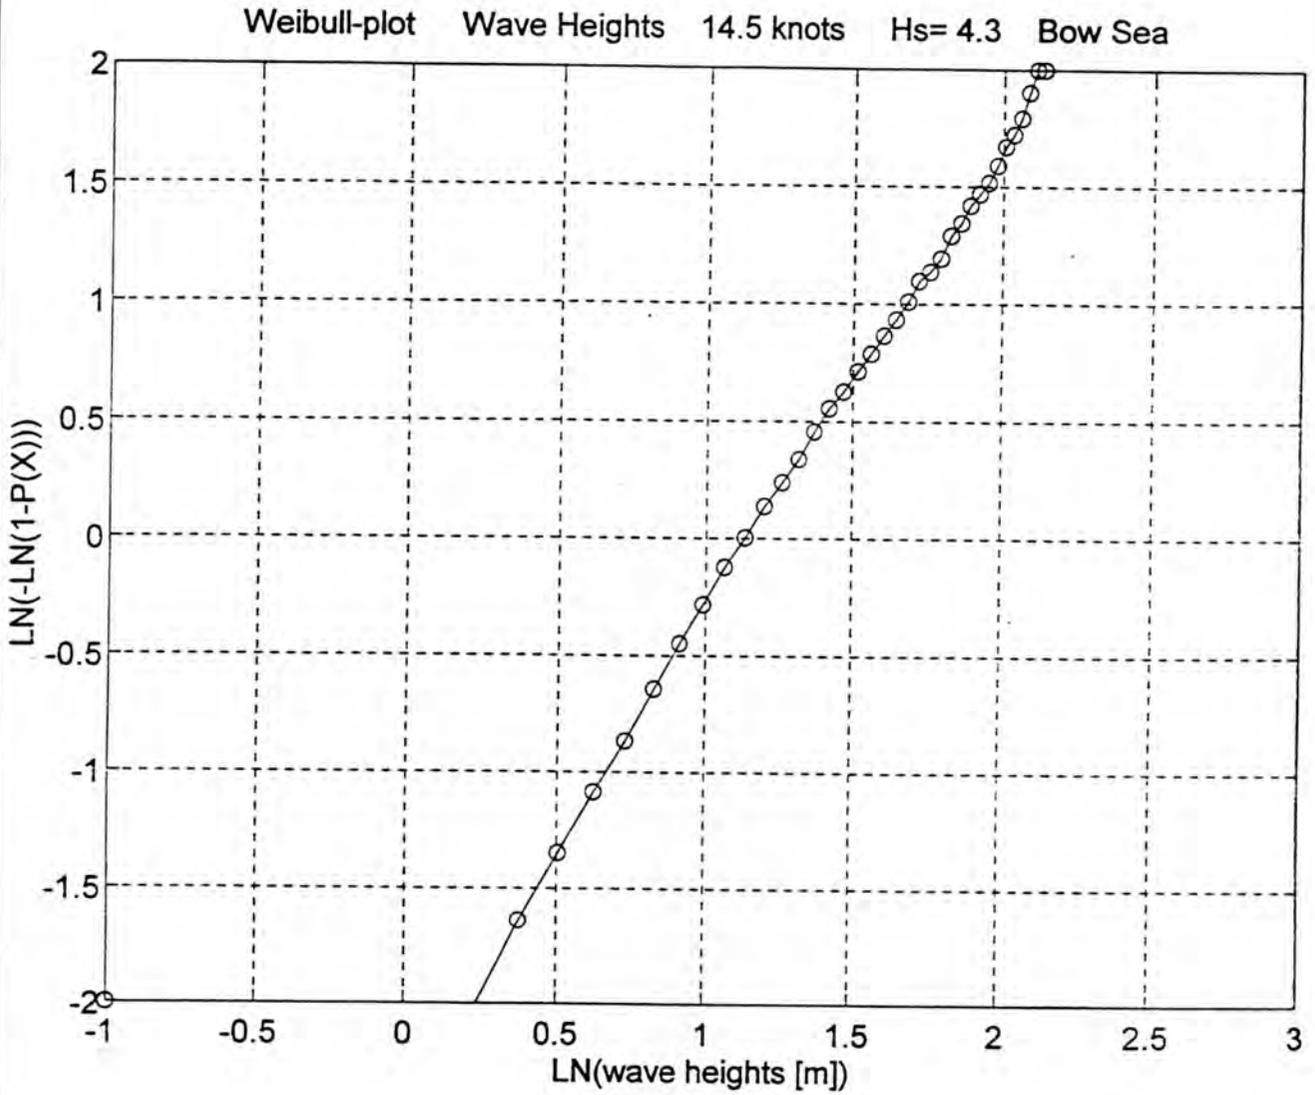
Fig 16a
Report 7524

M/S Estonia
MDL tests in irregular sea
Weibull diagram from run 67-116:
Wave height
Speed 14.5 knots in bow sea $H_s = 4.3$ m

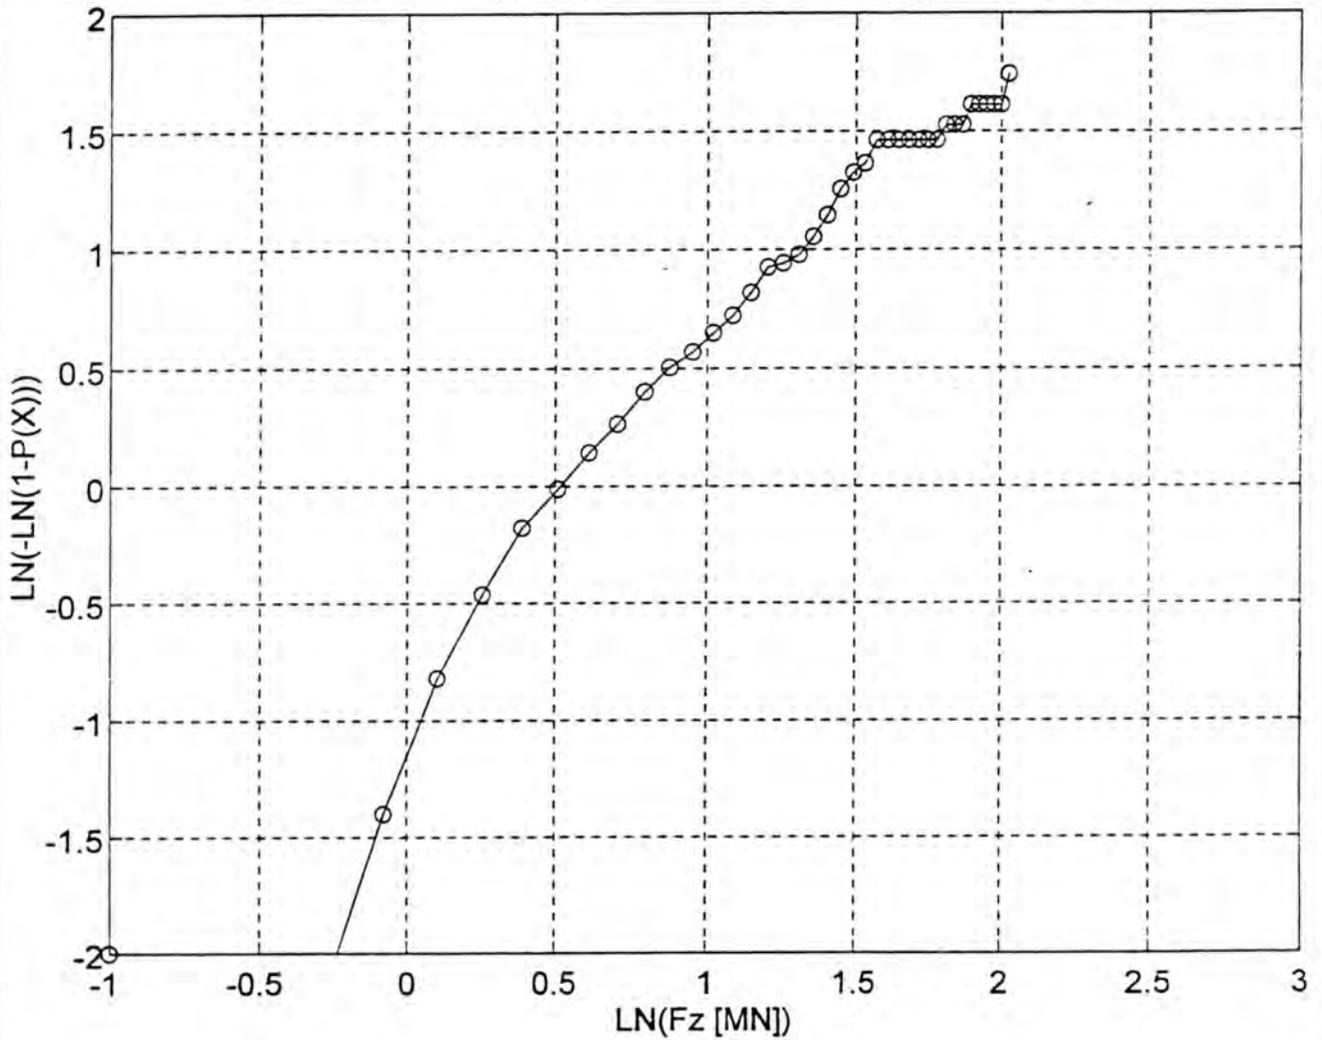
Fig 16b
Report 7524

M/S Estonia
MDL tests in irregular sea
Weibull diagram from run 67-116:
Vertical (Z) force on visor
Speed 14.5 knots in bow sea Hs= 4.3 m

Weibull-plot Z-forces 14.5 knots Hs= 4.3 Bow Sea

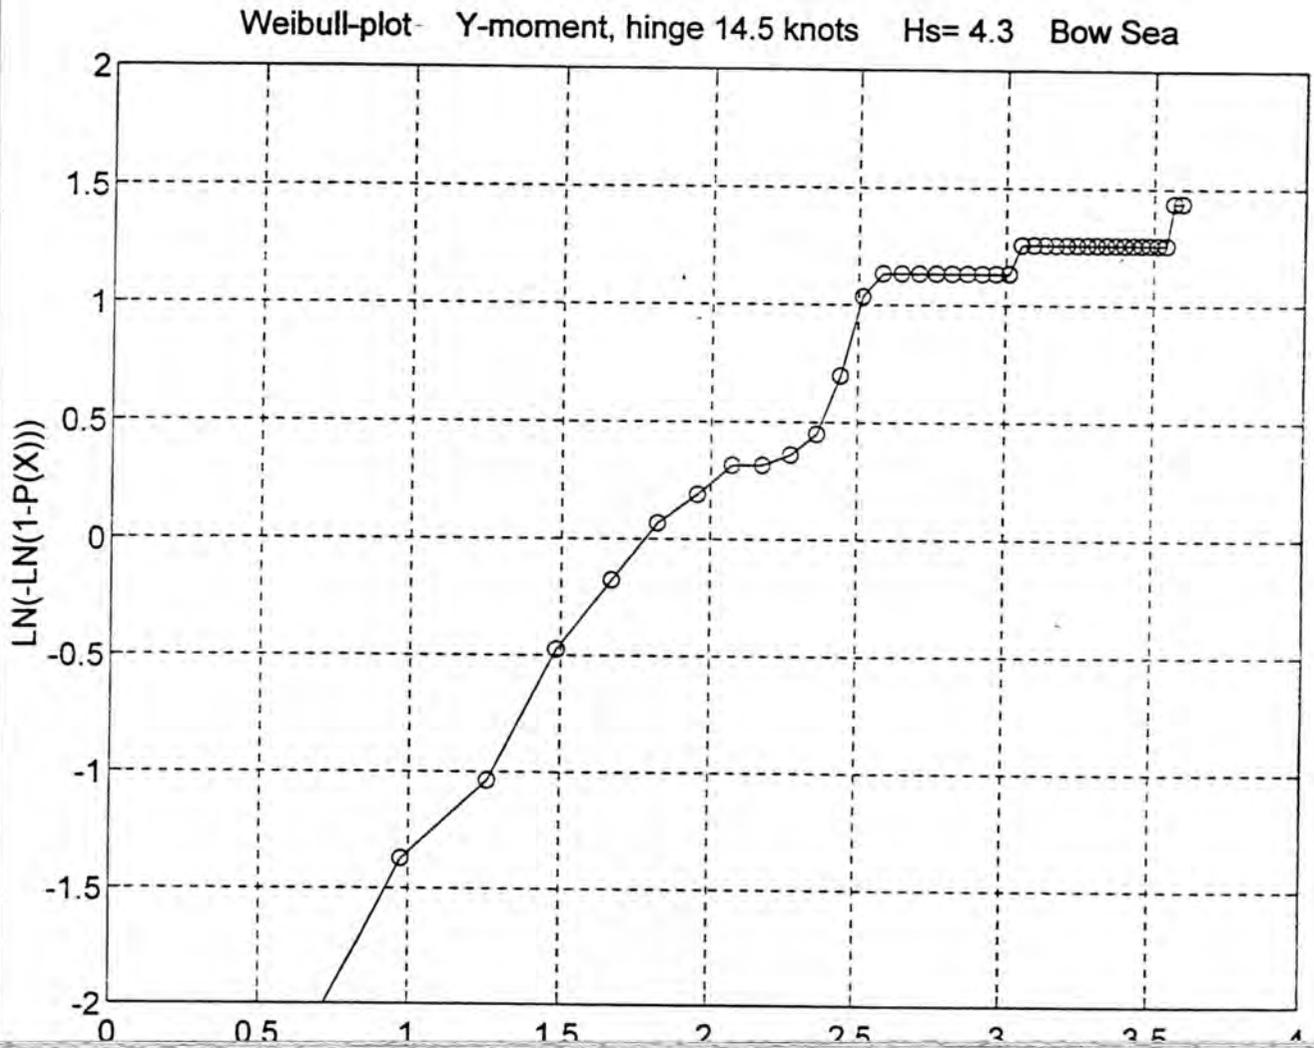
Fig 16c

M/S Estonia
MDL tests in irregular sea
Weibull diagram from run 67-116:
Deck hinge (Yh) moment
Speed 14.5 knots in bow sea Hs= 4.3 m

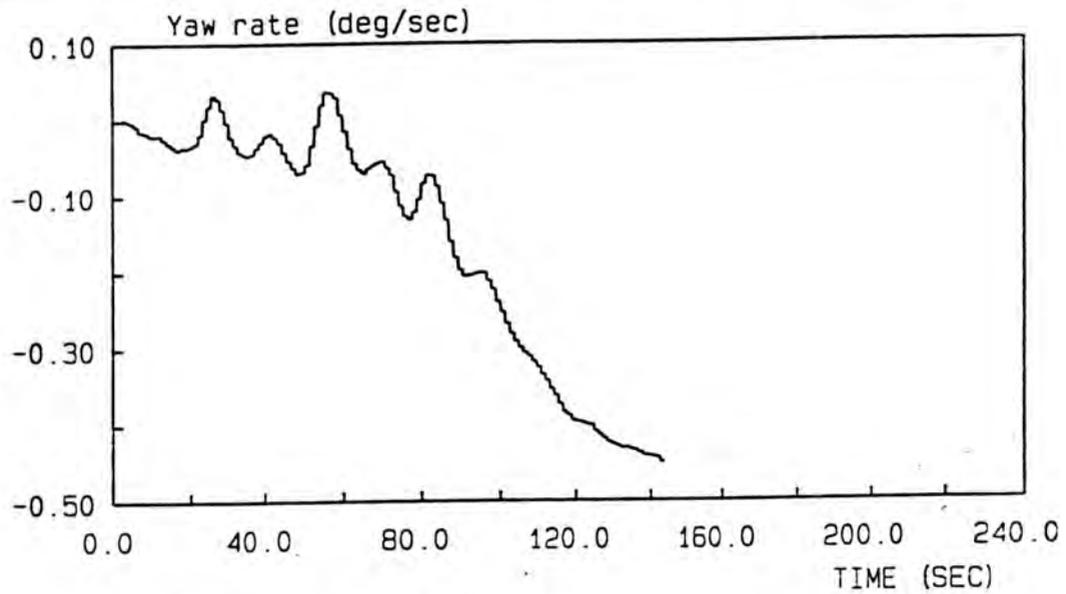
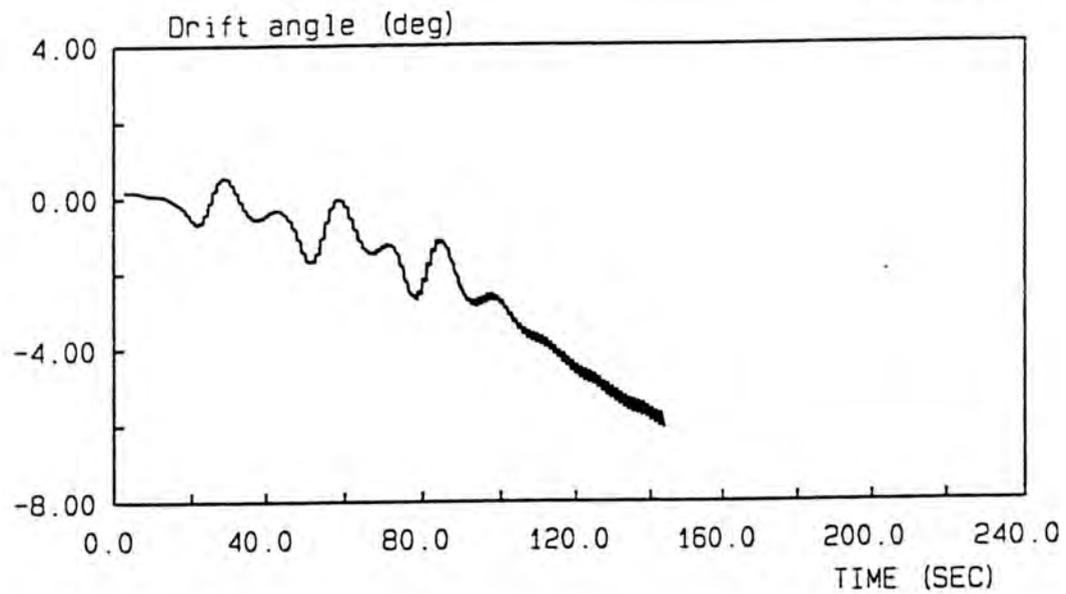
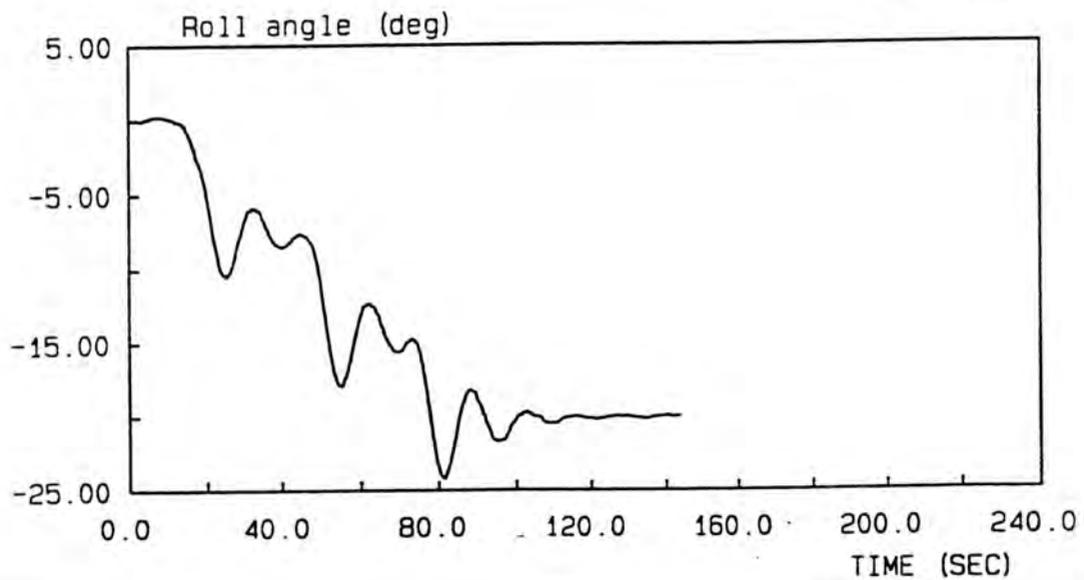
Fig 20b

Manoeuvring test in calm water
Run 26: Heel angle 21.5 deg
Speed 14.5 knots - zero rudder

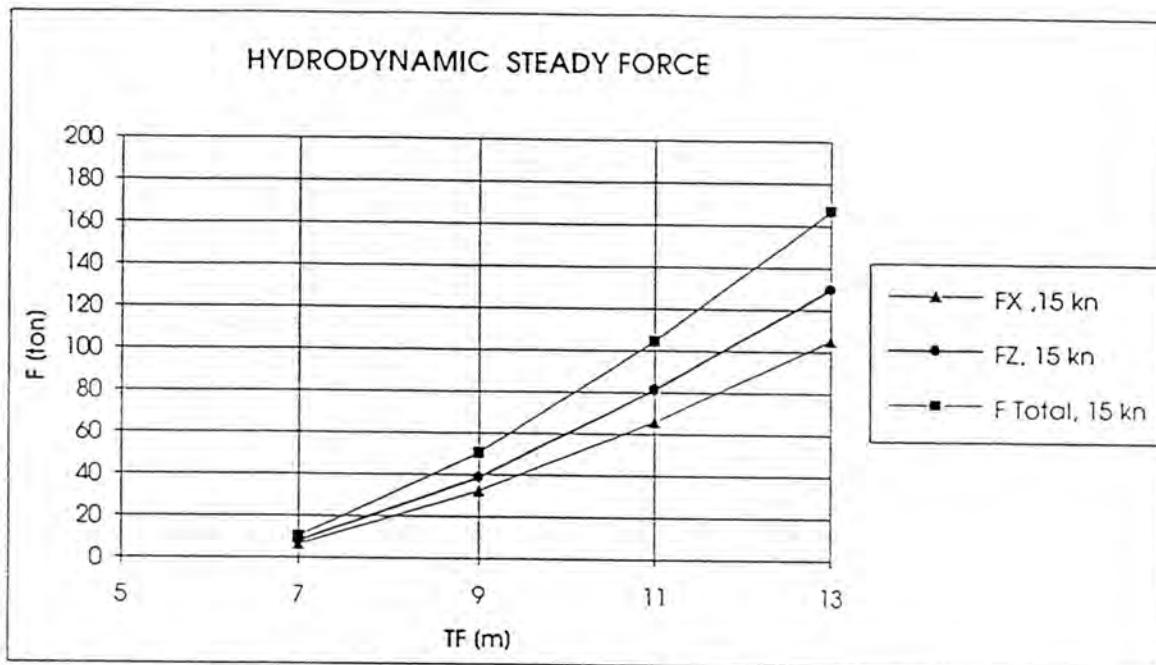
The pressure force on the bow visor and its horizontal (FX) and vertical (FZ) components at different bow submergence when the velocity is 15.0 knots is shown in Fig. 1. These results are obtained using the non-linear theory and include the effect of the bow wave.

Fig. 1. The computed hydrodynamic forces on the bow visor.

As seen in the figure the forces seem to vary almost linearly with the bow submergence. The effect of flow velocity is seen in Fig. 2. The force velocity coupling is larger than $F \propto V^2$.

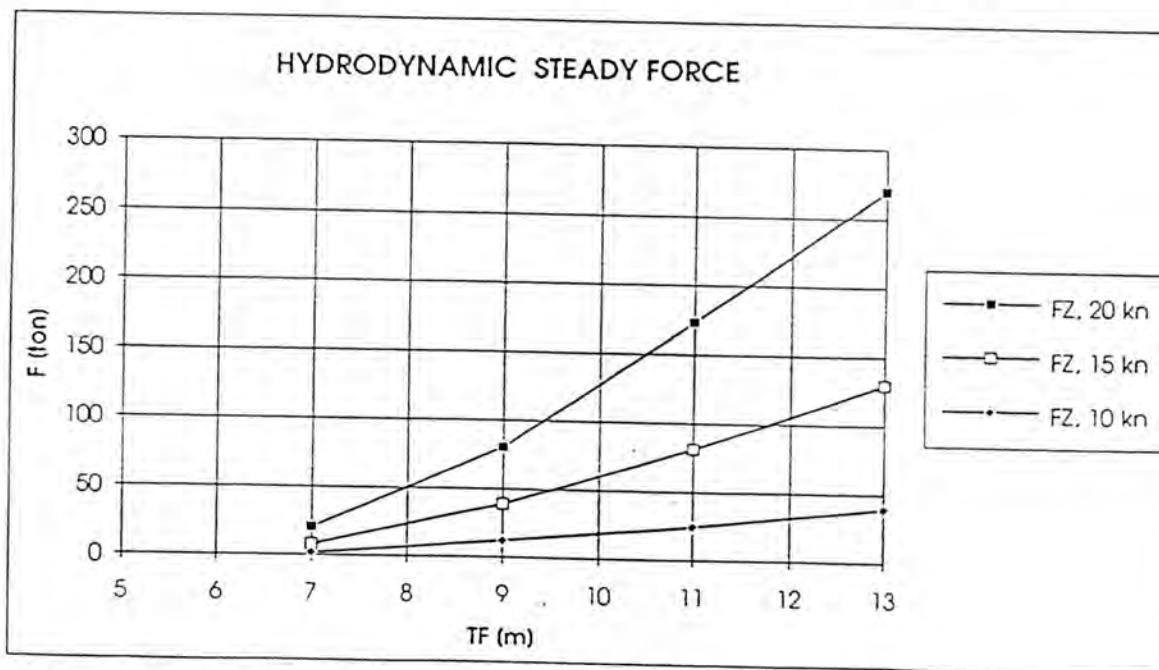
Fig. 2. The effect of flow velocity on the vertical force

Combining the data of figures 2,3 and 4 it is possible to estimate the approximate total vertical force in stationary flow. The estimate in Fig 5 is somewhat conservative, as the submergence of the visor is taken simply as a sum of the bow draft and swellup. In reality the maximum swellup is a local value, also the breaking of the bow wave would probably decrease the bow wave height.

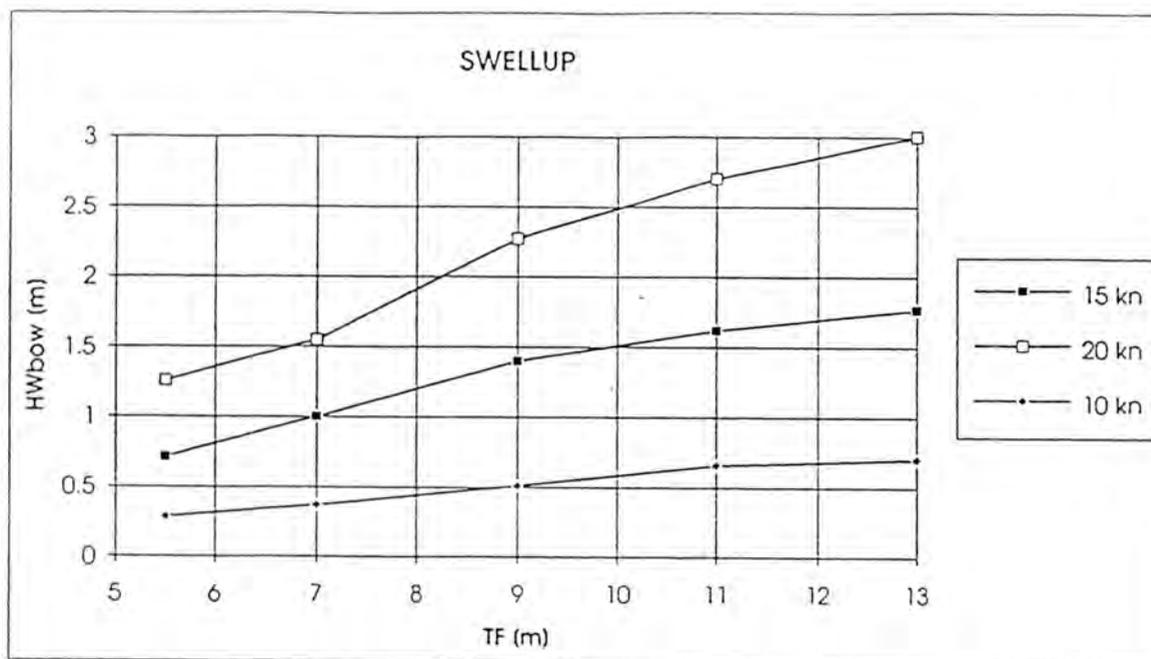
The swellup or bow wave height for the different submergence when the speed is 10.0 15.0 and 20 knots is shown in Fig. 3. In reality the bow wave will brake and it is questionable to what extent if it has time to grow to these heights in a dynamic situation.

Fig. 3. The bow wave height as a function of submergence and speed

As the swellup is a function of speed the hydrostatic force is also affected by speed. The computations indicate a bow wave height up to 3.0 meters, in the most severe condition. In some cases the increase of submergence due to the bow wave could more than double the displaced volume of the visor.

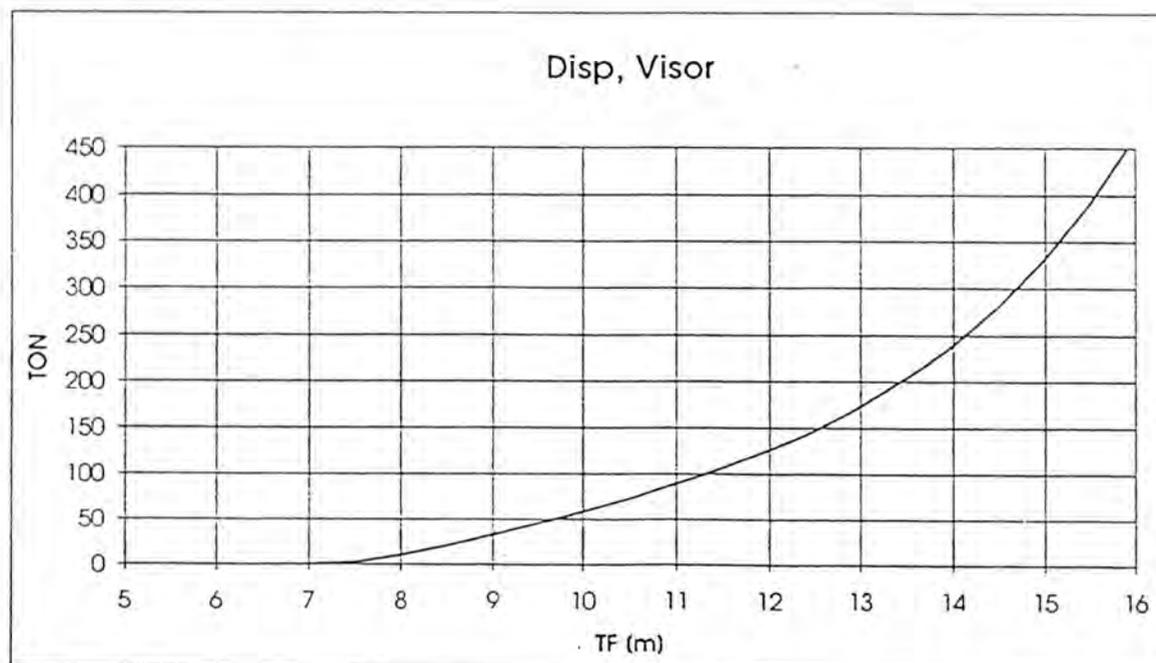
The submergence of the visor and the swellup in the bow results in a large hydrostatic force. In Fig. 4 the hydrostatic lifting force is plotted as a function of bow submergence. The volume shown in this figure is based on the actual visor geometry not the approximation used in the flow computations.

Fig. 4 The hydrostatic lift of the visor as a function of bow-submergence

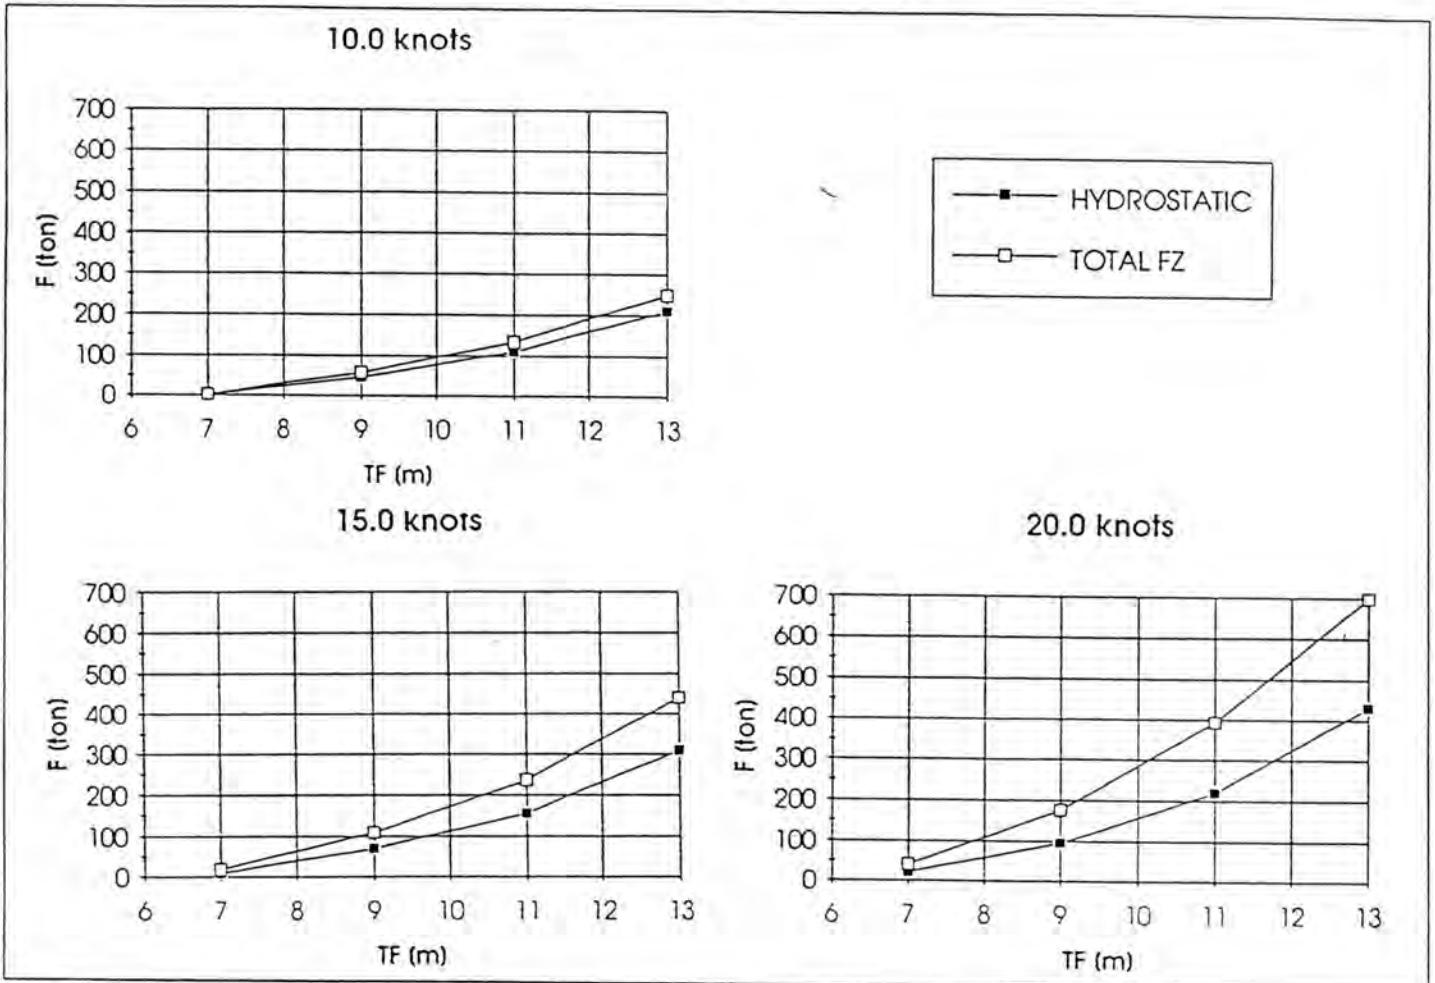
Fig. 5. The total steady vertical force, including both hydrodynamic and -static forces

In the most severe case when the visor is completely submerged the total computed vertical force is up to 700 tons.

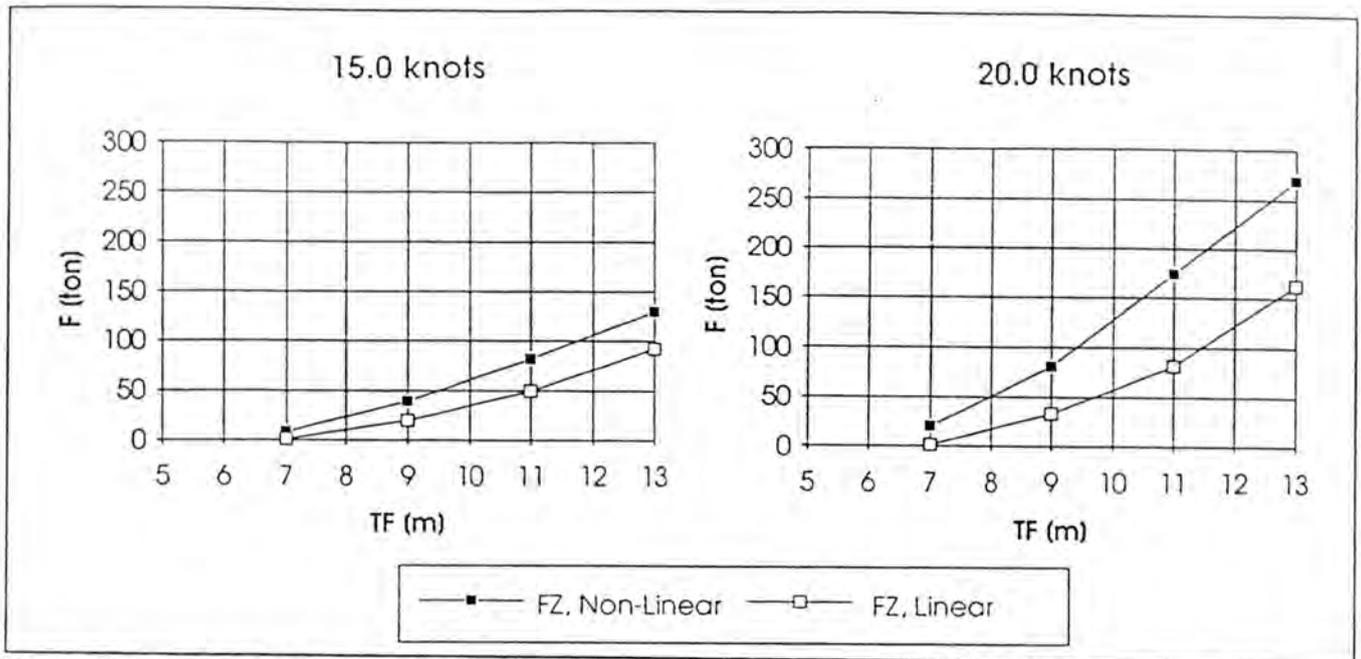
As it is doubtful to what extent the dynamic swellup will develop some results without the bow wave is also presented. In these results the undisturbed free-water surface is taken as a symmetry plane and no swellup is taken into account. The computed hydrodynamic lift for the linear and non-linear cases is plotted in Figure 6.

Fig. 6. Comparison of the non-linear and linear steady hydrodynamic lift for both 15.0 and 20.0 knots
