THE FINAL REPORT ON THE CAPSIZING ON 28
SEPTEMBER 1994 IN THE BALTIC SEA OF THE
RO-RO PASSENGER VESSEL MV ESTONIA

The Joint Accident Investigation Commission
of
Estonia, Finland and Sweden

The Joint Accident Investigation Commission publishes in this Supplement the most important documents used in Commission's work. Large appendices of some research reports have been edited, but a list of appendices has been included.

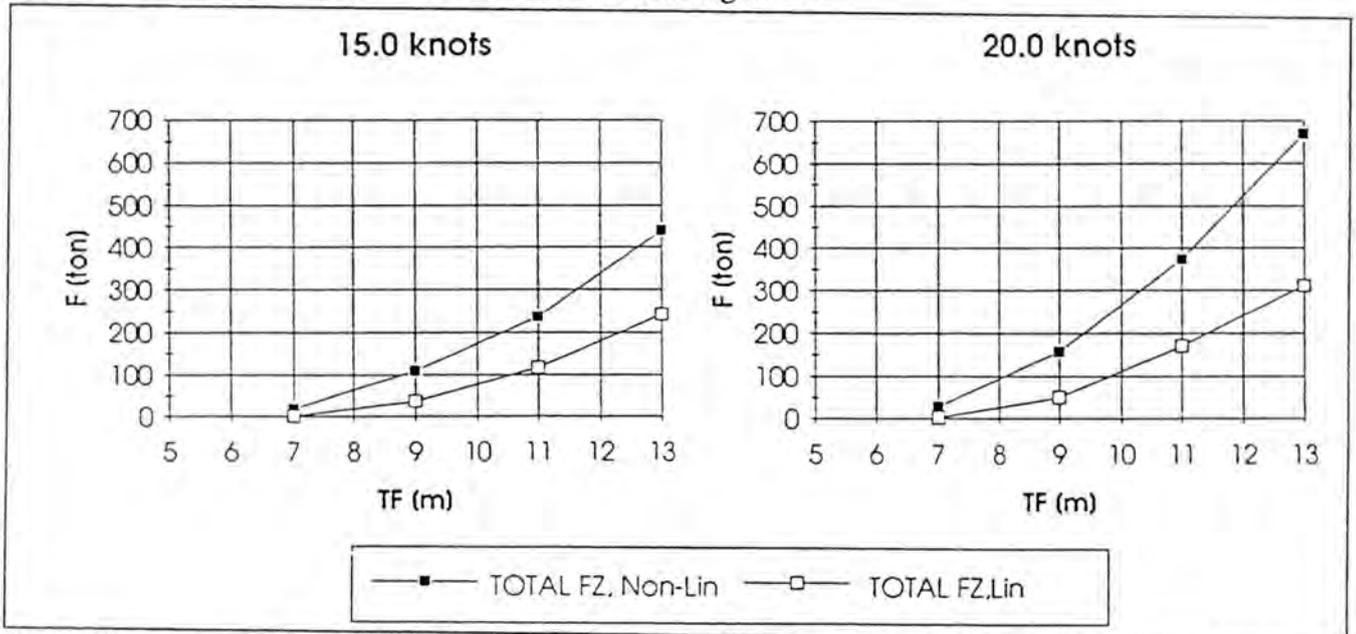
The bow wave increases in size with speed and thus also the difference between the linearly and non-linearly computed vertical hydrodynamic forces. The size of the bow wave also affects the displaced volume greatly. The effect of overlooking the bow wave is shown in Figure 7.

Fig. 7. Comparison of the non-linear and linear steady total vertical force for both 15.0 and 20.0 knots

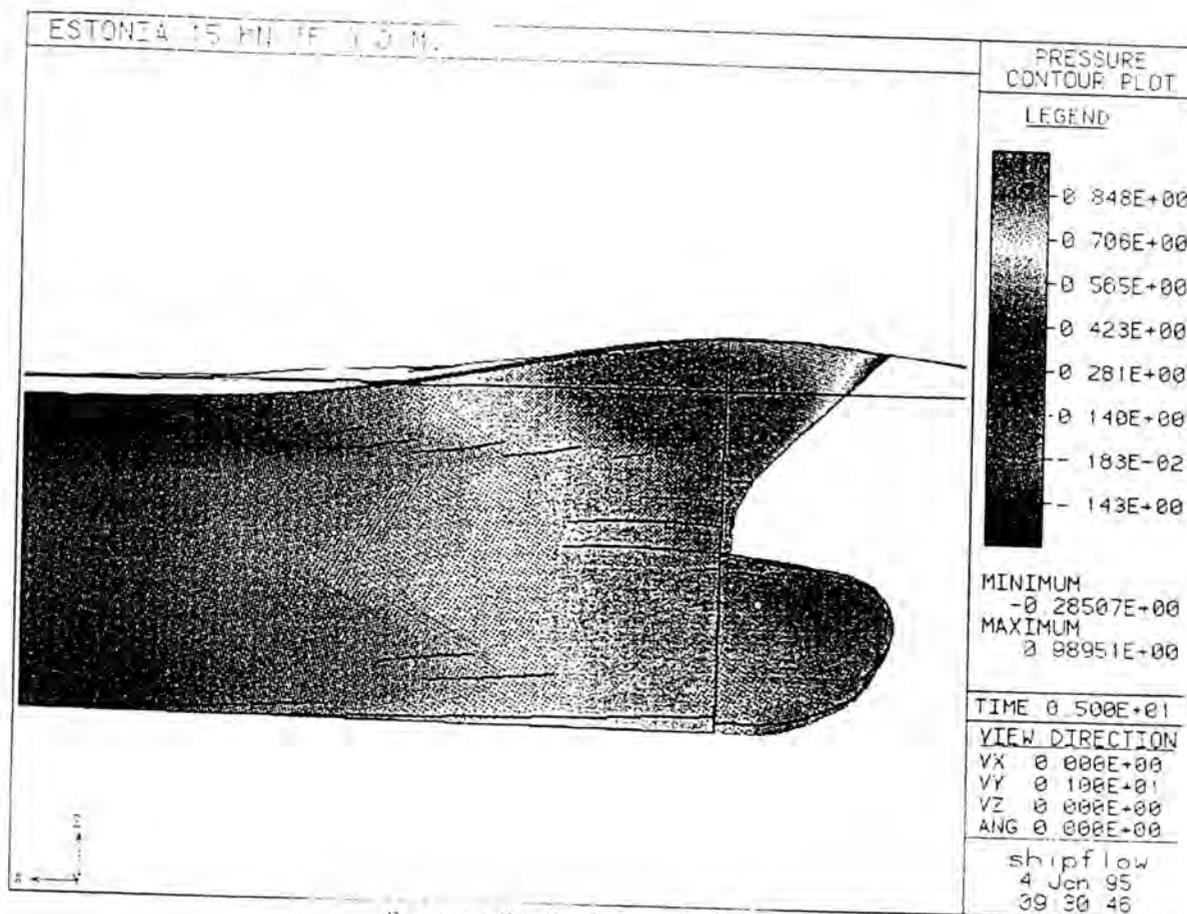
SPEED: 15.0 knots, TF: 9.0 m

Pressure distribution on the bow

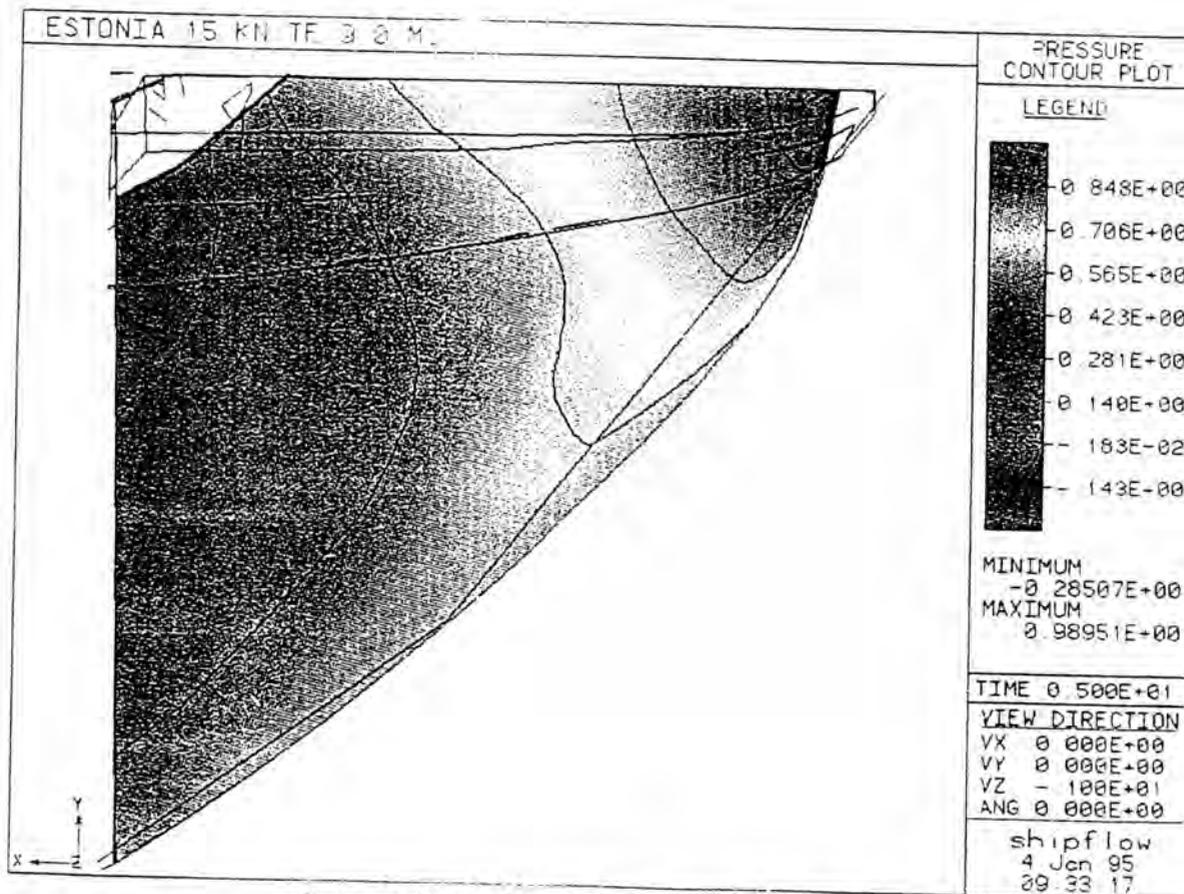
Pressure distribution on the visor, seen from above

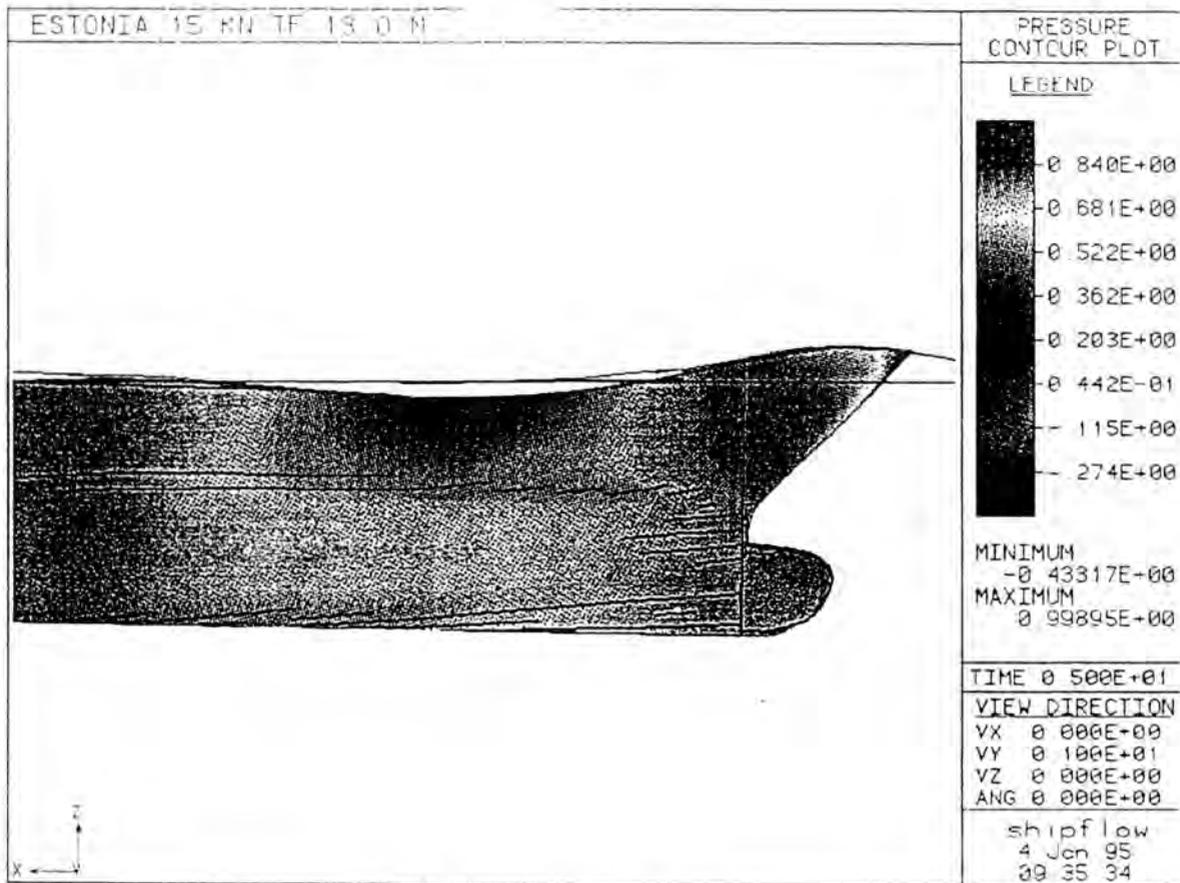
SPEED: 15.0 knots, TF: 13.0 m

Pressure distribution on the bow

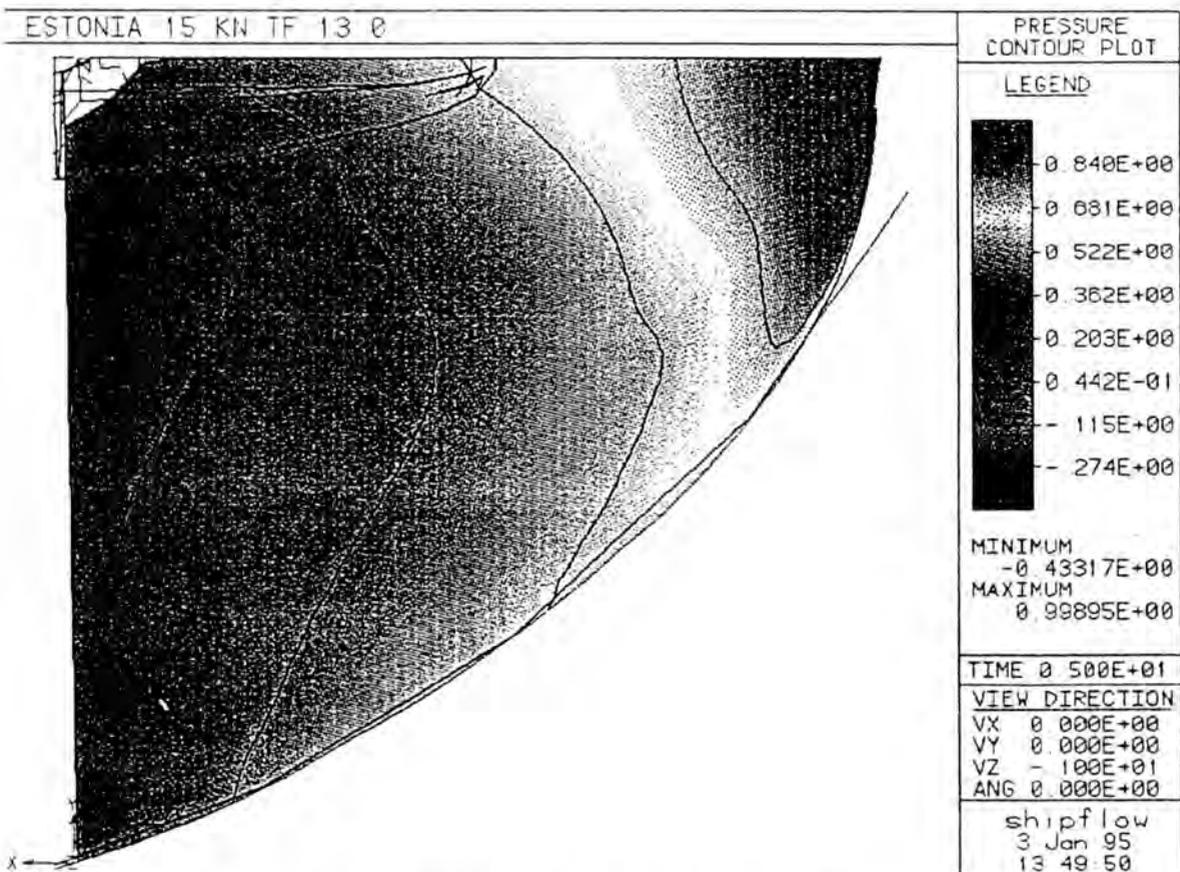
Pressure distribution on the visor, seen from above

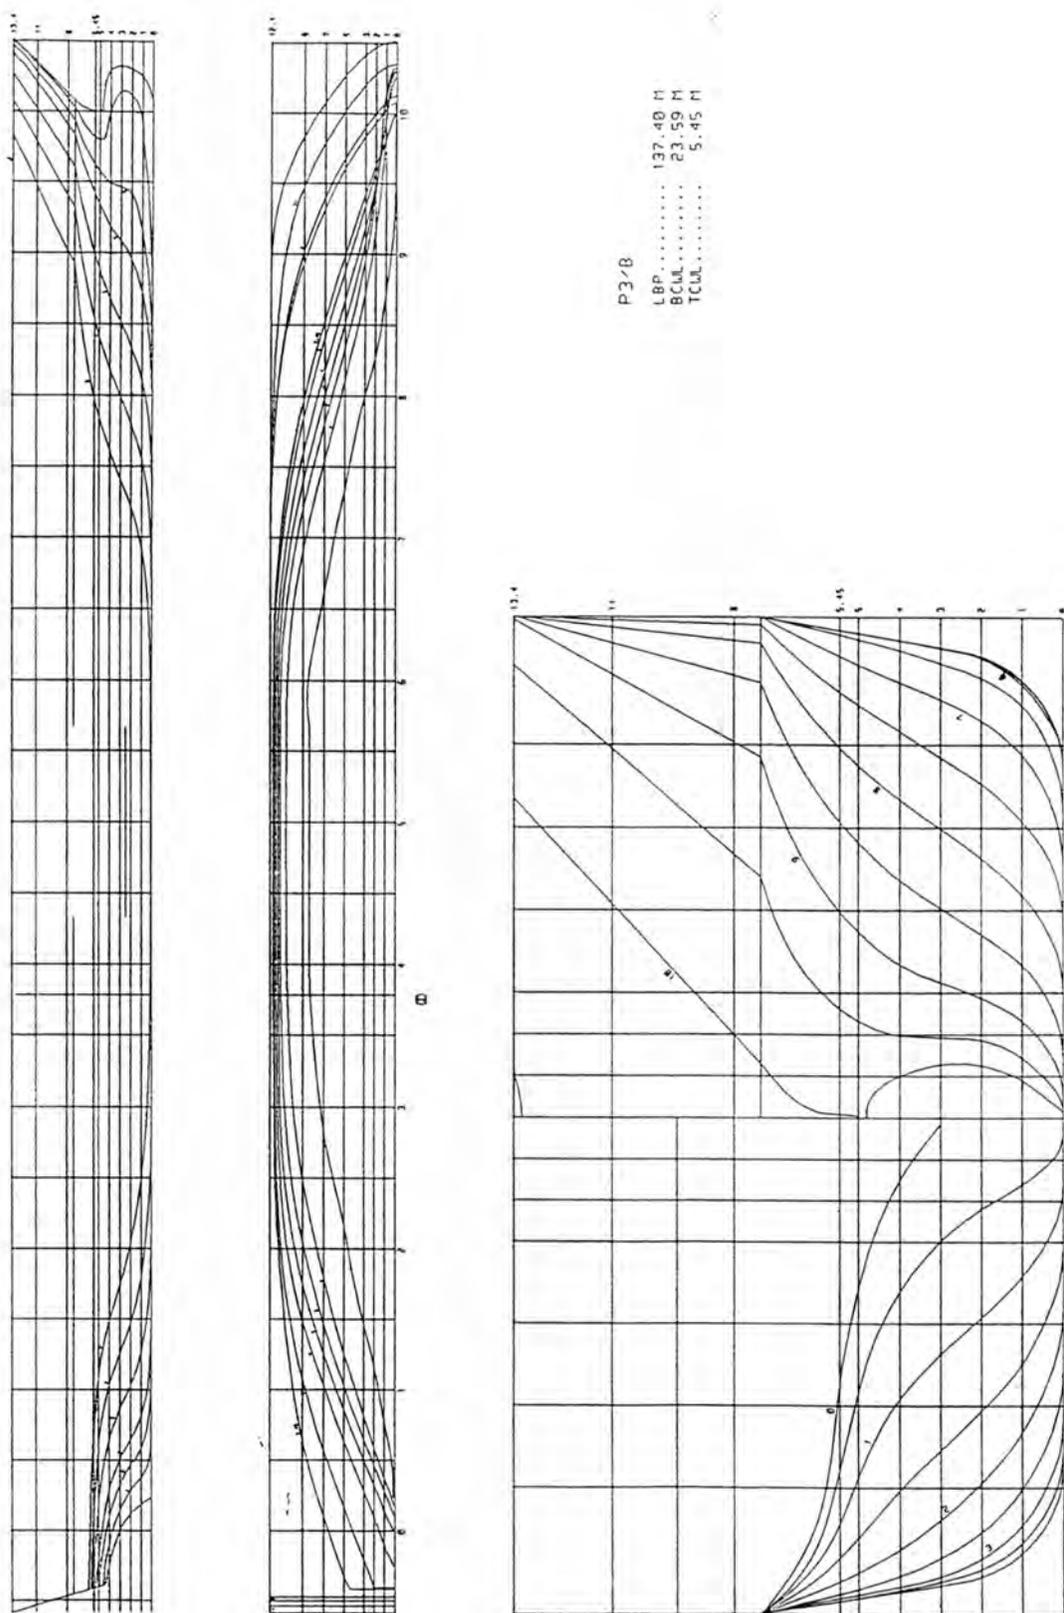
Figure 2.1 shows the body plan and lines of MV Estonia. In the numerical predictions, the vessel hull form was defined by 11 and 21 sections. The number of sections had an insignificant effect on the wave-induced motions. Lewis-forms were used in defining the section shapes. Table 2.4 presents a summary of the main particulars of MV Estonia.

Fig. 2.1 Body and lines plan of MV Estonia.

The numerical predictions are for a vessel mean draught of 5.5 m and an aft trim of 0.5 m, i.e. the draft at the forward perpendicular was 5.25 m and at AP 5.75 m. The displacement of 12 365 tons at a water density of 1.01 tons/m³ and the longitudinal centre of gravity were taken from hydrostatic calculations by the NAPA-program. After the predictions had been made, the load condition of MV Estonia during the accident trip was estimated as 12050 tons and 0.435 aft trim. The fore and aft draughts are respectively 5.172 m and 5.607 m. The difference between the actual and the assumed loading condition is so small that it has hardly any effect on the wave-induced motions.

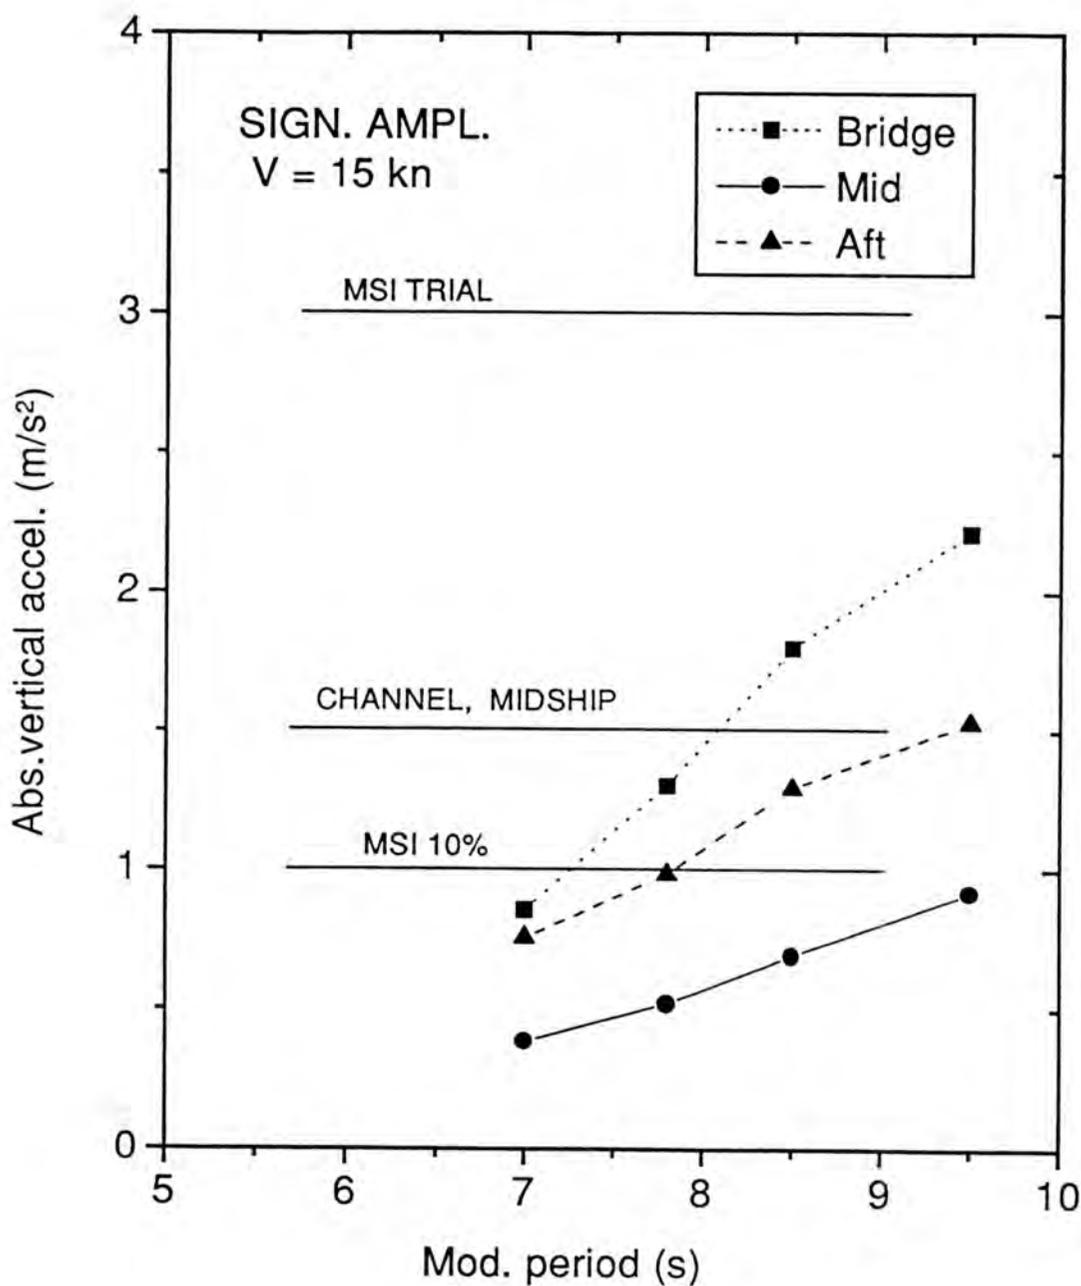
ESTONIA, HEADING 150°, Hs=4m

Figure 3.1 compares the significant vertical accelerations on board MV Estonia to vertical accelerations measured on board some other vessels and to the ISO 2631/3 (1985) motion sickness standard which is based on the limiting Motion Sickness Incidence (MSI) of 10 % amongst the passengers. The corresponding limiting significant vertical acceleration level is 1.0 m/s^2 . On the bridge and in the forward cabins of MV Estonia, the significant vertical acceleration was about 1.5 m/s^2 which is somewhat high from the point-of-view of passenger comfort. About 20 % of the passengers in the foremost cabins may have felt seasick. On the other hand, people tolerate higher vertical accelerations without getting seasick when they are laying in bed than when standing or sitting.

Fig. 3.1 Vertical accelerations on board MV Estonia compared to some other results.

At midship, the acceleration level of about 0.7 m/s^2 significant amplitude was just perceptible and not many people should have felt symptoms of seasickness. At aftship in the cafeteria and restaurant spaces, the significant vertical acceleration was near the ISO 2631/3 limit of 1.0 m/s^2 when about 10 % of standing or sitting people unused to ship motion are seasick (vomiting) after an exposure of two hours. Thus, with regard to the passenger comfort the wave-induced motions of MV Estonia on the accident night after midnight Finnish time were near the comfort limit which is significantly below survival conditions. Before midnight, when the significant wave height was under 3 m, the vertical accelerations on board MV Estonia were at least 25 % lower than just before the accident.

Lawther and Griffin (1986) report on Channel crossings when the significant vertical acceleration at the centre of the ship has been $1.1 - 1.5 \text{ m/s}^2$ and 25 - 35 % of the passengers on board have been seasick (vomiting). Significant vertical acceleration amplitudes of $1.2 - 2.2 \text{ m/s}^2$ have been measured in the foreship on board ms Silja Symphony during a scheduled voyage from Helsinki to Stockholm in heavy bow seas (VTT Report VALC138 dated 12.9.1995). Ikeda and Shirazawa (1994) have observed MSI ratios of 20 to 40 % on board Japanese passenger/car ferries when the significant vertical acceleration has been $2 \text{ to } 4 \text{ m/s}^2$.

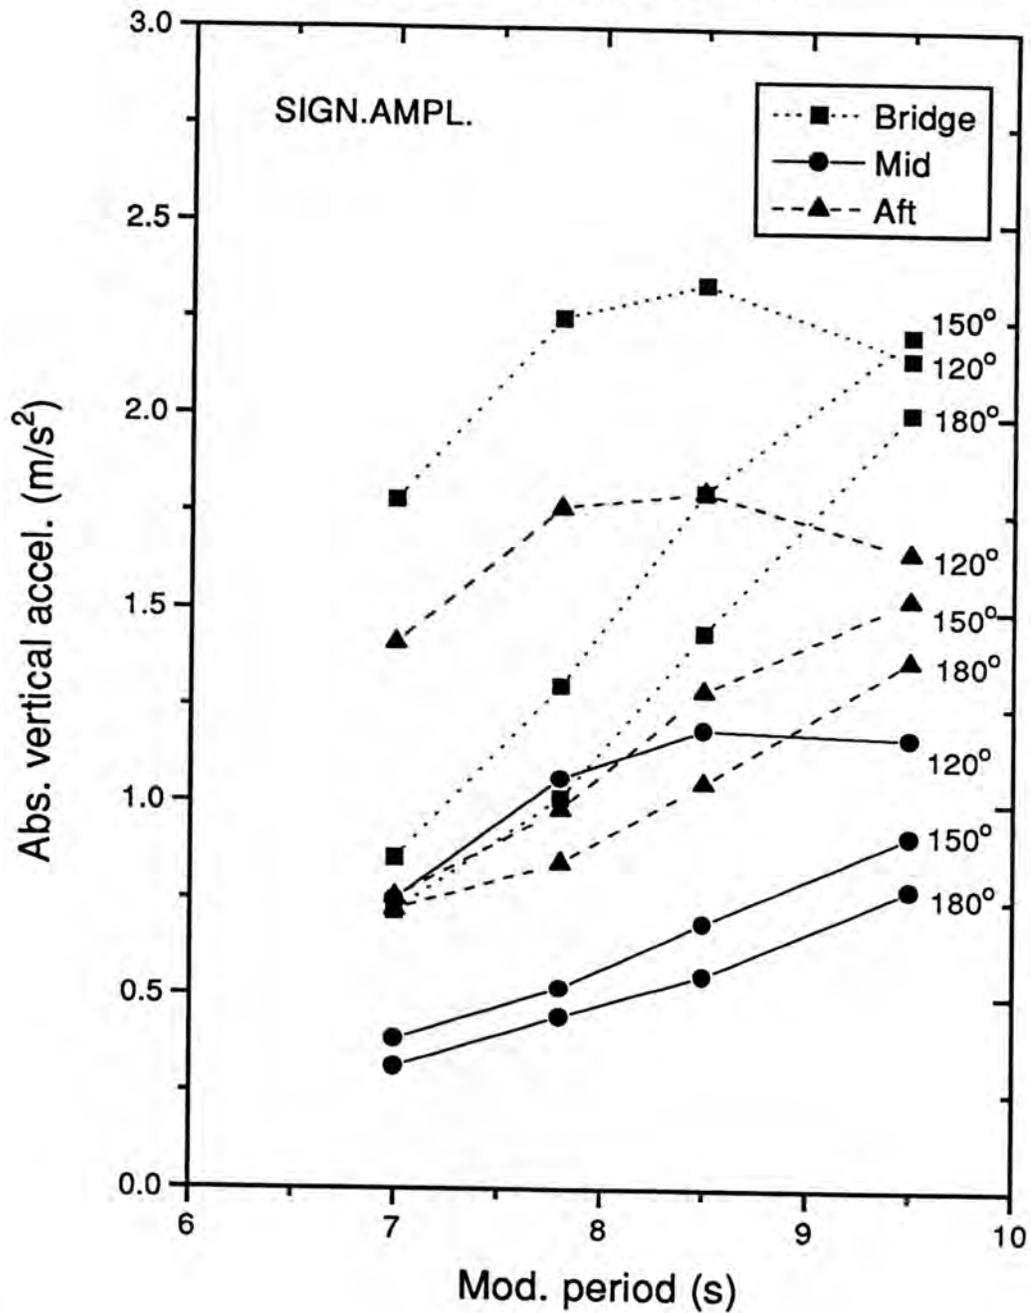
ESTONIA,
SPEED= 15kn, Hs=4m

Fig. 3.2 The effect of heading on the vertical acceleration. JONSWAP spectrum.

If MV Estonia was running in near head seas as assumed, a change of heading or reduction of forward speed would have had only a moderate effect on the vertical acceleration level (Figures 3.2 and 3.3). With a change of heading from bow seas towards beam seas, the accelerations would have increased while by dropping the speed to 7 knots the vertical acceleration level on the bridge would have decreased from about 1.5 m/s^2 to 1.3 m/s^2 . In following seas, the vertical accelerations would of course have been significantly lower.

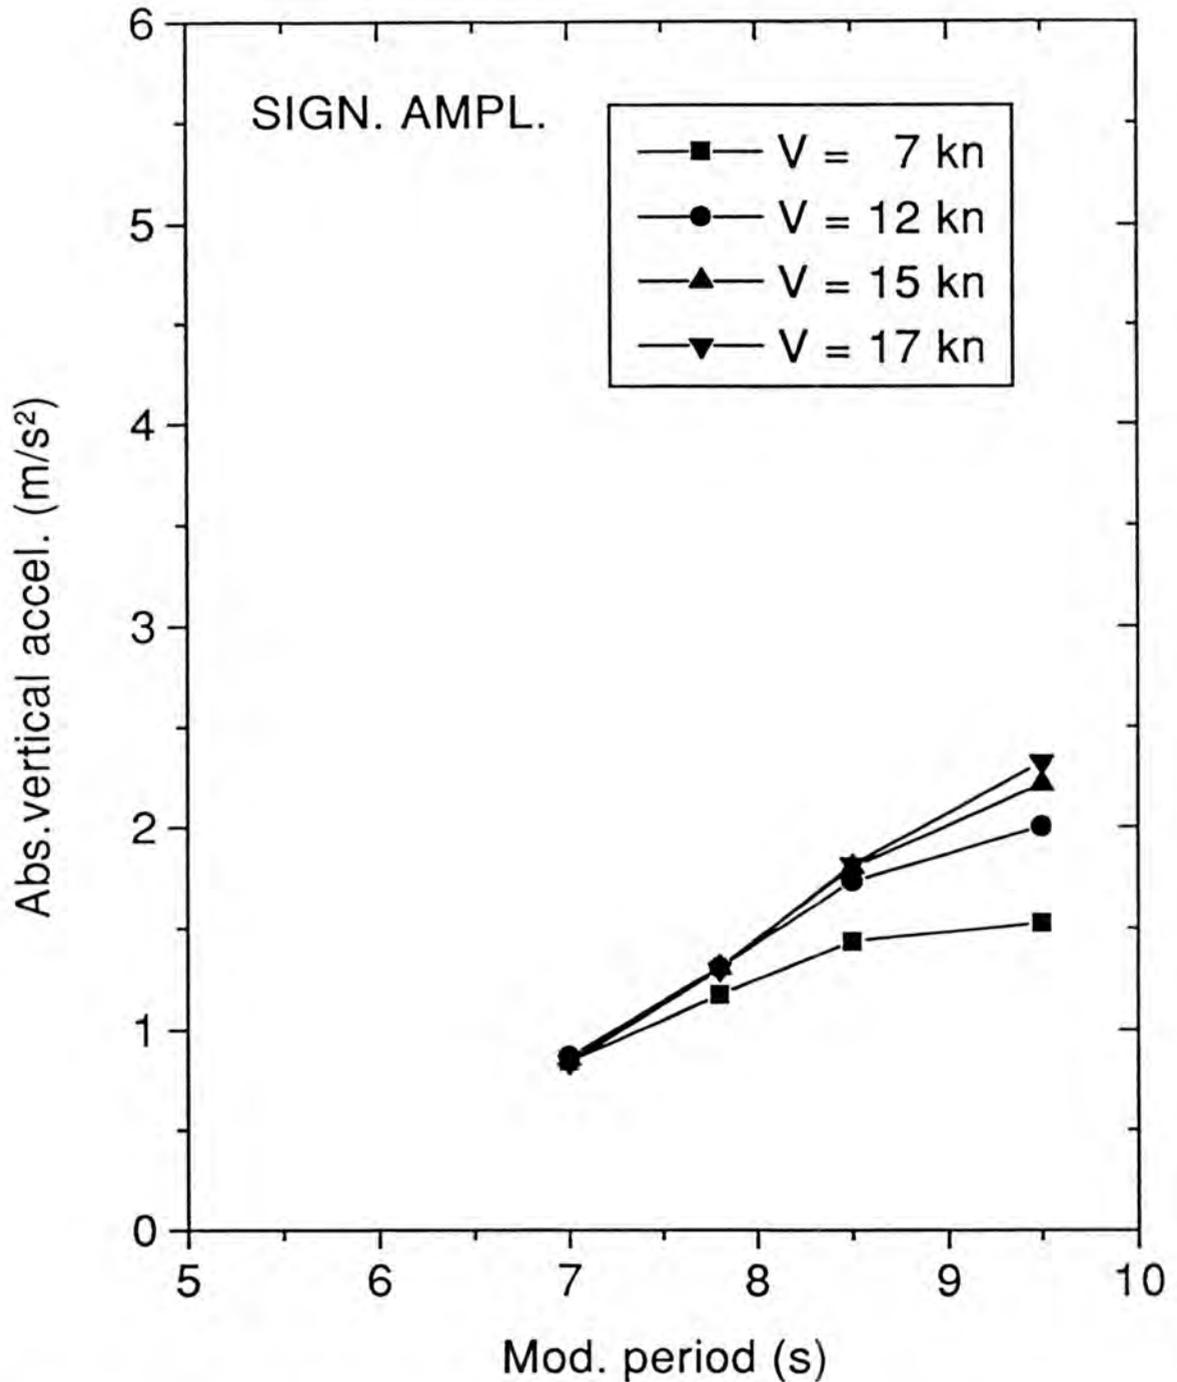
ESTONIA, # Bridge
HEADING 150°, Hs=4m

Fig. 3.3 The effect of speed on the vertical acceleration on the bridge in bow seas.

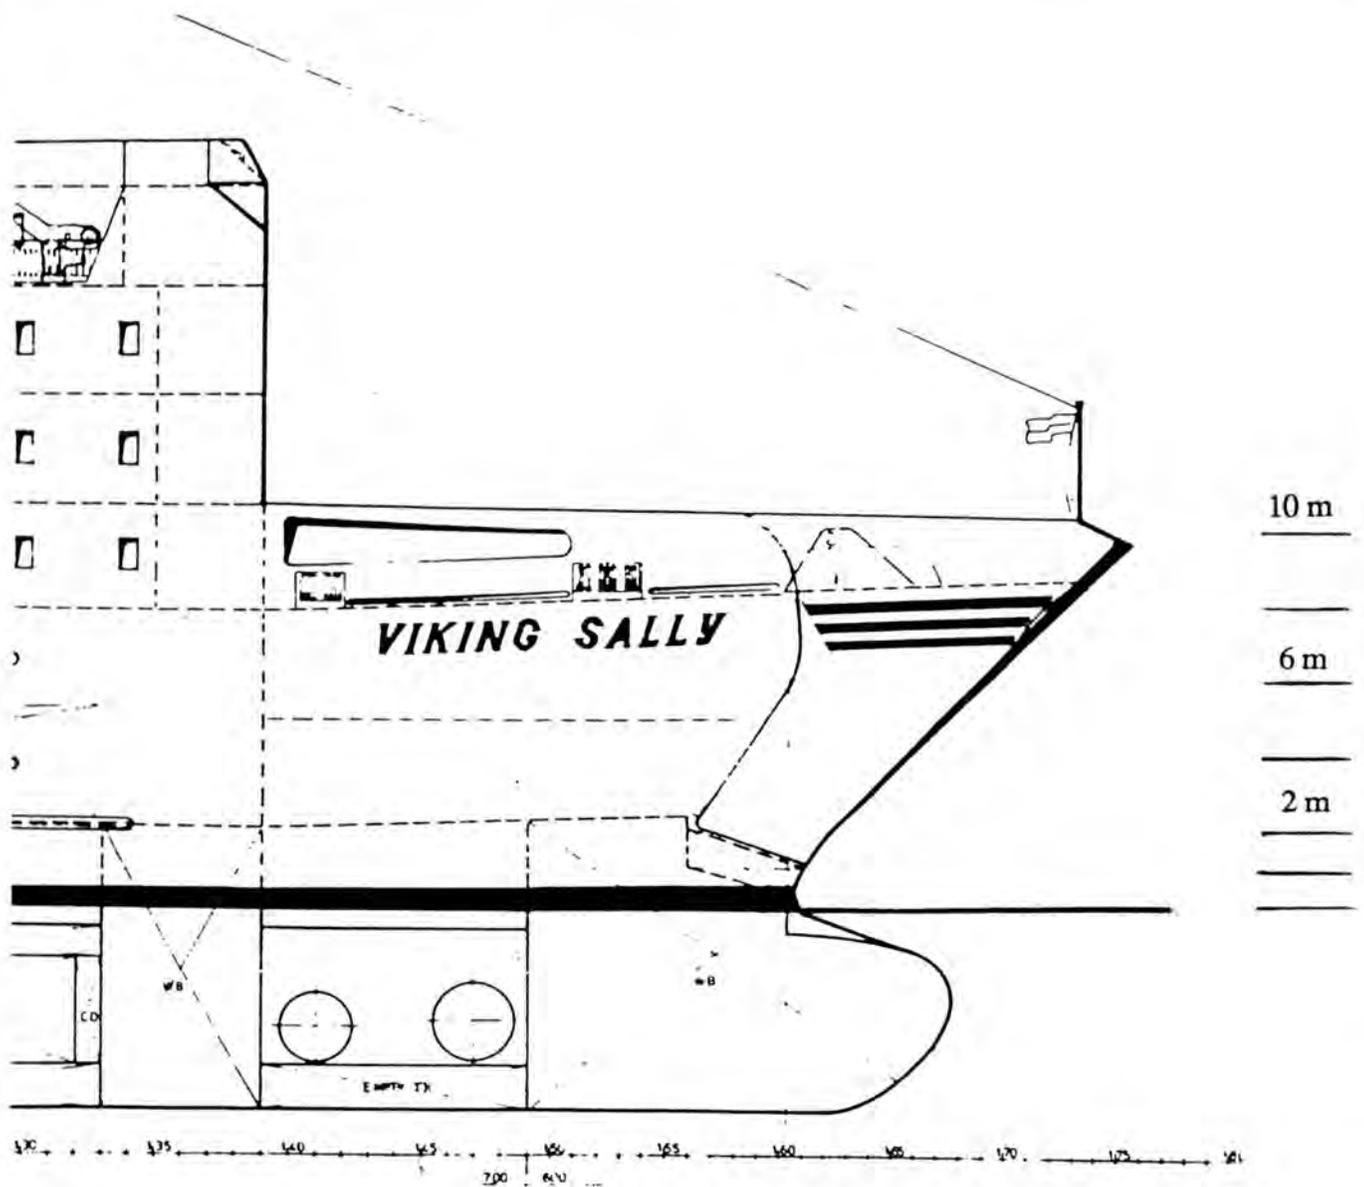
The significant amplitude of the vertical relative motion at the bow visor of MV Estonia was according to the predictions 3 - 4 m. The freeboard to the car deck was about 2.0 m, to the upper edge of the ramp about 7.0 m and to the stemhead about 9.5 m (Figure 3.4). The stationary bow wave may be assumed to reduce these freeboards by 1 m though it is not clear whether the bow wave height should be taken into account.

Fig. 3.4 Bow of MV Estonia.

The water level at bow rose in practice nearly at every wave encounter above the car deck level. One wave in hundred, or about once in five minutes the wave surface reached the level of the upper edge of the ramp opening from where there was still 2.5 m freeboard to the stemhead. With these waves, spray and some water came to the foredeck. The probability of relative motion exceeding the stemhead was about 1/10 000. Thus, it is possible that more water came to the foredeck a few times during the accident voyage.
